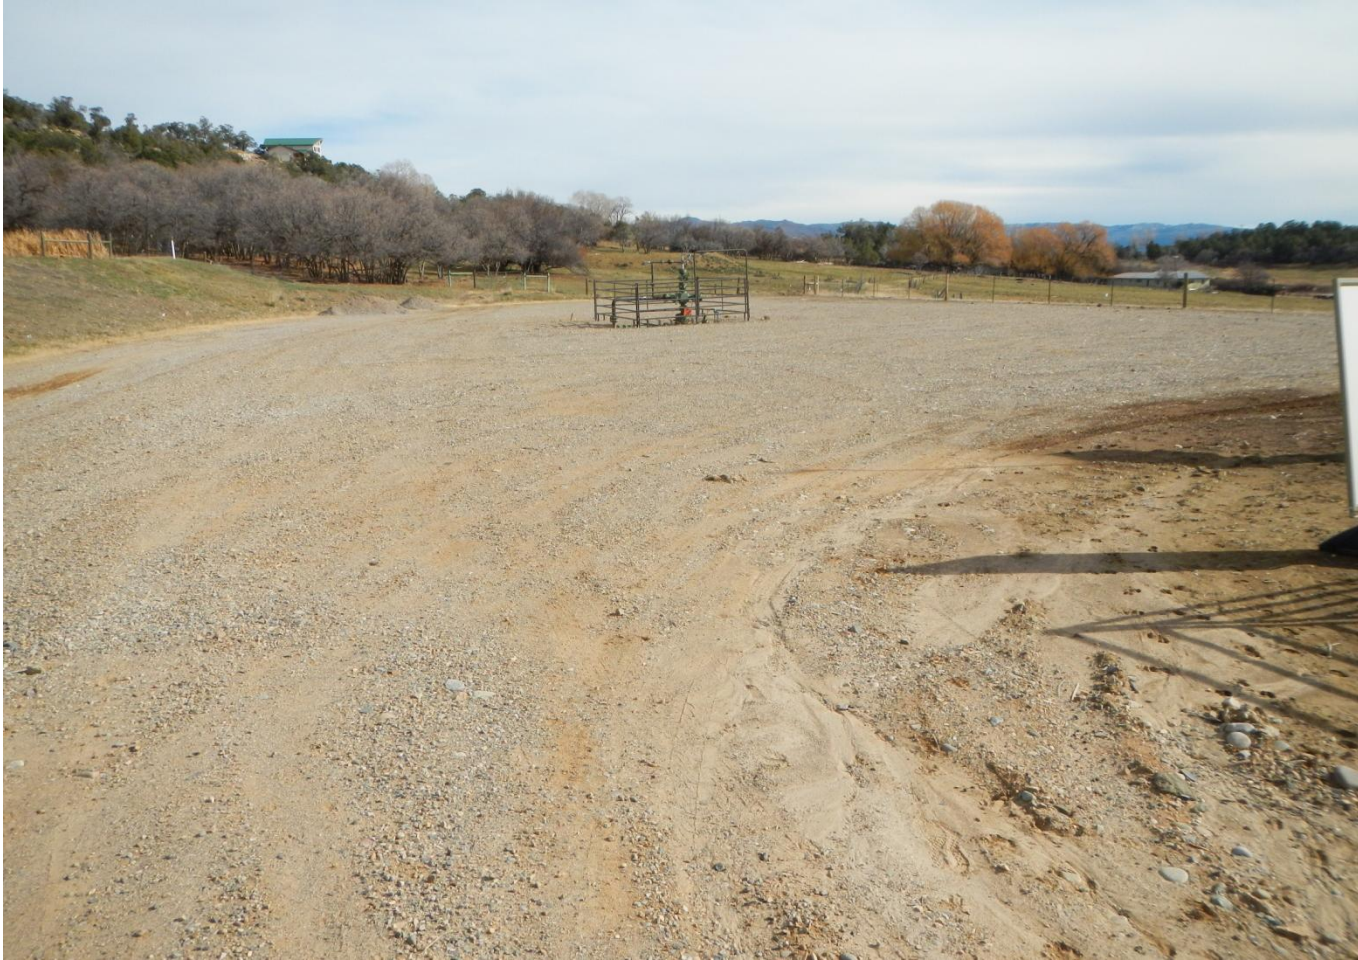
Photo 1. View from well pad entrance to center. One well on location.

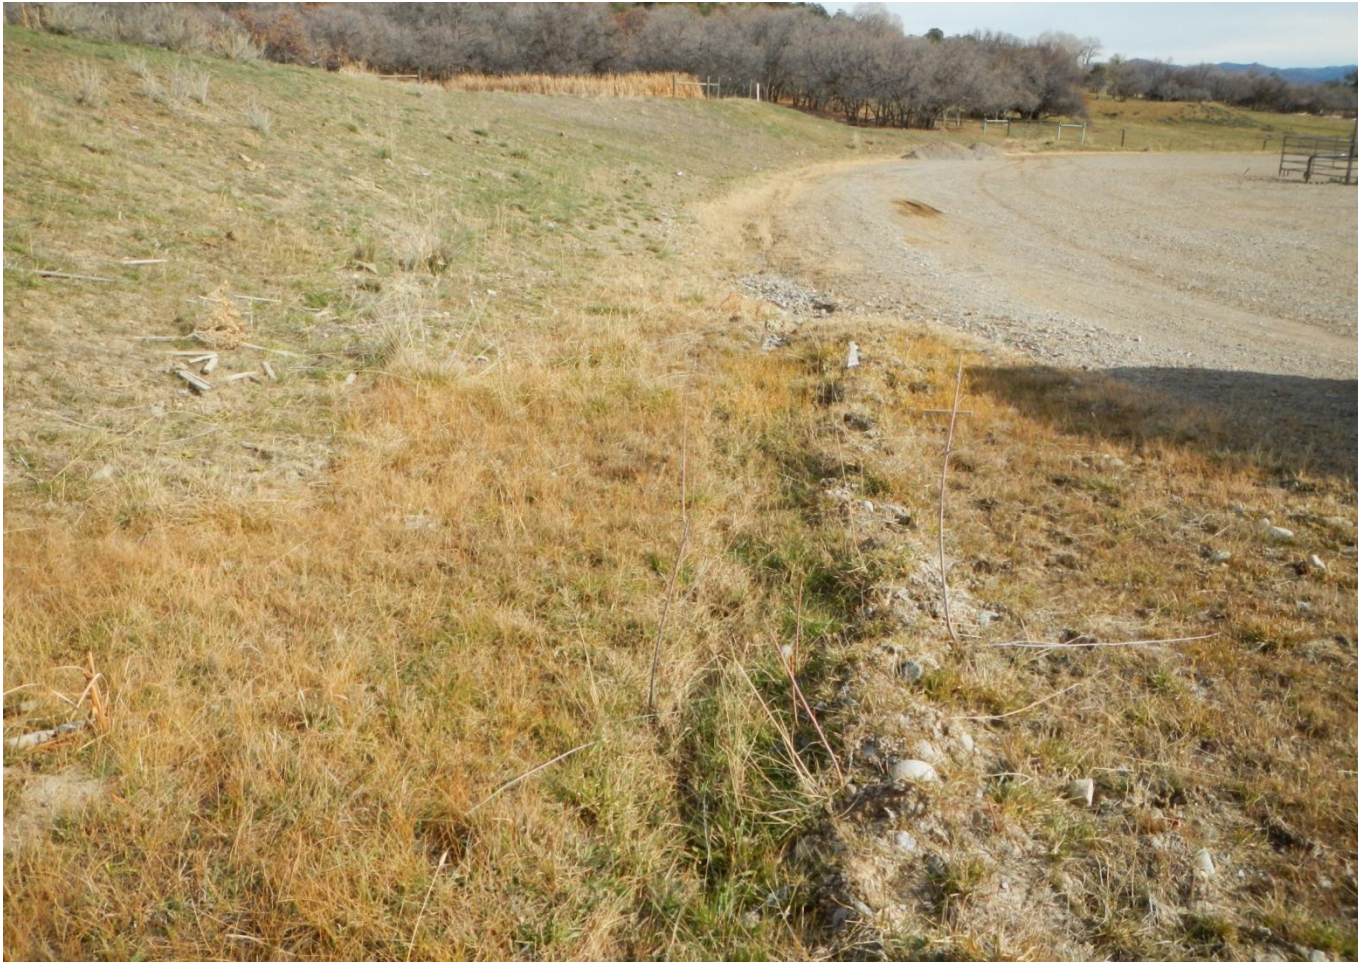
Photo 2. View of vegetated stormwater diversion ditch adjacent to northern edge of working area.

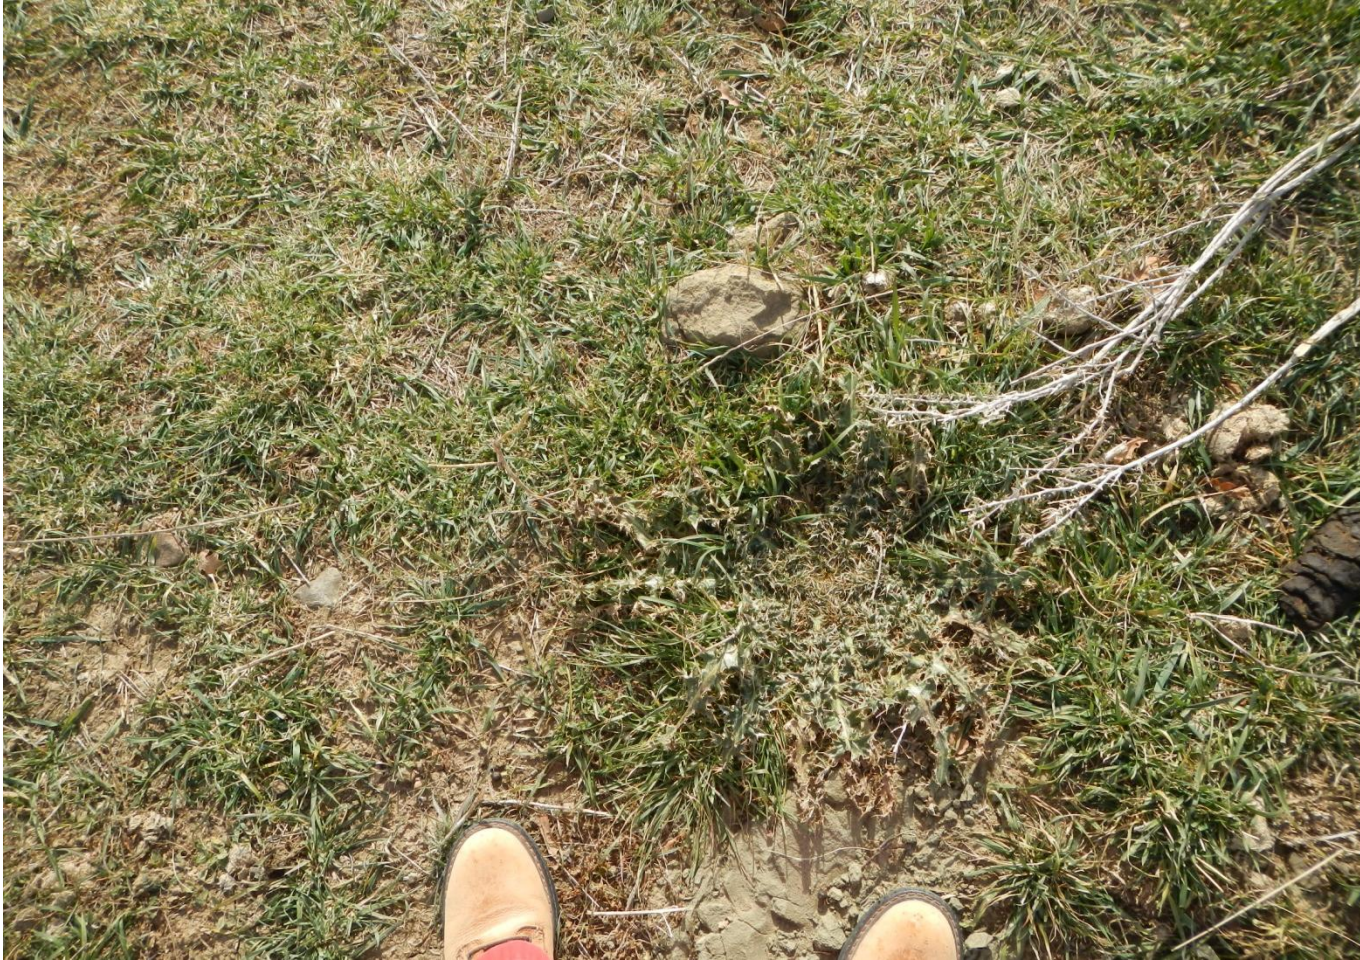
Photo 3. View of thistle rosette in northern portion of project area.

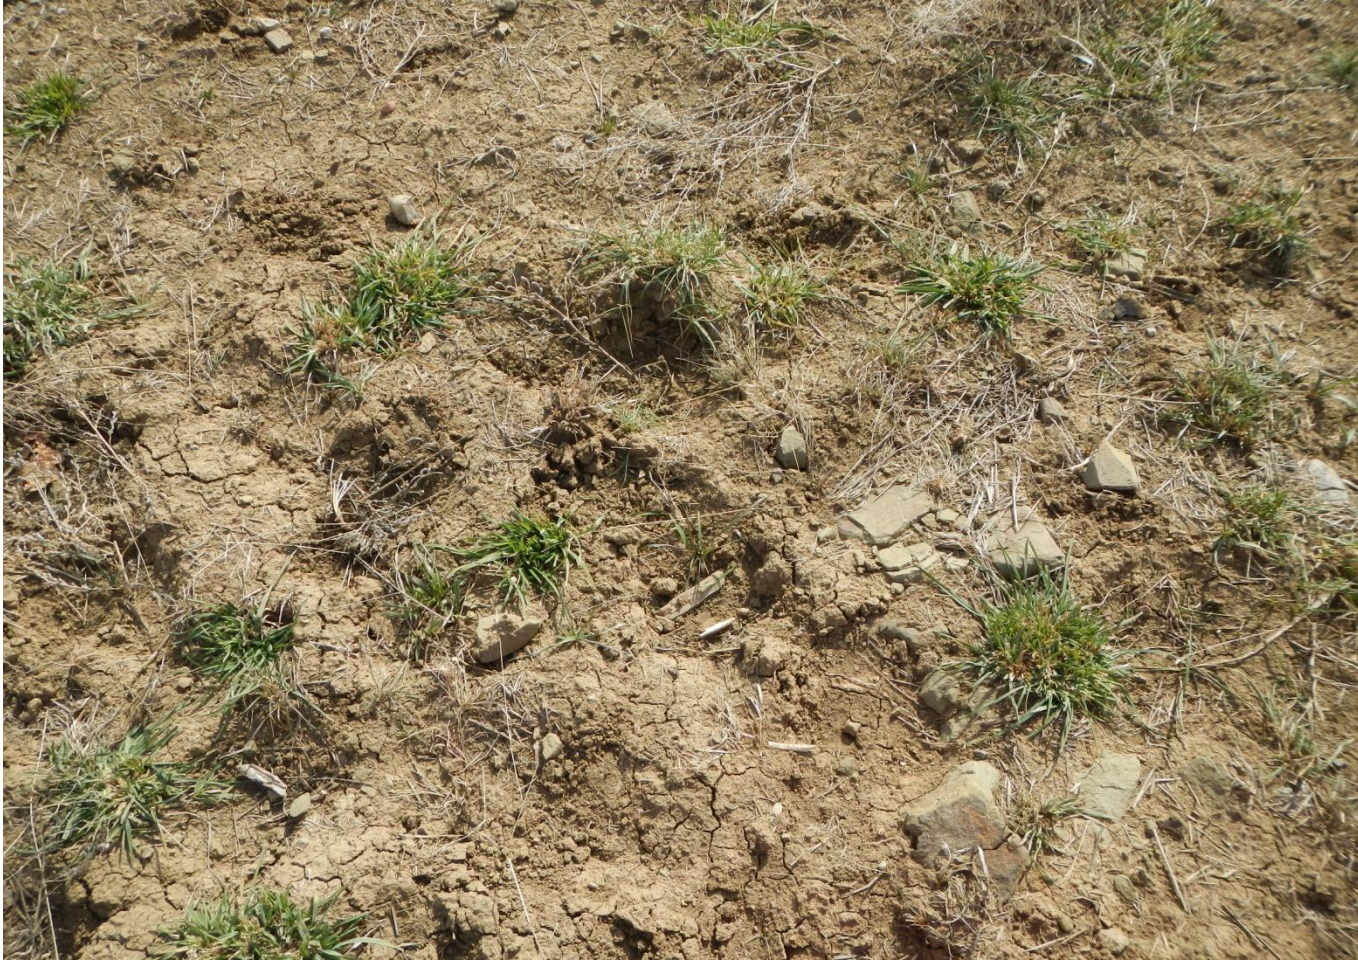
Photo 4. View of vegetation that appears to be stressed by grazing pressure within northern portion of interim reclamation area.

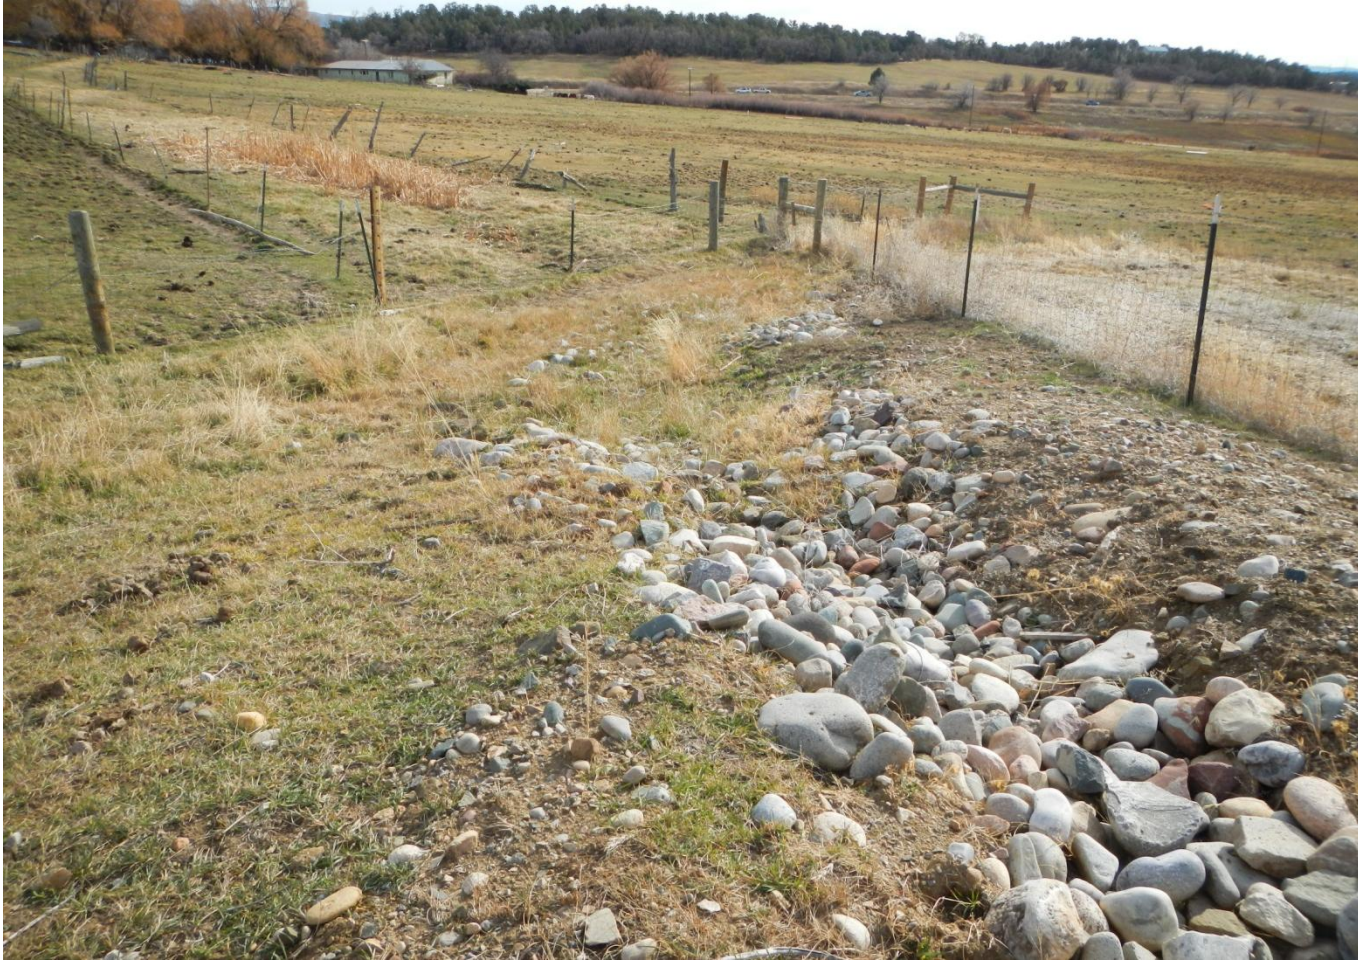
Photo 5. View of cobble revetment along stormwater channel exiting the southeastern corner of the project area.

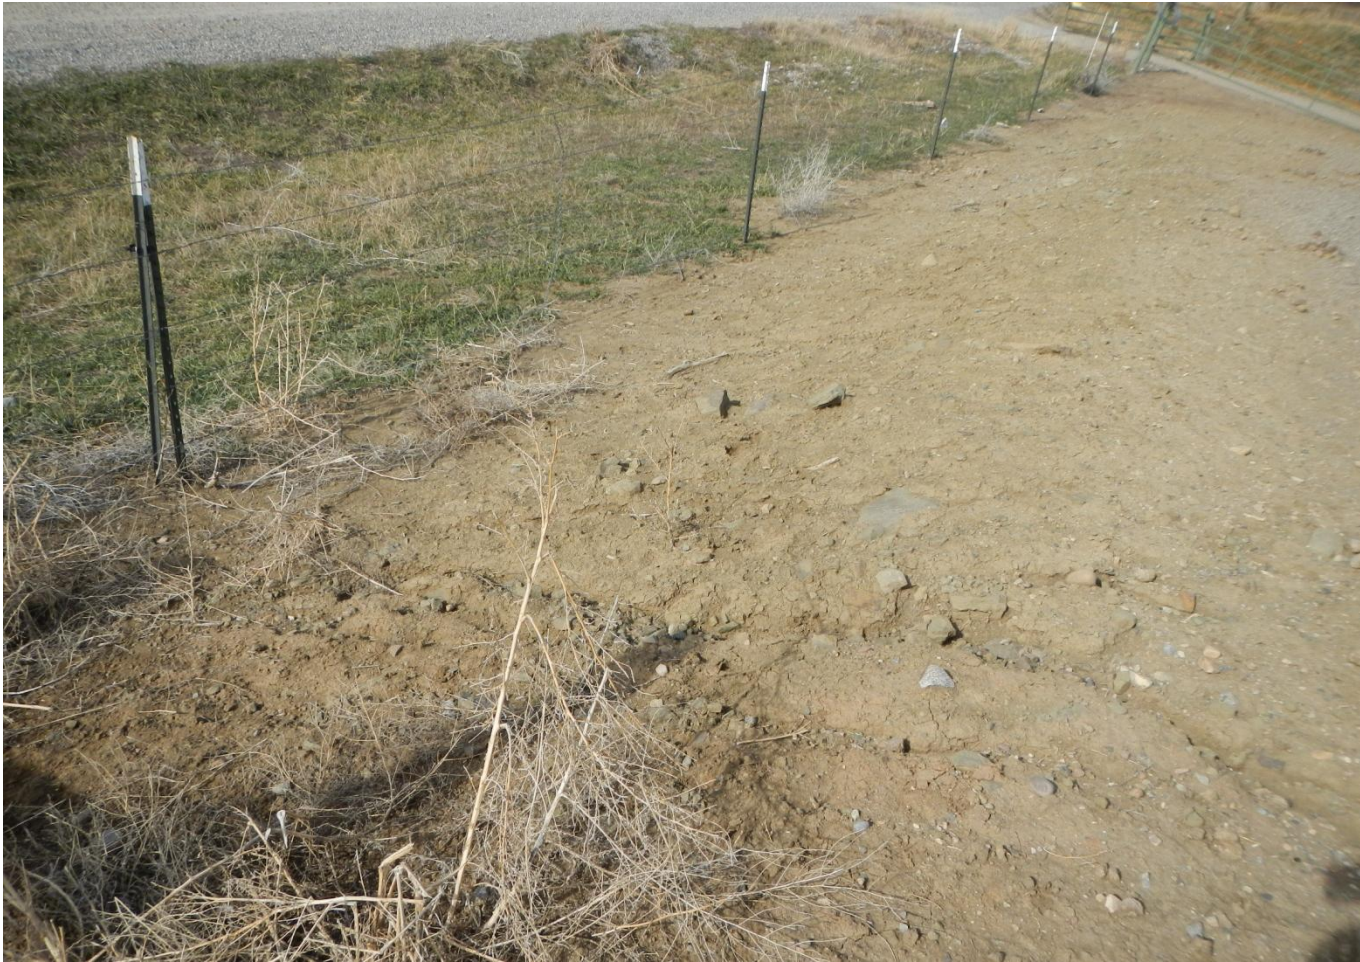
Photo 6. View of rill erosion and unvegetated slope in western portion of project area.
