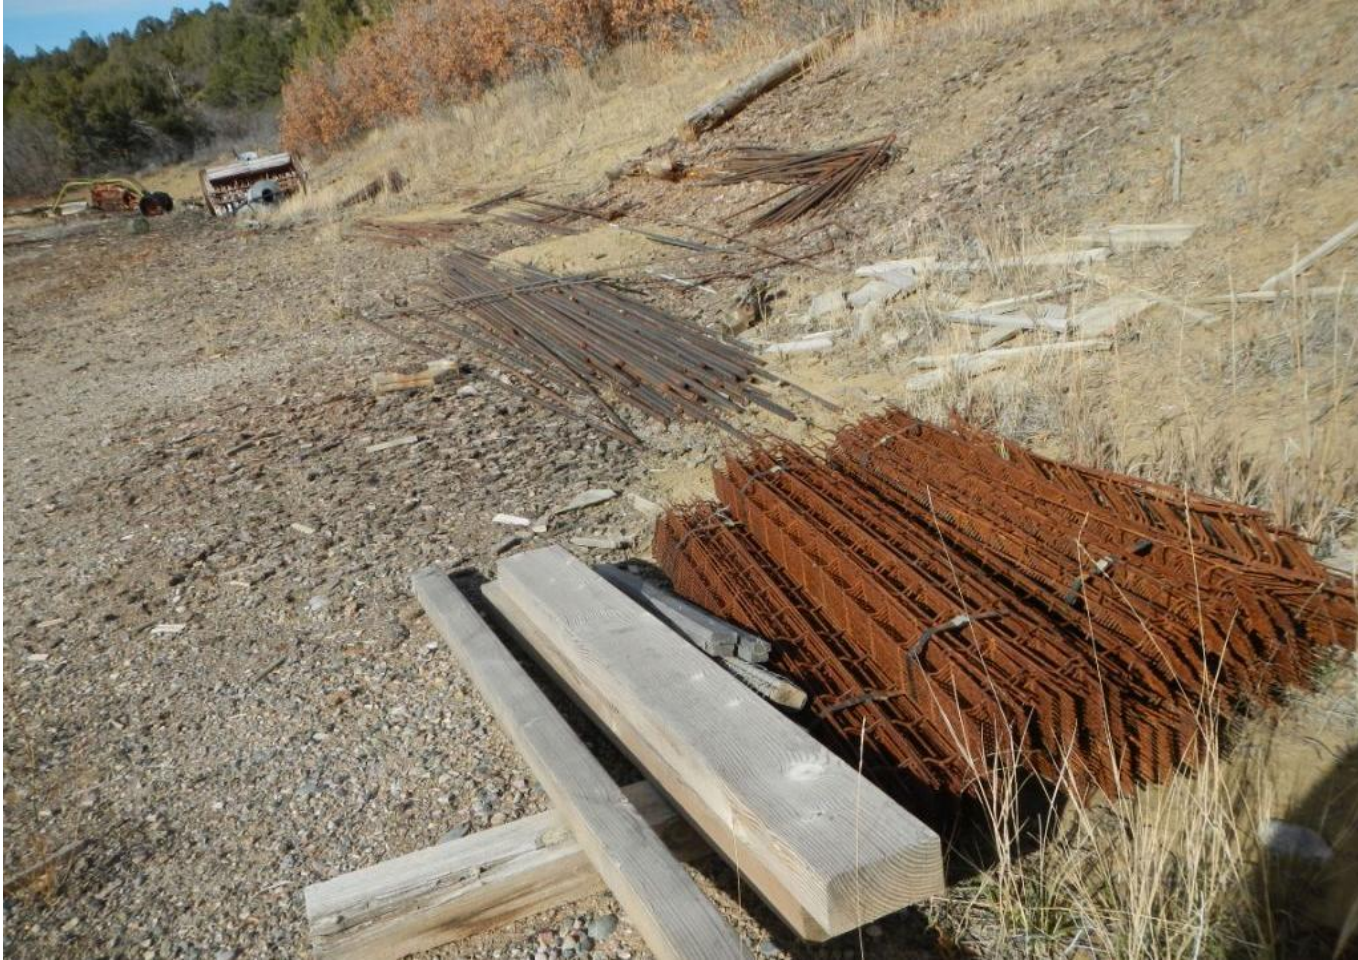
Photo 1. View of stockpiled materials in eastern portion of project area.

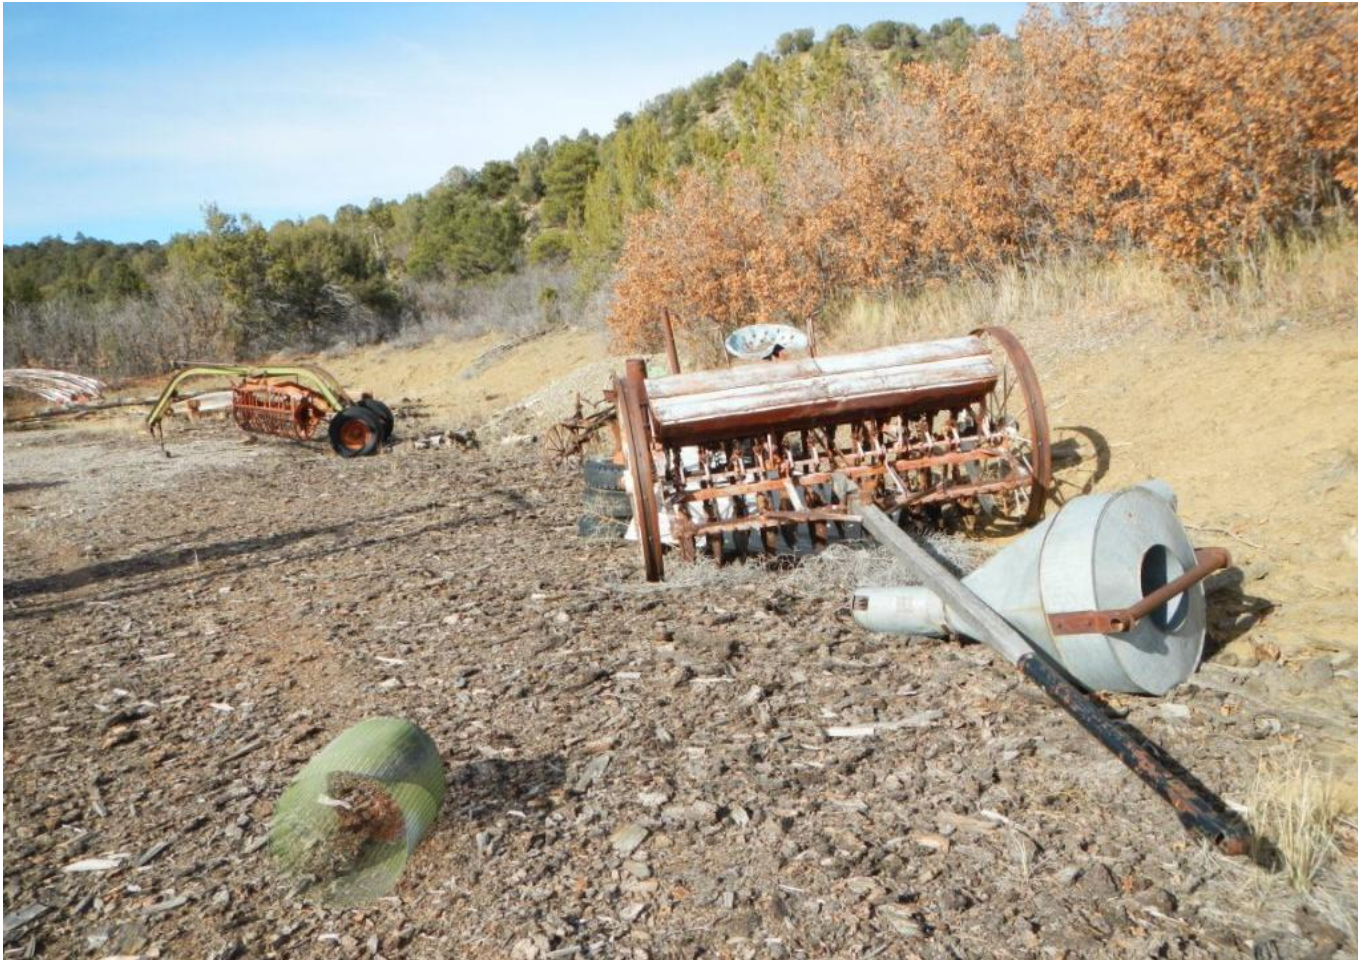
Photo 2. View of unused equipment in eastern portion of project area.

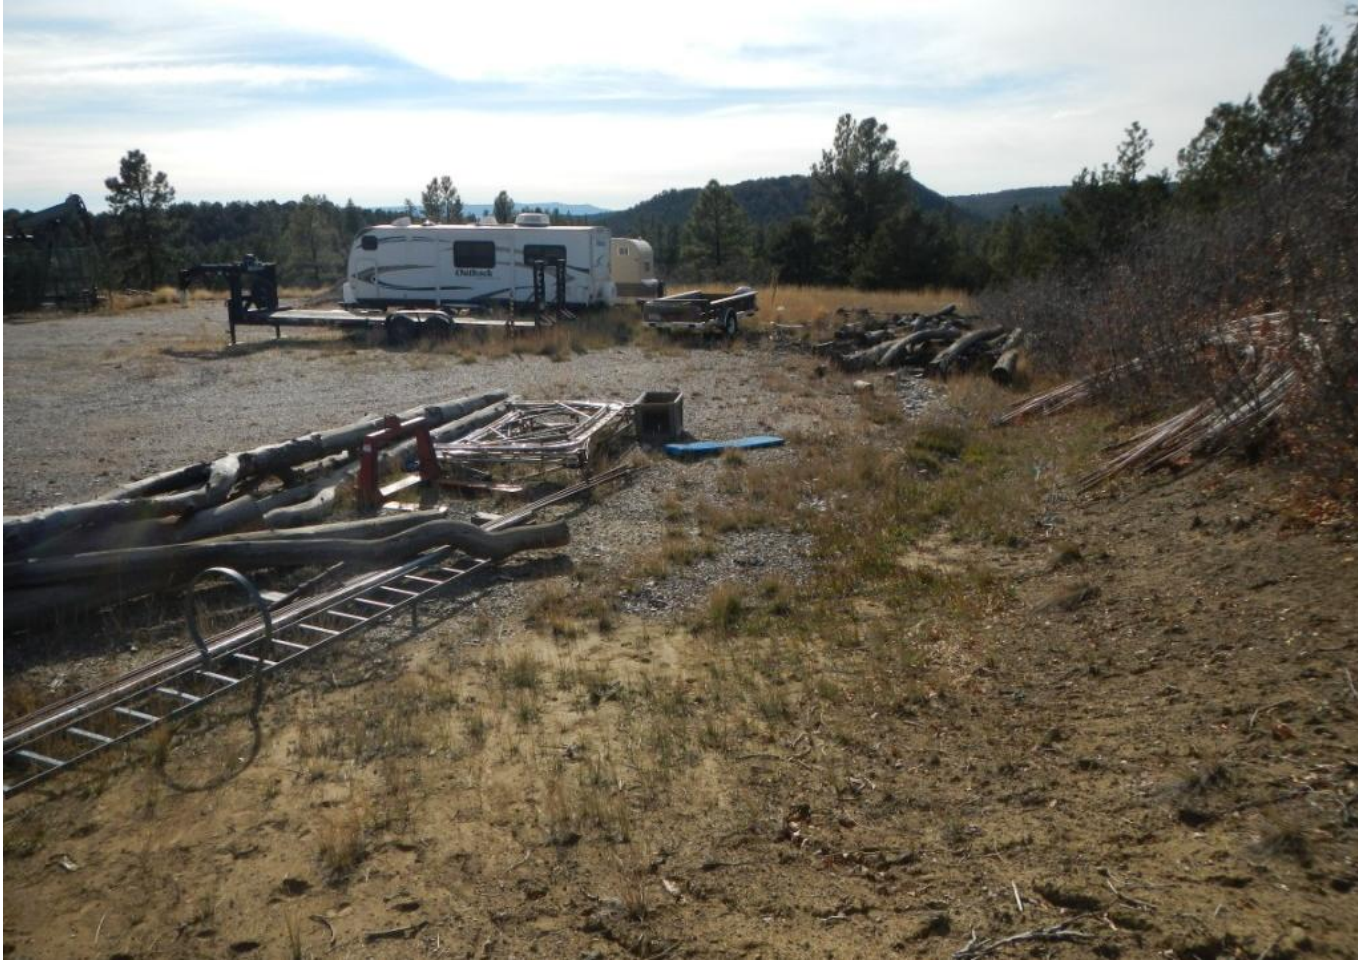
Photo 3. View of debris and unused equipment in northern portion of project area.

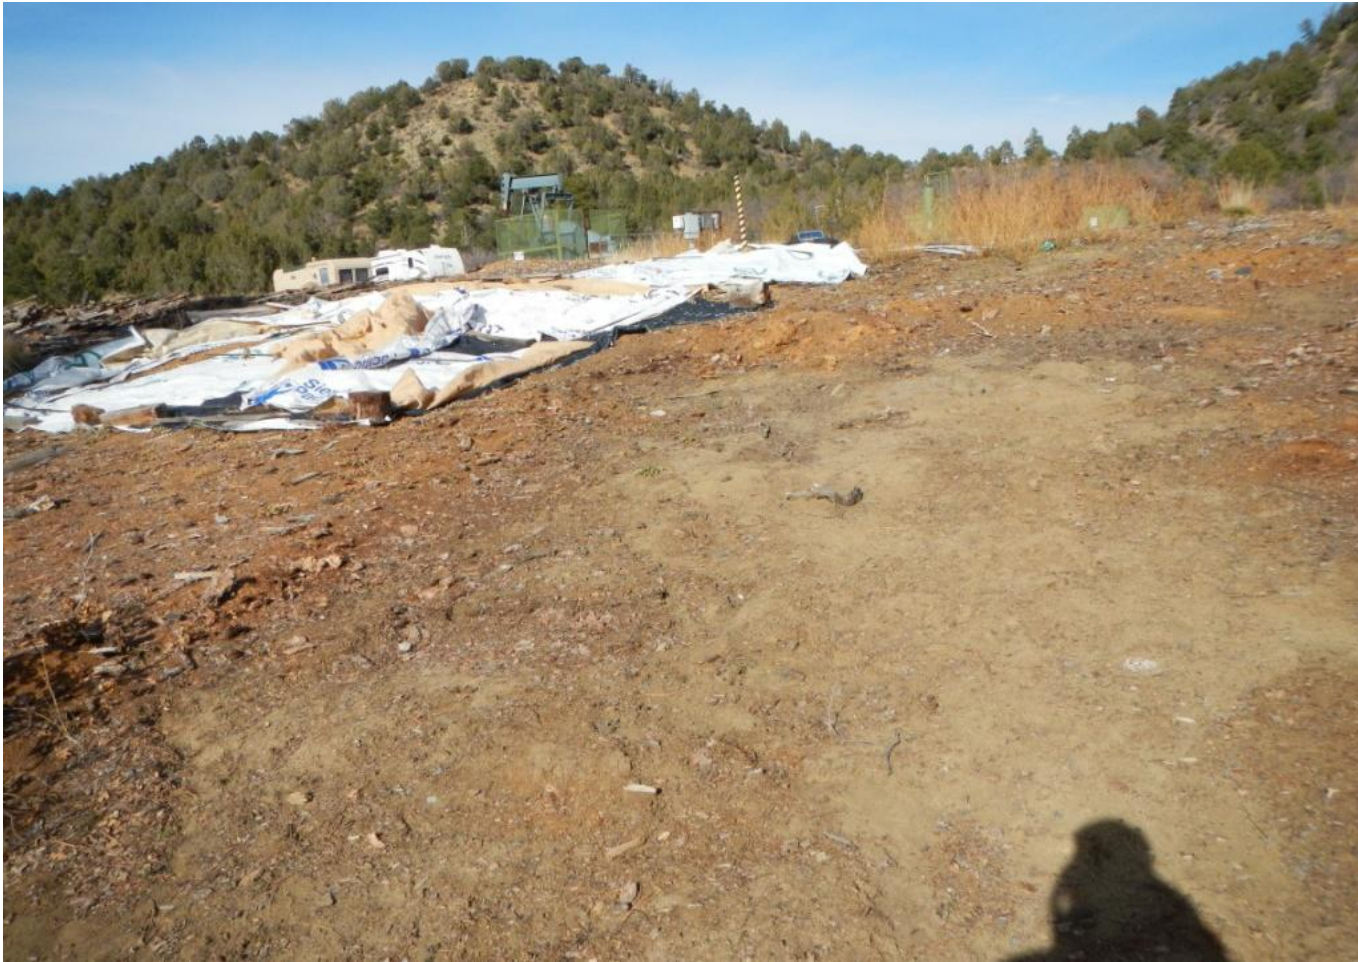
Photo 4. View from southwestern corner of project are facing center. Large tarps, woody debris, and trash are spread across the interim reclamation area.

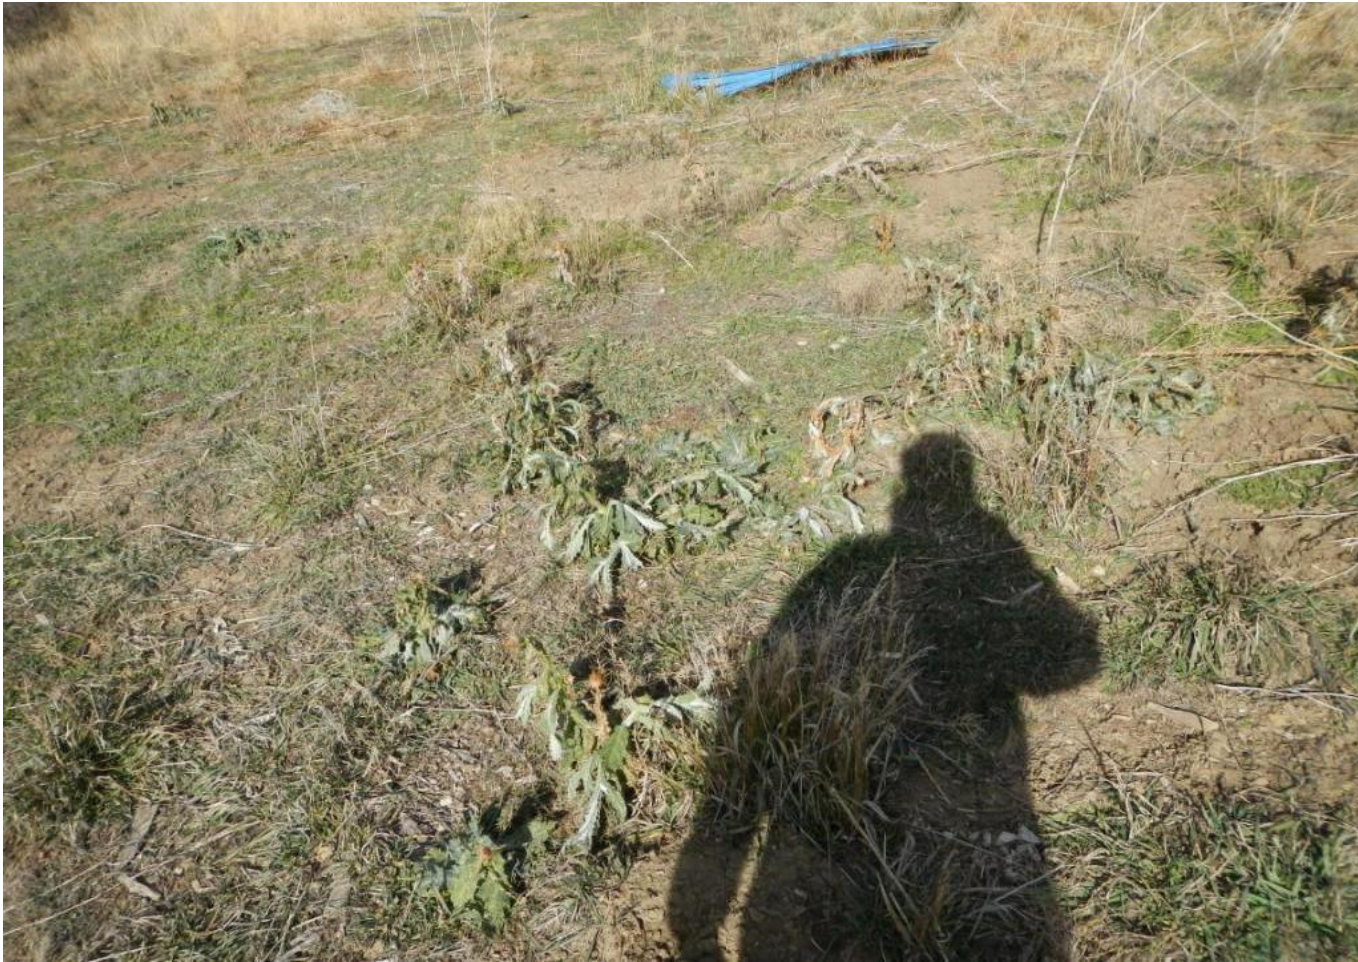
Photo 5. View of Scotch thistle (*Onopordum acanthium*) plants within the interim reclamation area.

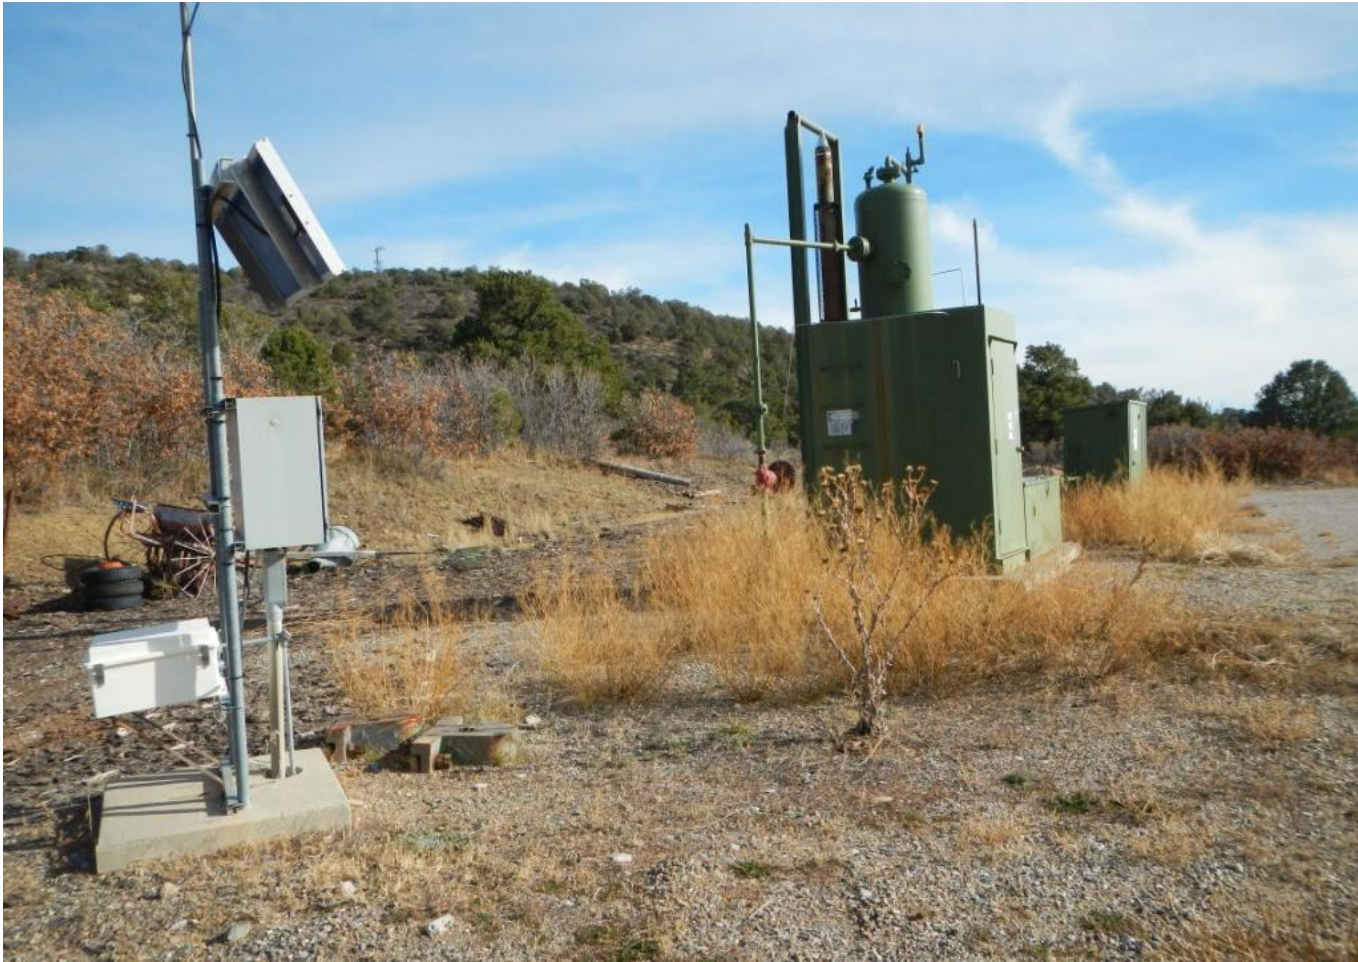
Photo 6. View of tall weeds around project facilities.

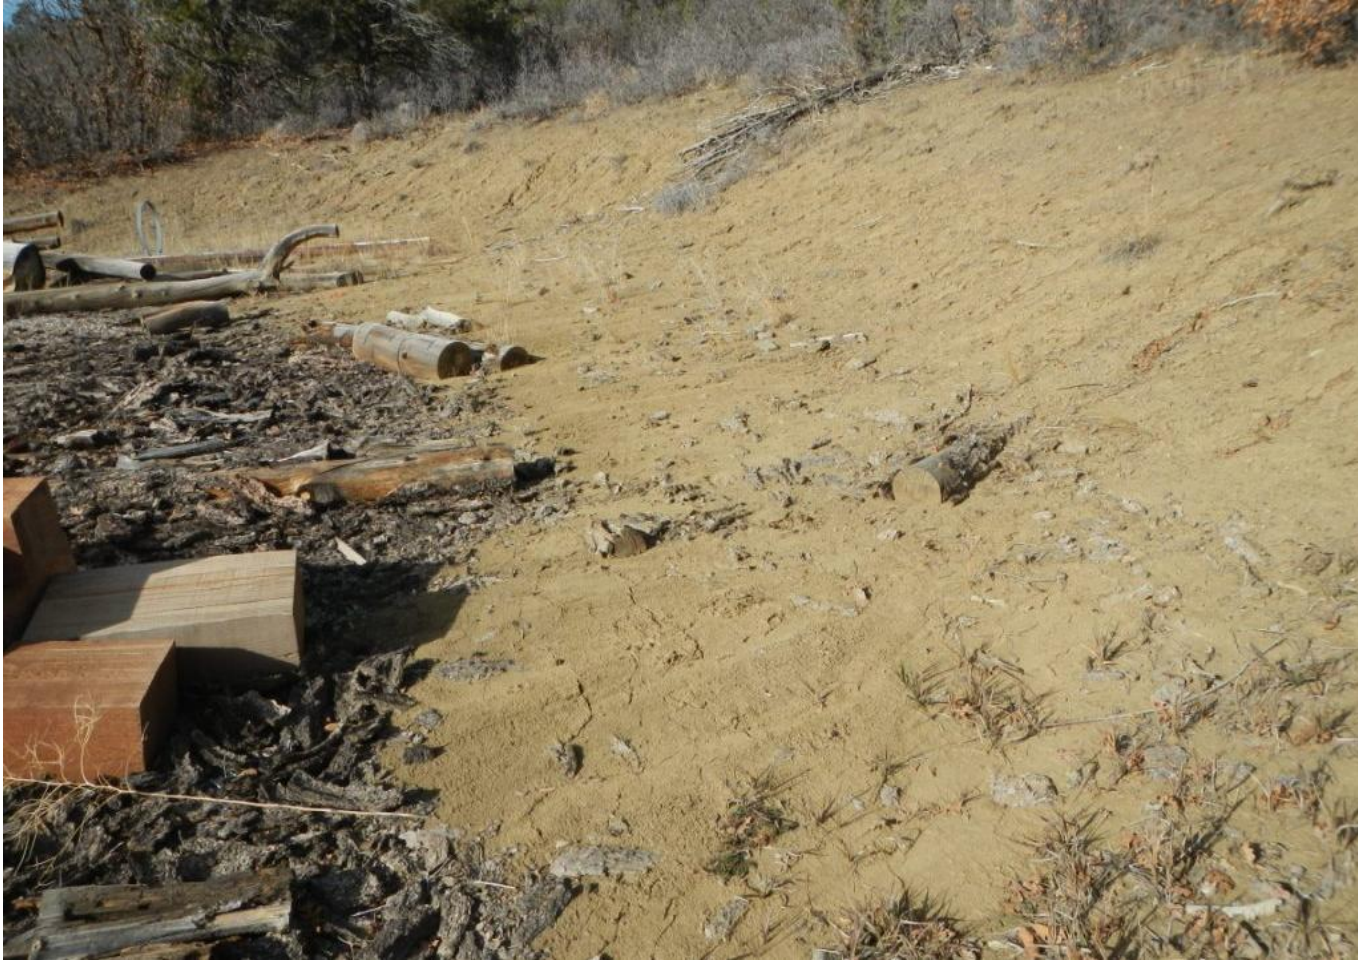
Photo 7. View of stormwater erosion in northeastern corner of project area from unstabilized cut-slope onto well pad.
