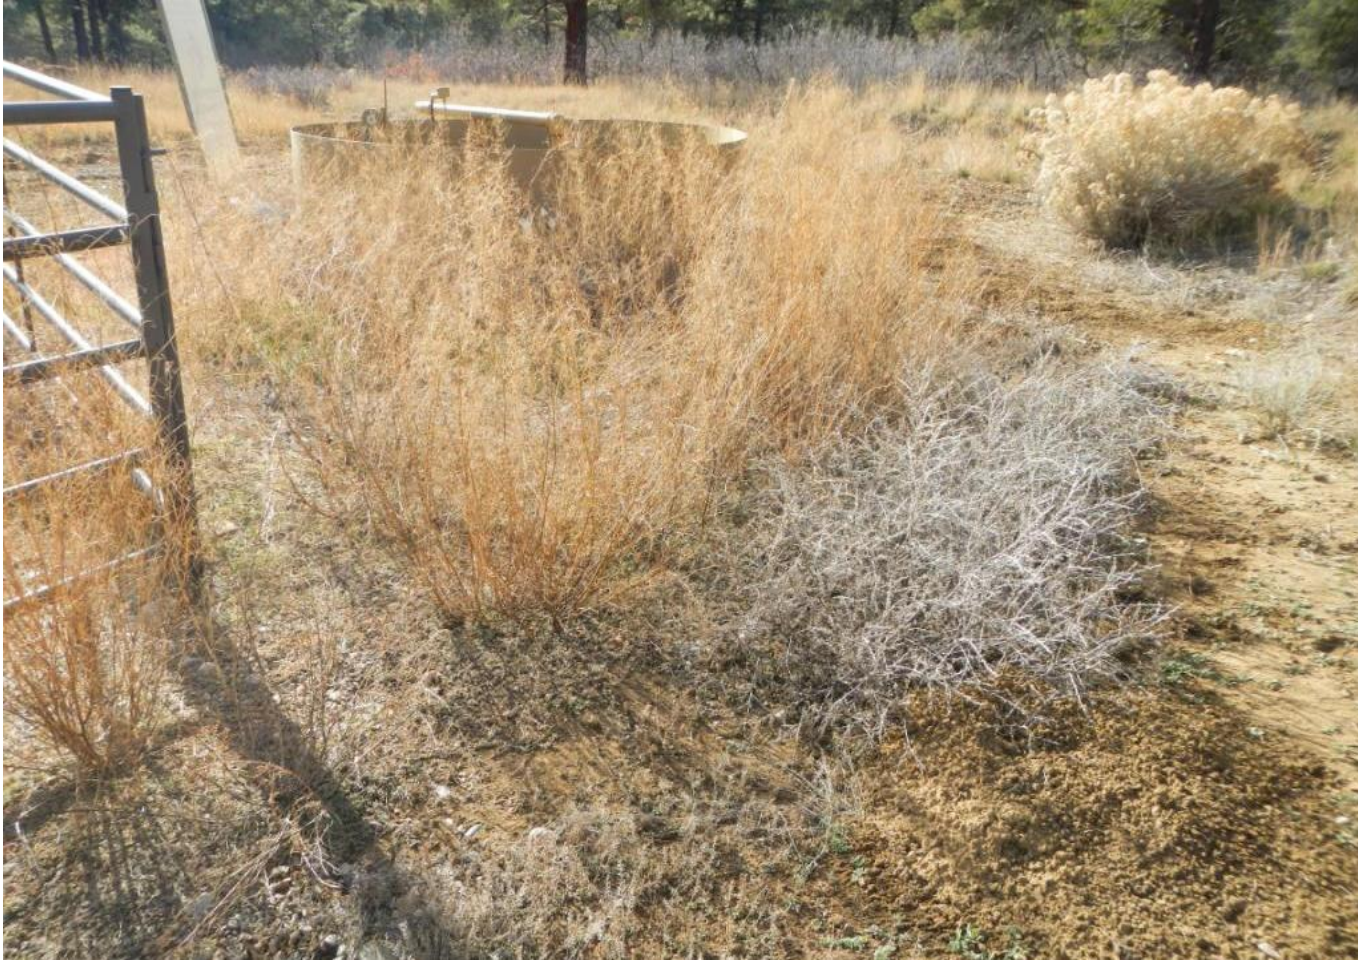
Photo 1. View of dried weeds near the project facilities that need to be removed and controlled.

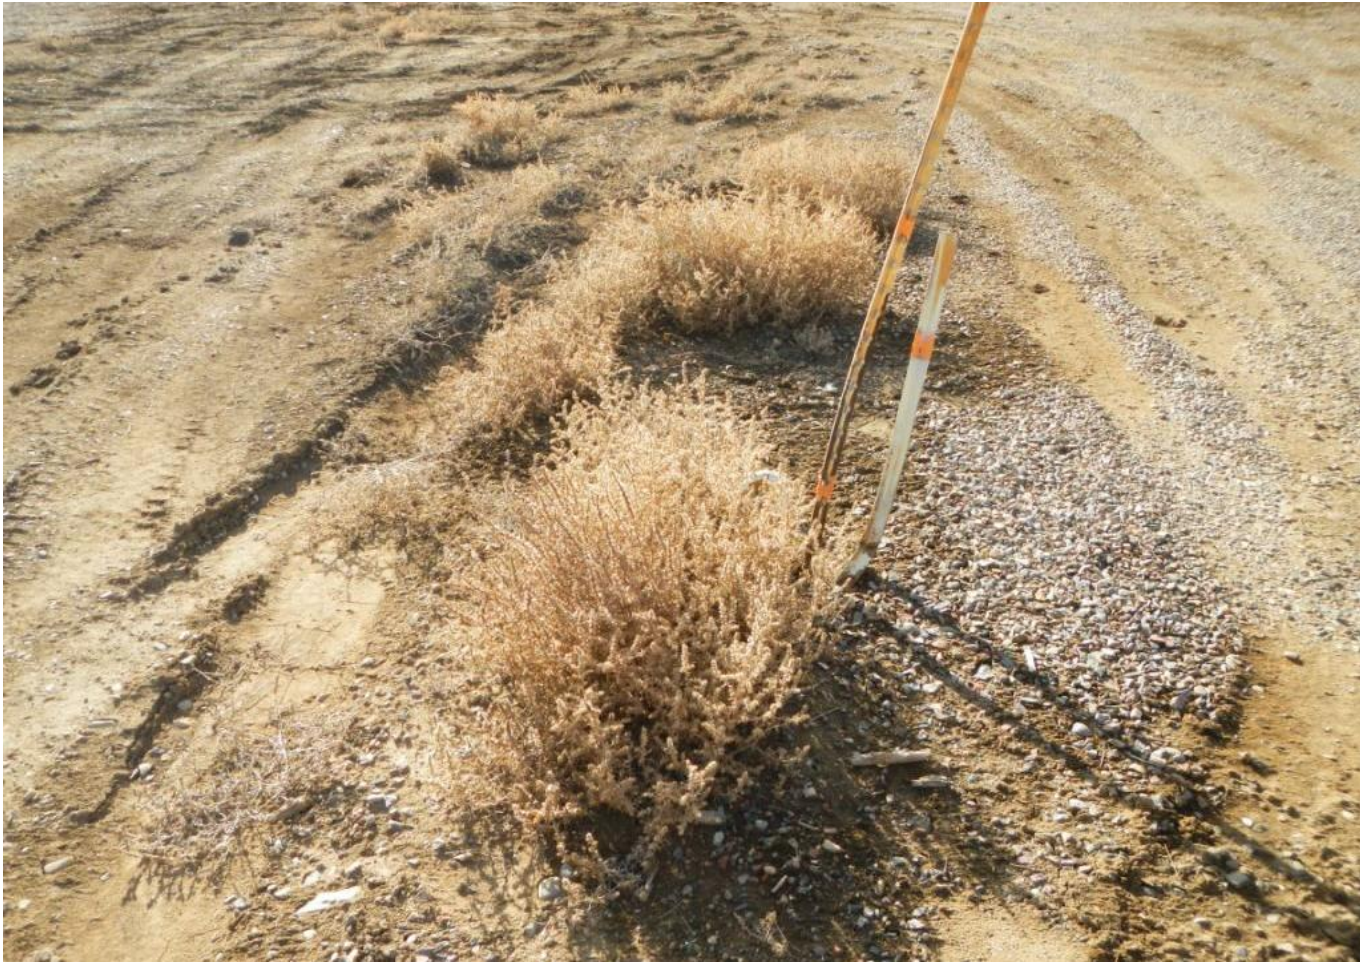
Photo 2. View of Russian thistle plants in the working area that need to be removed.

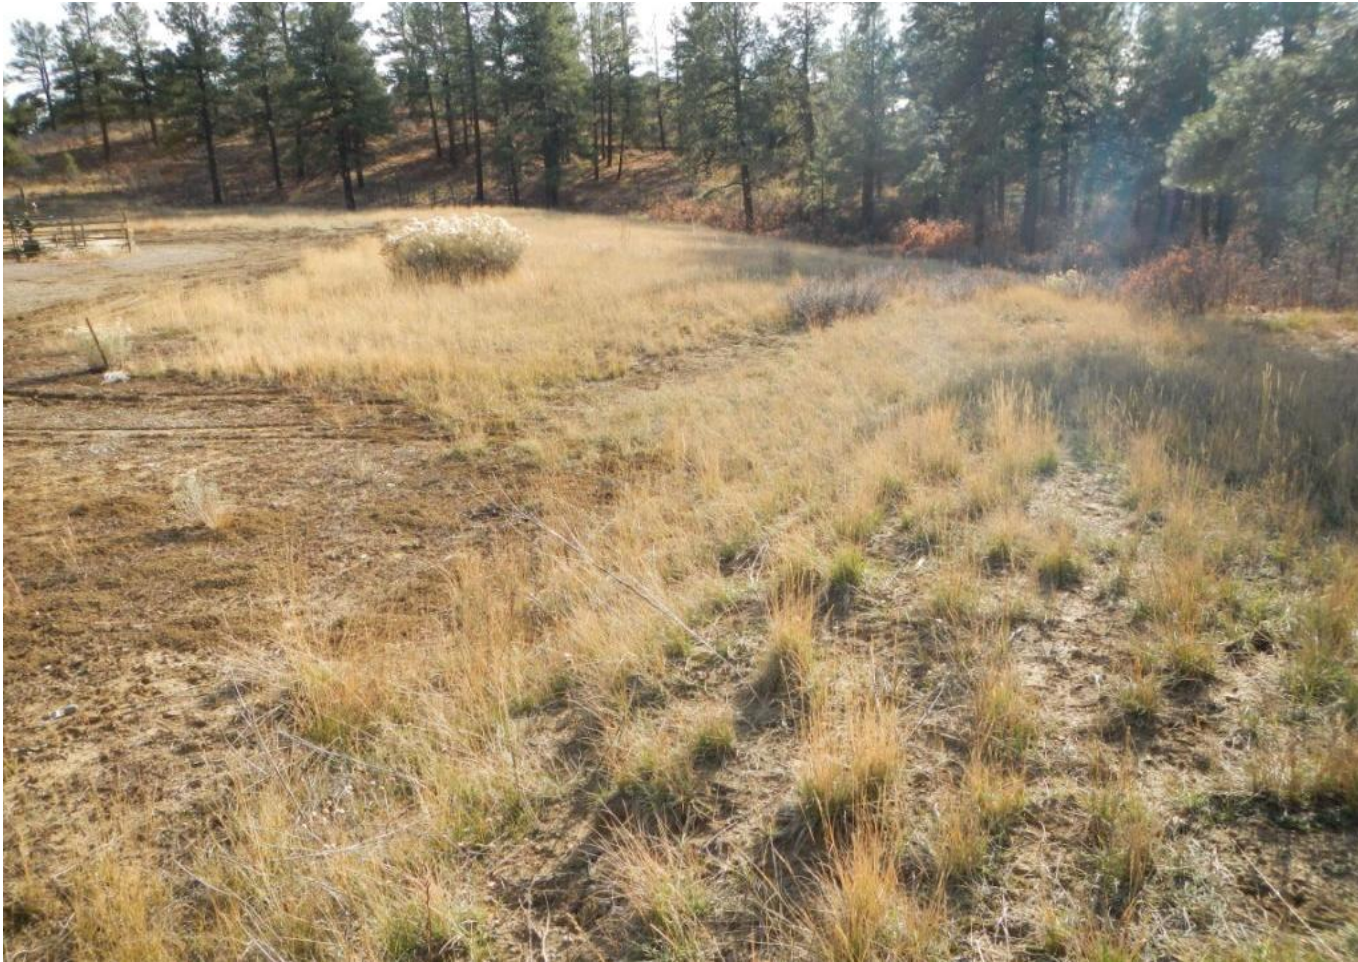
Photo 3. View of western portion of the project area from northwestern corner facing southward.

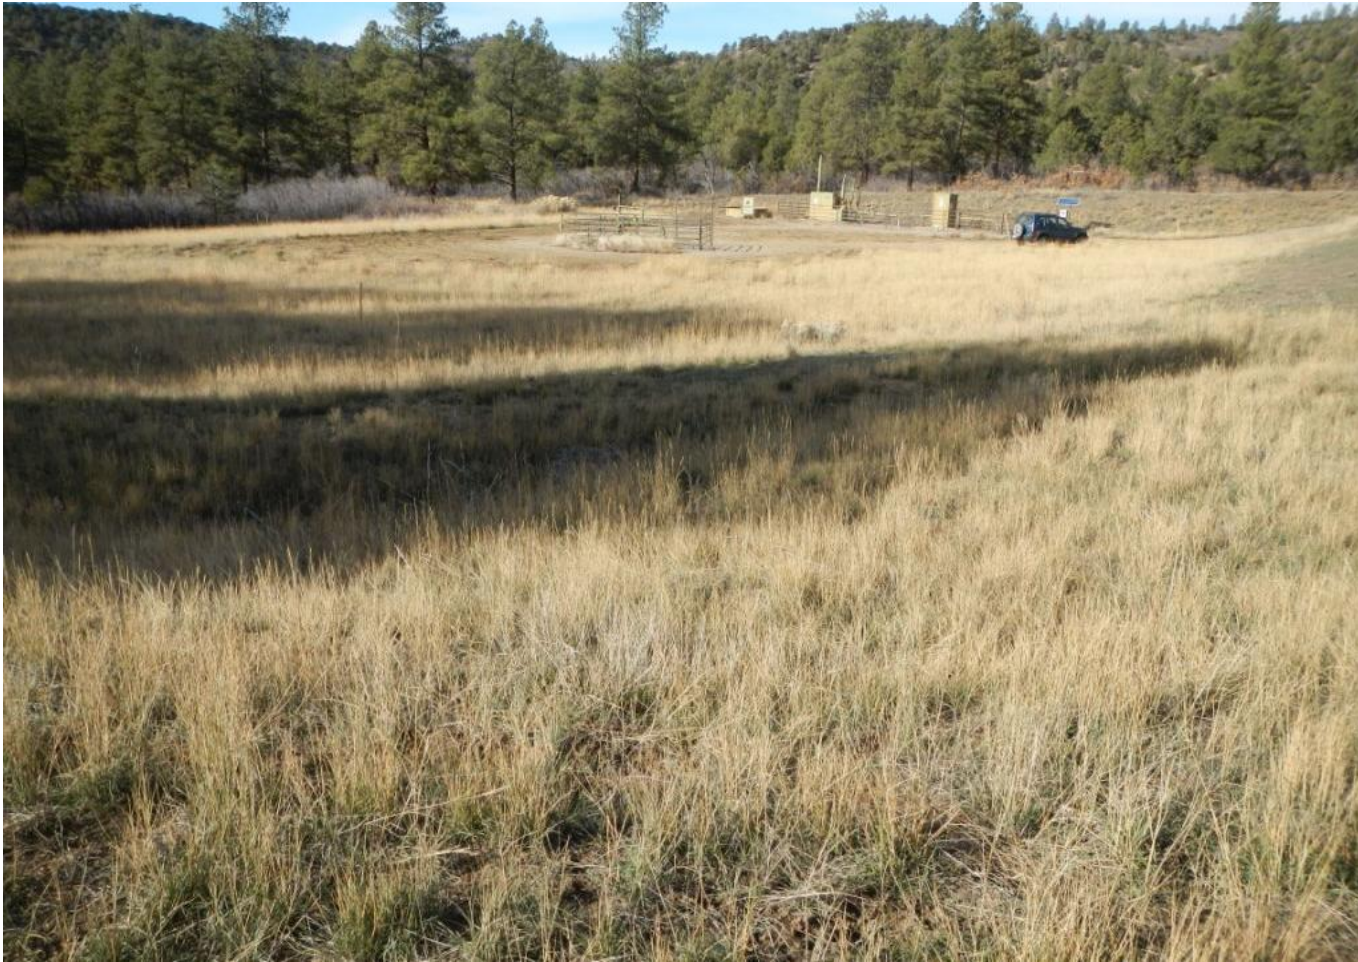
Photo 4. View from southeastern corner of project area facing center. Good revegetation here.

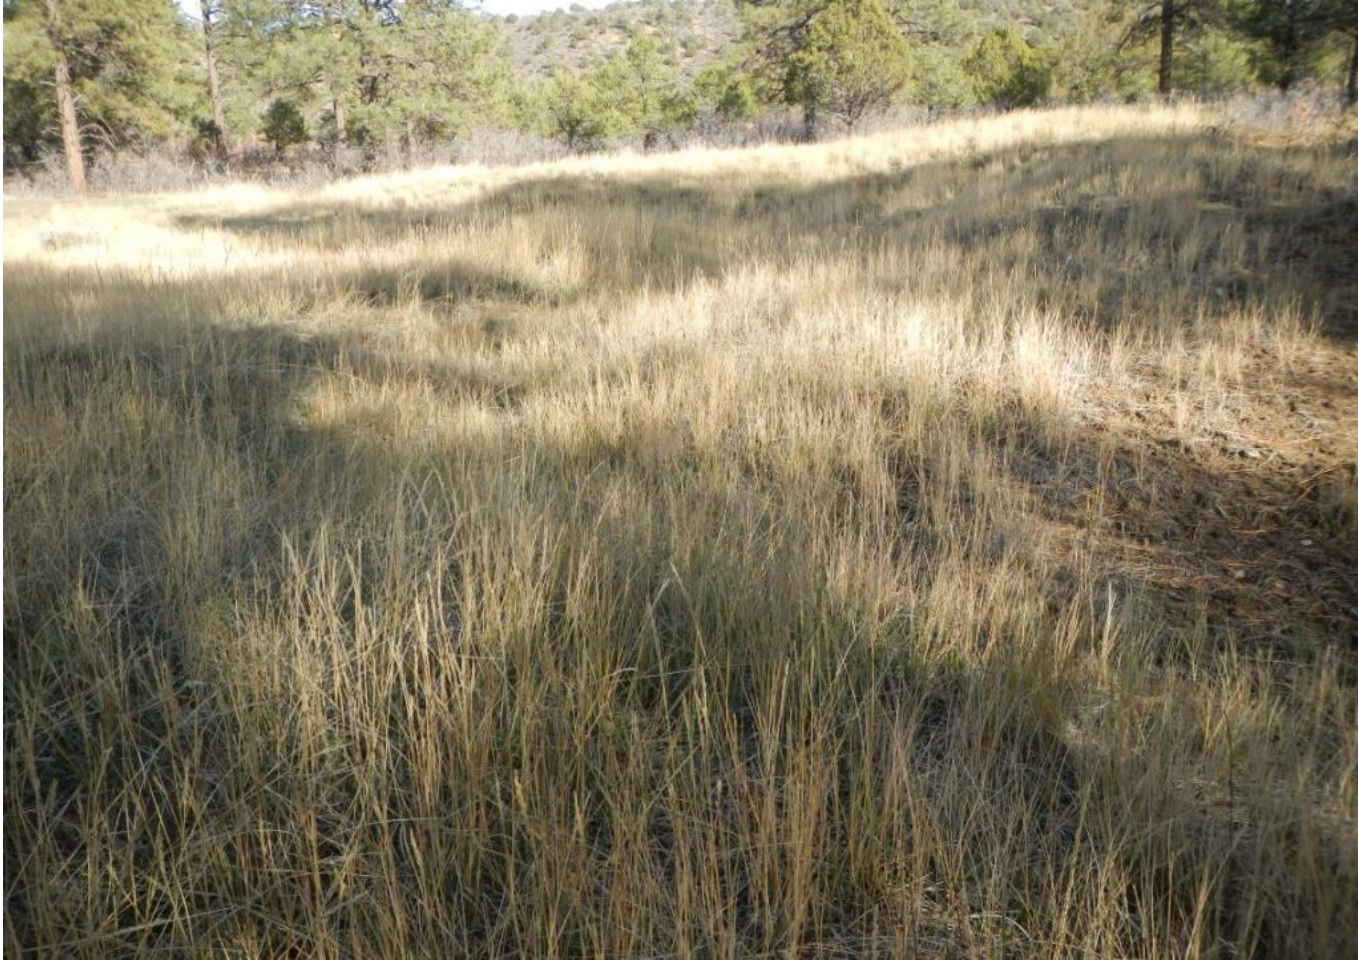
Photo 5. View of vegetated stormwater diversion swale that is sinuous and appears to be functioning properly.

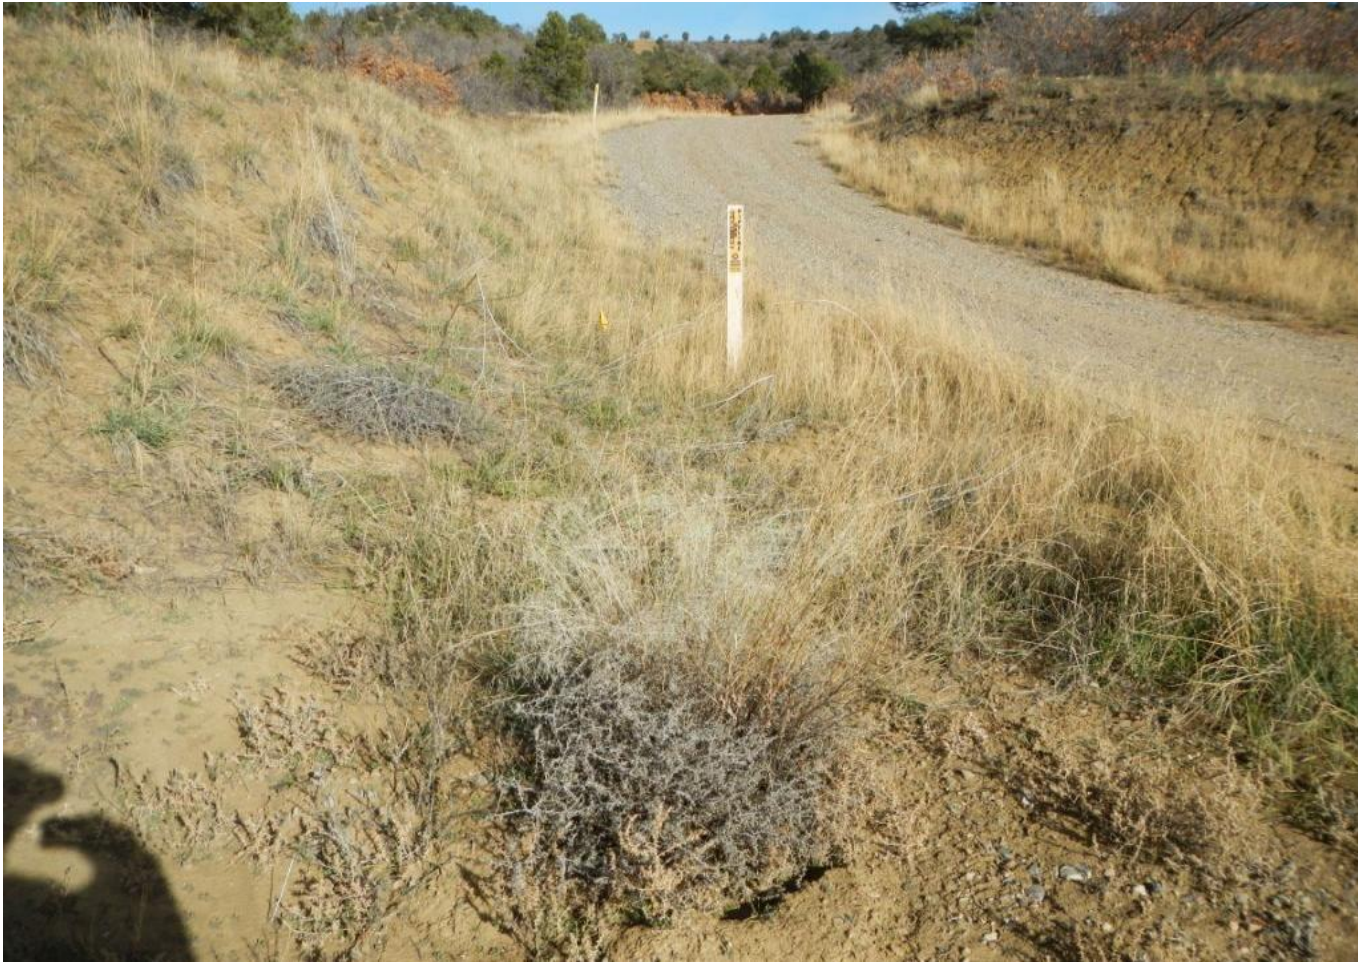
Photo 6. View of rill erosion in cut-slopes along access road near well pad entrance facing northward.
