Site Photos: API# 05-073-06529

Date: November 20, 2014

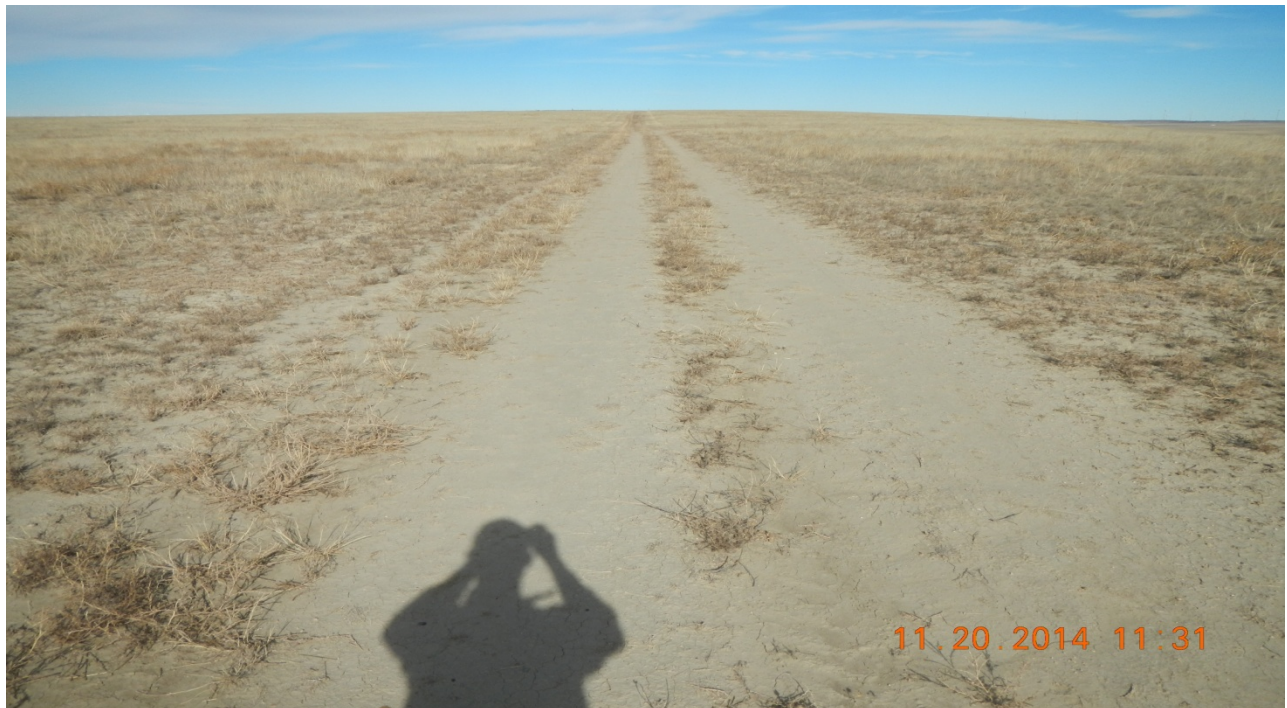
photo 1: Access Road North, to the location.

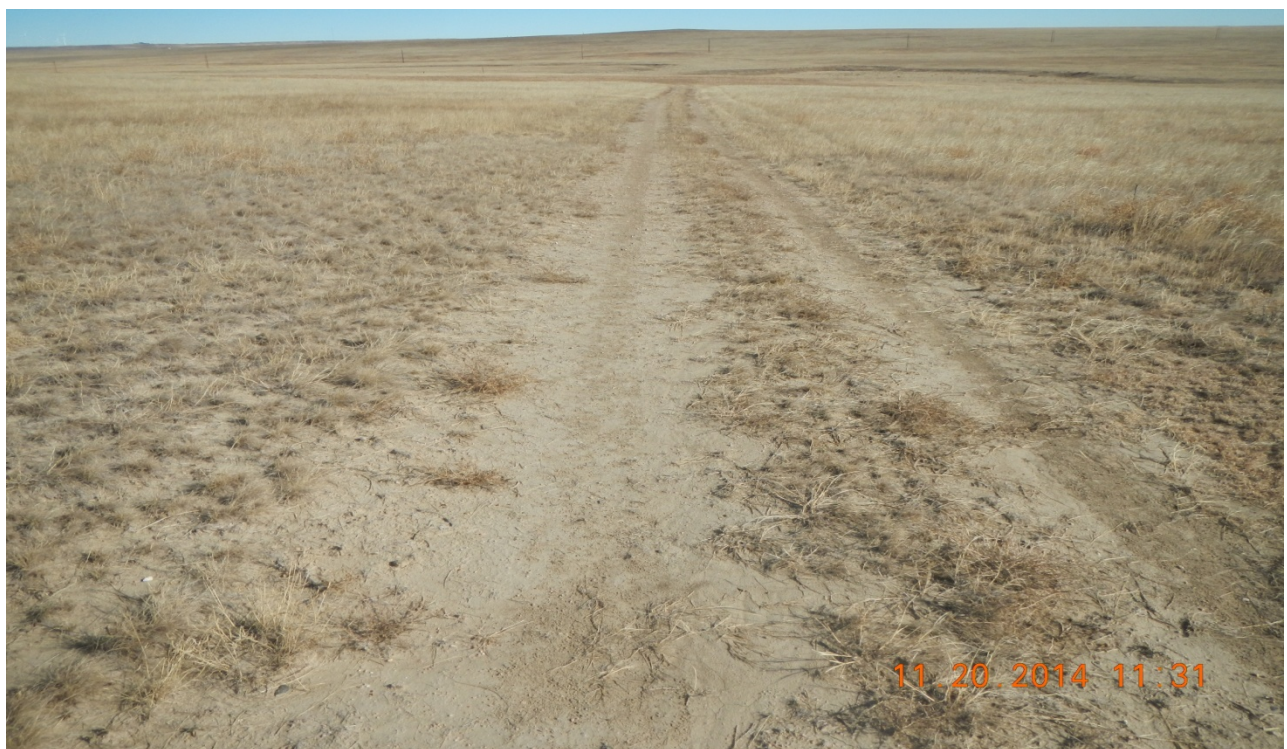
photo 2: Access road has not been de-compacted and does not have sufficient vegetation.

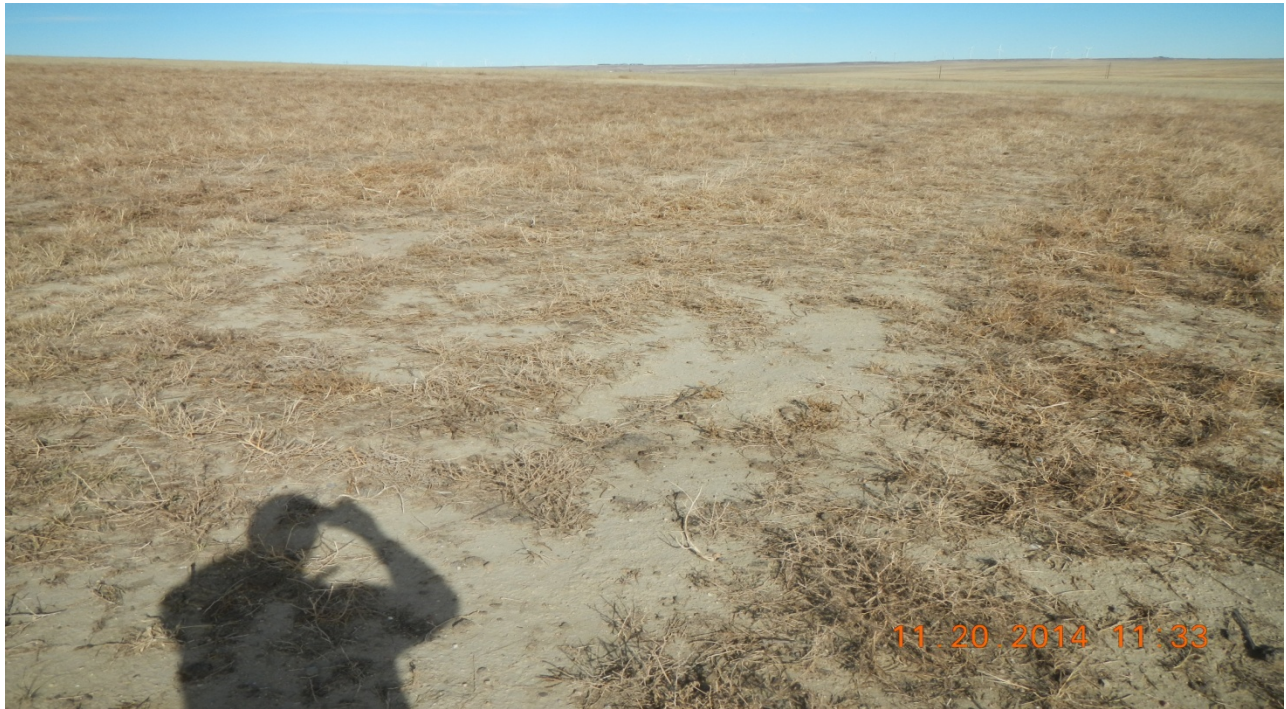
photo 3: Center of the location facing North.

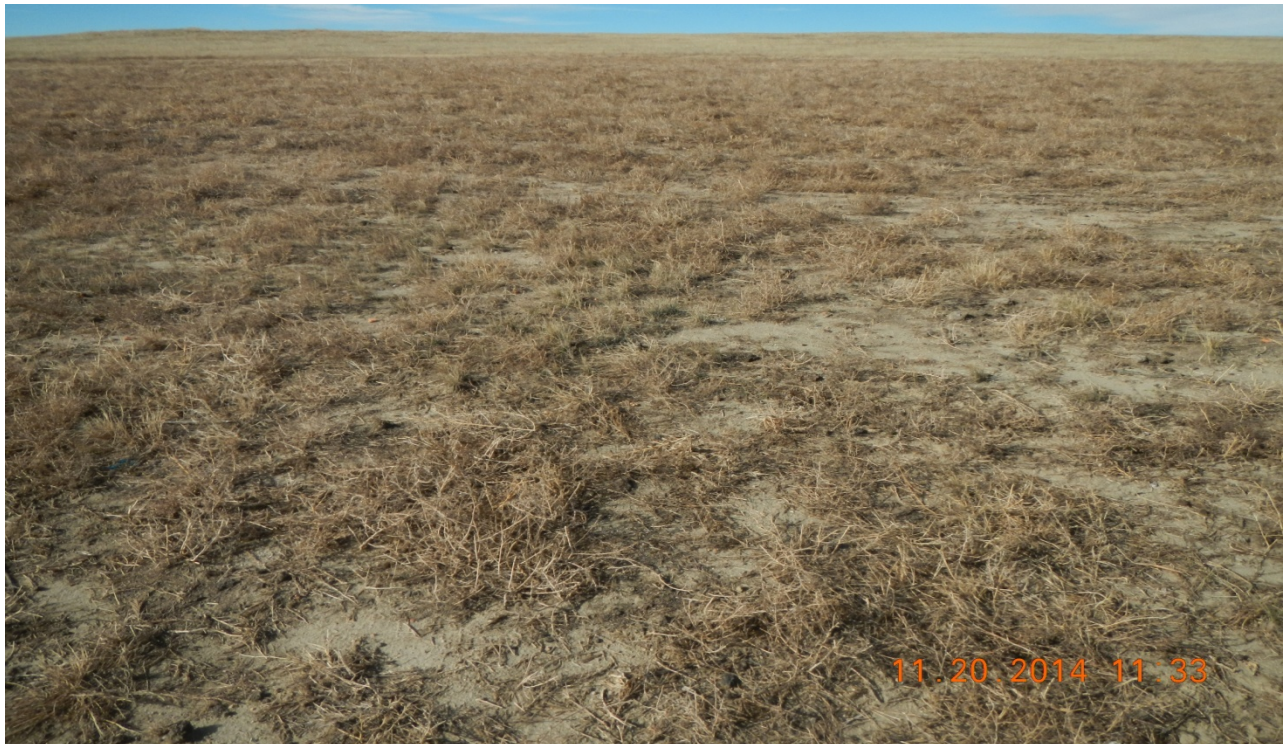
photo 4: Center of the location facing West.

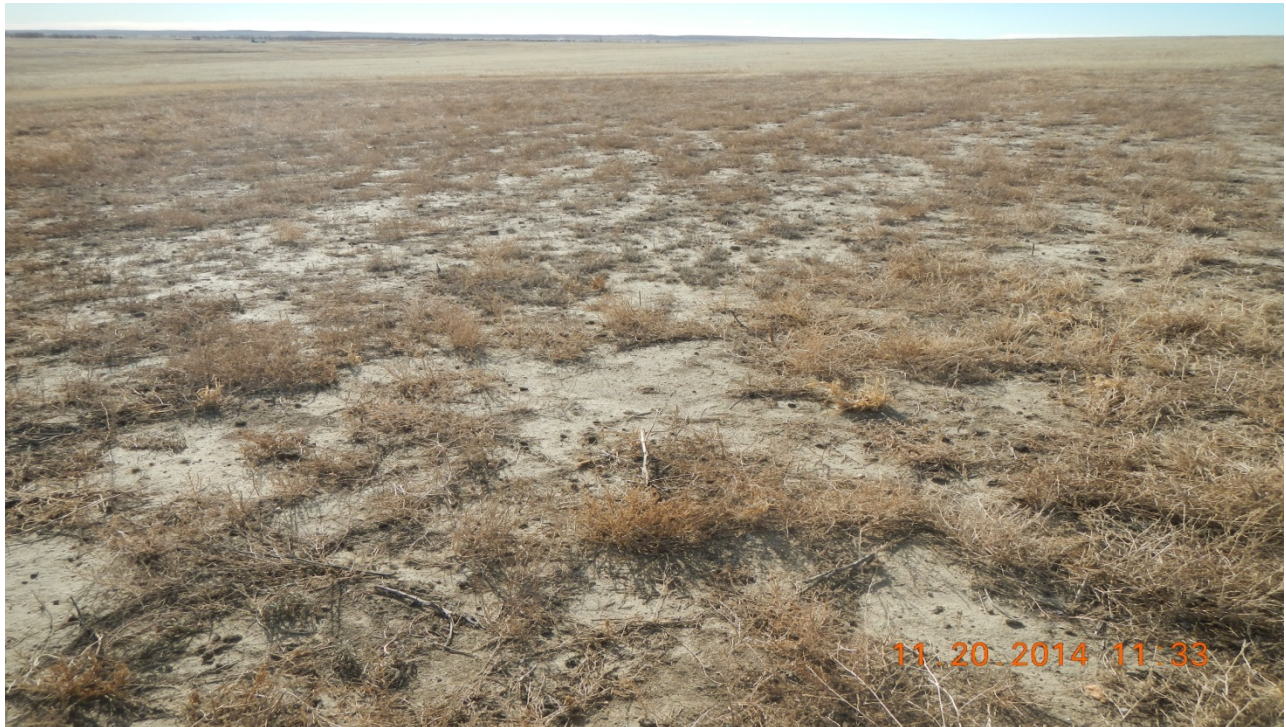
photo 5: Center of the location facing South.

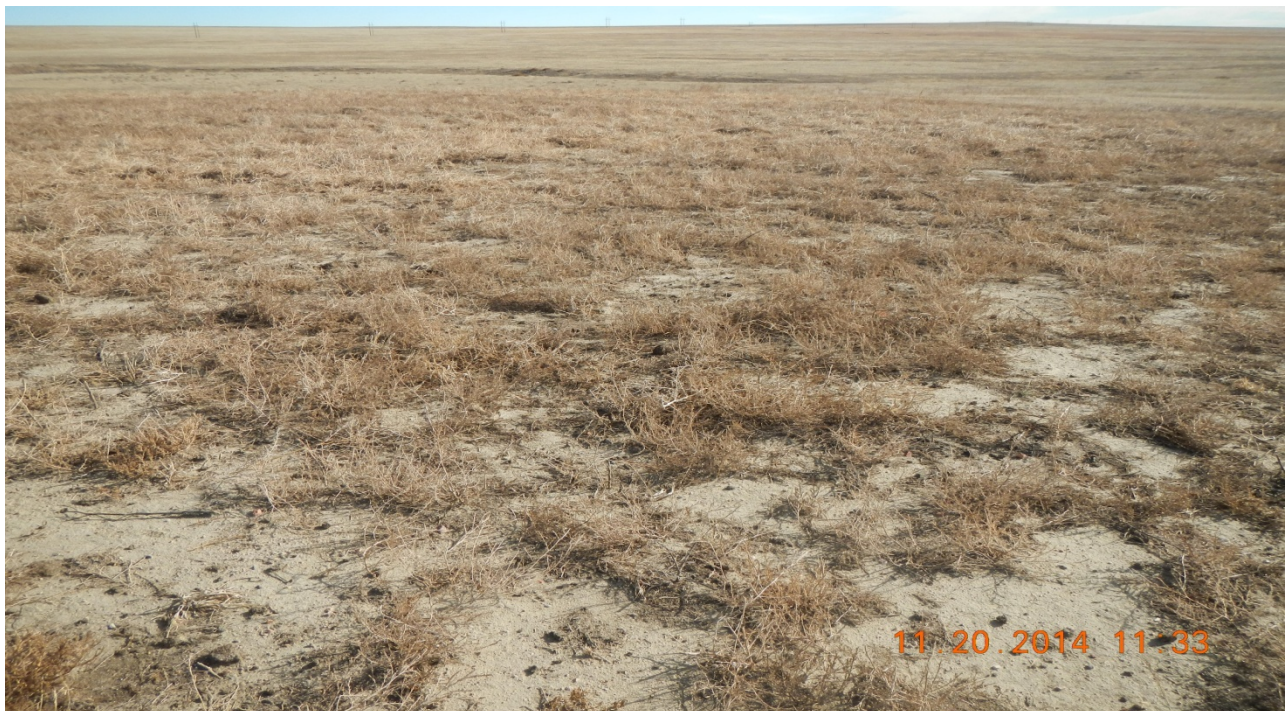
photo 6: Center of the location facing East.

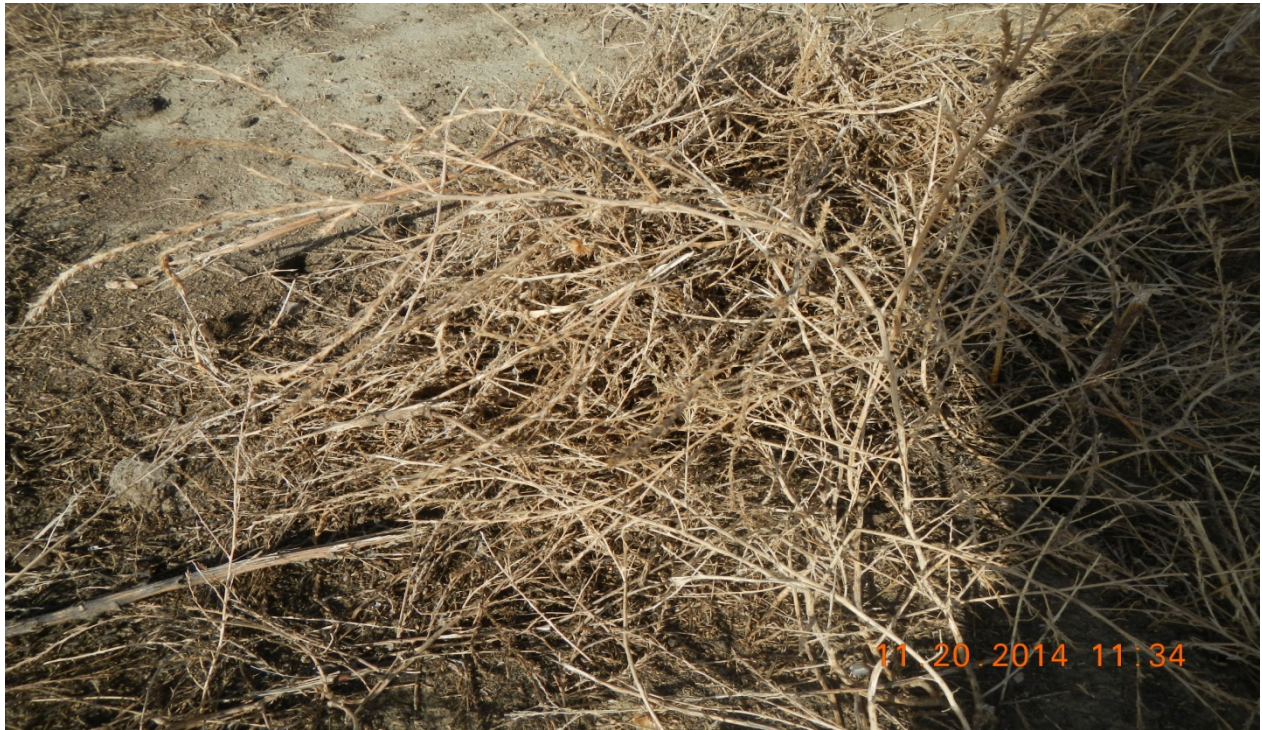
photo 7: Weed cover (Russian thistle) throughout the location.

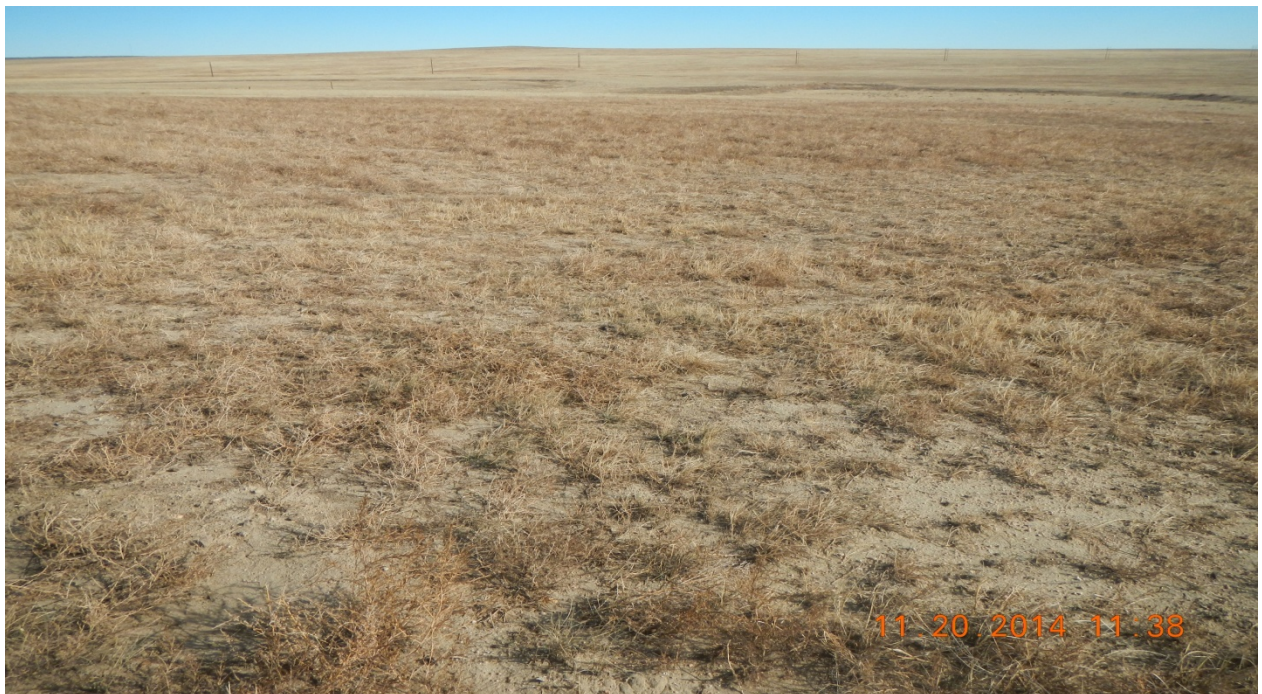
photo 8: Southwest corner of the location facing towards the Northeast.

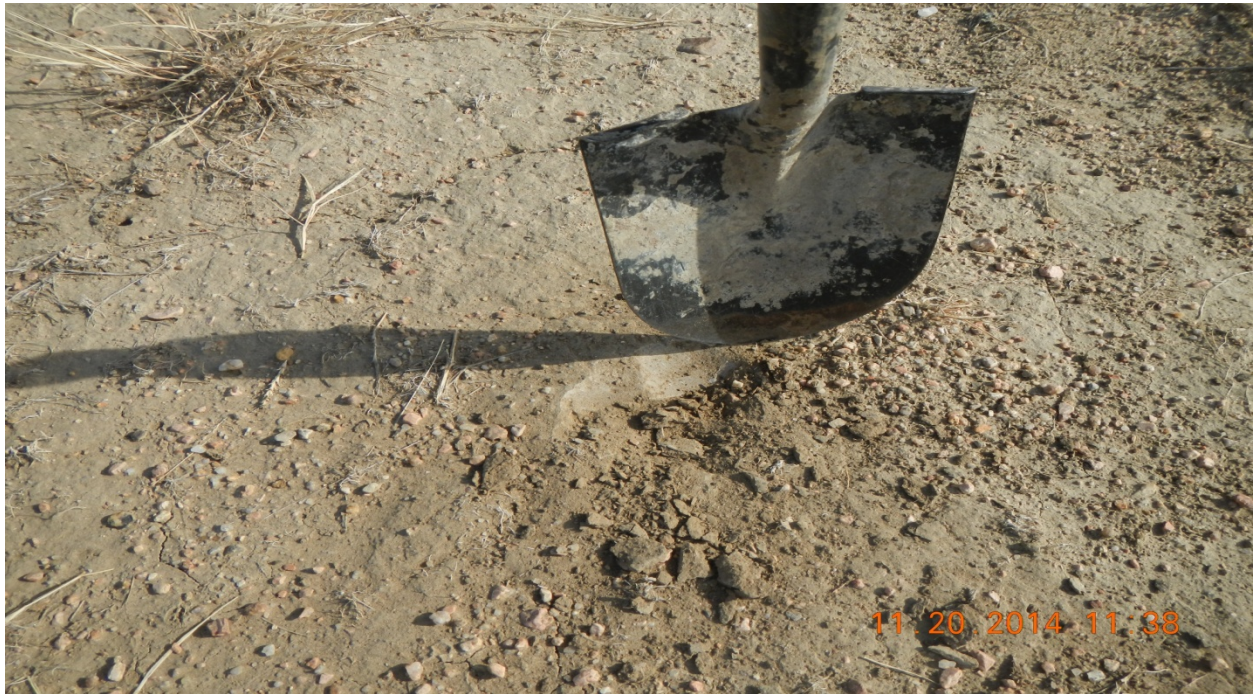
photo 9: Shovel could not break through soil surface indicating soil compaction along the access road.

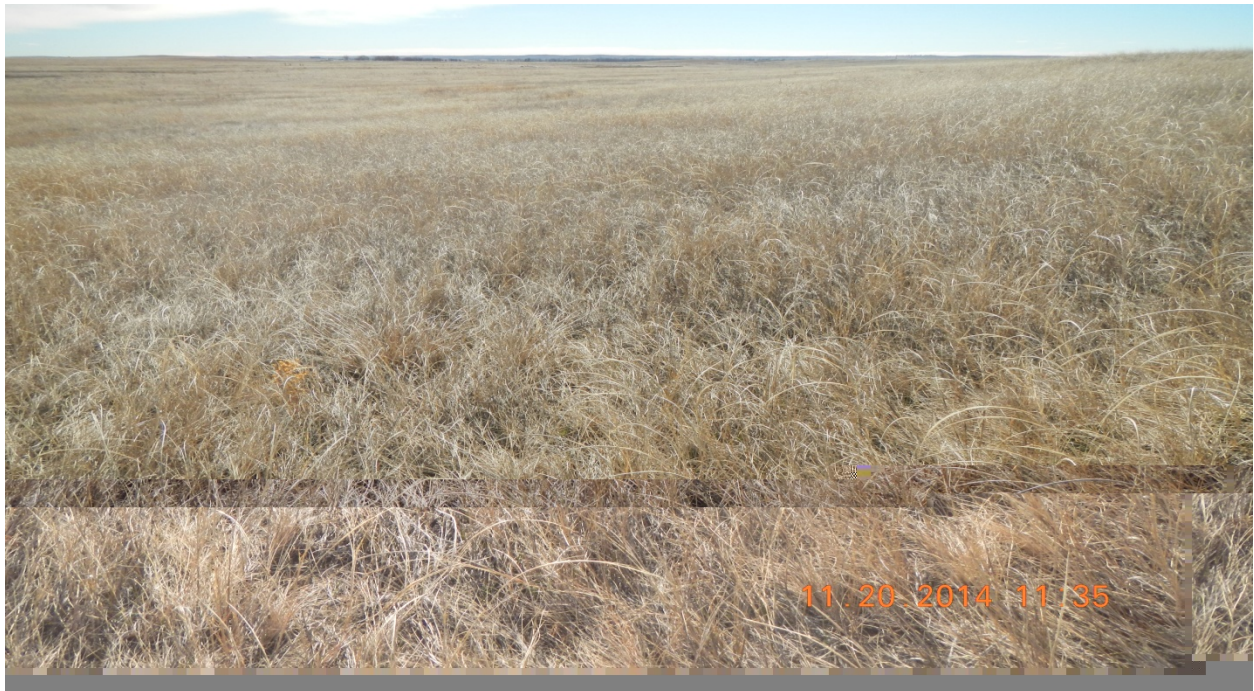
photo 10: Surrounding vegetation, reference area.
