Site Photos: API# 05-055-06306

Date: December 4, 2014

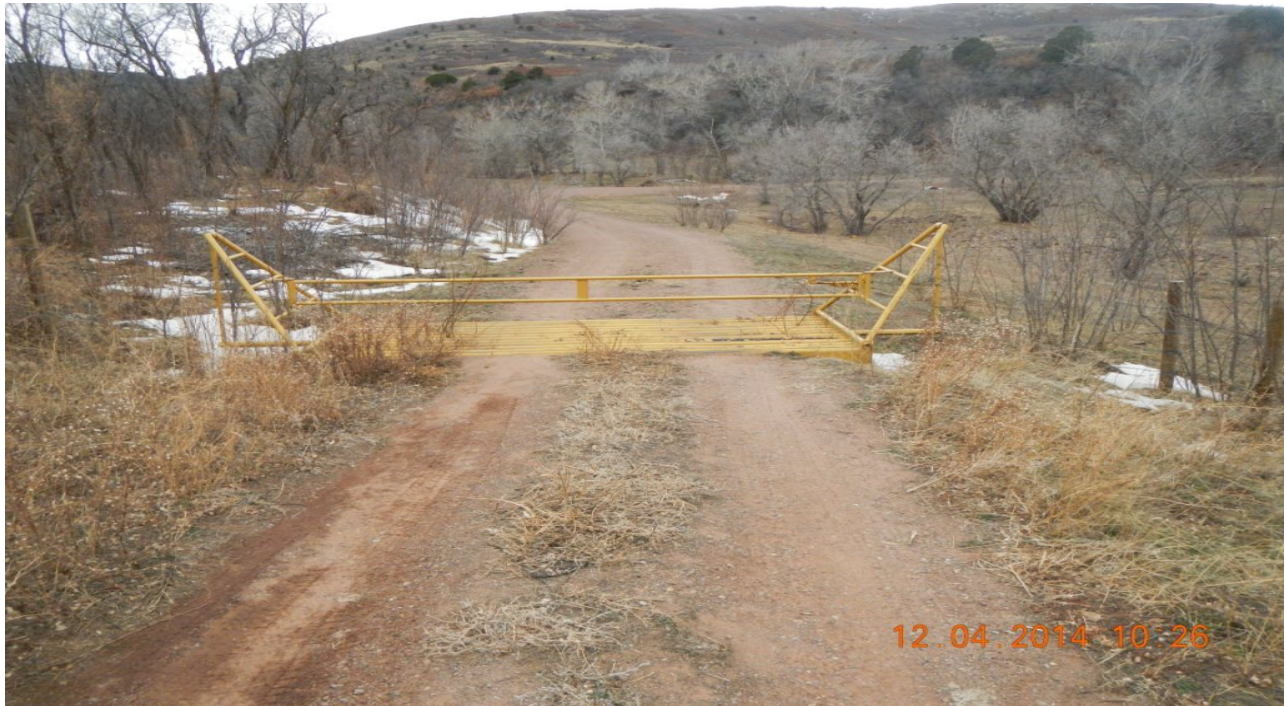
photo 1: Gate and cattle guard at the beginning of the access road.

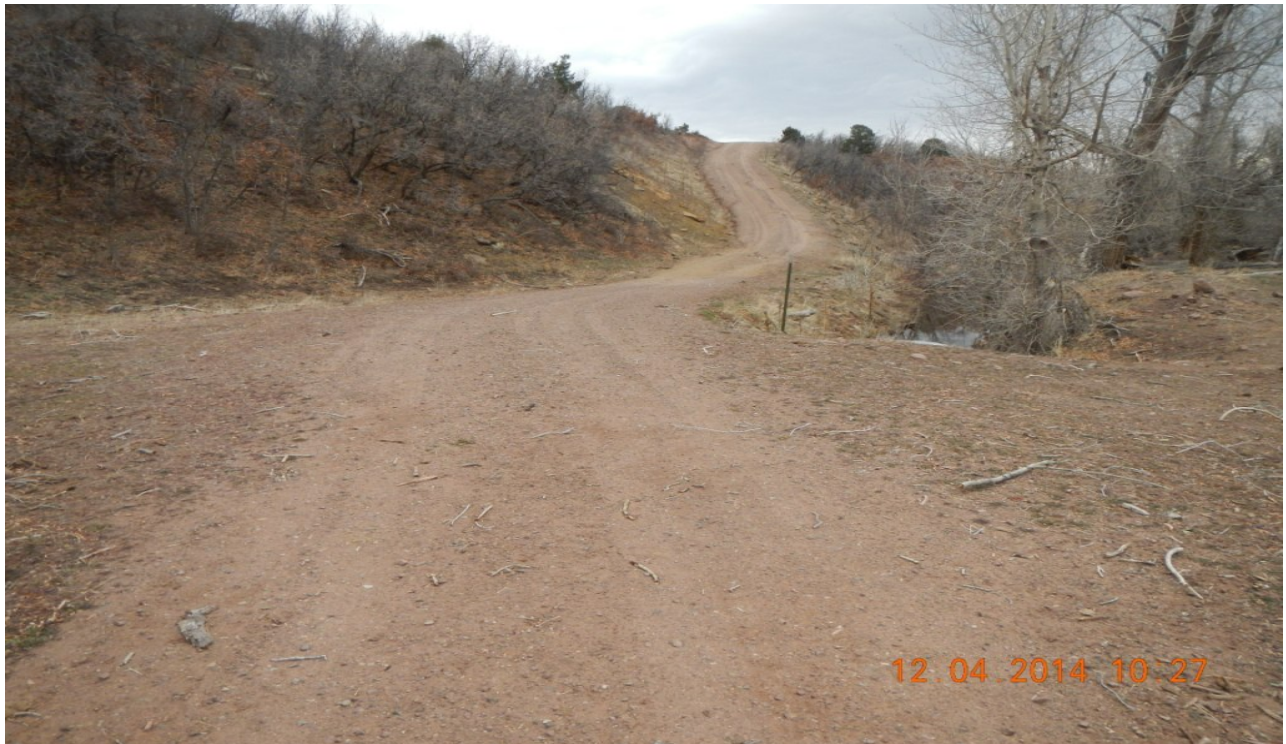
photo 2: Access road goes across the creek and goes north to the location.

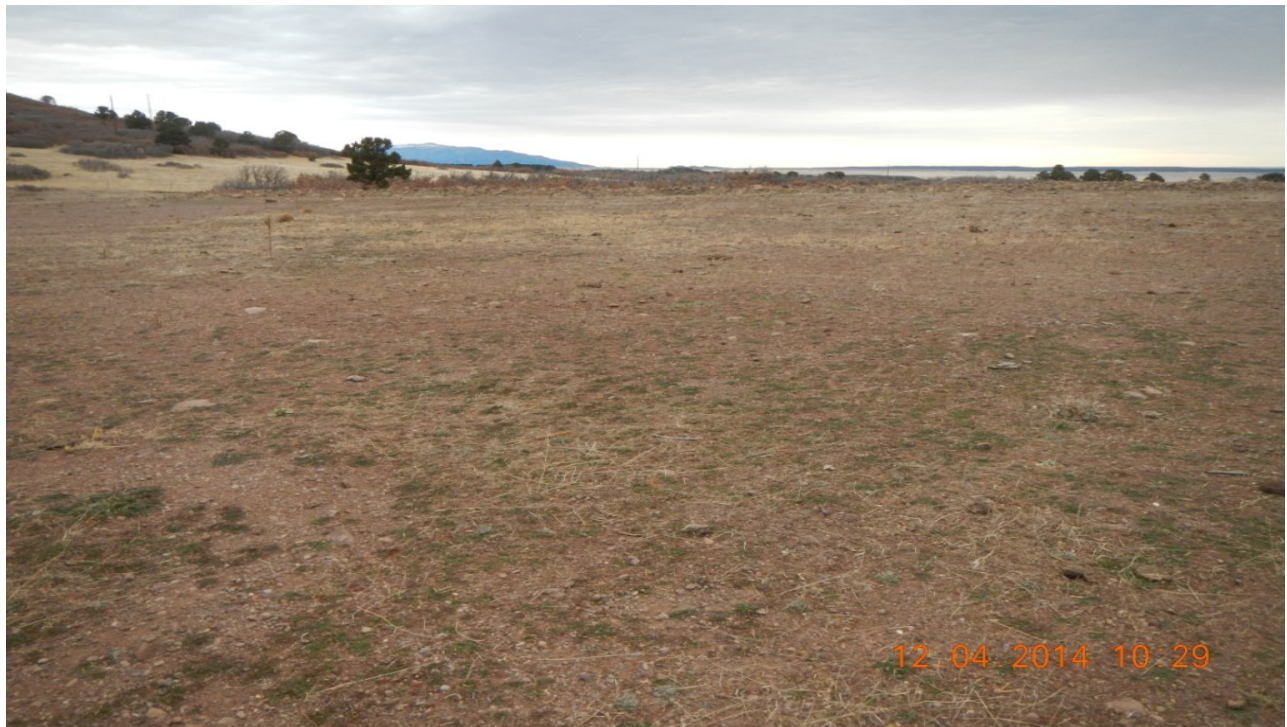
photo 3: Center of the location facing north.

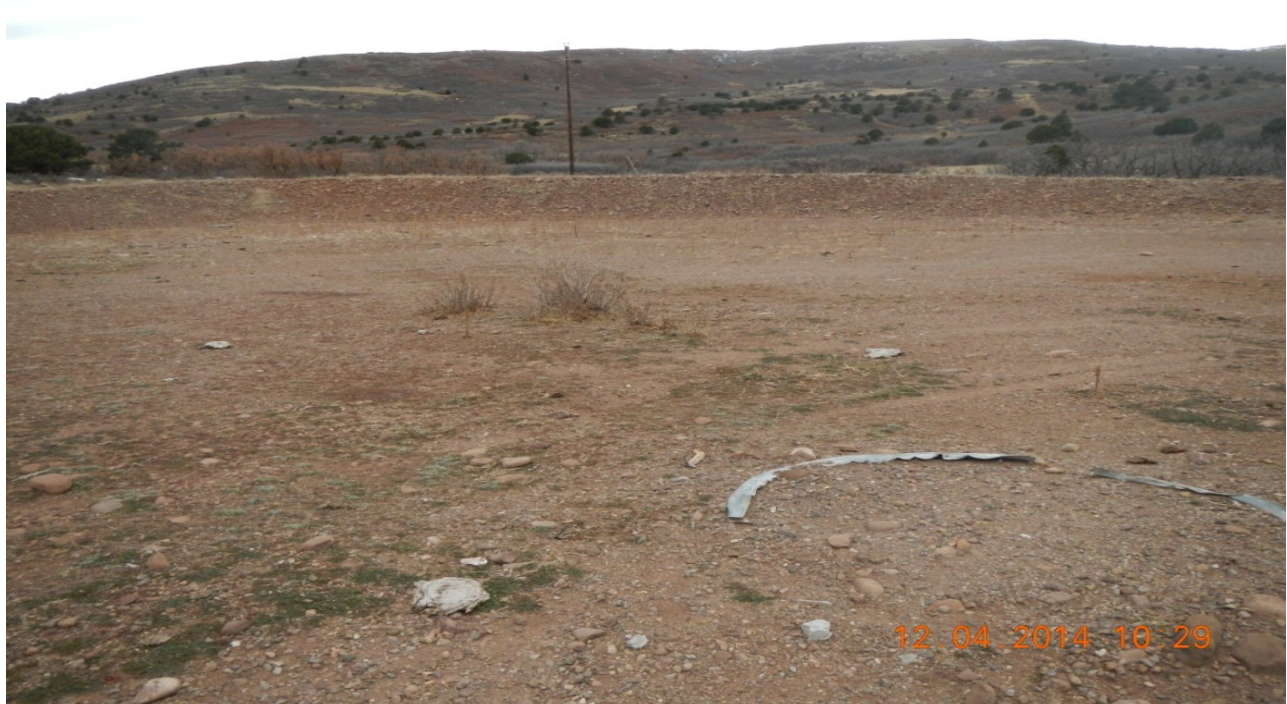
photo 4: Center of the location facing west.

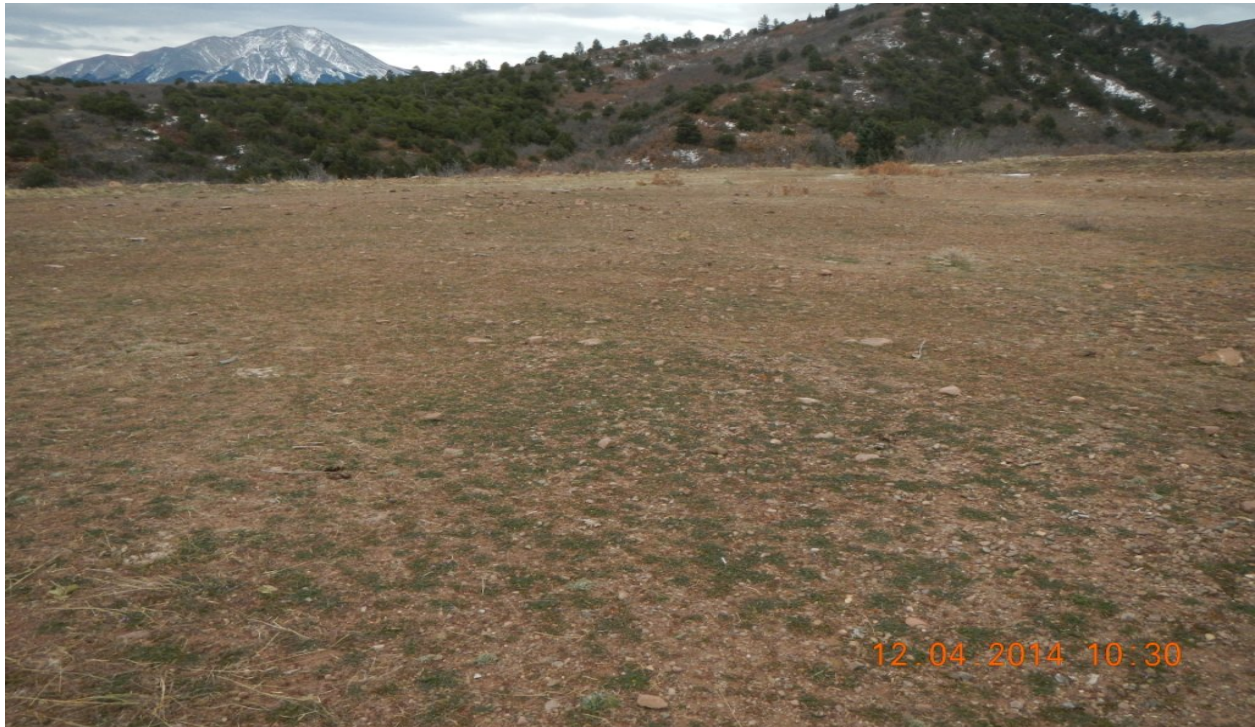
photo 5: Center of the location facing south.

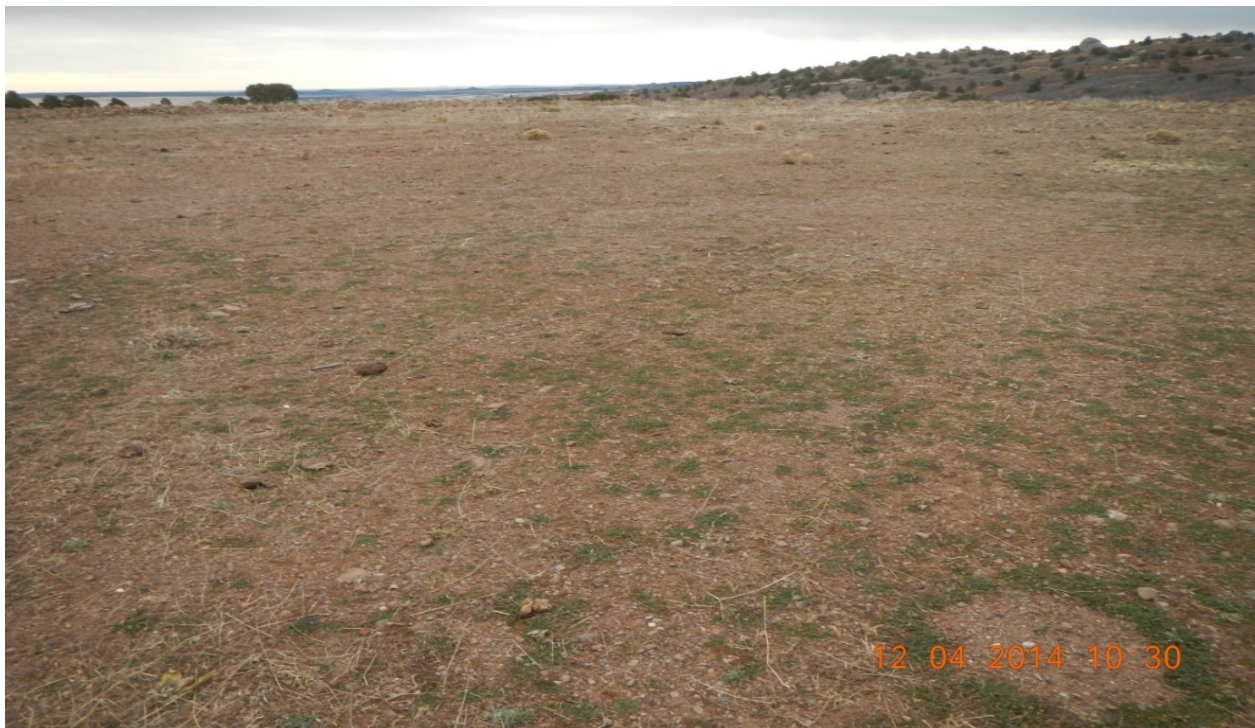
photo 6: Center of the location facing east.

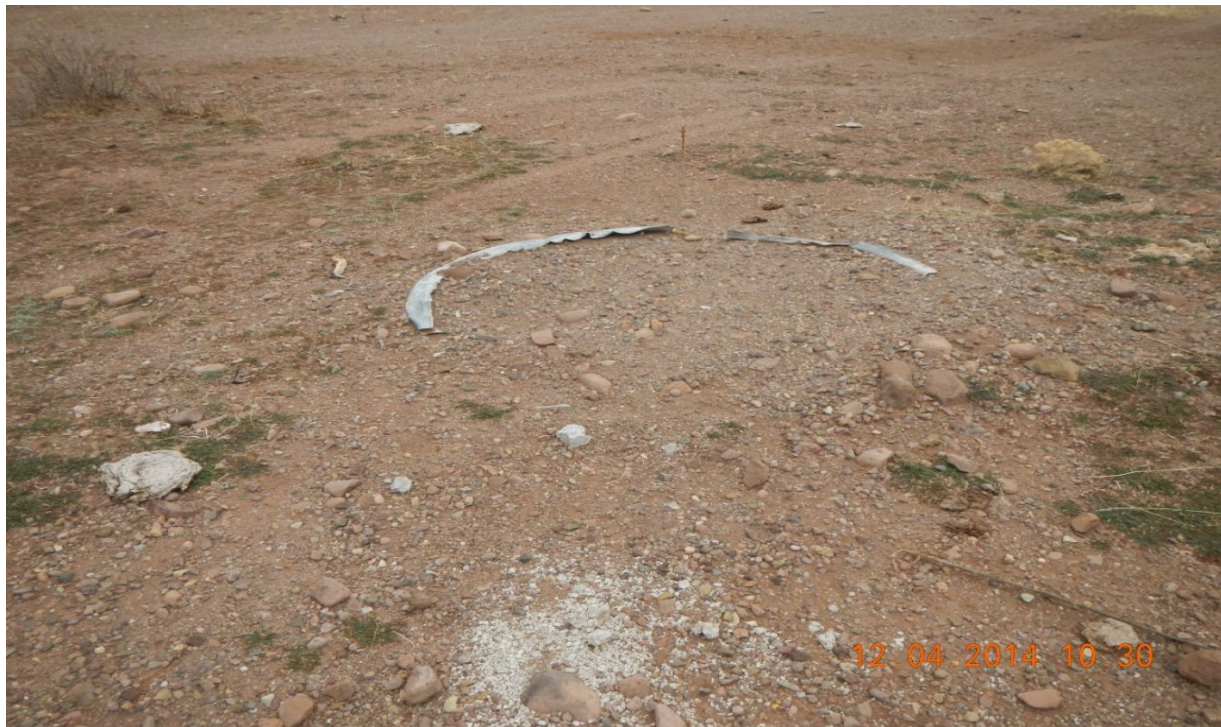
photo 7: Metal ring (culvert) remains in the center of the location.

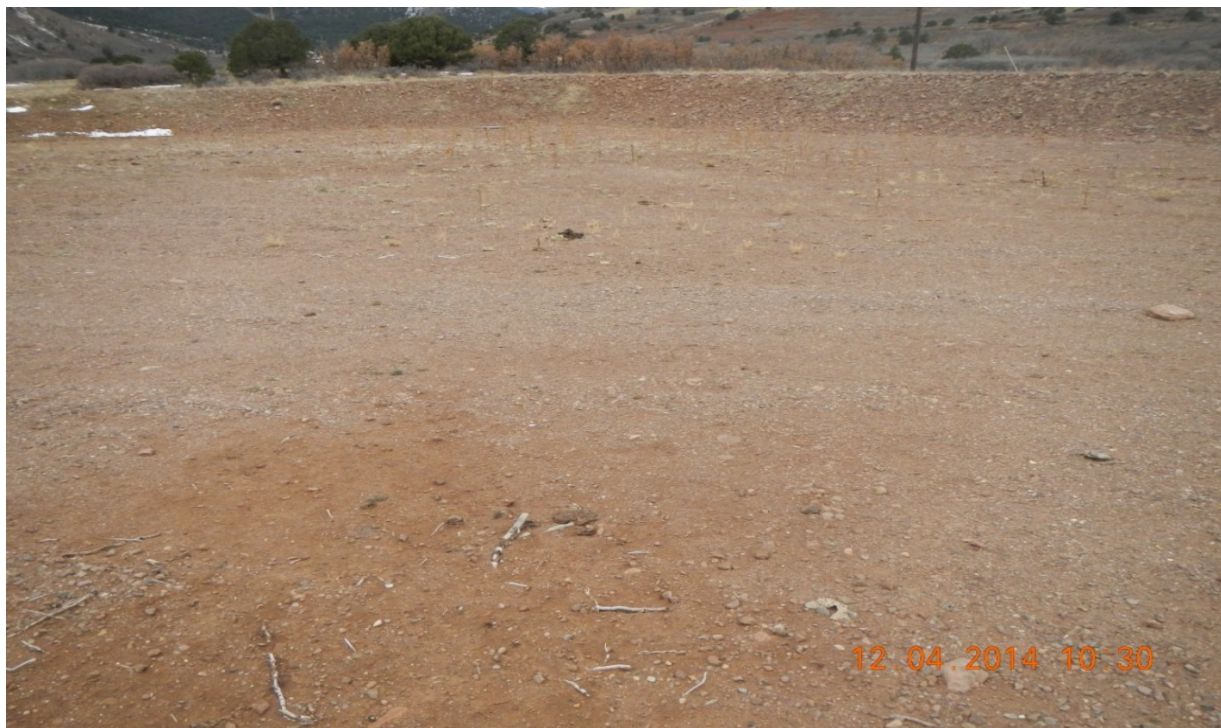
photo 8: Most of the location is completely bare of vegetation.

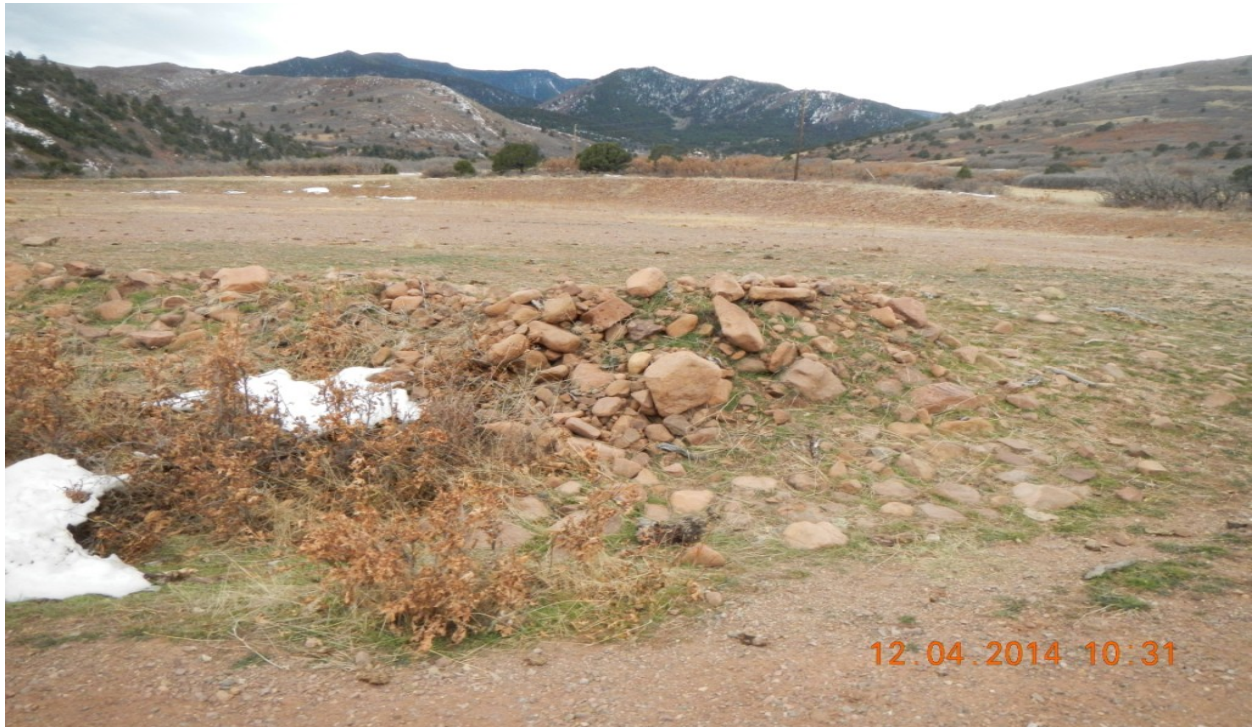
photo 6: Facing west from the access road on the east side of location.

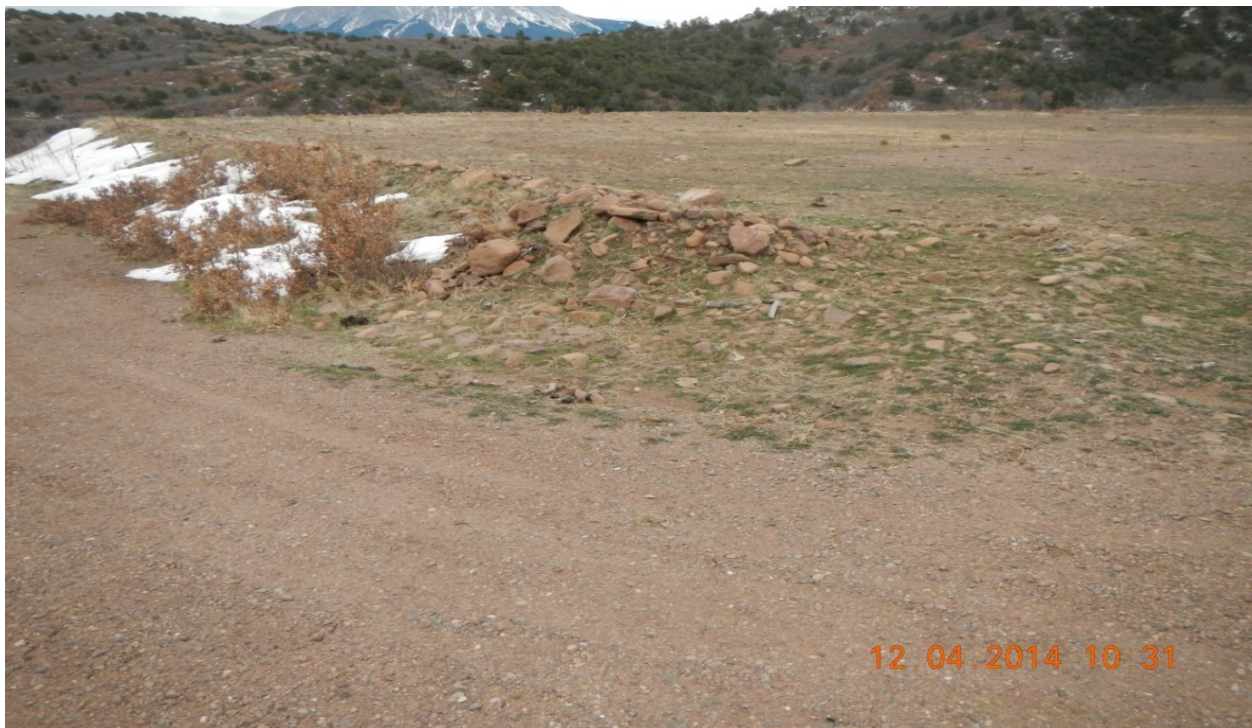
photo 6: Facing south towards the pad from the northeast corner of the location.

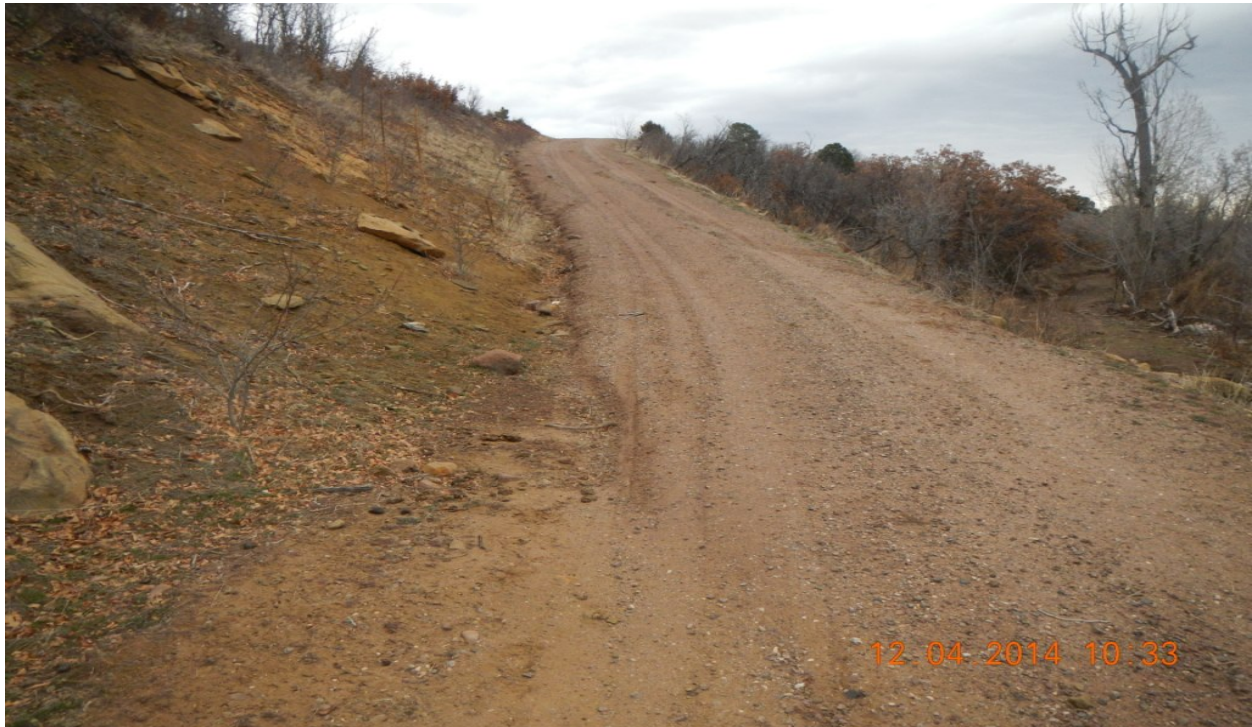
photo 6: Erosion is occurring off the slope and down the access road.

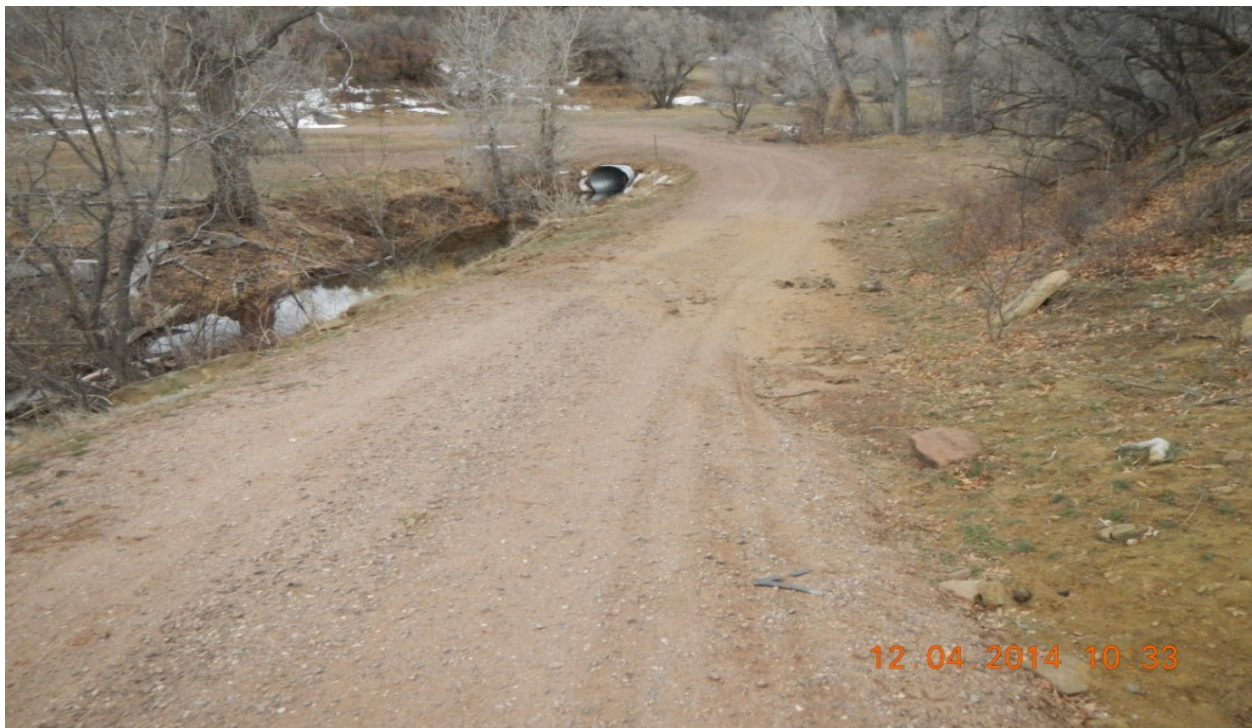
photo 6: Culvert remains in creek crossing.
