Hagan Federal 22-8A

Inspection# 675200924

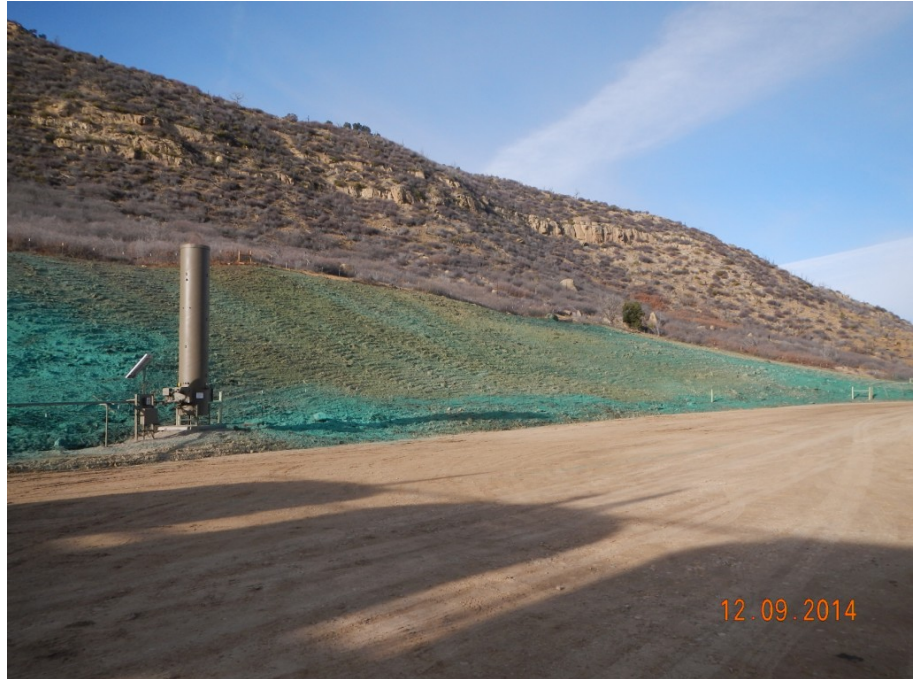
Reclaimed cut slope with hydro-mulch.

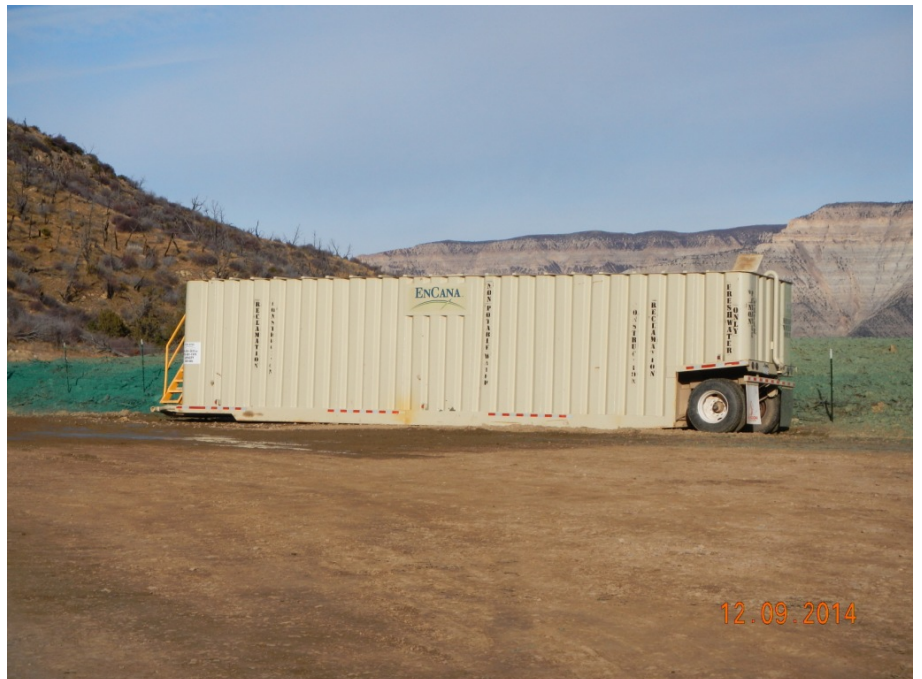
Frac tank to be removed to comply with COGCC rules.

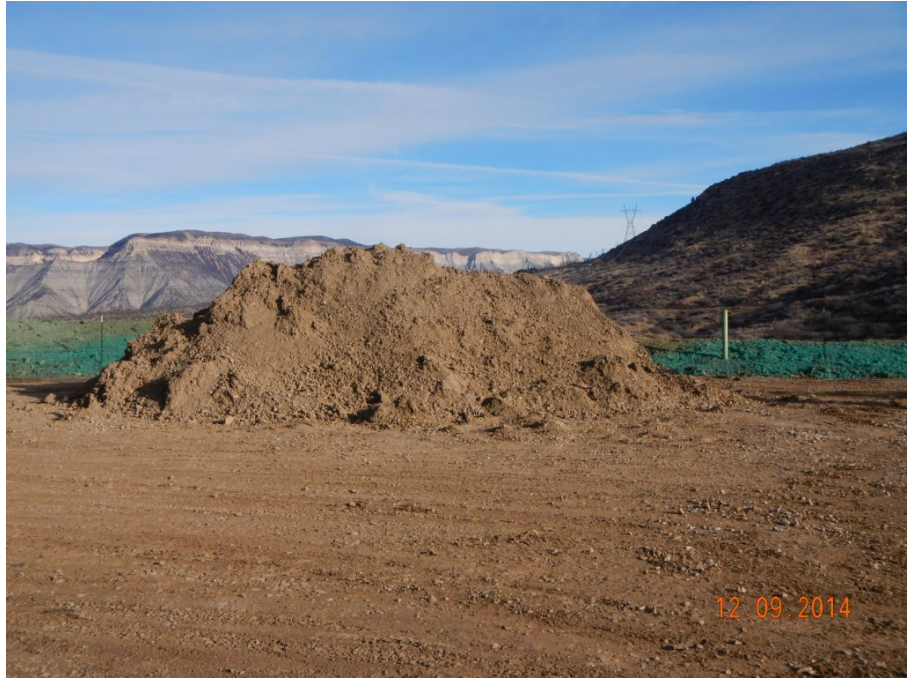
Dirt/gravel pile to be removed or
have stormwater BMPs in place
around base.
