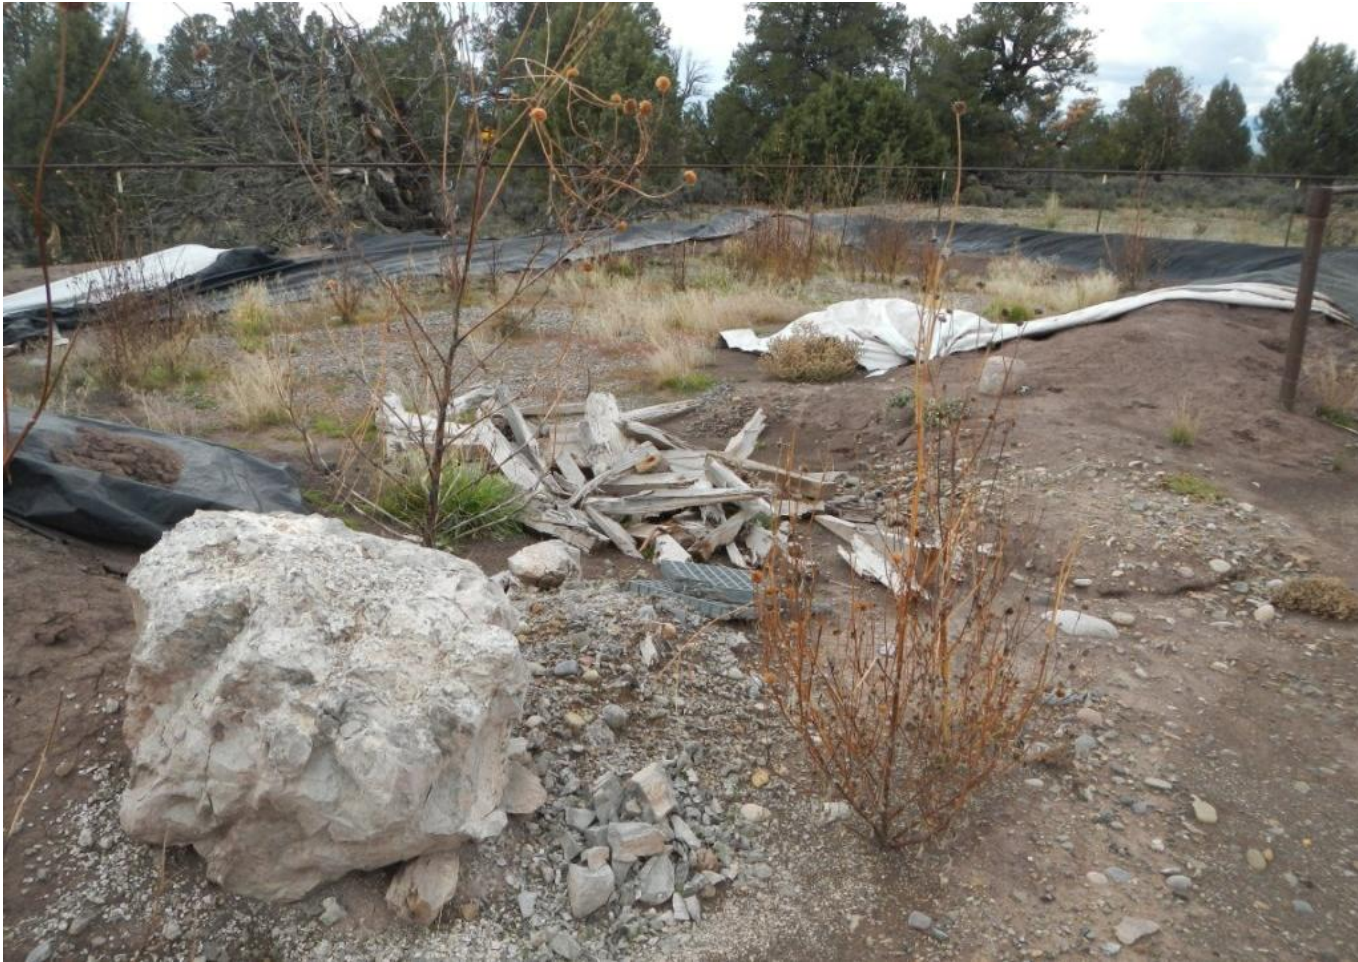
Photo 1. View of old pit, trash, and debris that need to be reclaimed in western portion of project area.

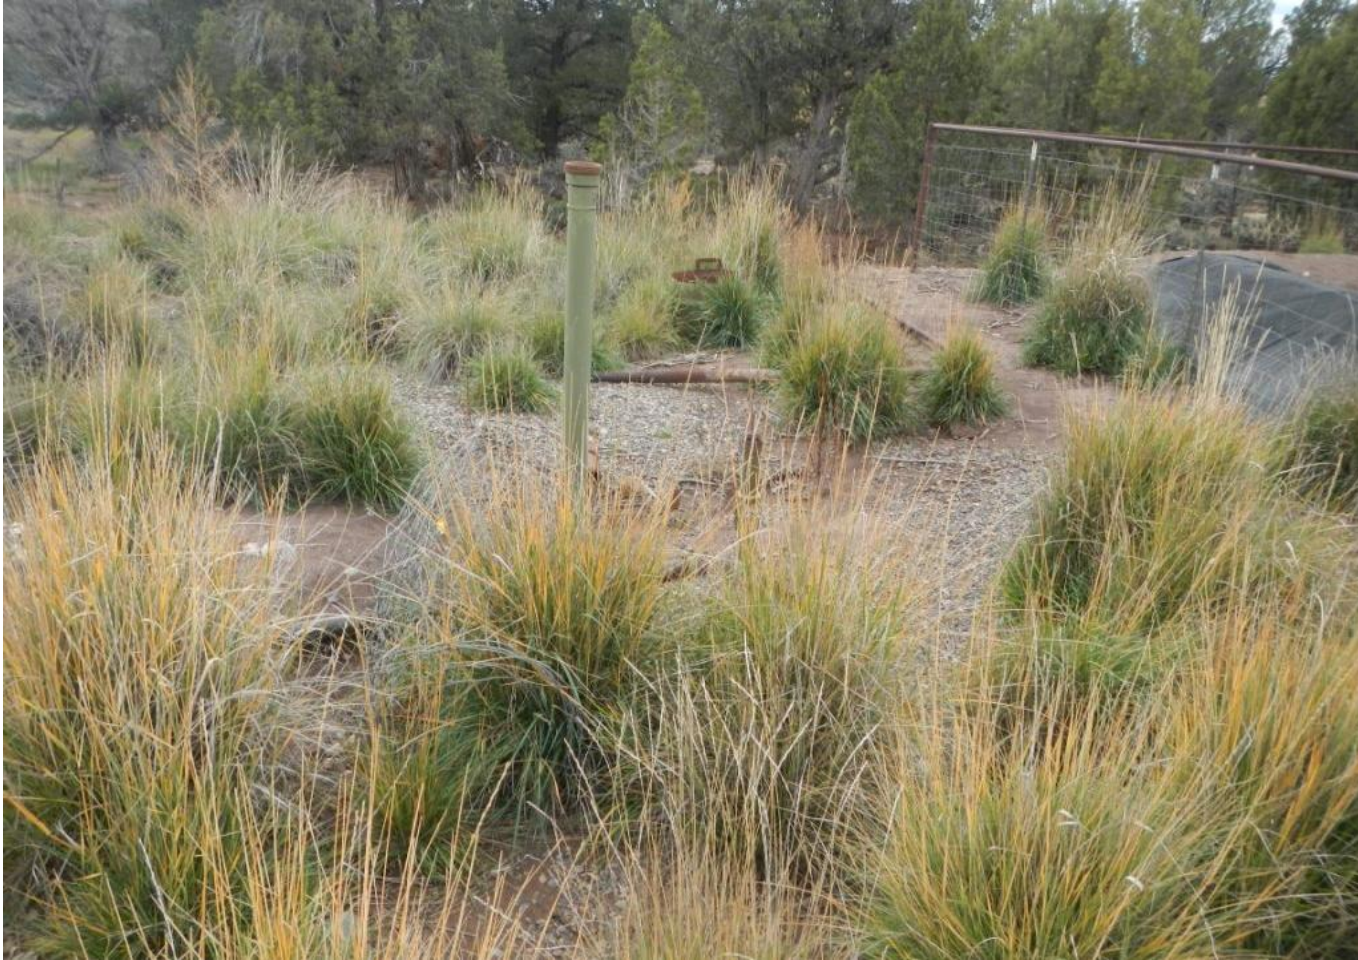
Photo 2. View of old equipment that needs to be removed in western portion of project area.

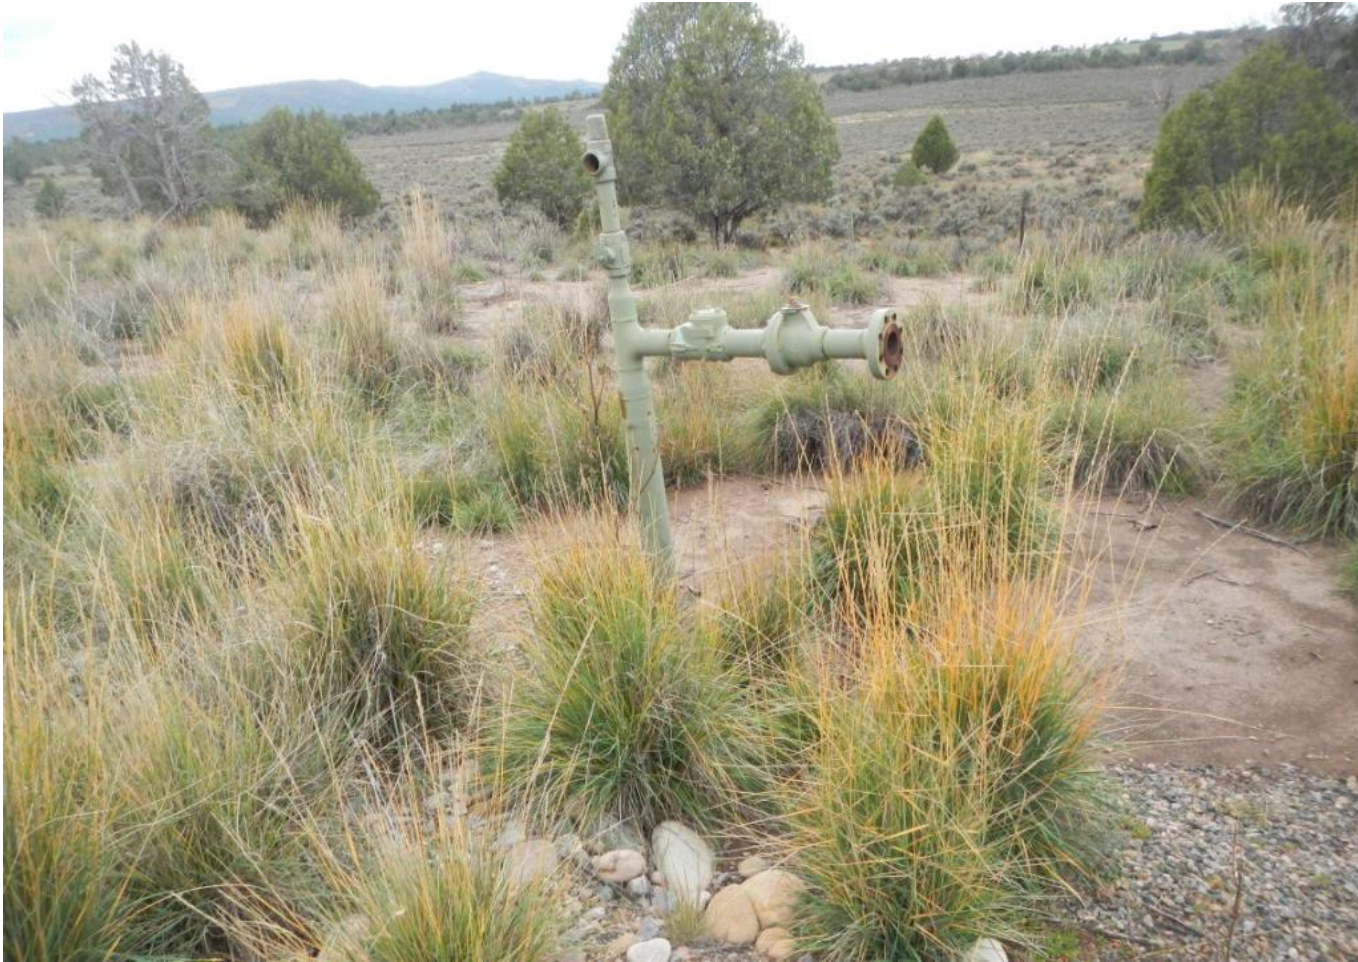
Photo 3. View of more old equipment that needs to be removed in western portion of project area.

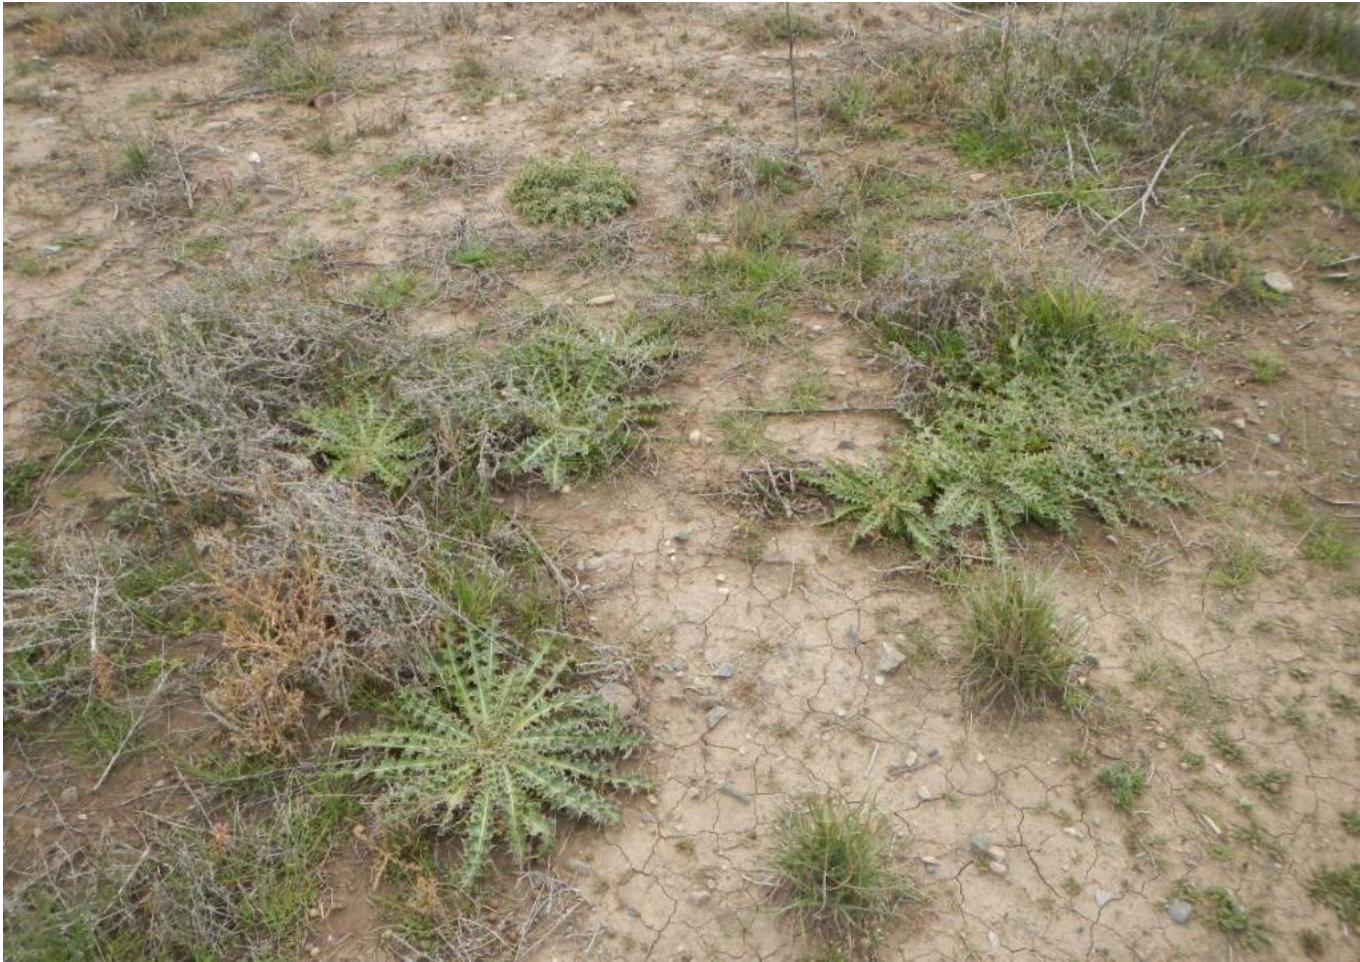
Photo 4. View of numerous Musk thistle rosettes established in the project area.

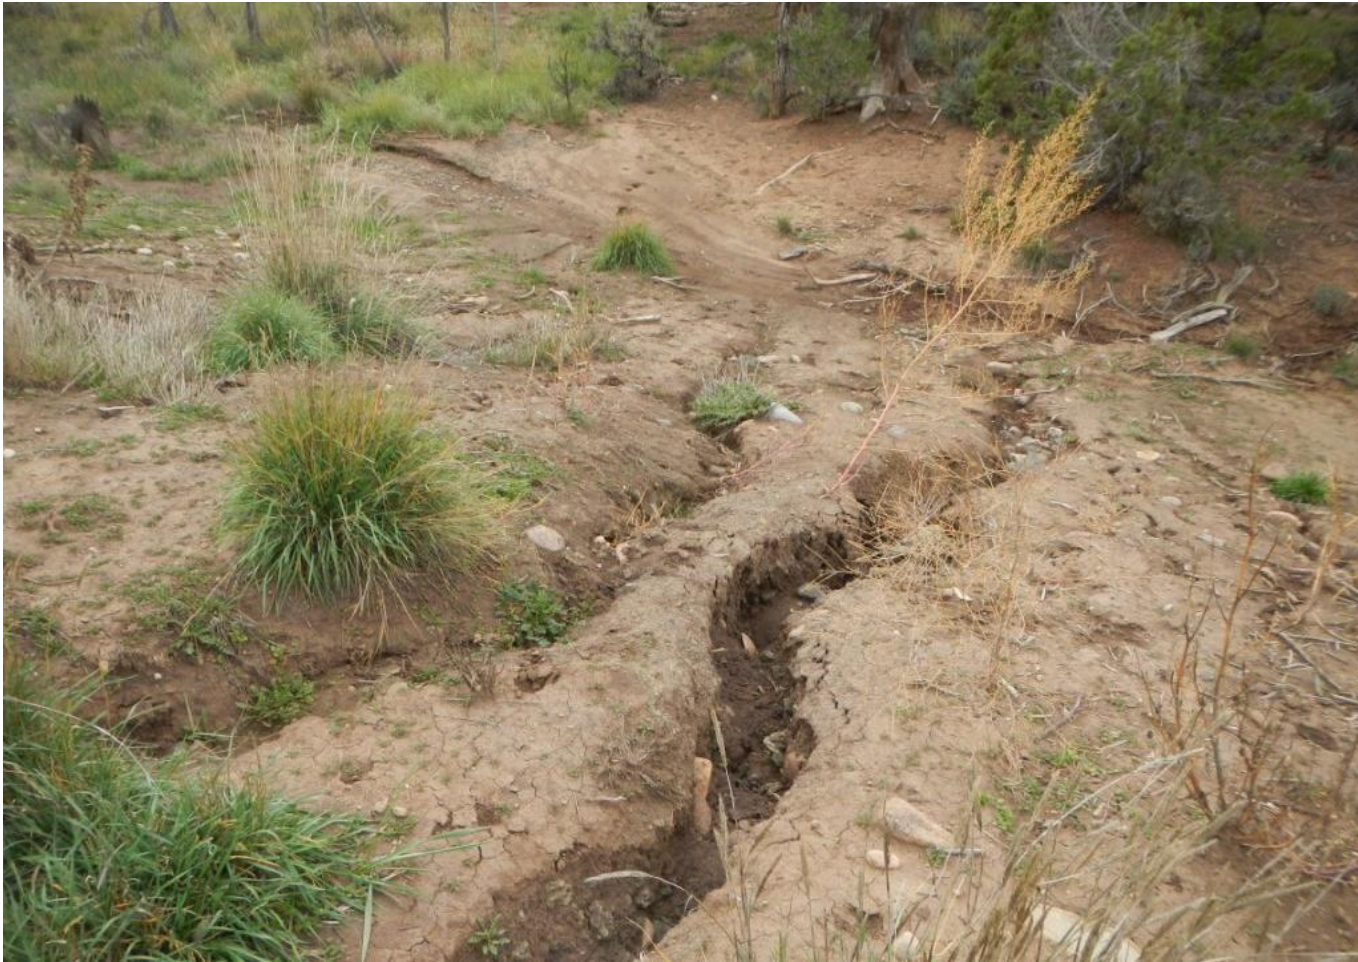
Photo 5. View of deep rills (more than 1 foot deep) and sediment runoff in western portion of project area.

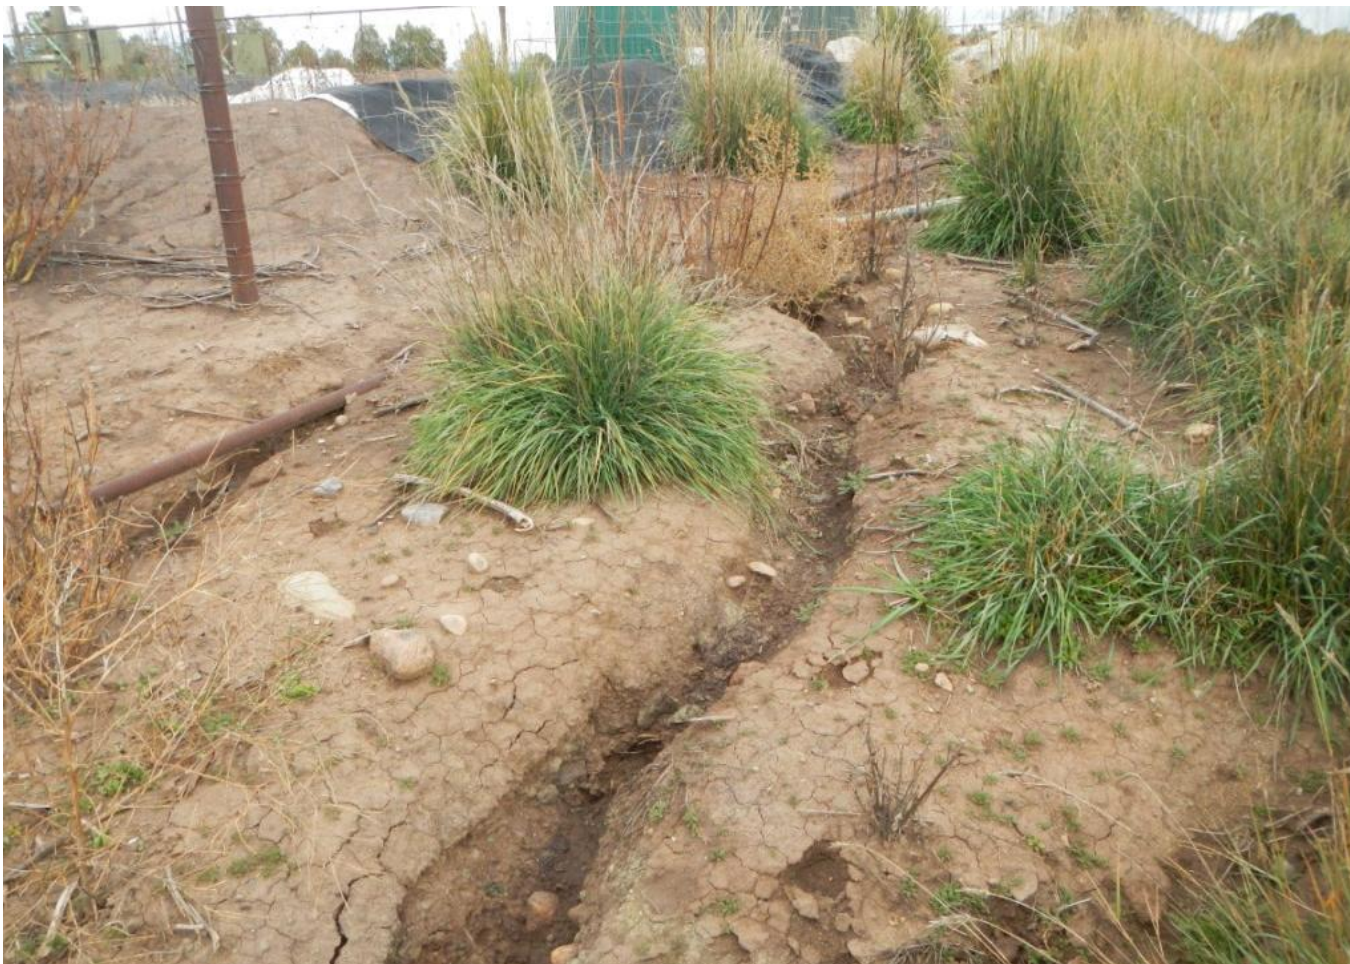
Photo 6. View of erosion at edge of old pit and exposed pipe in western portion of project area.

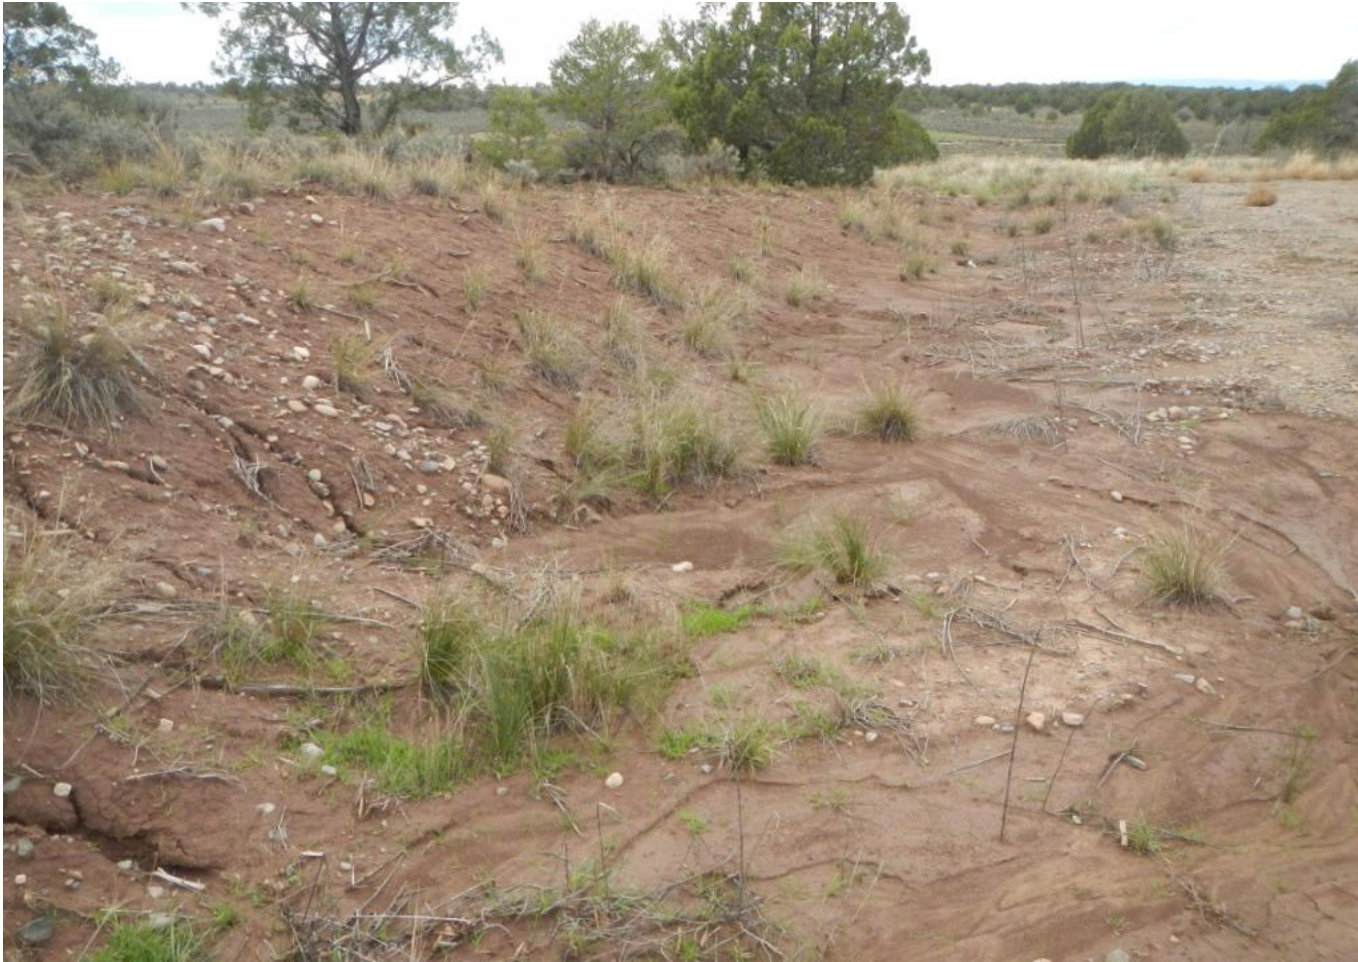
Photo 7. View of rill erosion and sediment deposition in southern portion of project area.

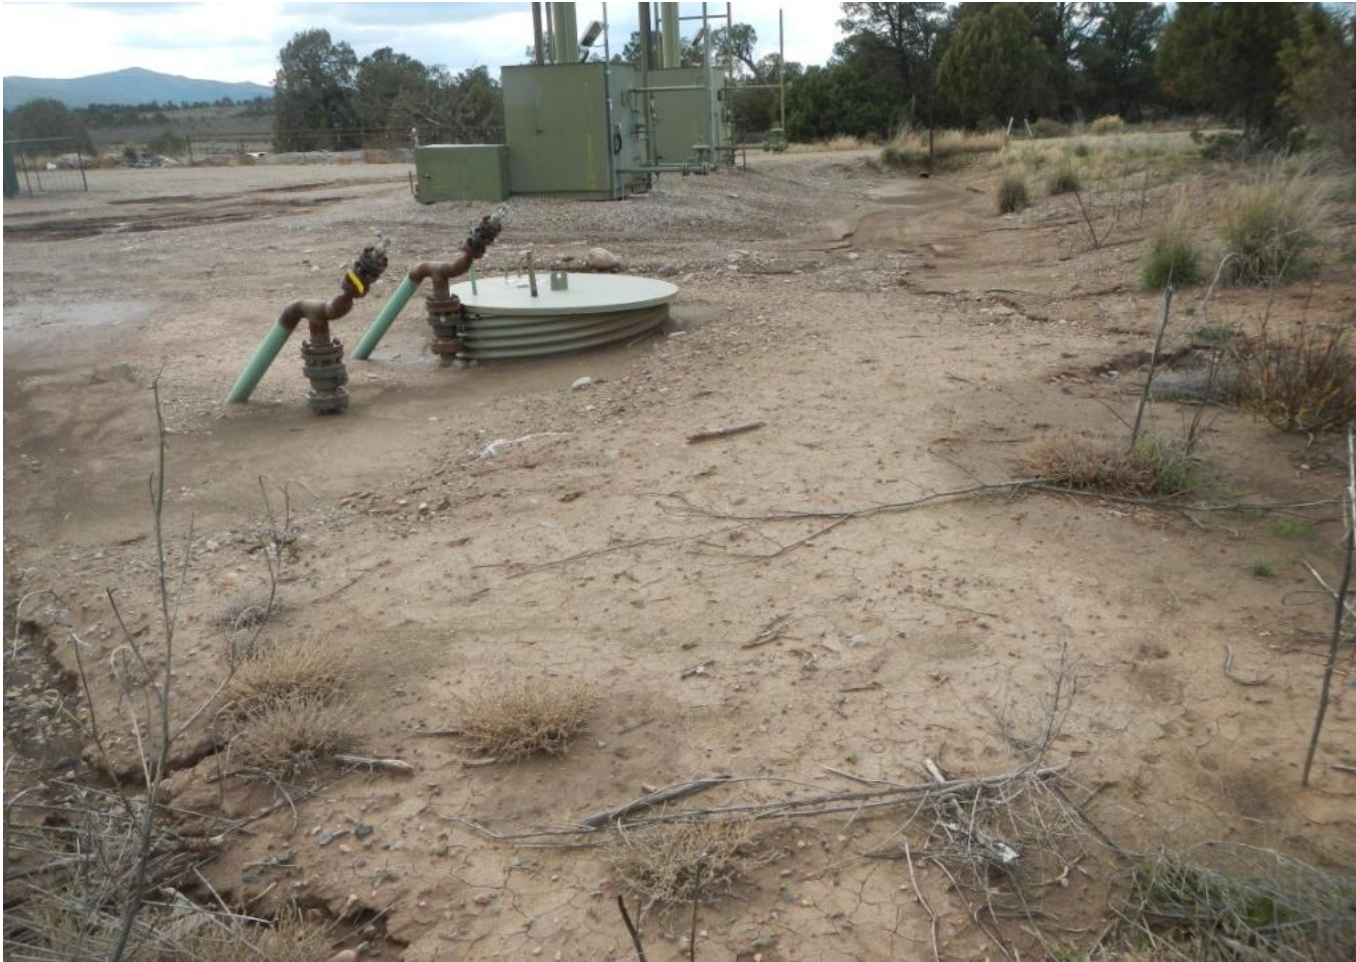
Photo 8. View of sediment run-on and erosion onto well pad in northern portion of project area.

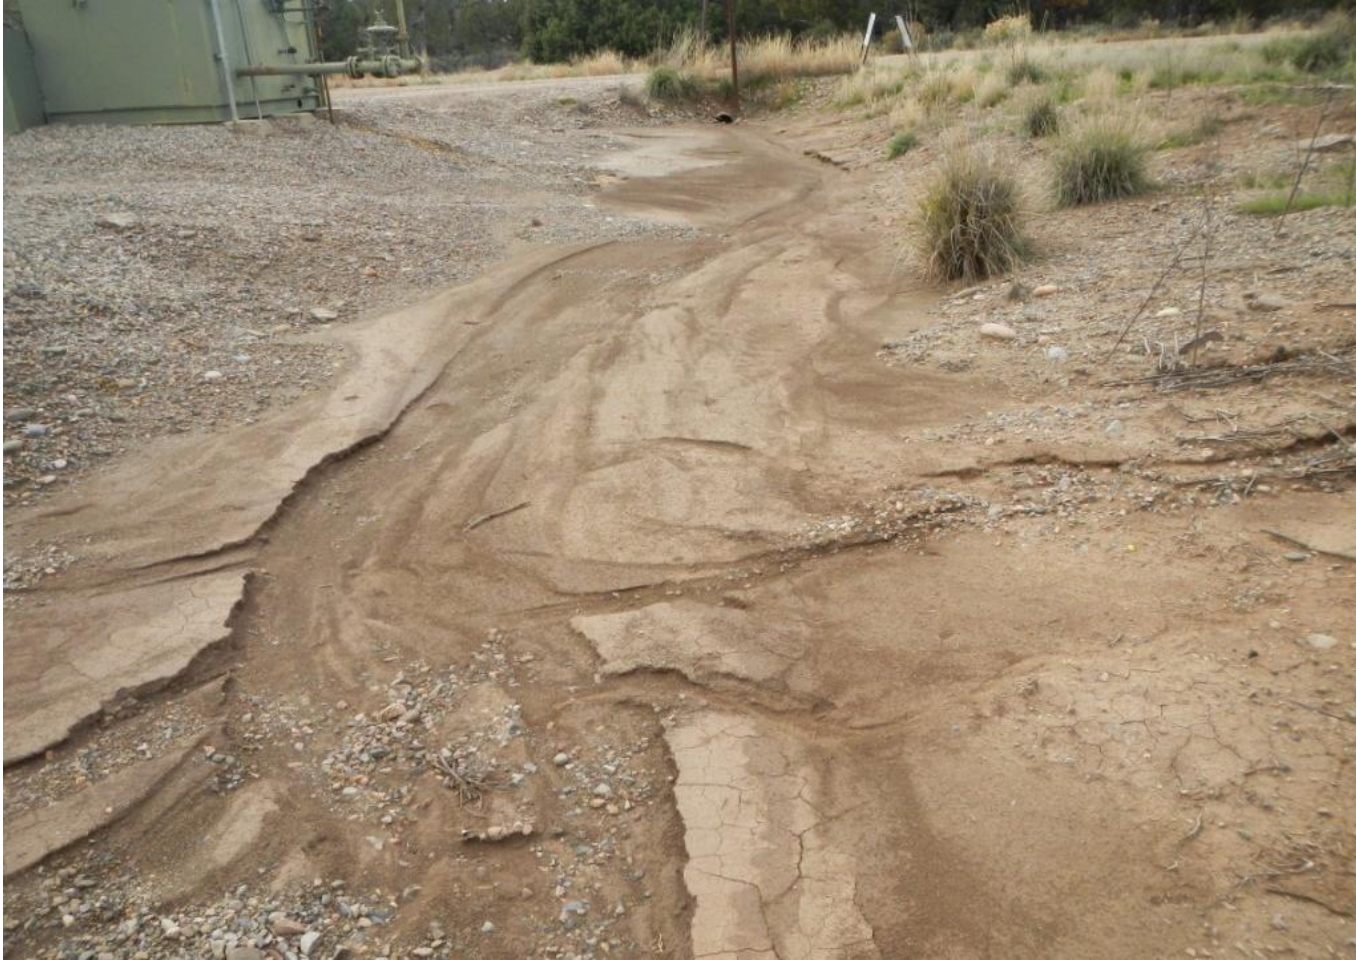
Photo 9. View of large amounts of sediment in stormwater diversion channel in northern portion of project area. Culvert in background is filling with sediment.

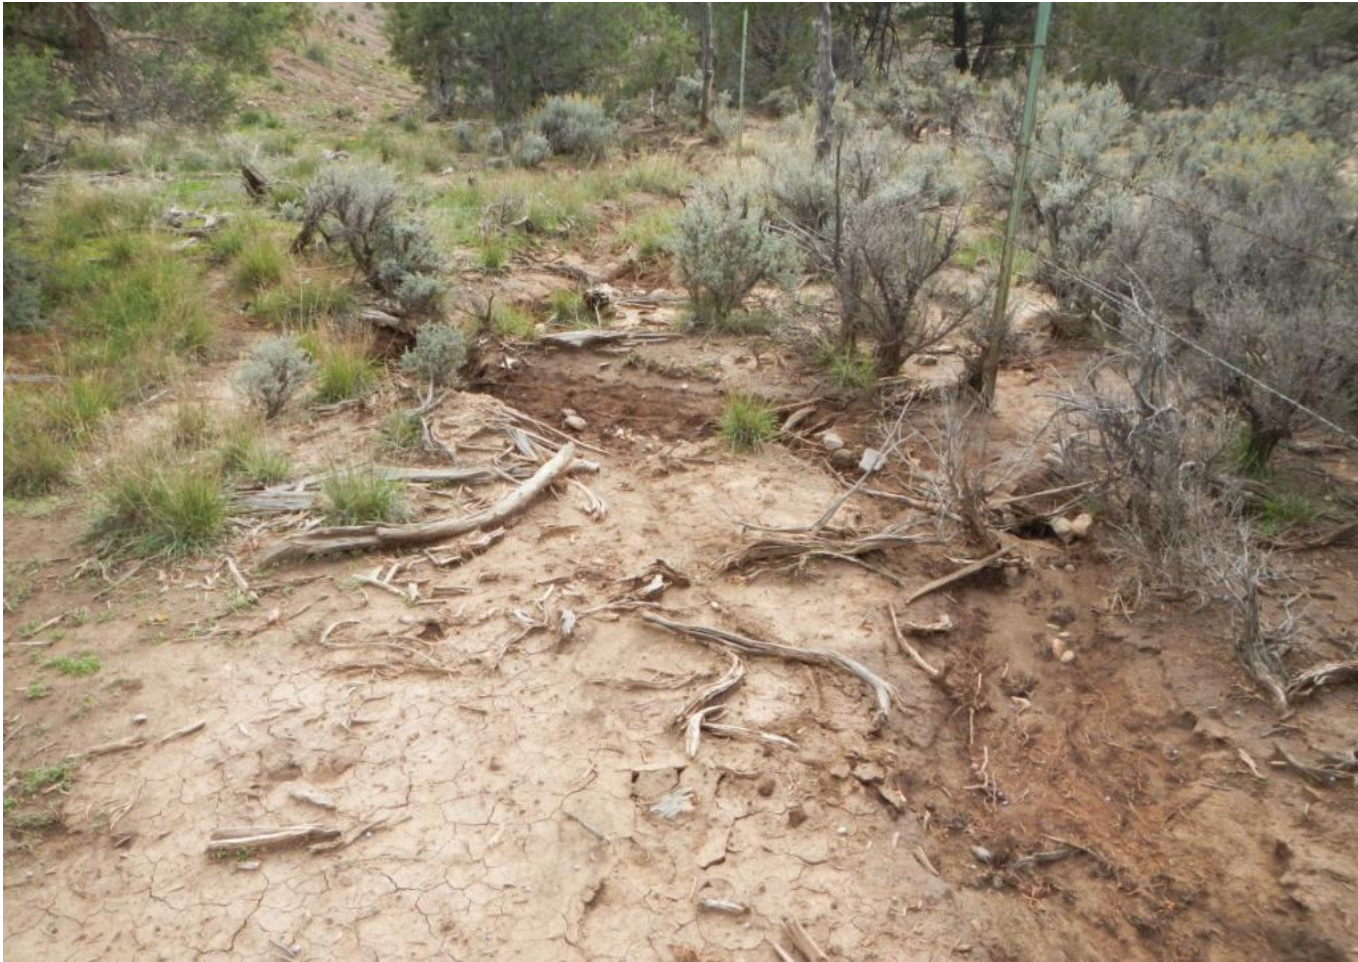
Photo 10. View of stormwater erosion outside of project area from concentrated flows not properly de-energized exiting the culvert at the well pad entrance.
