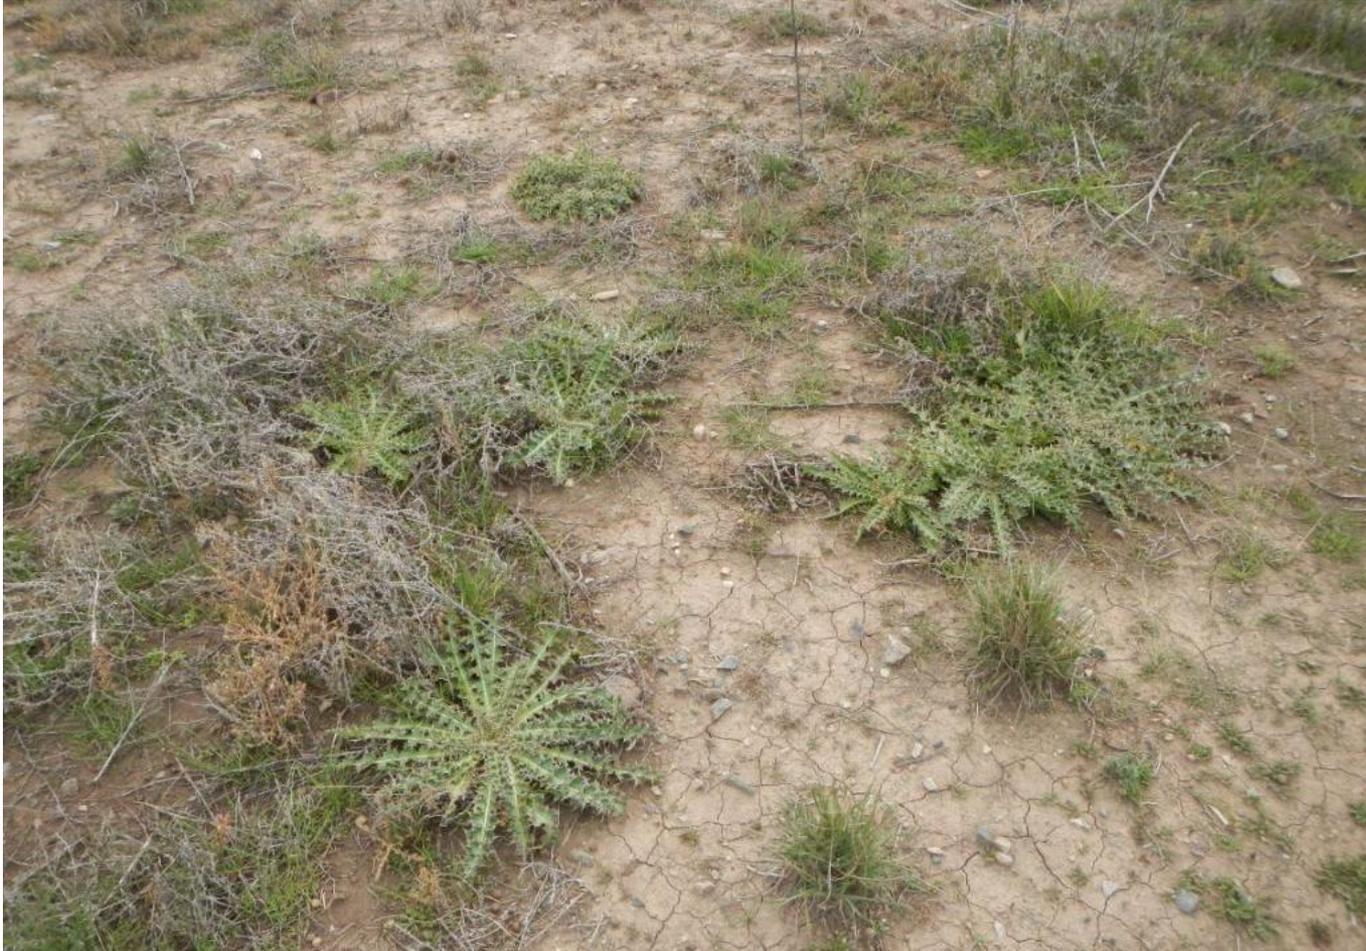
Photo 1. View of numerous Musk thistle rosettes established in the project area.

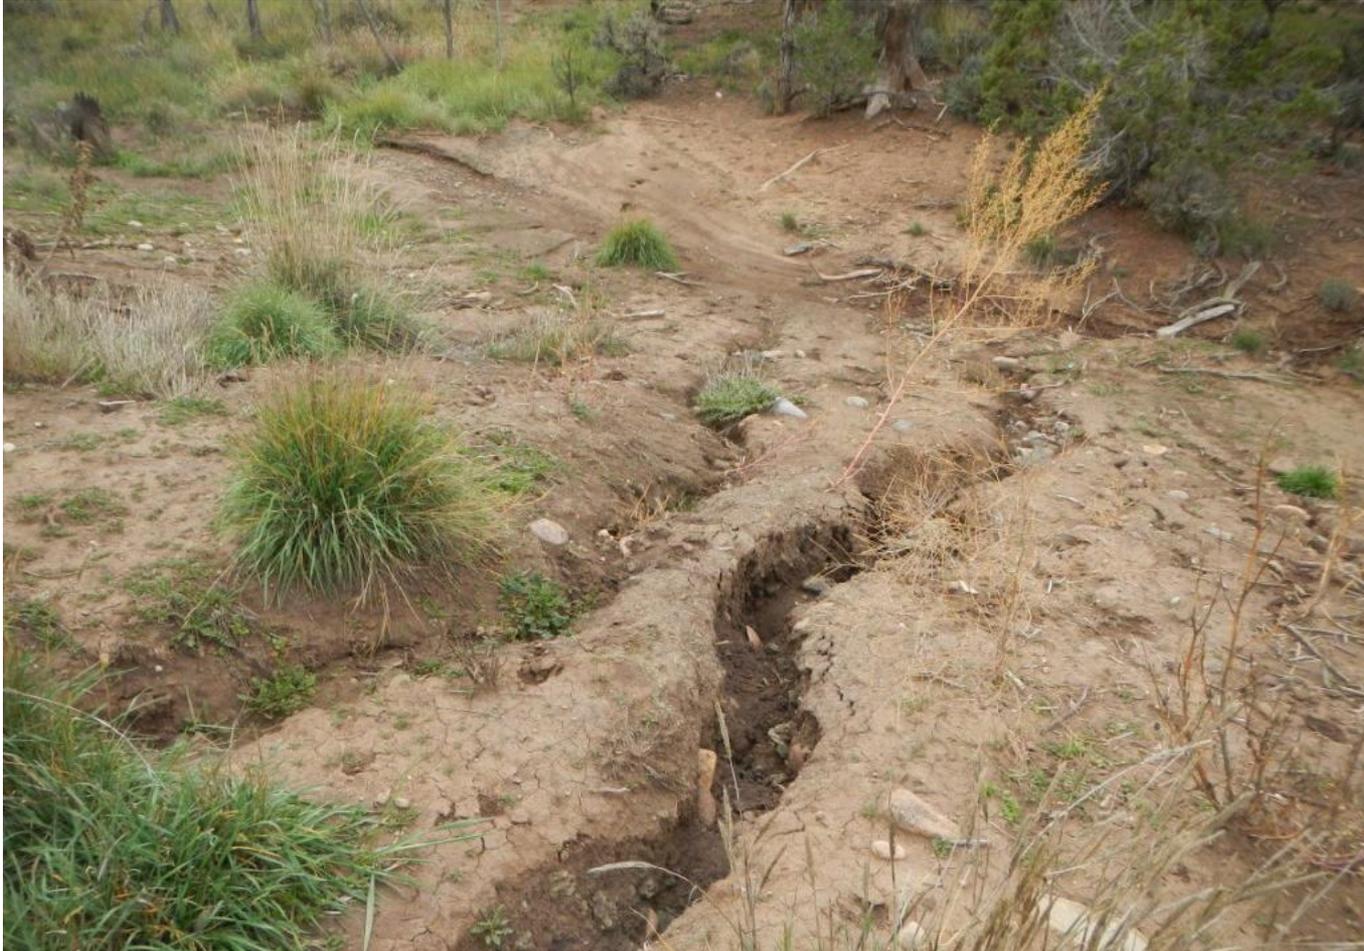
Photo 2. View of deep rills (more than 1 foot deep) and sediment runoff in western portion of project area.

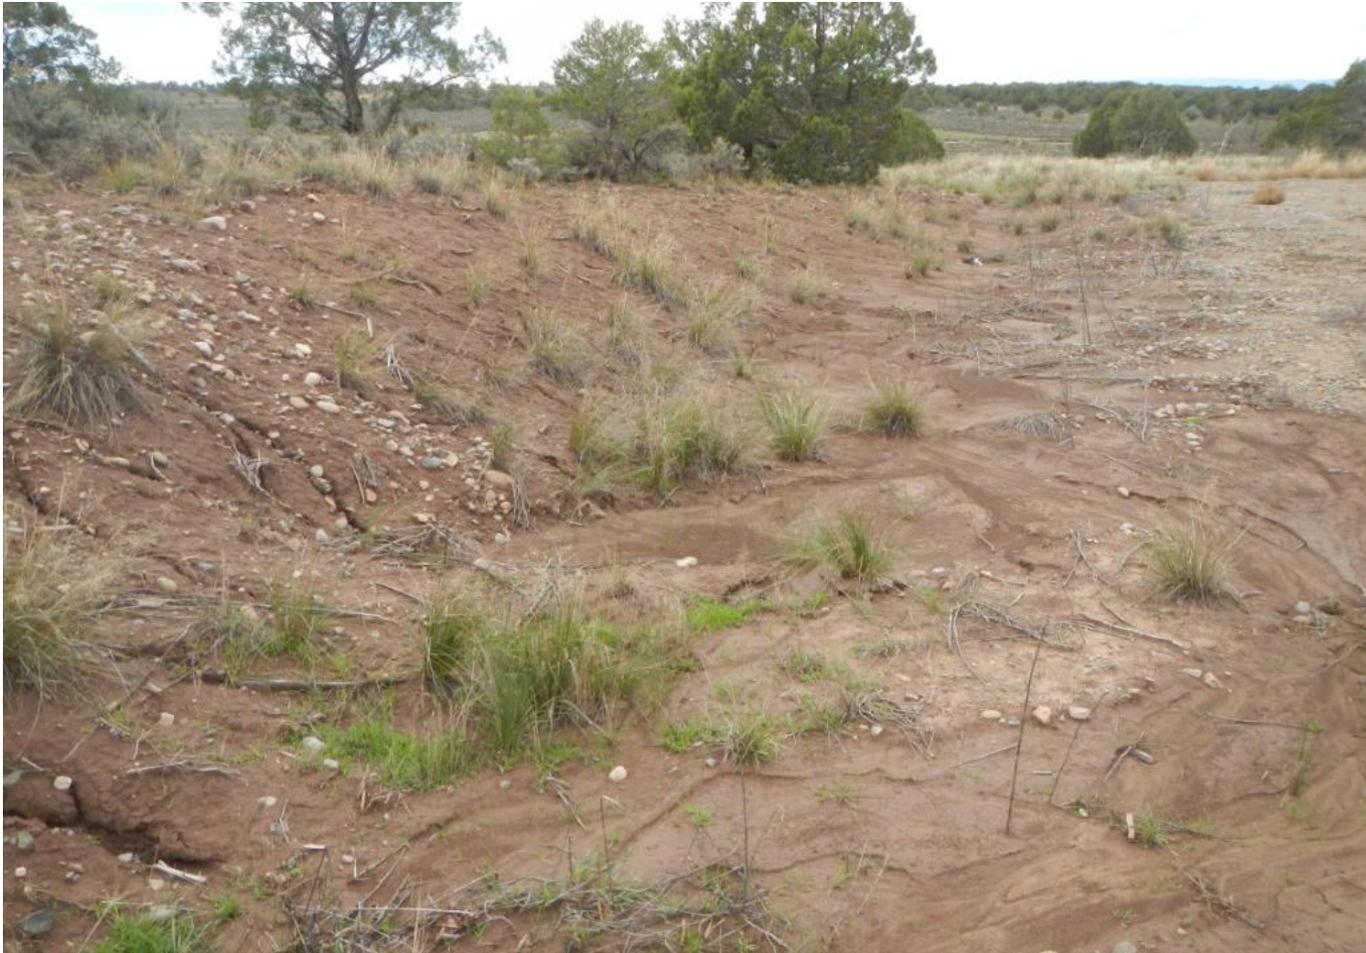
Photo 3. View of rill erosion and sediment deposition in southern portion of project area.

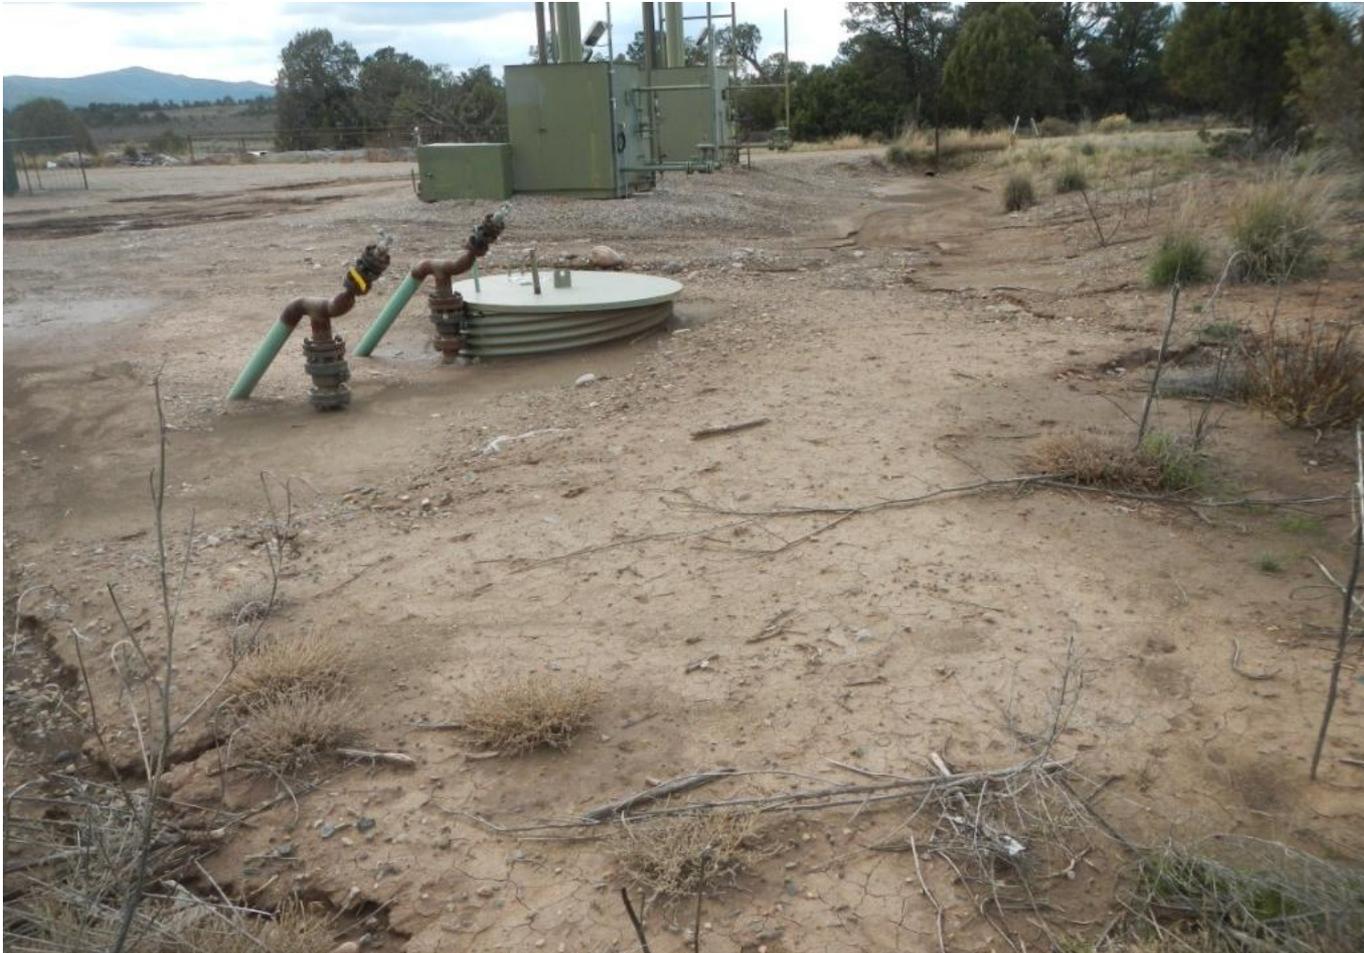
Photo 4. View of sediment run-on and erosion onto well pad in northern portion of project area.

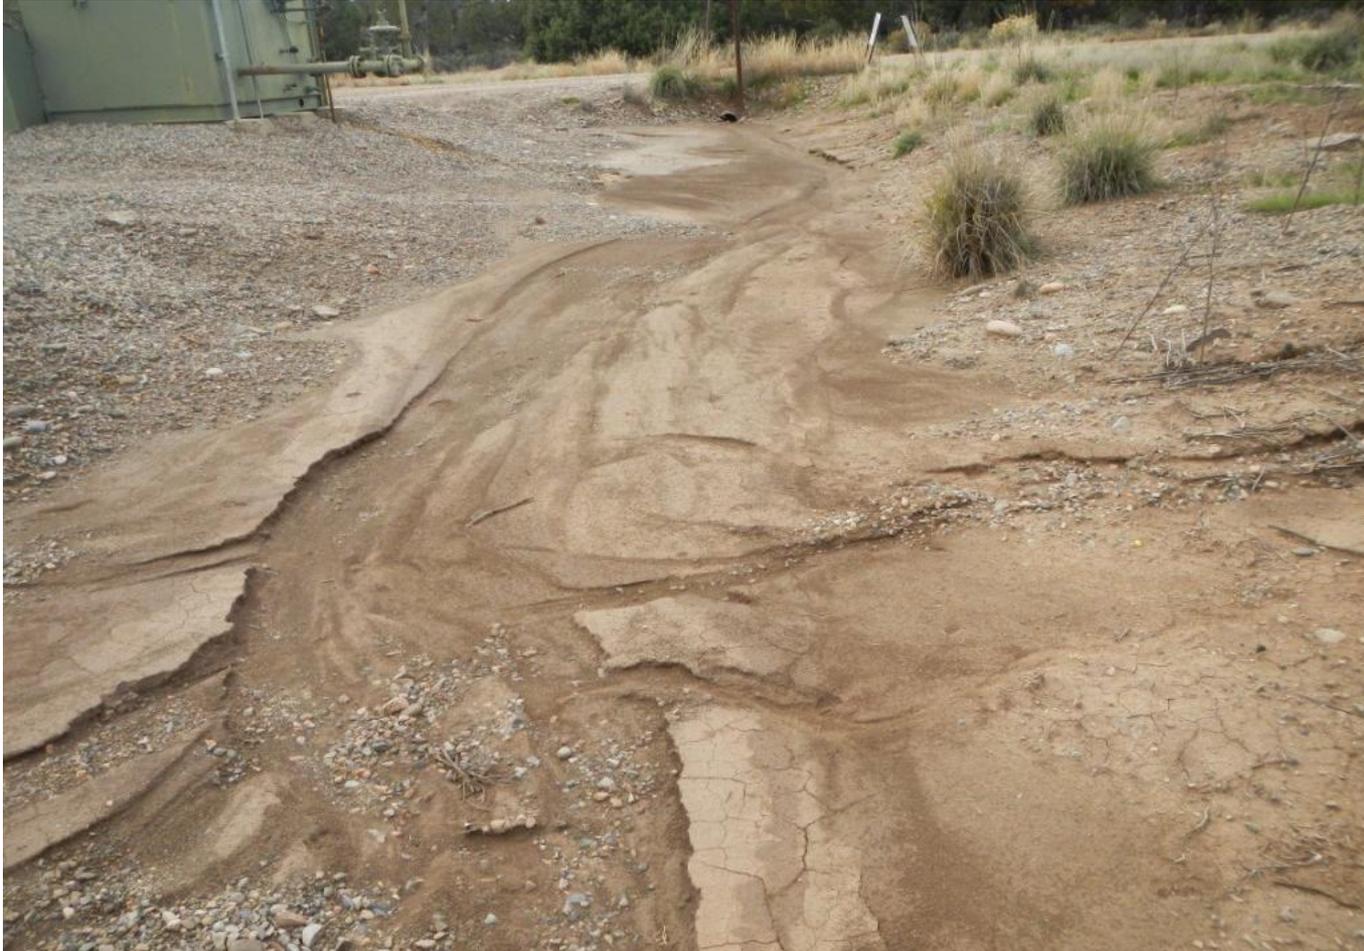
Photo 5. View of large amounts of sediment in stormwater diversion channel in northern portion of project area. Culvert in background is filling with sediment.

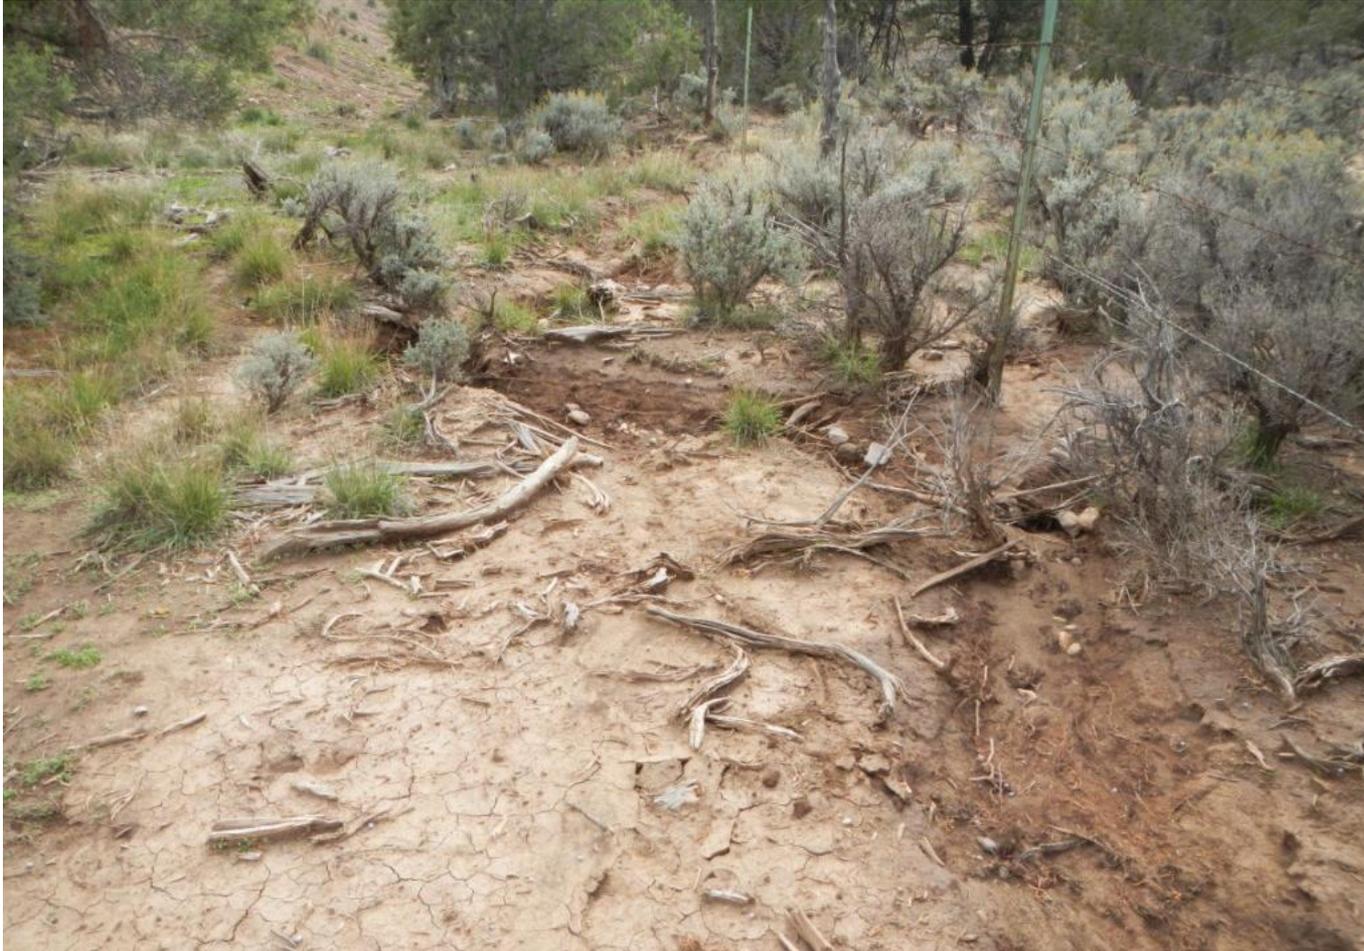
Photo 6. View of stormwater erosion outside of project area from concentrated flows not properly de-energized exiting the culvert at the well pad entrance.
