**BP America Production Company
Floirine Hudspeth A2 API 05-067-08937
COGCC Field Inspection # 674601294 12/11/14**

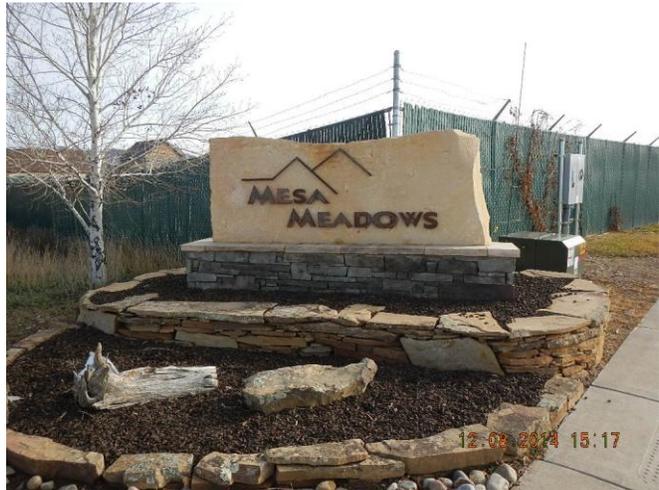
Subdivision sign and well pad in background.

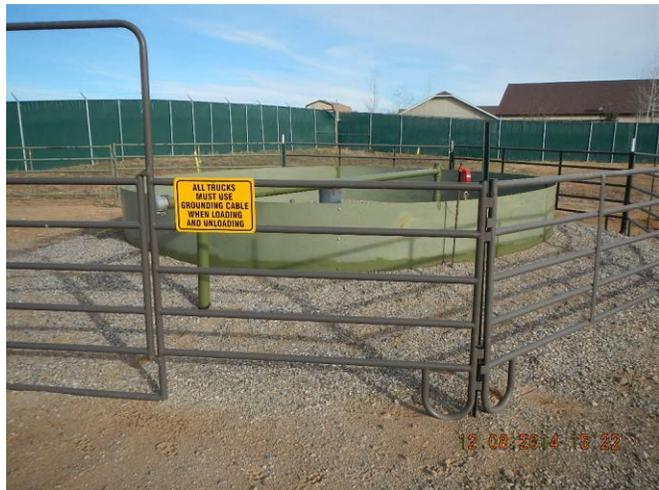
Produced water tank without signage to meet rule 210d requirements.

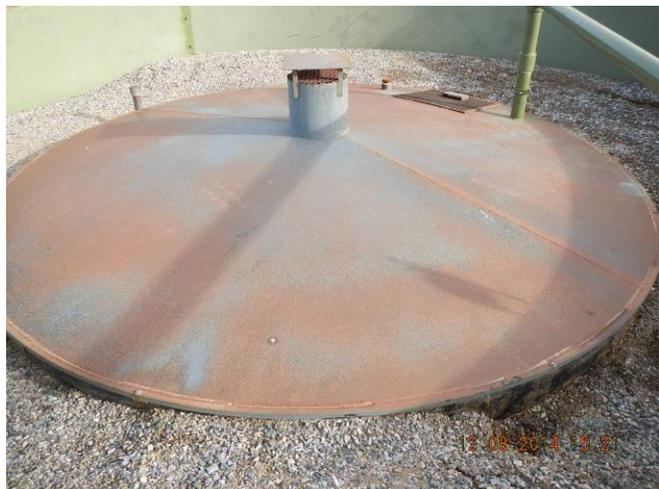
Unpainted produced water tank lid.

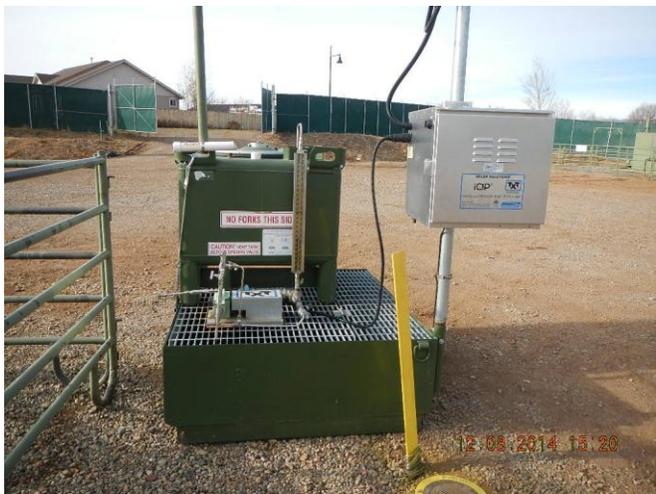
Disconnected/ unused chemical injection system.

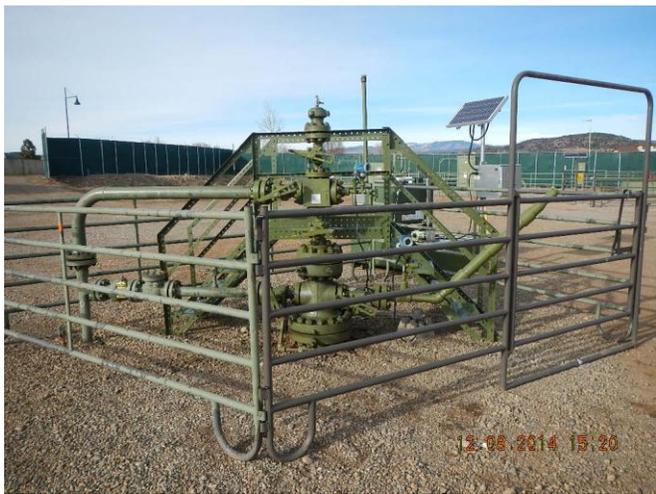
View of wellhead/ equipment looking northwest.

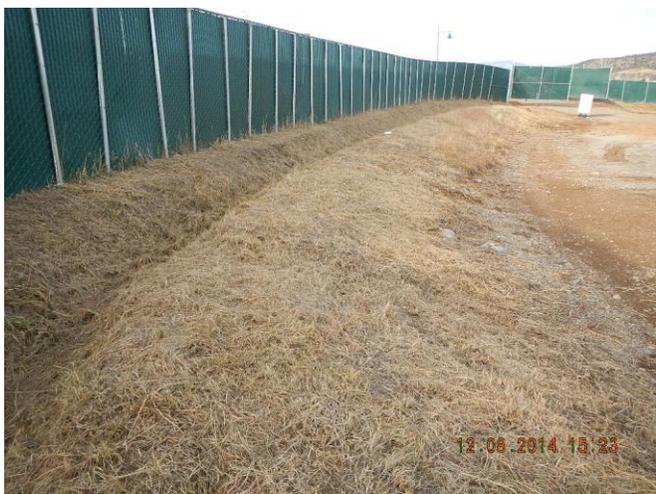
Upslope stormwater ditch/ berm running along west side of well pad.

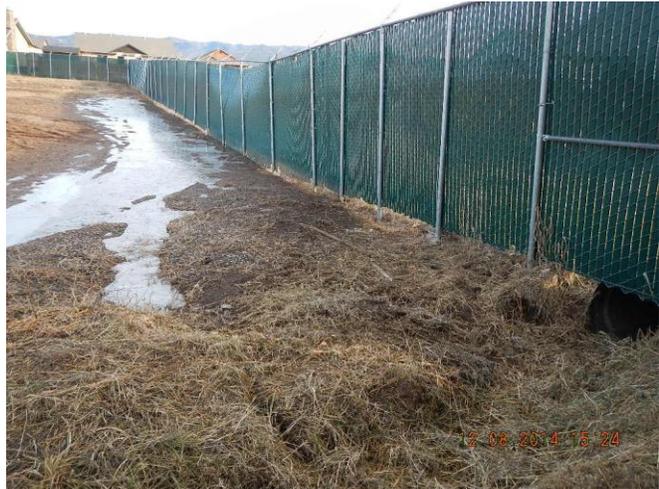
Breached/ eroded area of storm water ditch/ berm at the tie in to the drain system. Stormwater run on and accumulation on well pad.

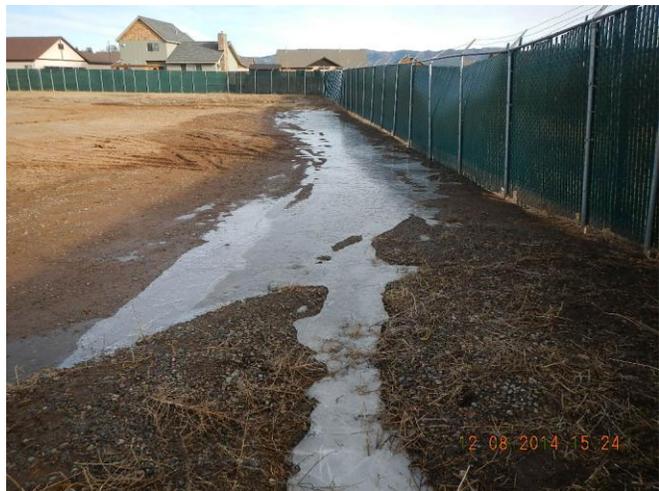
Stormwater accumulation on location from breached ditch and low lying area adjacent to south fence line.

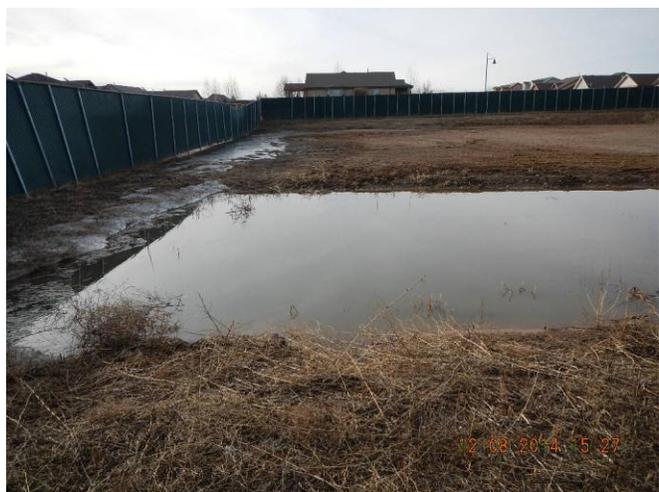
Stormwater accumulation/ ponding on well pad. View looking west toward ditch.

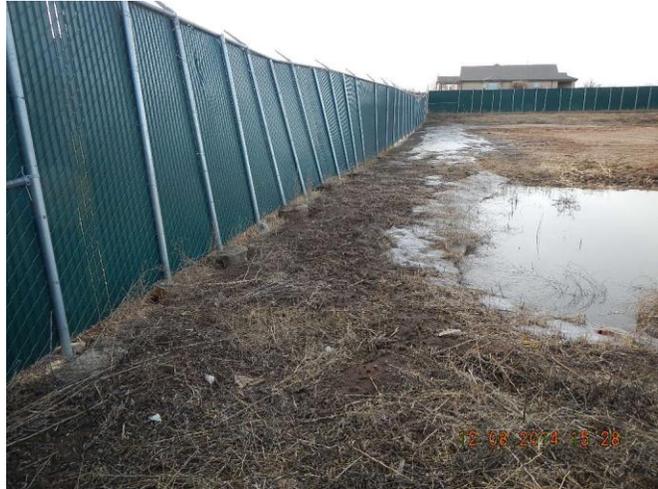
Location perimeter fencing damage along area of stormwater ponding.

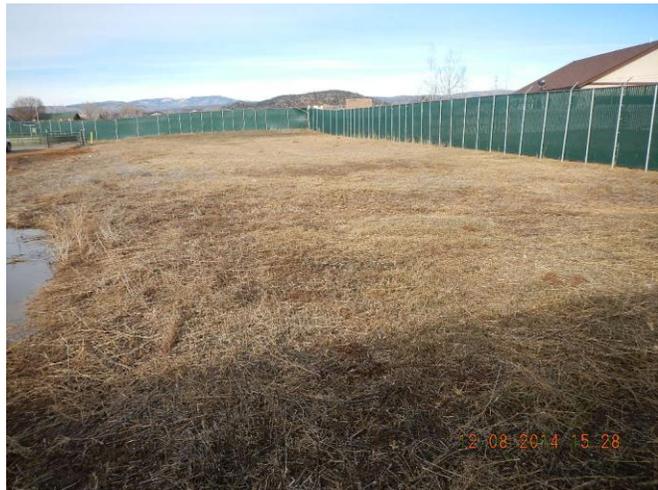
East side location, recently mowed. Large well pad footprint inside fenced area.

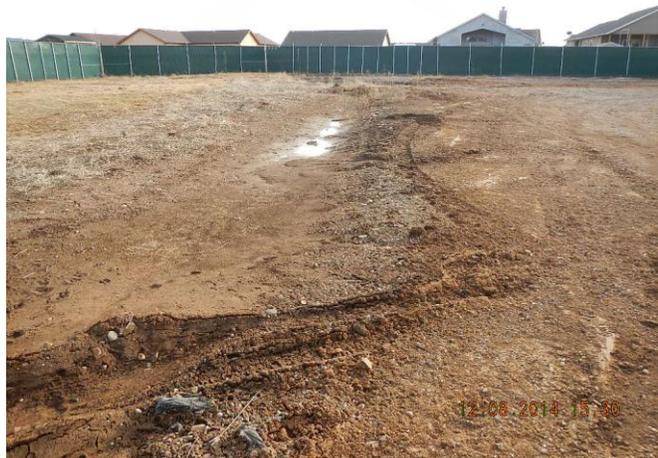
Low lying area/ earthen trough running north- south across well pad behind wellhead and equipment used to catch/ divert stormwater.

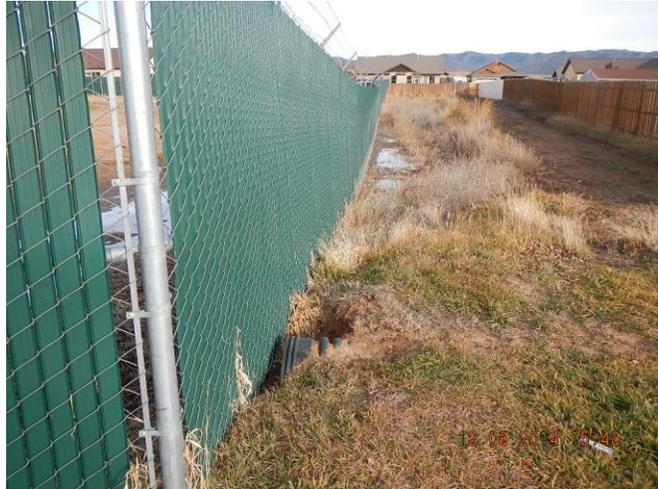
Low lying area outside south fence line accumulating stormwater; Weeds/ undesirable vegetation along fenced area; stormwater ditch exit drain on SW corner fence line.

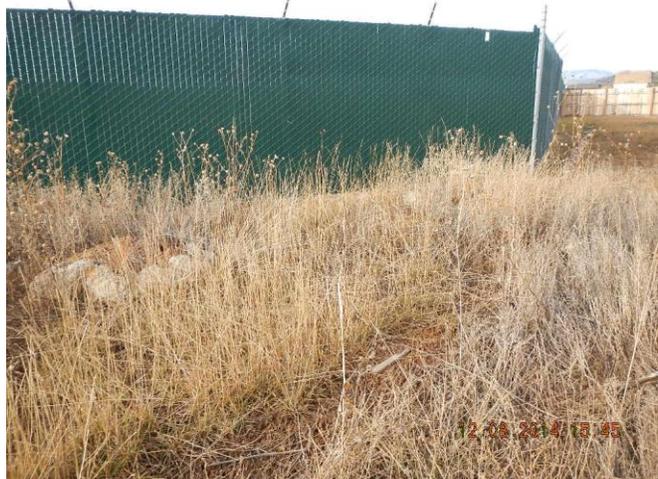
View of SE corner of perimeter fencing around well pad.

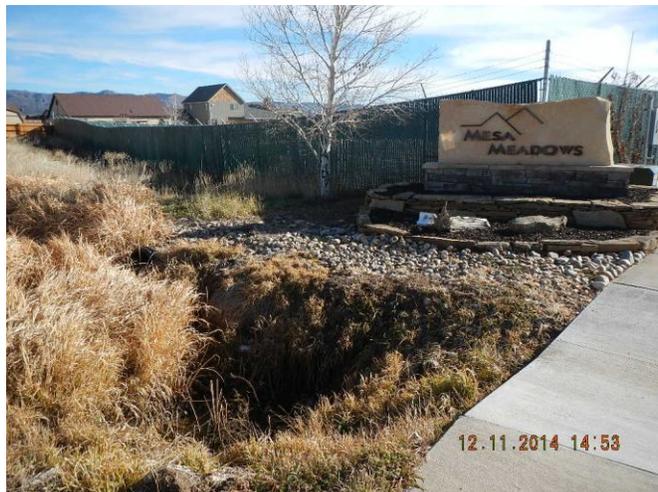
Stormwater ditch and low lying area adjacent to North side well pad.
