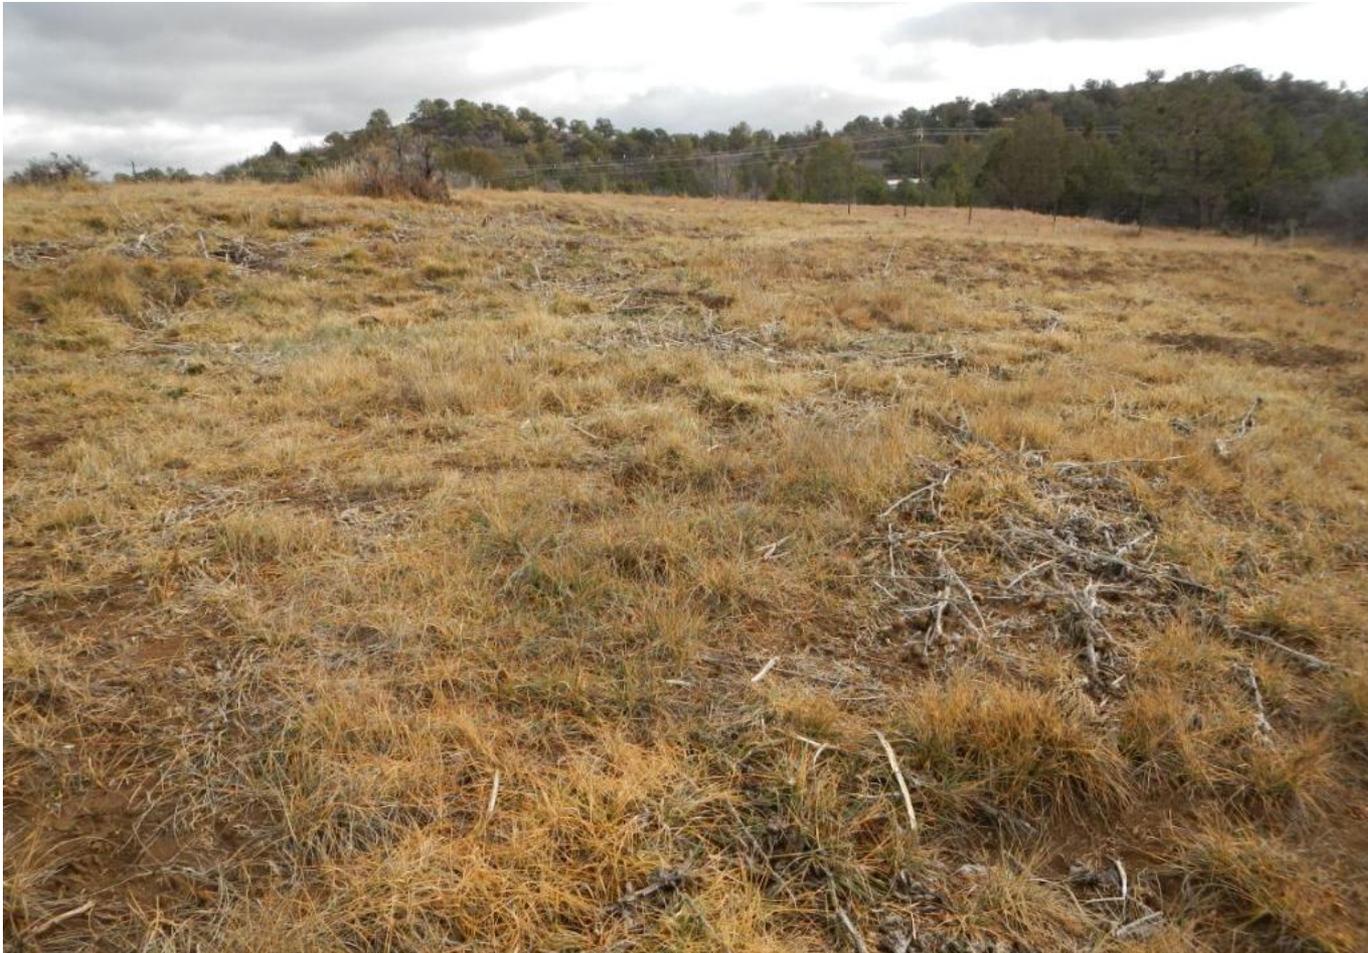
Photo 1. View of hill slope where Scotch thistle plants have been cut.

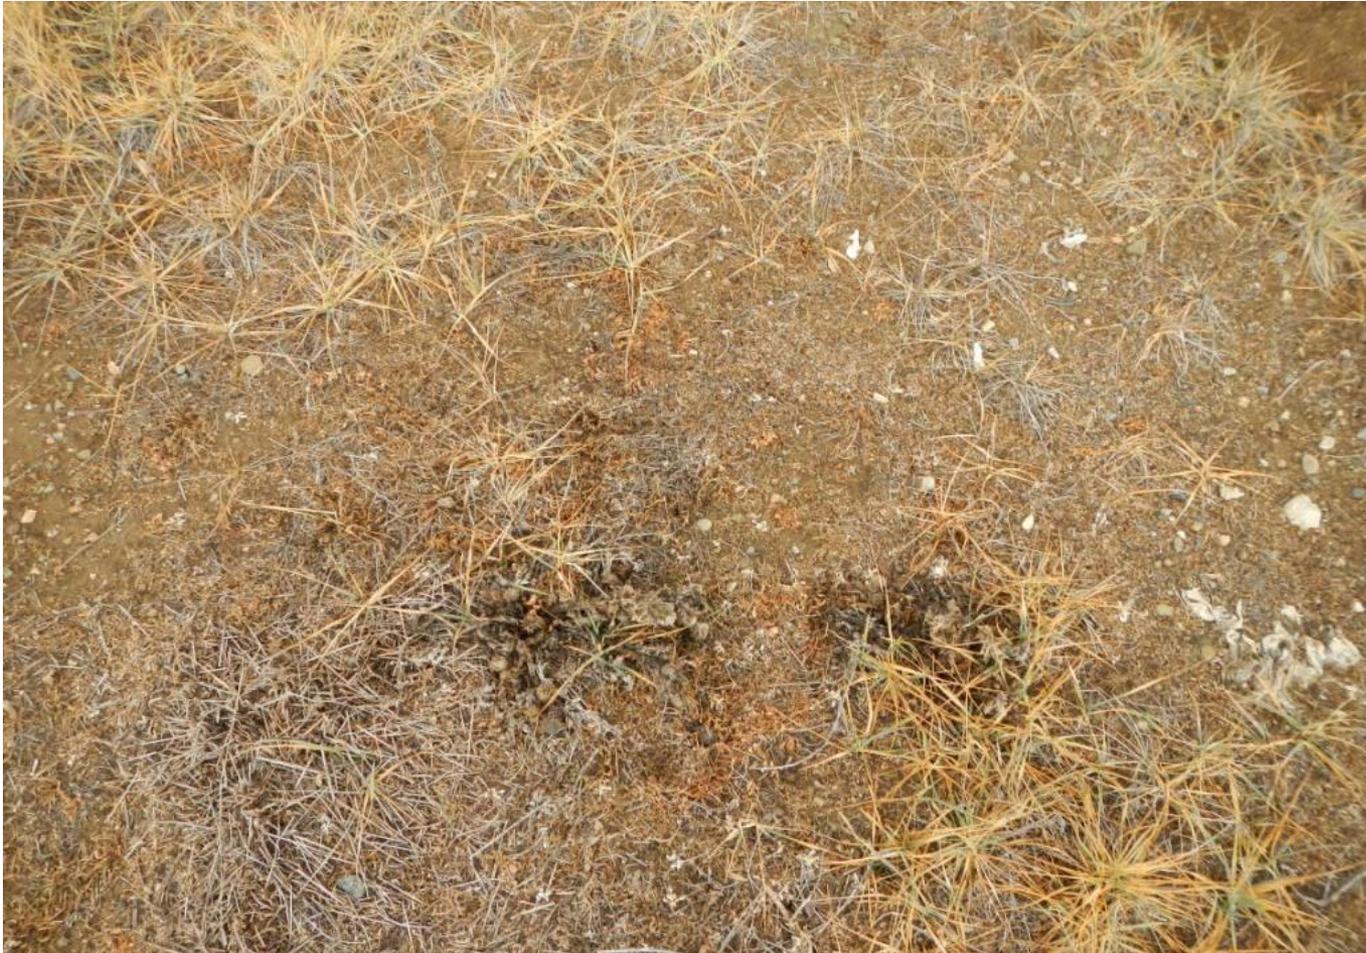
Photo 2. View of Scotch thistle plants in interim reclamation area that appear to have been treated with herbicide. Treated plants are dark leafy material in center of photo.

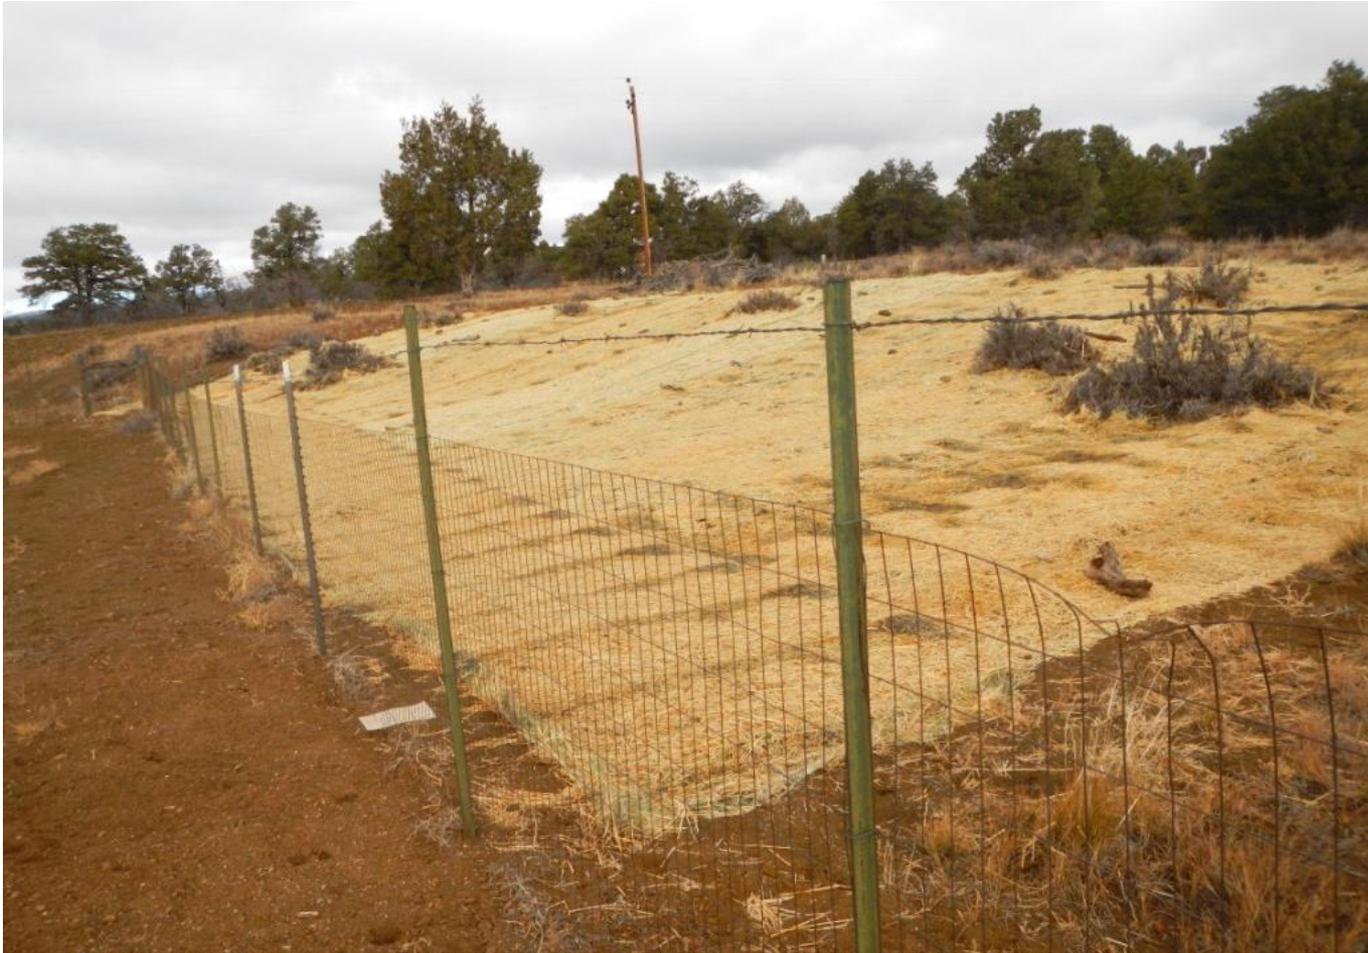
Photo 3. View of straw blanket placed on cut slope for stormwater control.

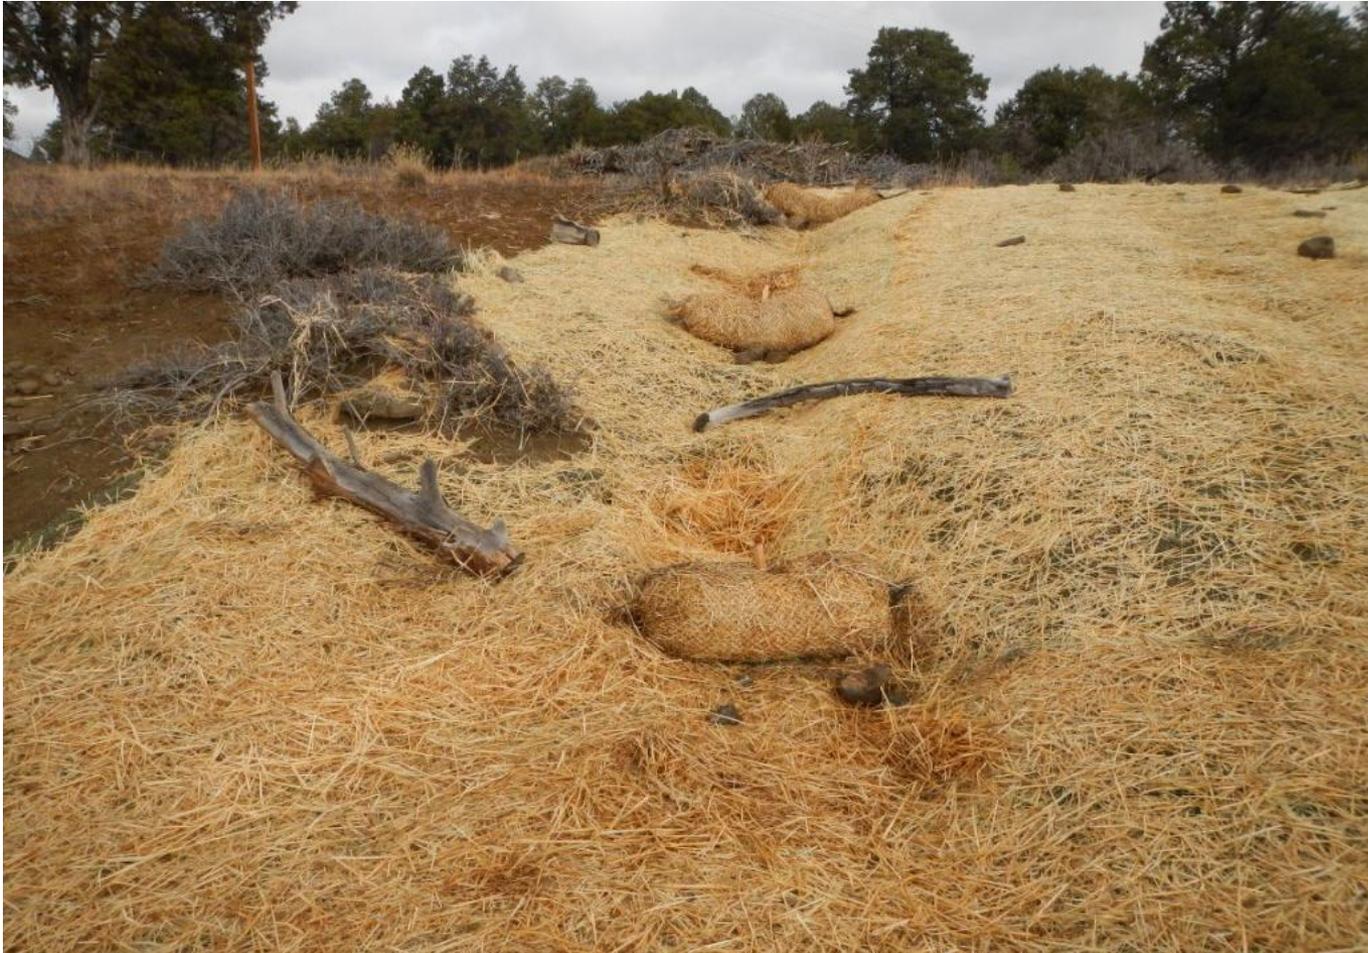
Photo 4. View of straw logs place in erosional channel.
