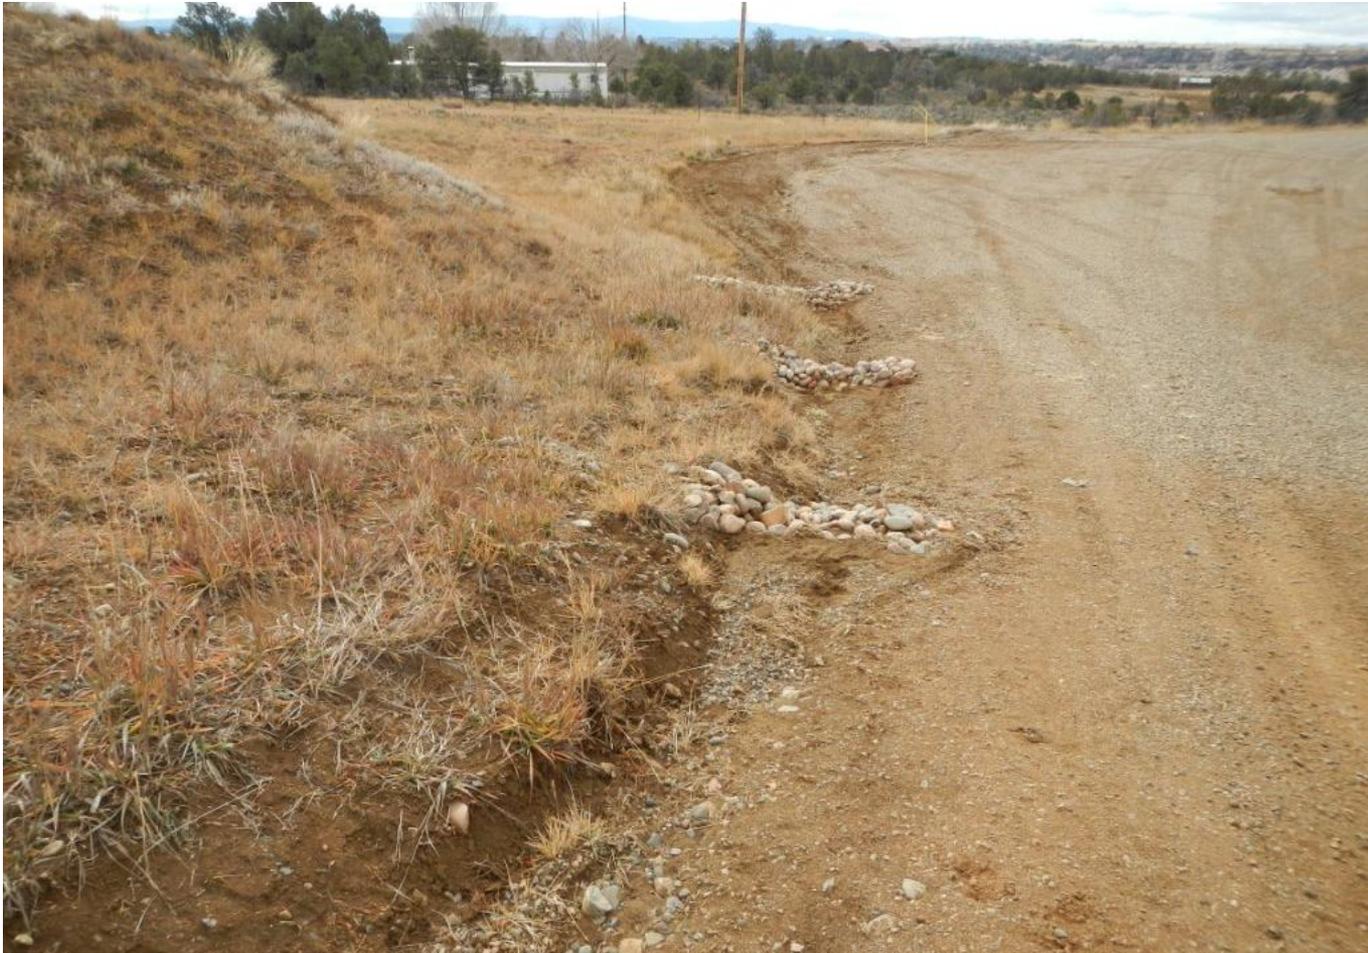
Photo 1. View of newly installed rock check dams on eastern side of access road.

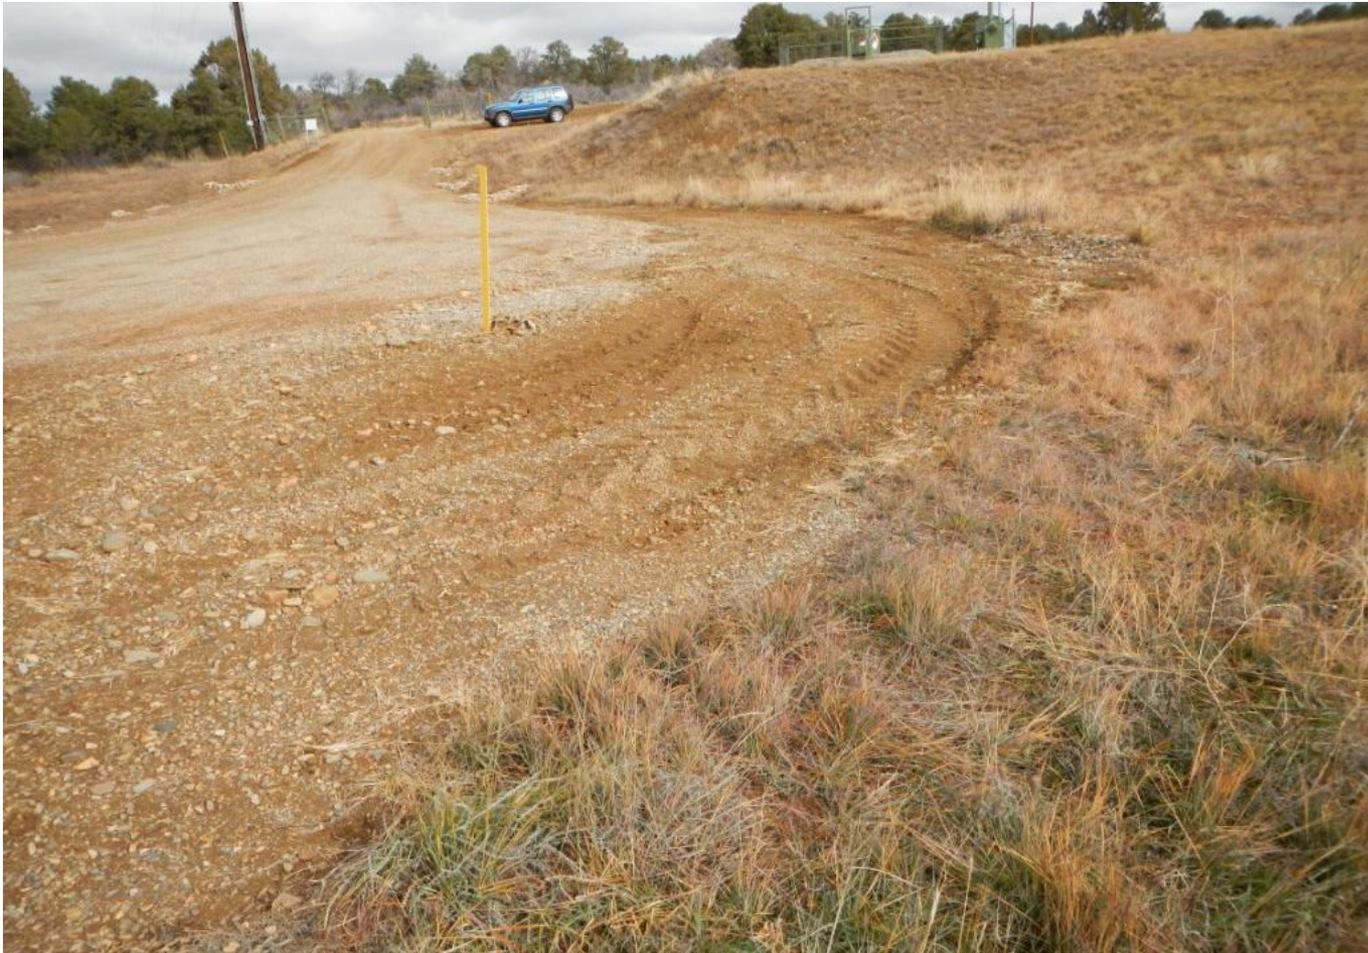
Photo 2. View of northeastern edge of working area downstream from access road that appears to have been recently bladed to divert stormwater flows to the eastern interim reclamation area.

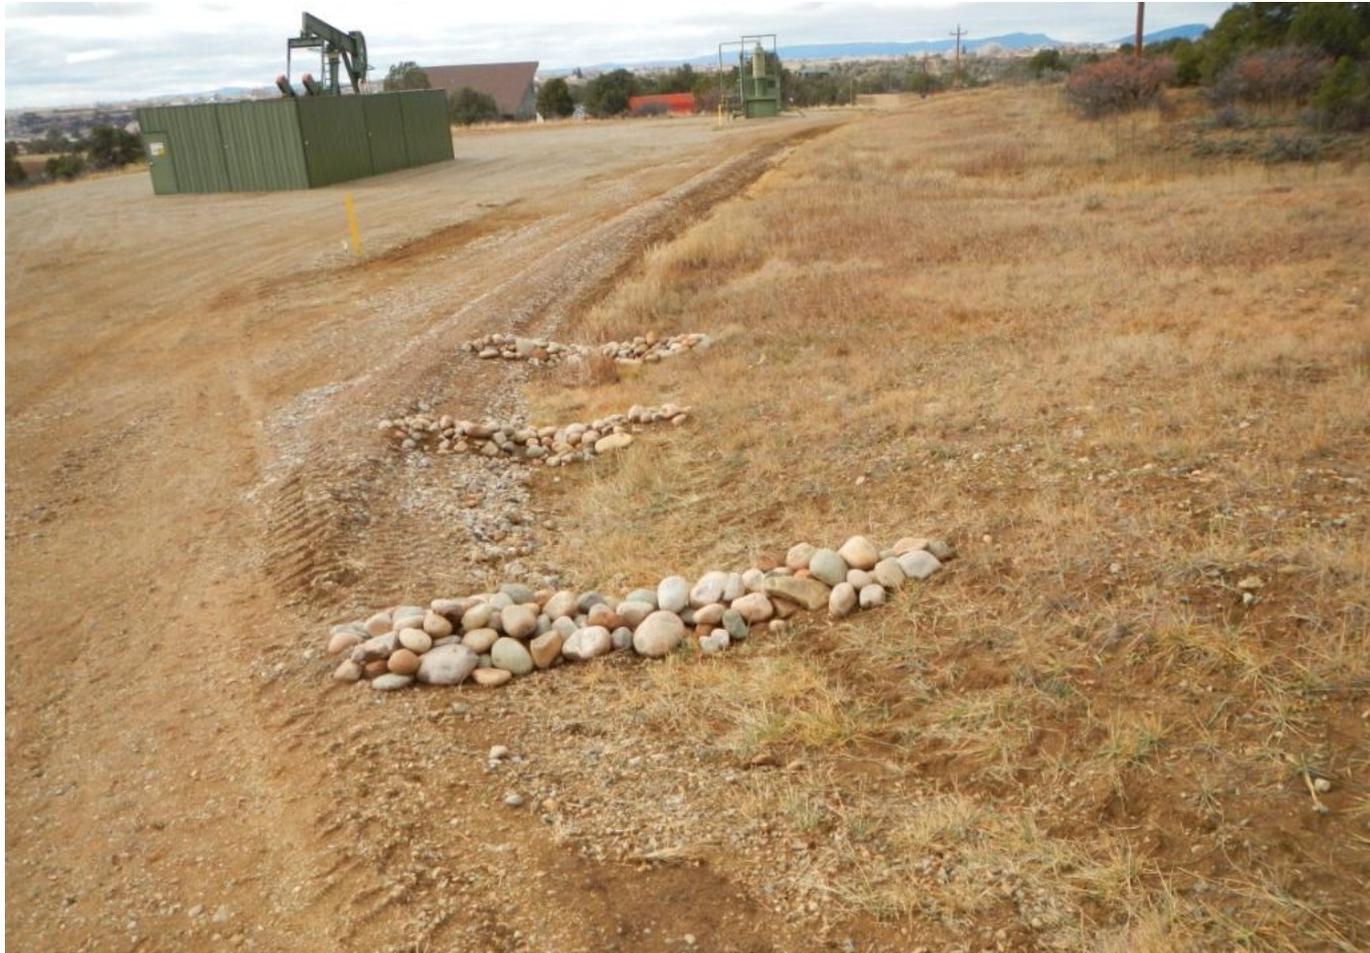
Photo 3. Newly installed rock check dams along the western edge of the access road.

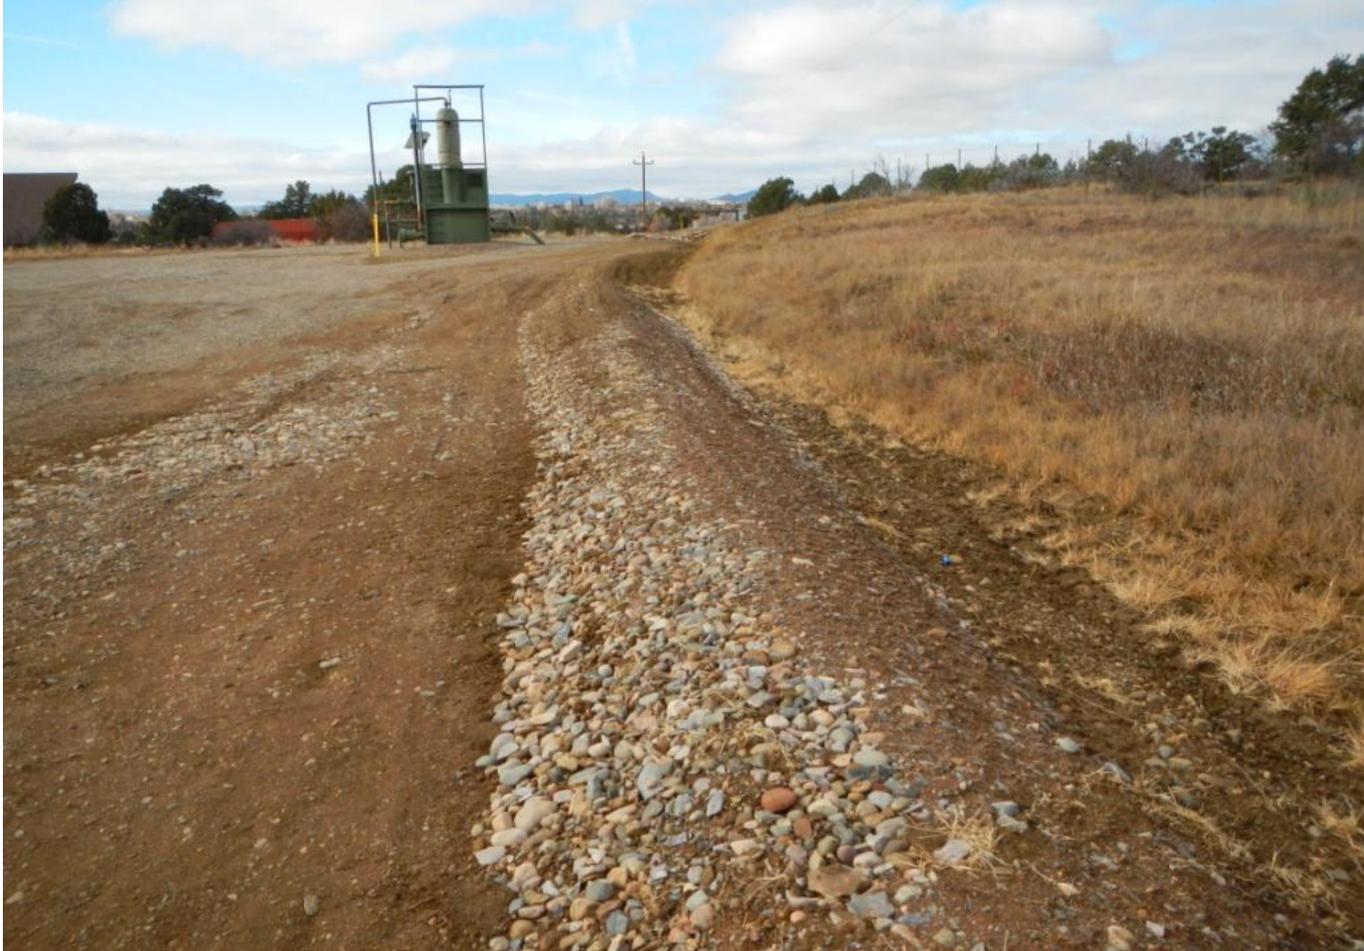
Photo 5. Newly installed berm to divert stormwater flows on the western edge of the well pad.

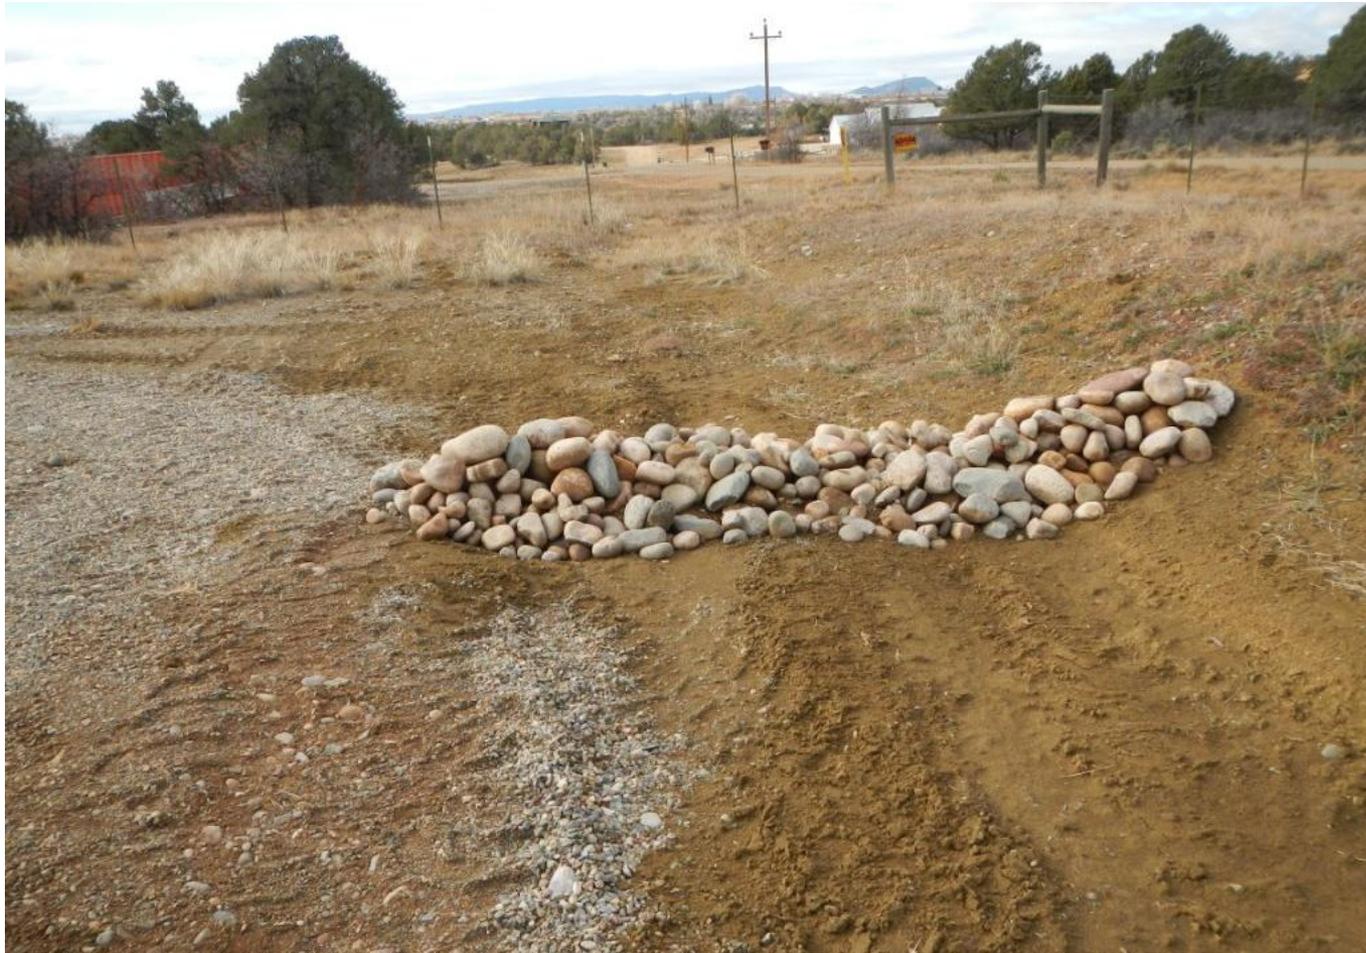
Photo 5. View of cobble check dam in southwestern corner of working area where diverted stormwater flows exit the project area.

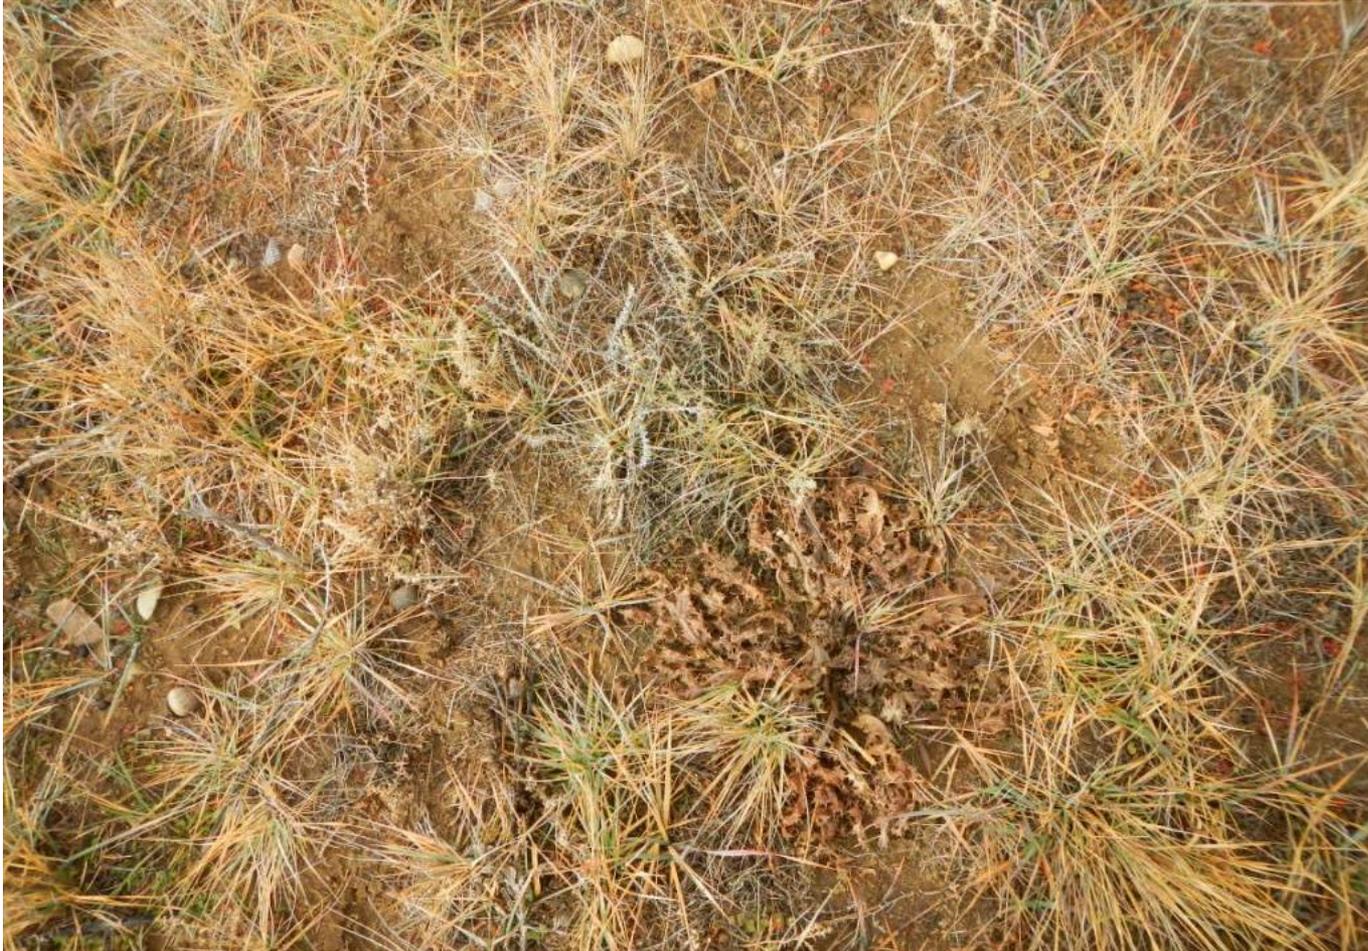
Photo 6. View of Scotch thistle rosette that appears to have been chemically treated.
