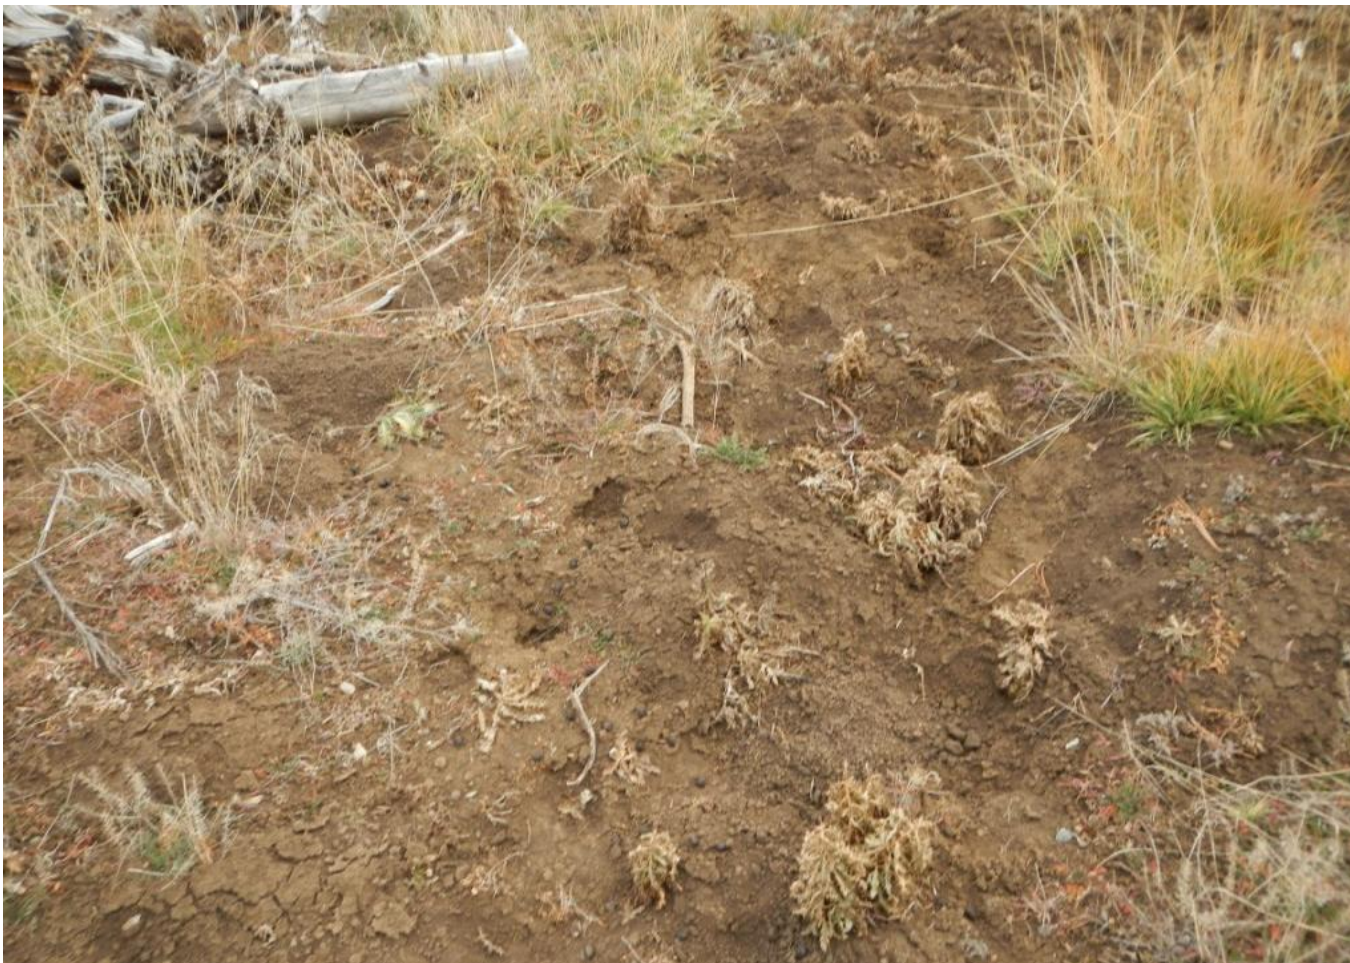
Photo 1. View of Russian thistle plants that appear to have been chemically treated.

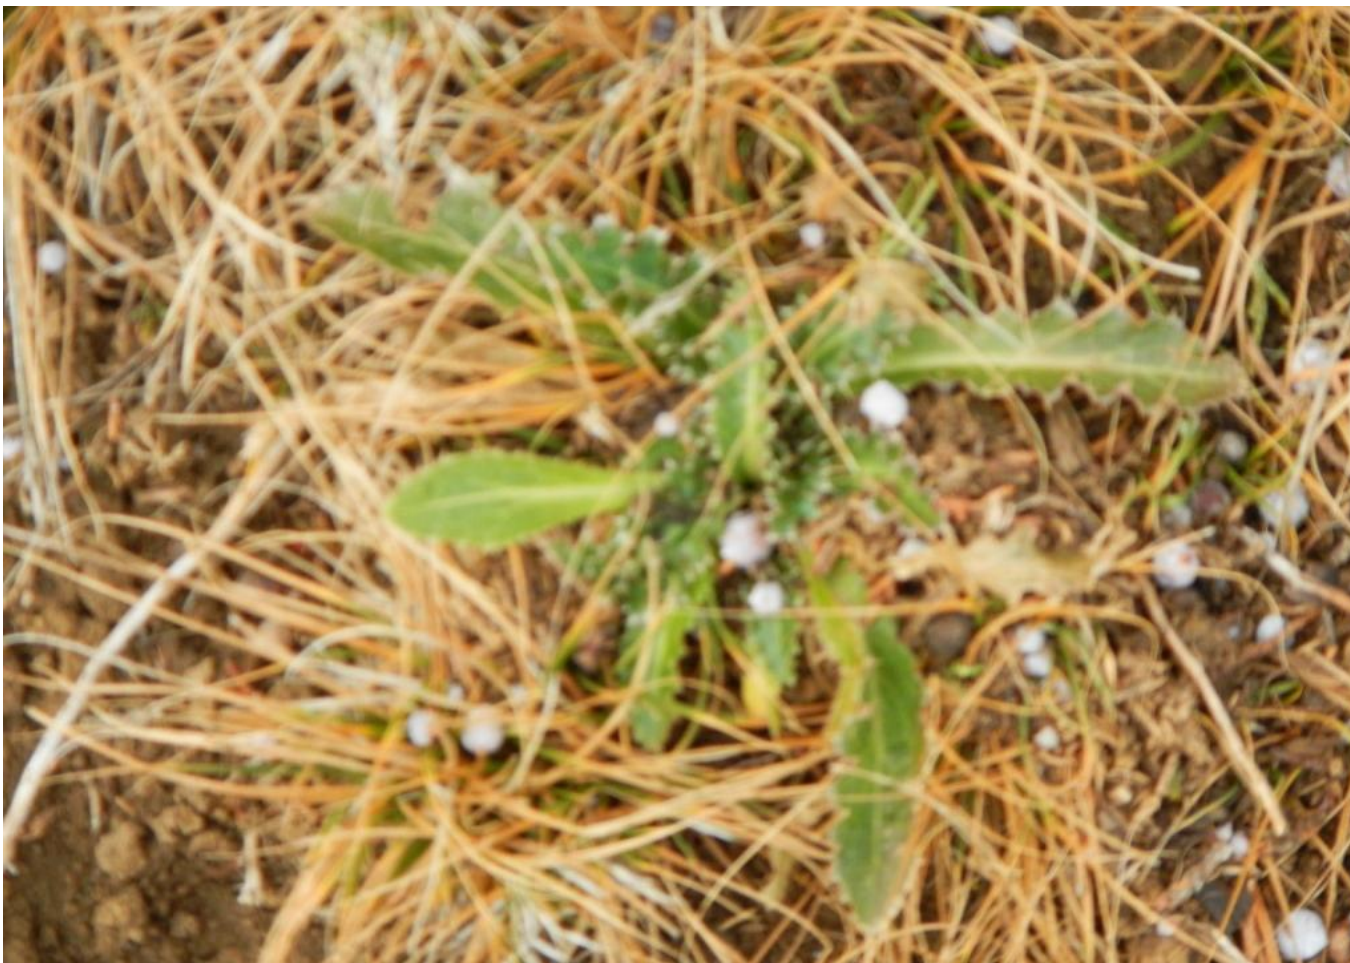
Photo 2. View of young Russian thistle rosette that will need to be removed before seedhead maturity in 2015.

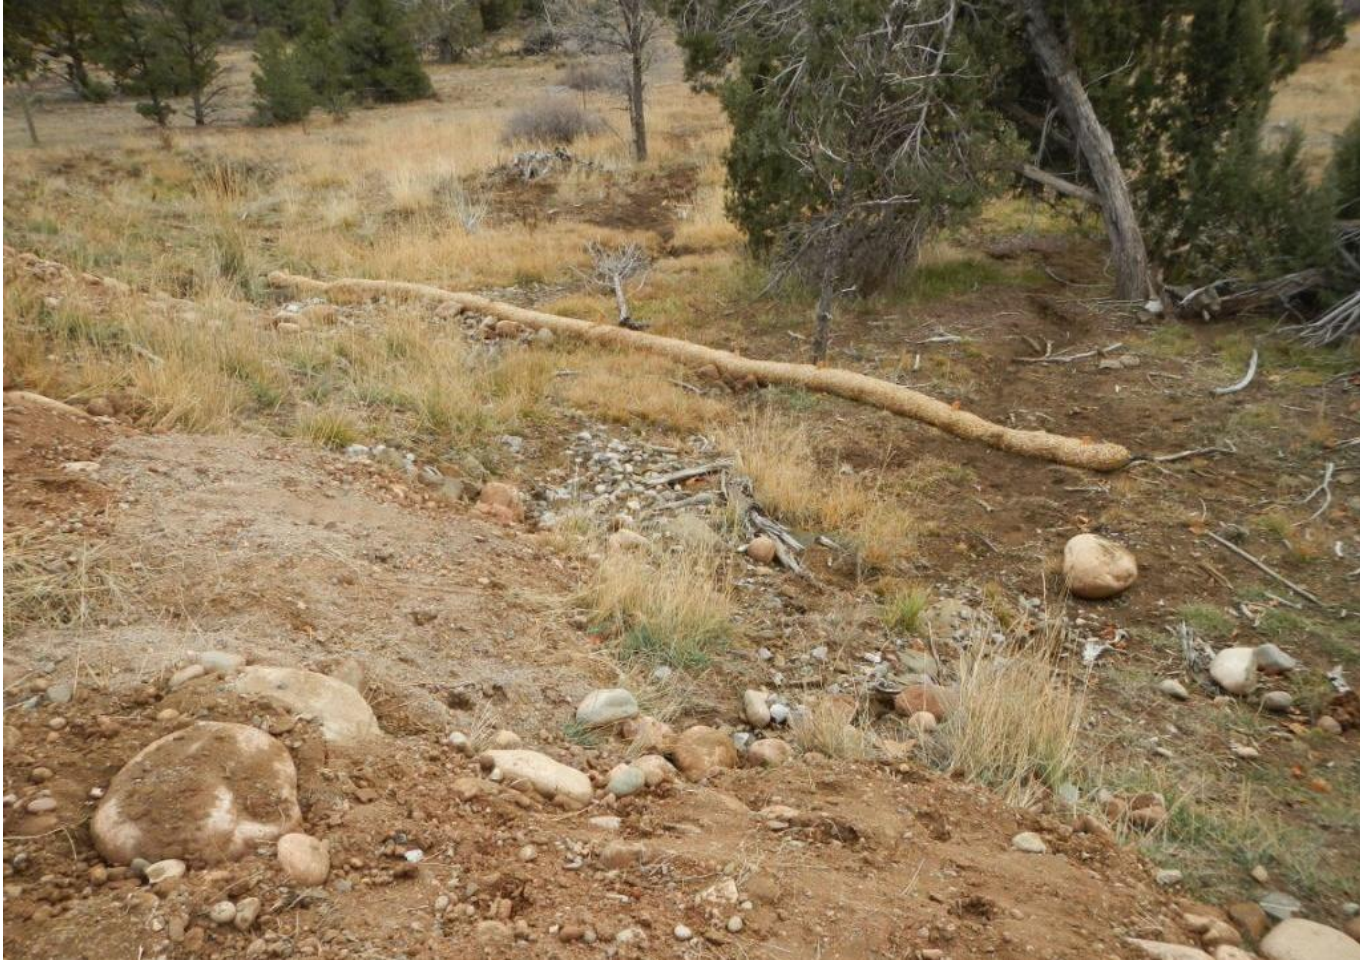
Photo 3. View of repaired gully and newly installed straw wattle.

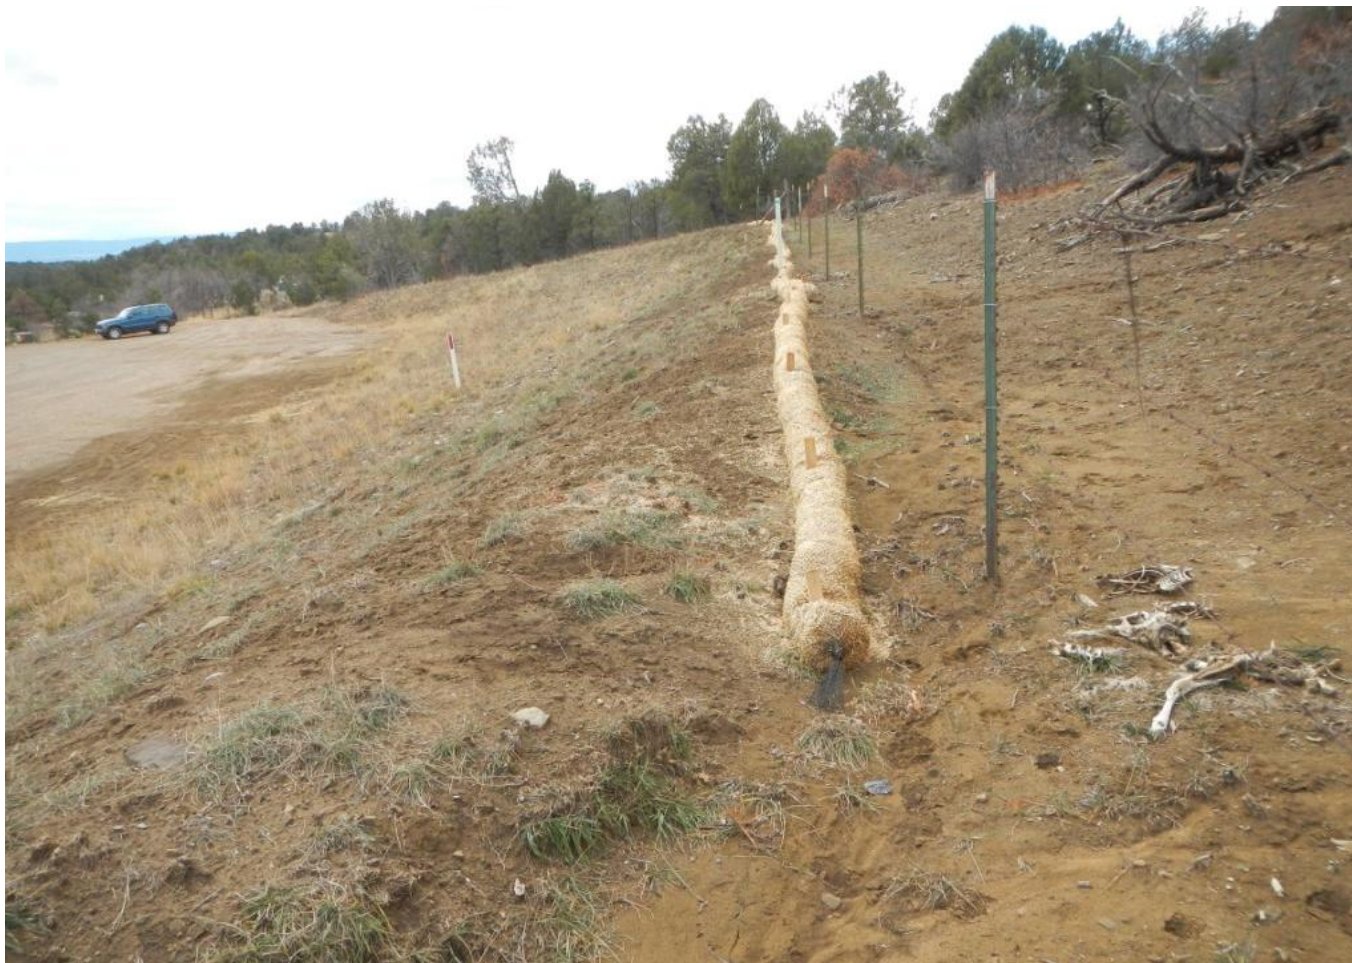
Photo 4. View of an approximately 120-foot-straw-wattle placed approximately 2/3 up the western cut-slope. Stormwater flows appear to be flowing around the edge of the straw wattle toward the northeastern corner of the project area.

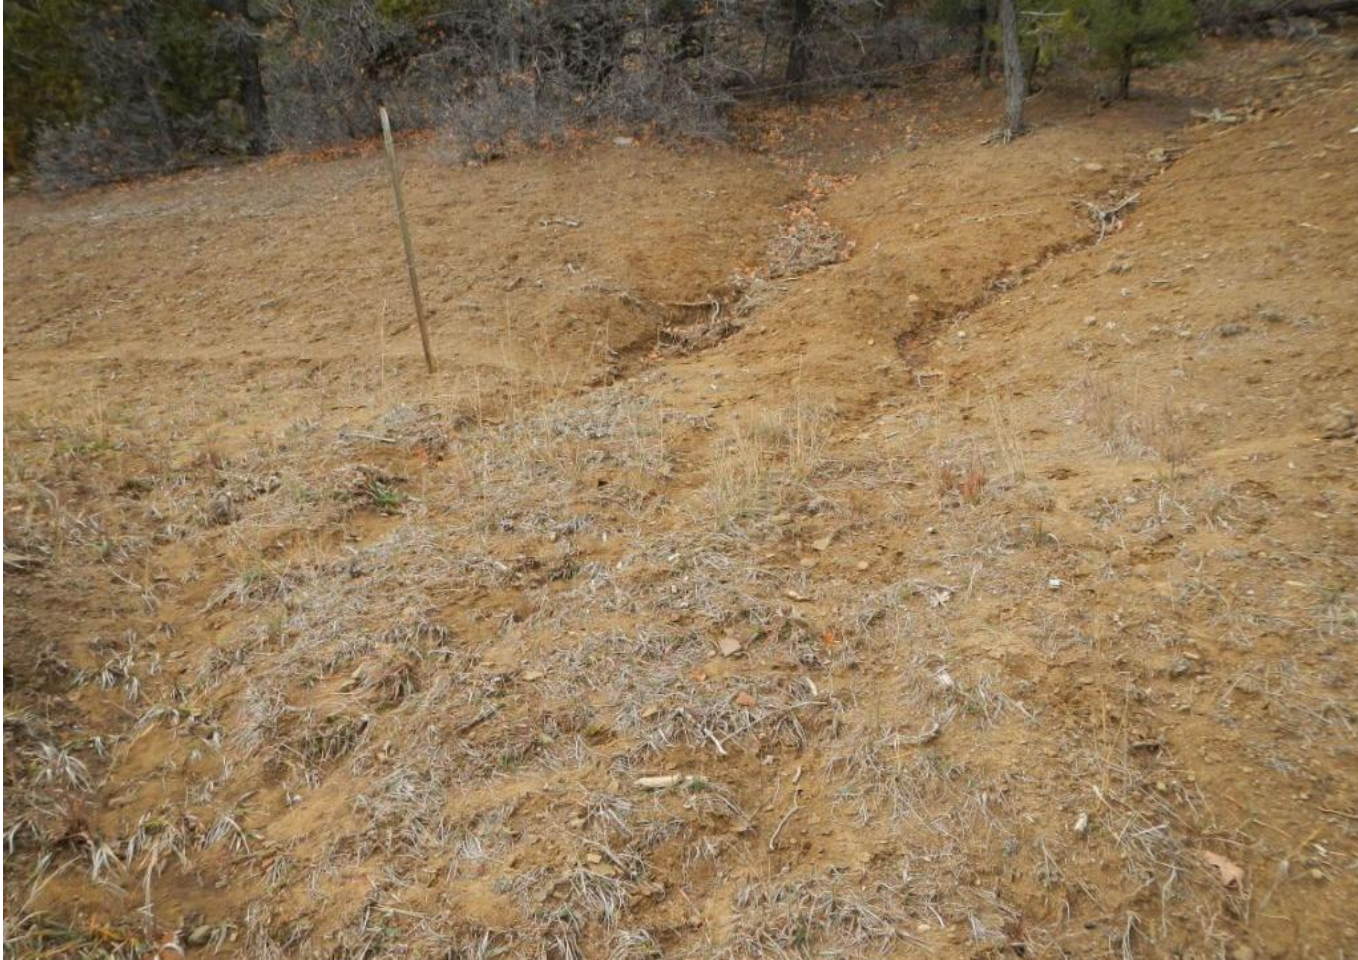
Photo 5. View of erosion on unstabilized cut-slope in northeastern corner of project area.

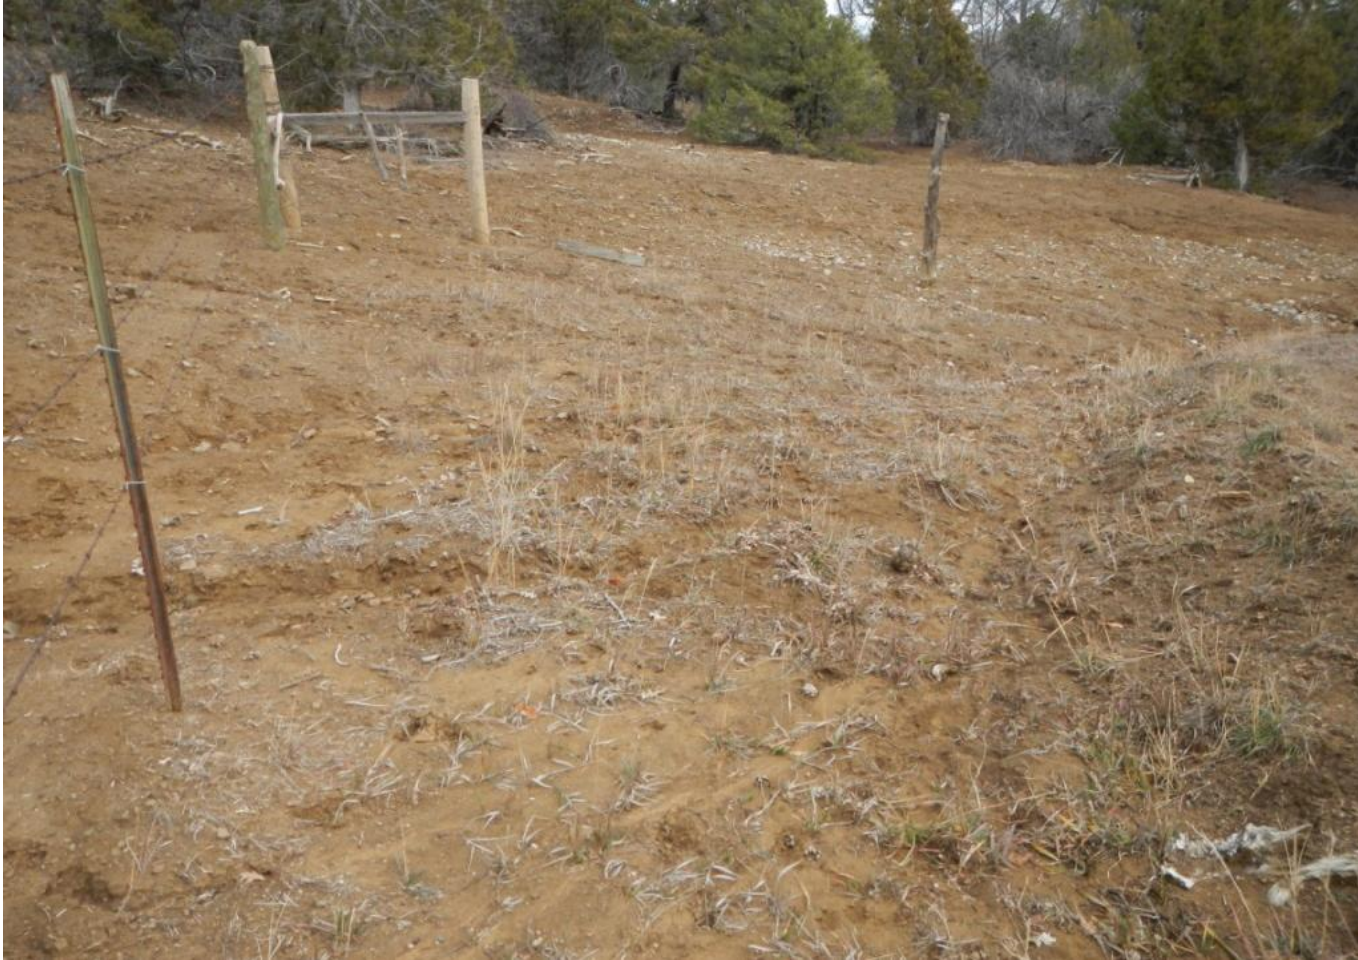
Photo 6. View of erosion in northeastern corner of project area where rill channels and diverted flows from the straw wattle shown in Photo 4, appear to be combining and eroding the northern edge of the project area.

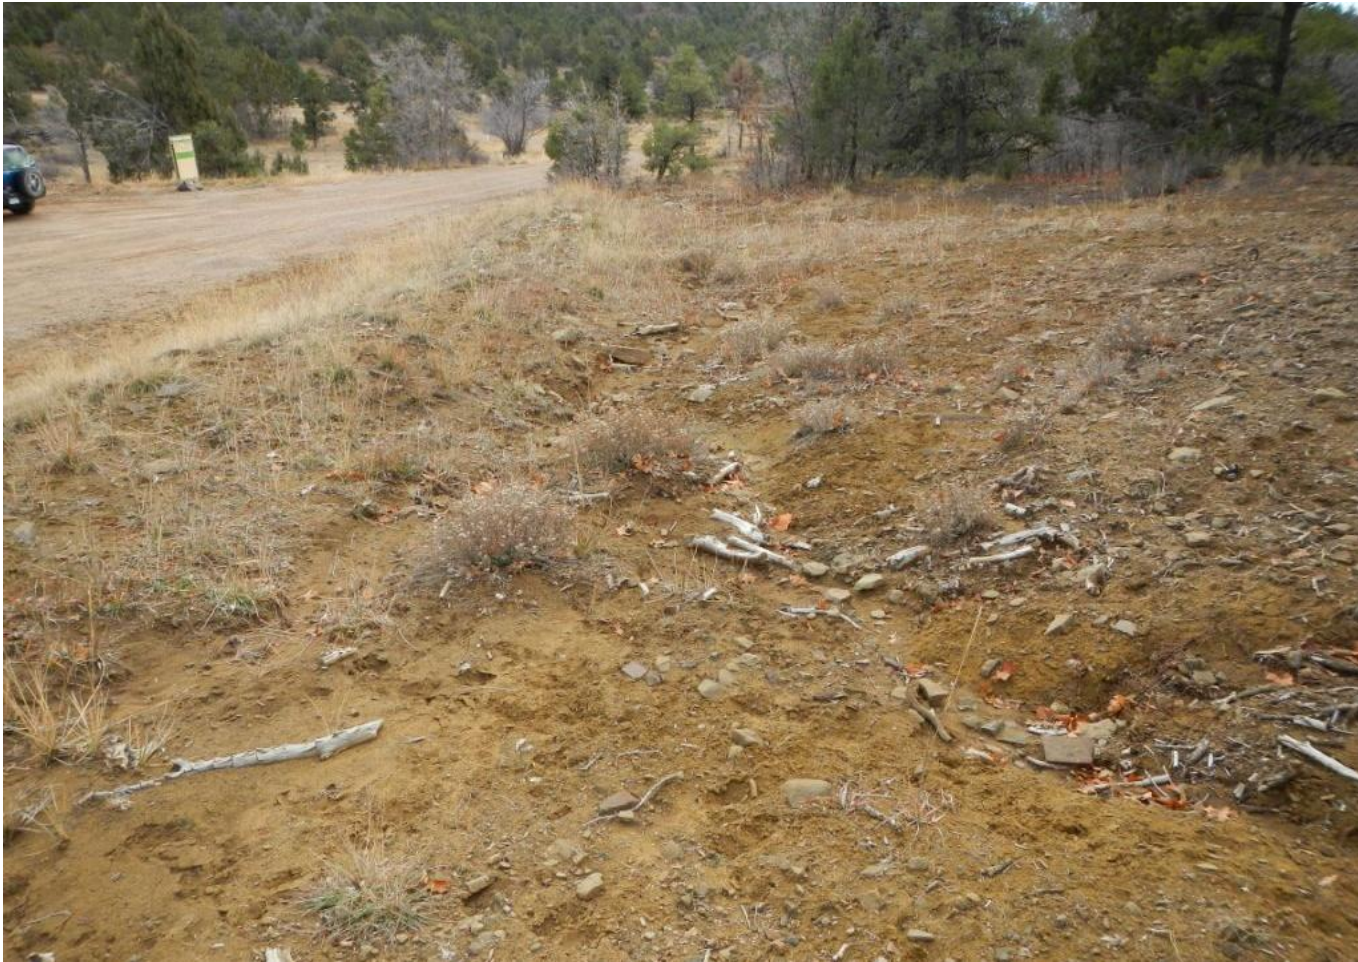
Photo 7. View of stormwater erosion forming a channel in southern portion of project area where there are no BMPs to reduce down-cutting and erosion.

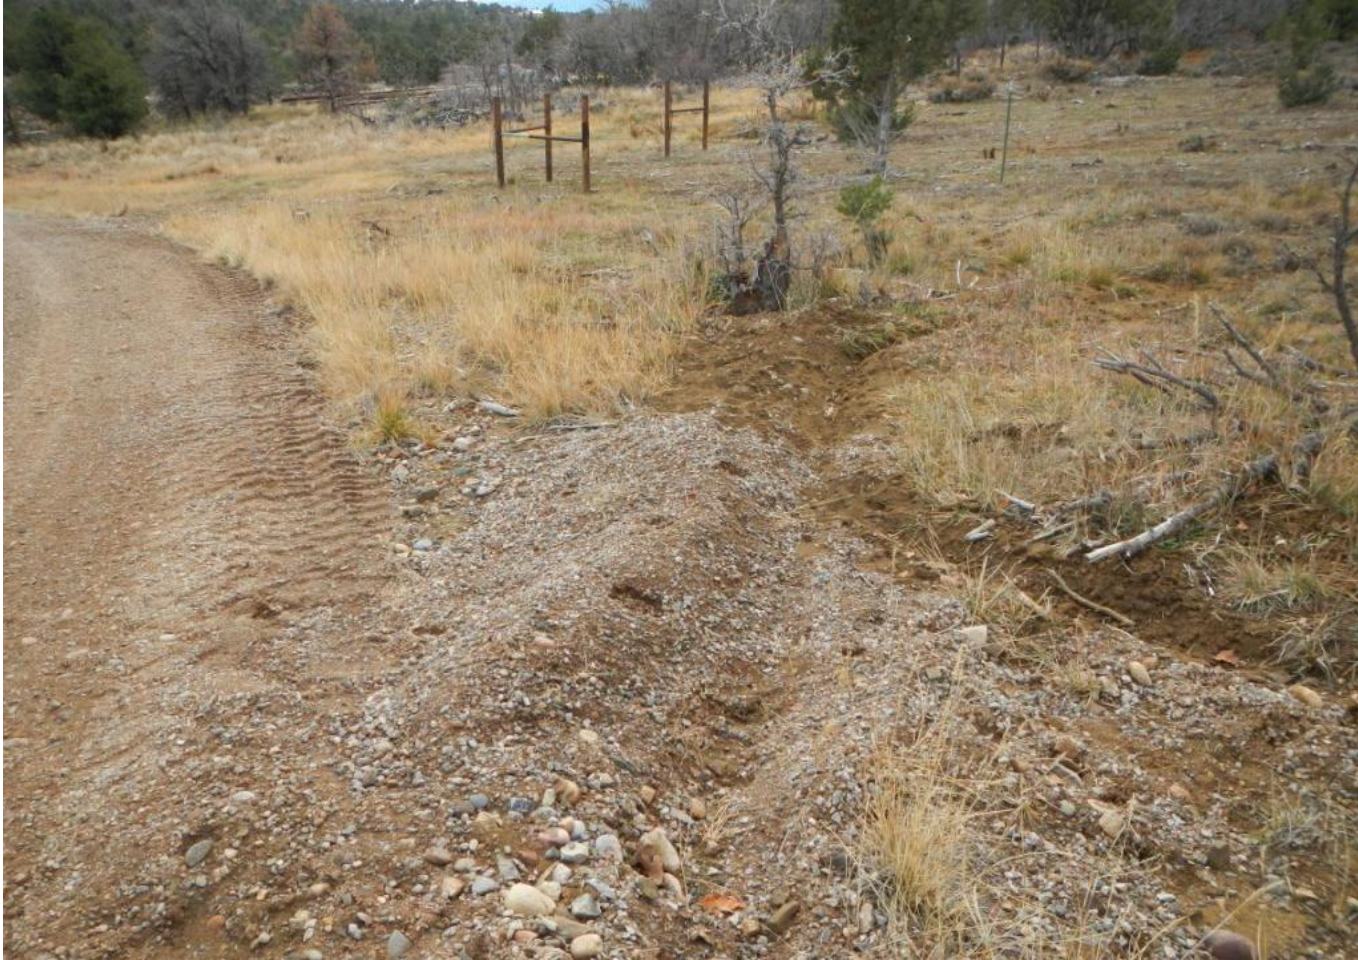
Photo 8. A bar ditch along the western portion of the access road that appears to be newly installed.
