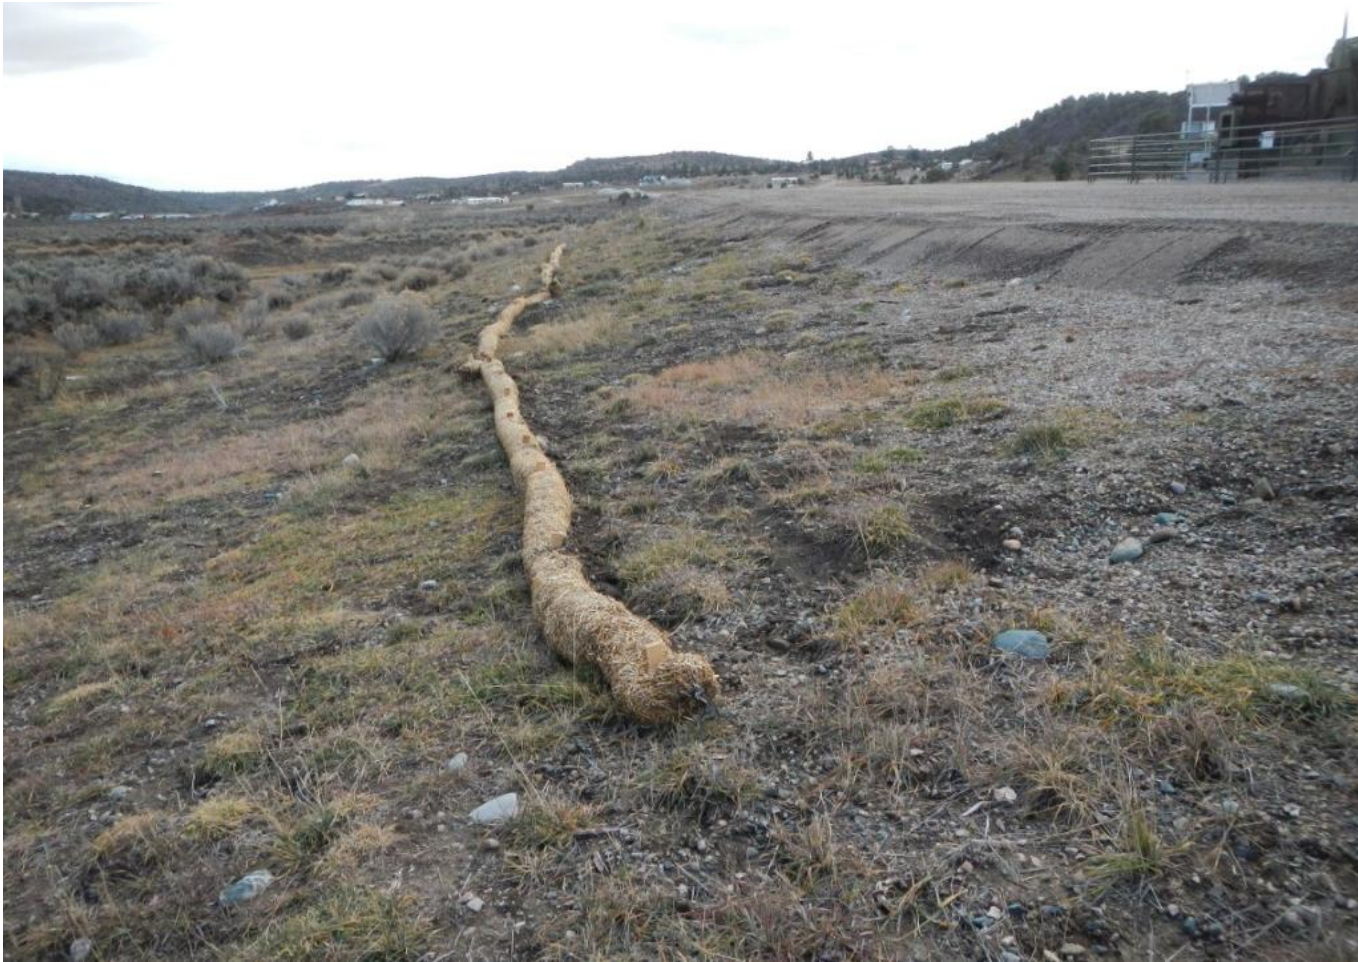
Photo 1. View of newly installed straw wattle in northern portion of the project area from northwestern corner facing eastward.

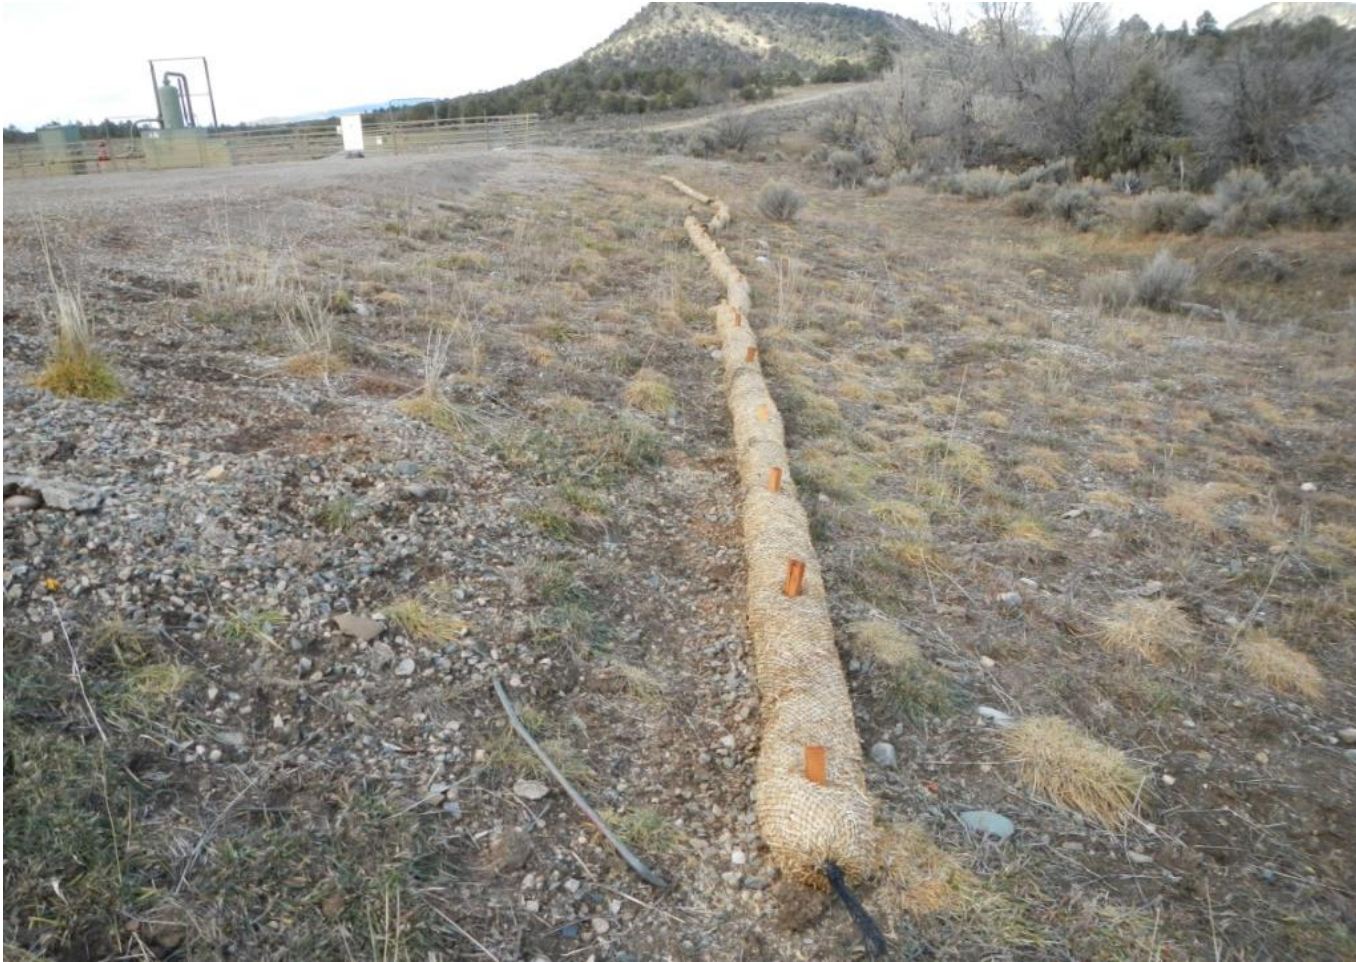
Photo 2. View of newly installed straw wattle in northern portion of the project area from northeastern corner facing westward.

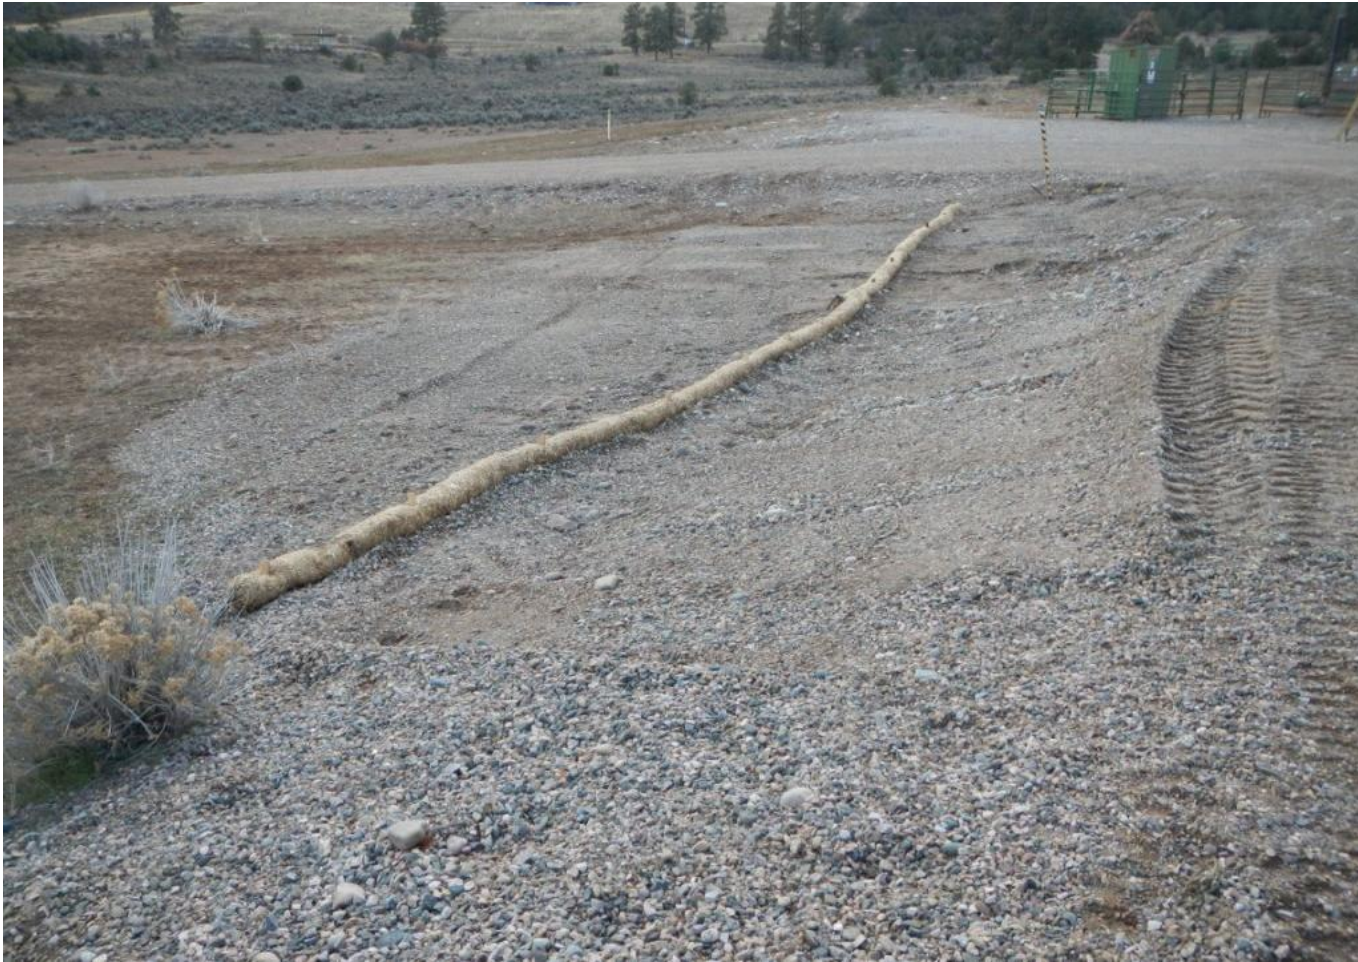
Photo 3. View of repaired gullies, new gravel, and straw wattle in eastern portion of project area.
