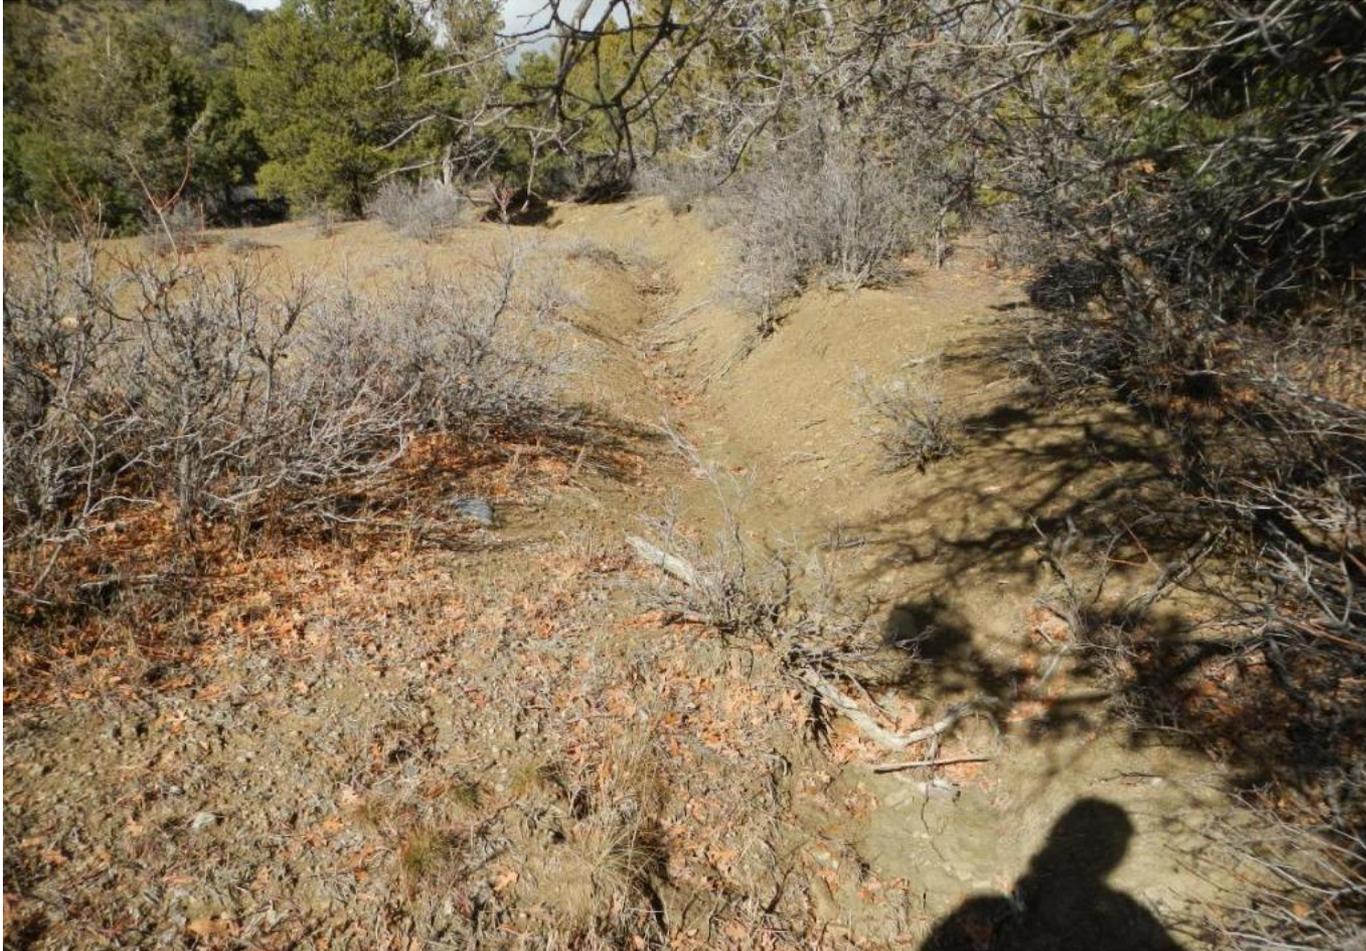
Photo 1. View of diversion channel on eastern edge of well pad facing upstream (northward).

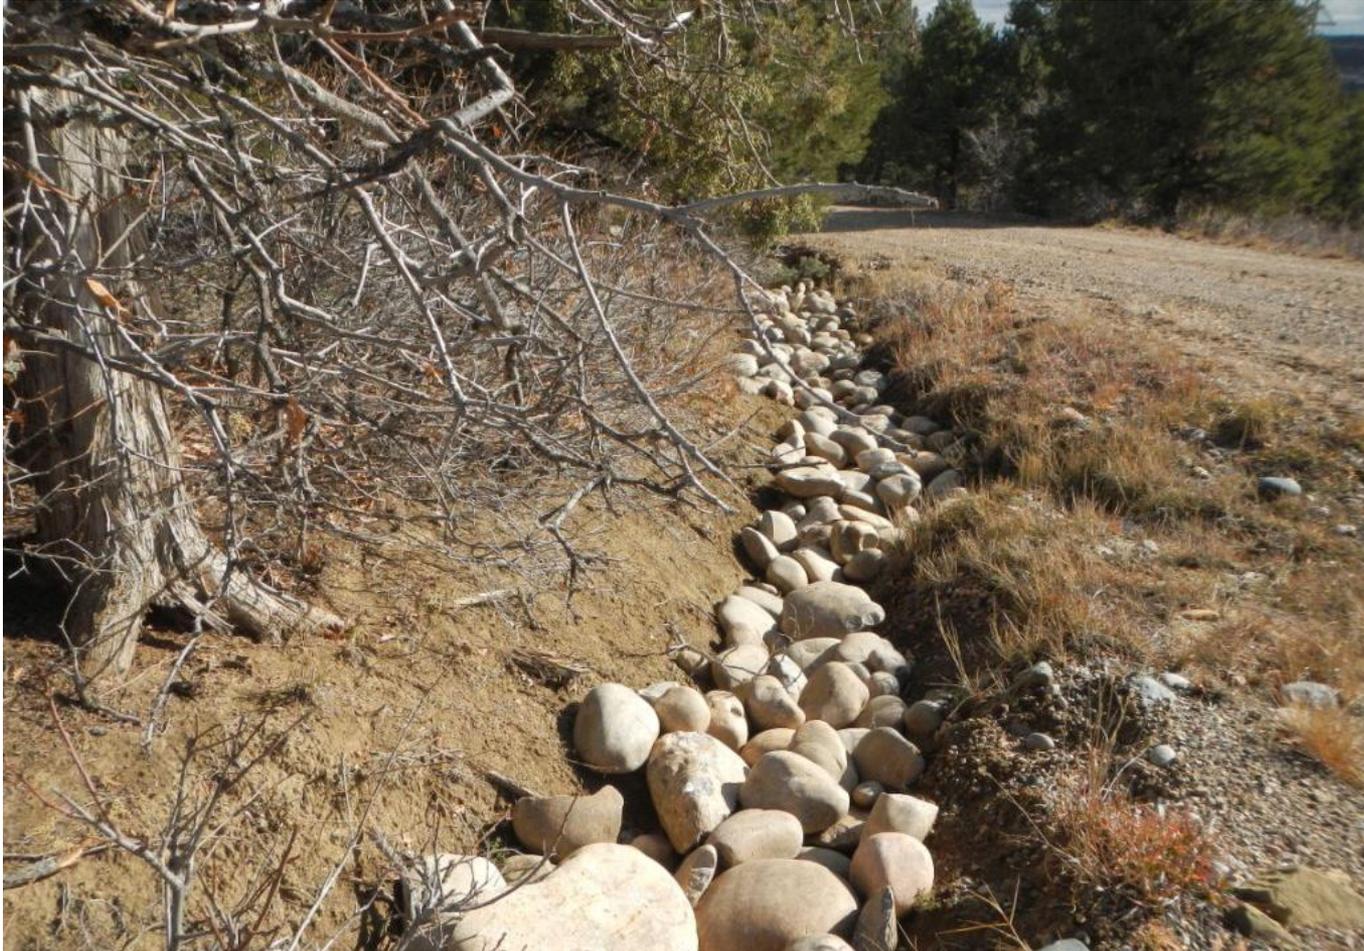
Photo 2. View of diversion channel downstream from Photo 1, where channel flows along access road (facing southeastward). Large cobble has recently been placed in channel.

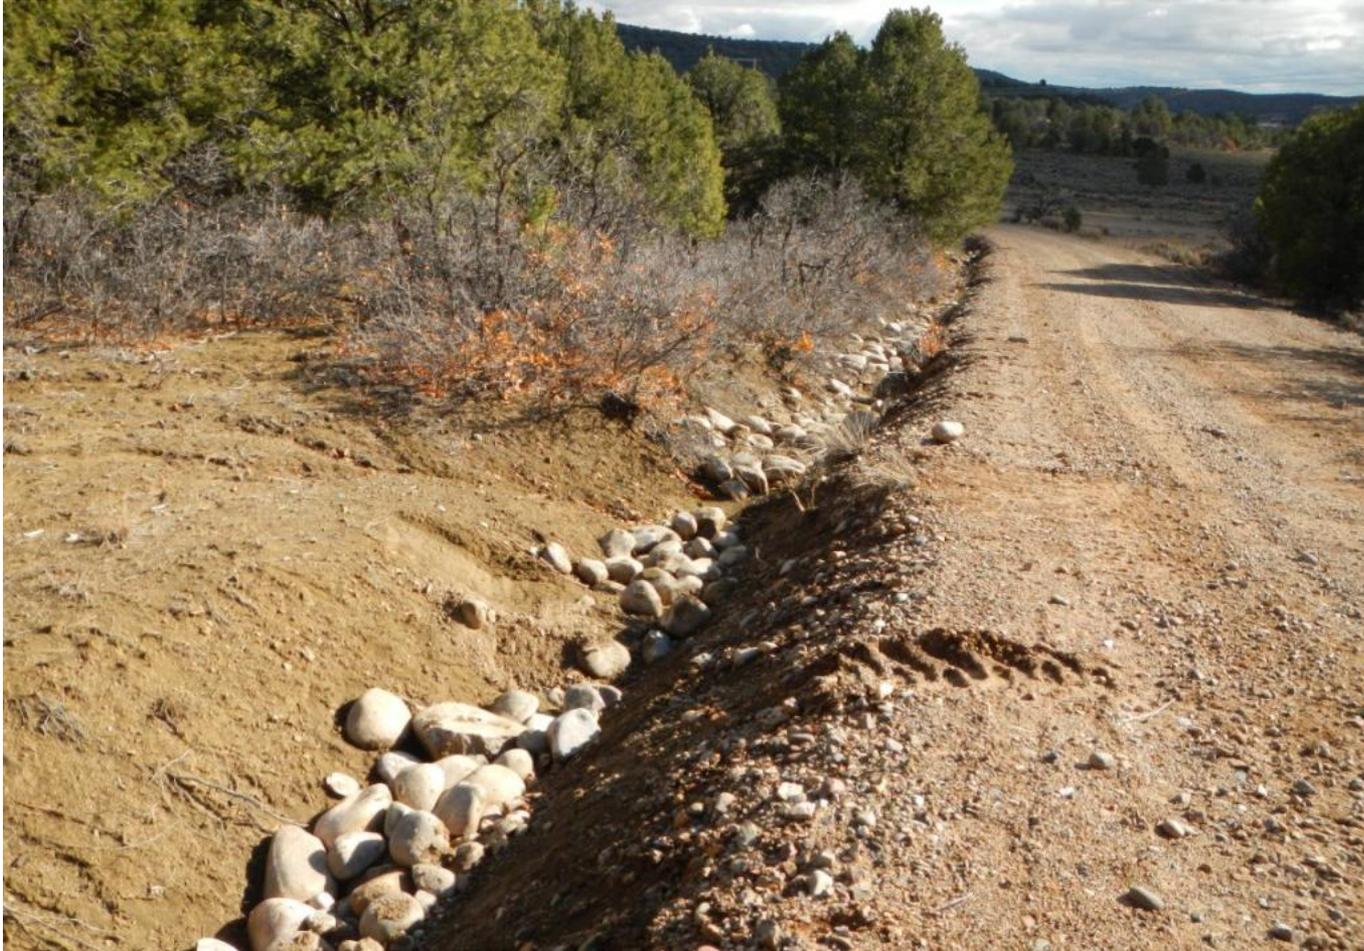
Photo 3. View downstream of diversion channel shown in photo 1 and 2, where cobble has been placed in the channel along the roadside.

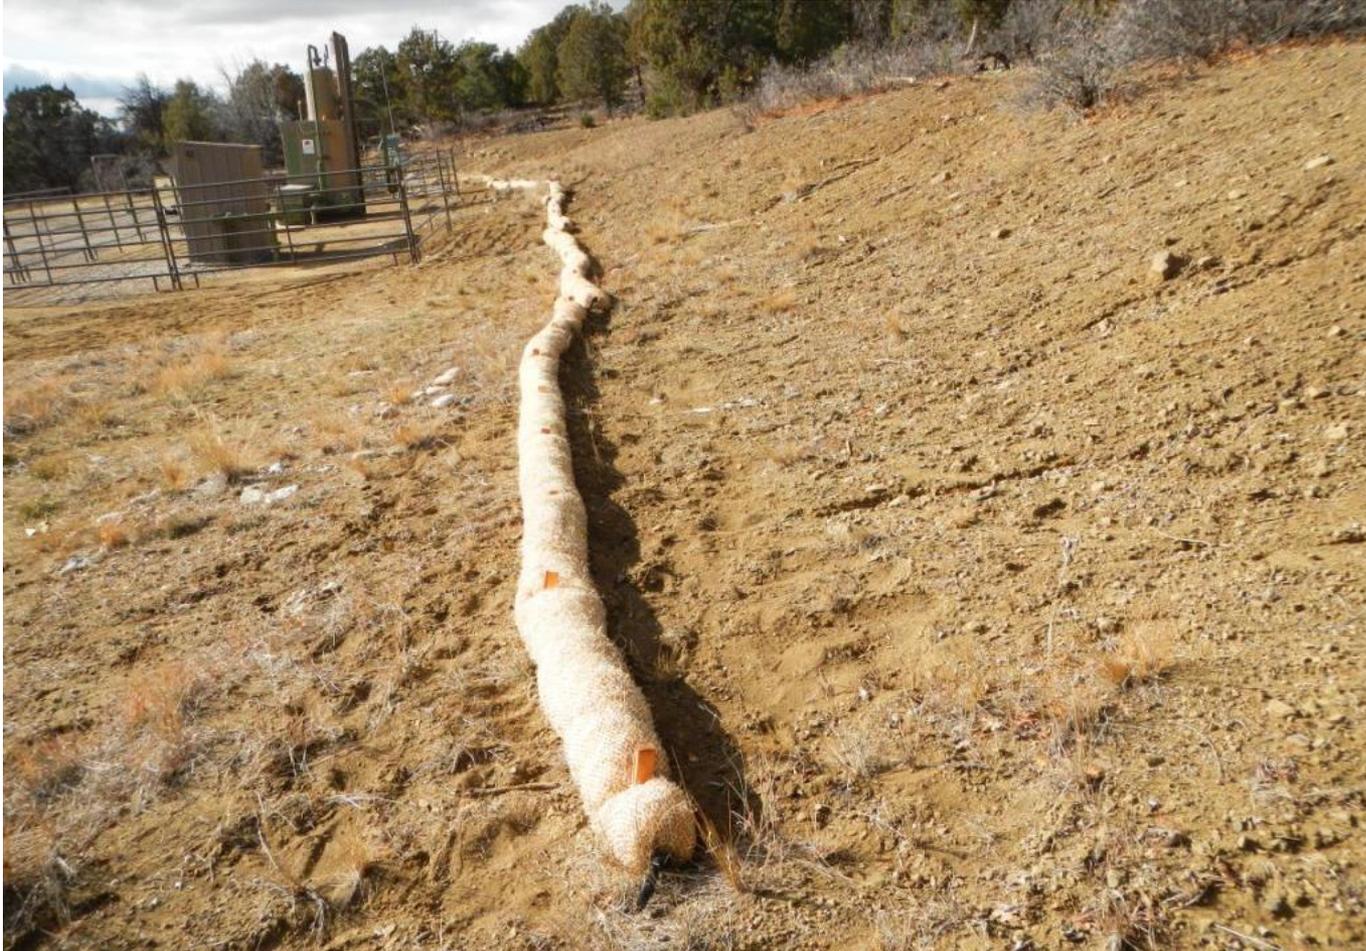
Photo 4. View of new straw wattle placed at the toe of the length of the northern cut-slope, from eastern edge facing westward.

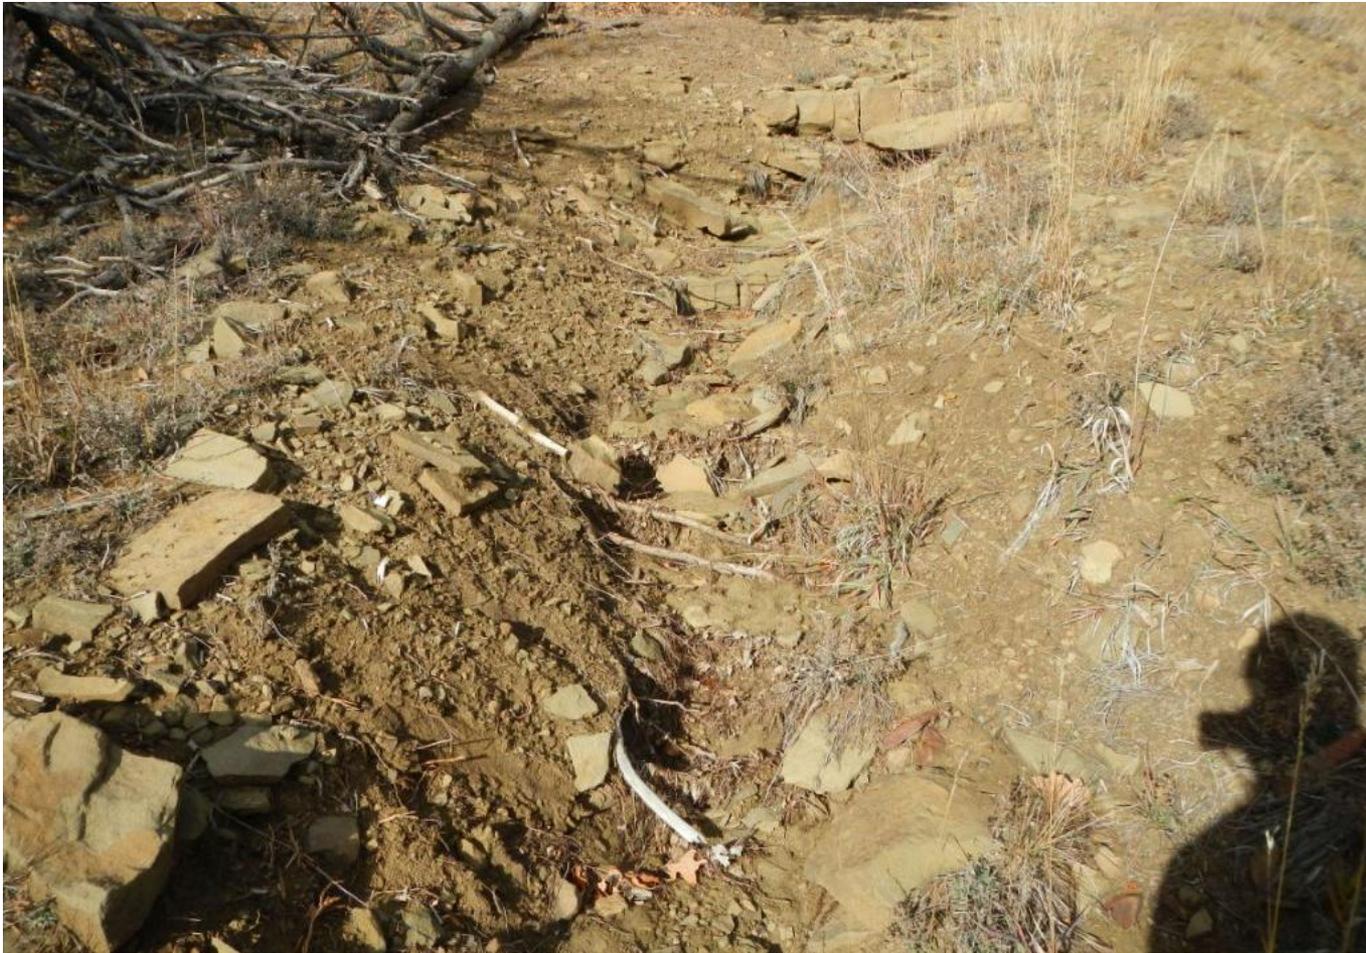
Photo 5. View of diversion channel on western edge of well pad facing upstream (northward).

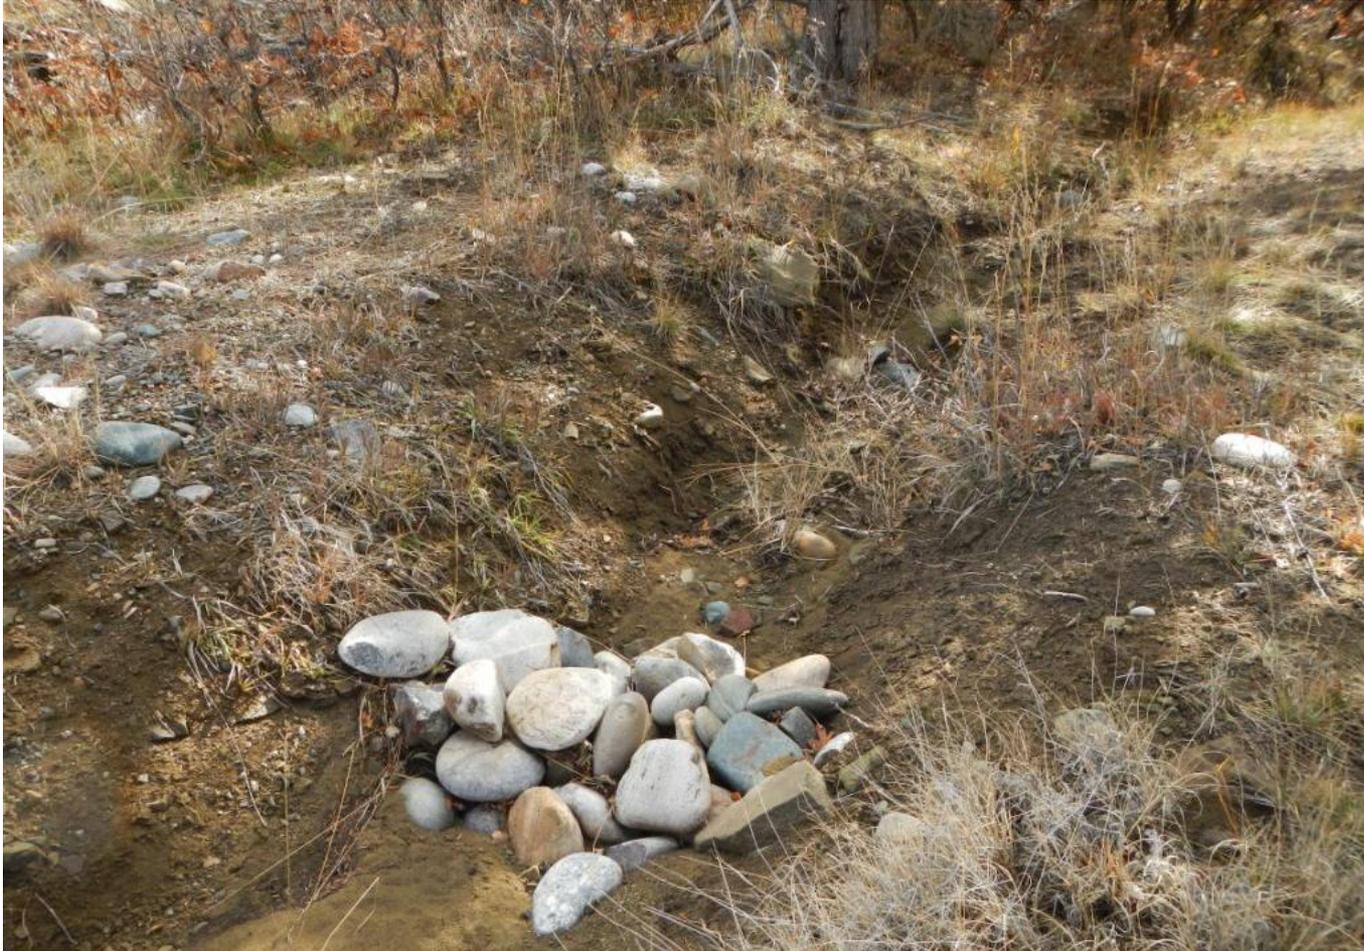
Photo 6. View of diversion channel shown in Photo 5, facing downstream (southward) where the channel exits the project area. The filter dam in the foreground was recently installed.

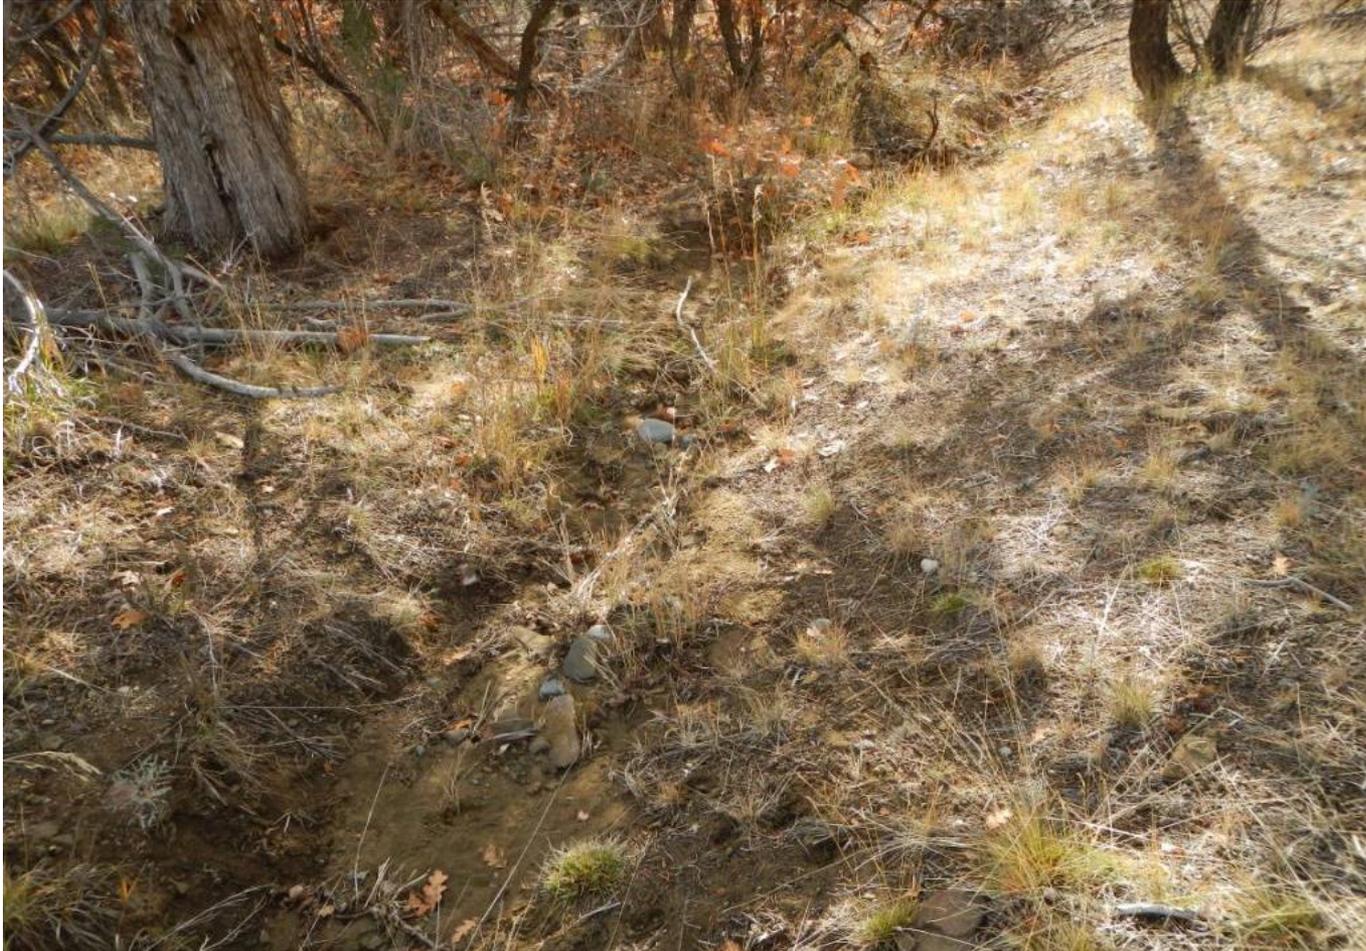
Photo 7. View of incised channel downstream from photos 5 and 6, that is formed and eroding outside of the project area.

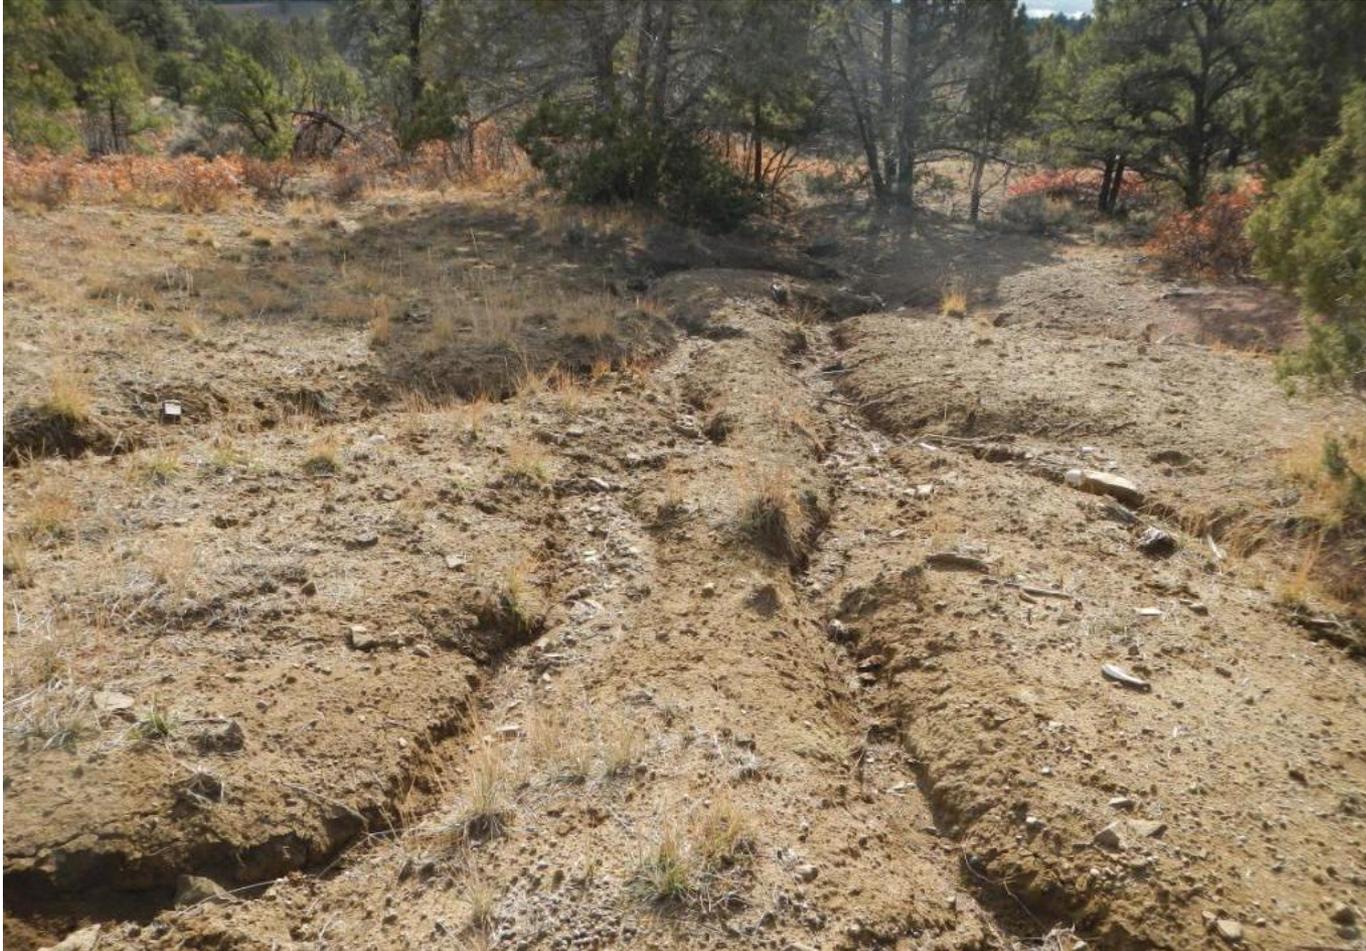
Photo 8. View of erosional channels in southern portion of project area facing downstream (southward).

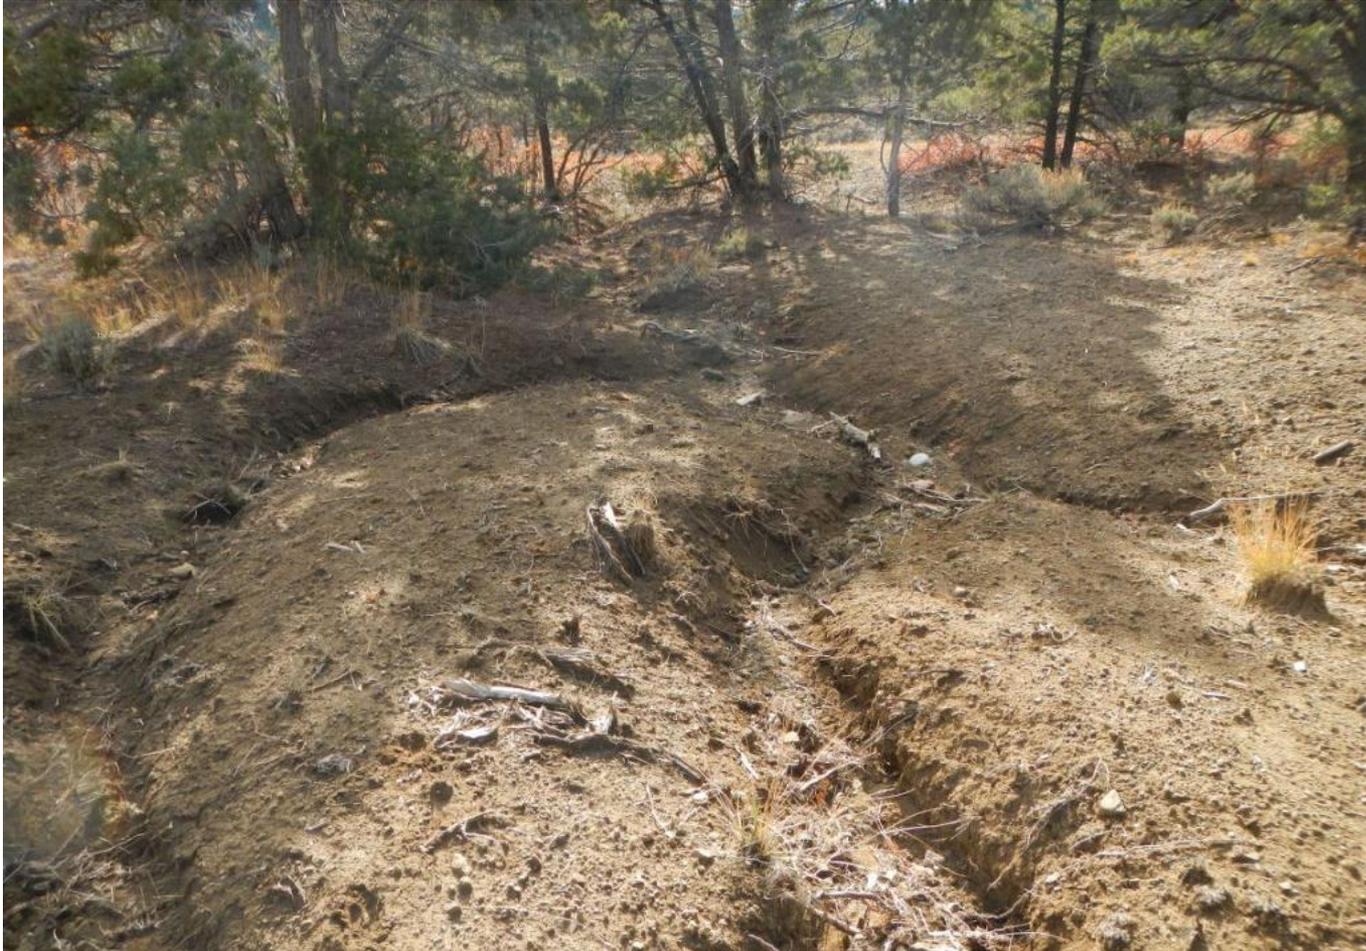
Photo 9. View of erosional channels in Photo 8, where they combine to form a single channel exiting the project area (facing downstream).

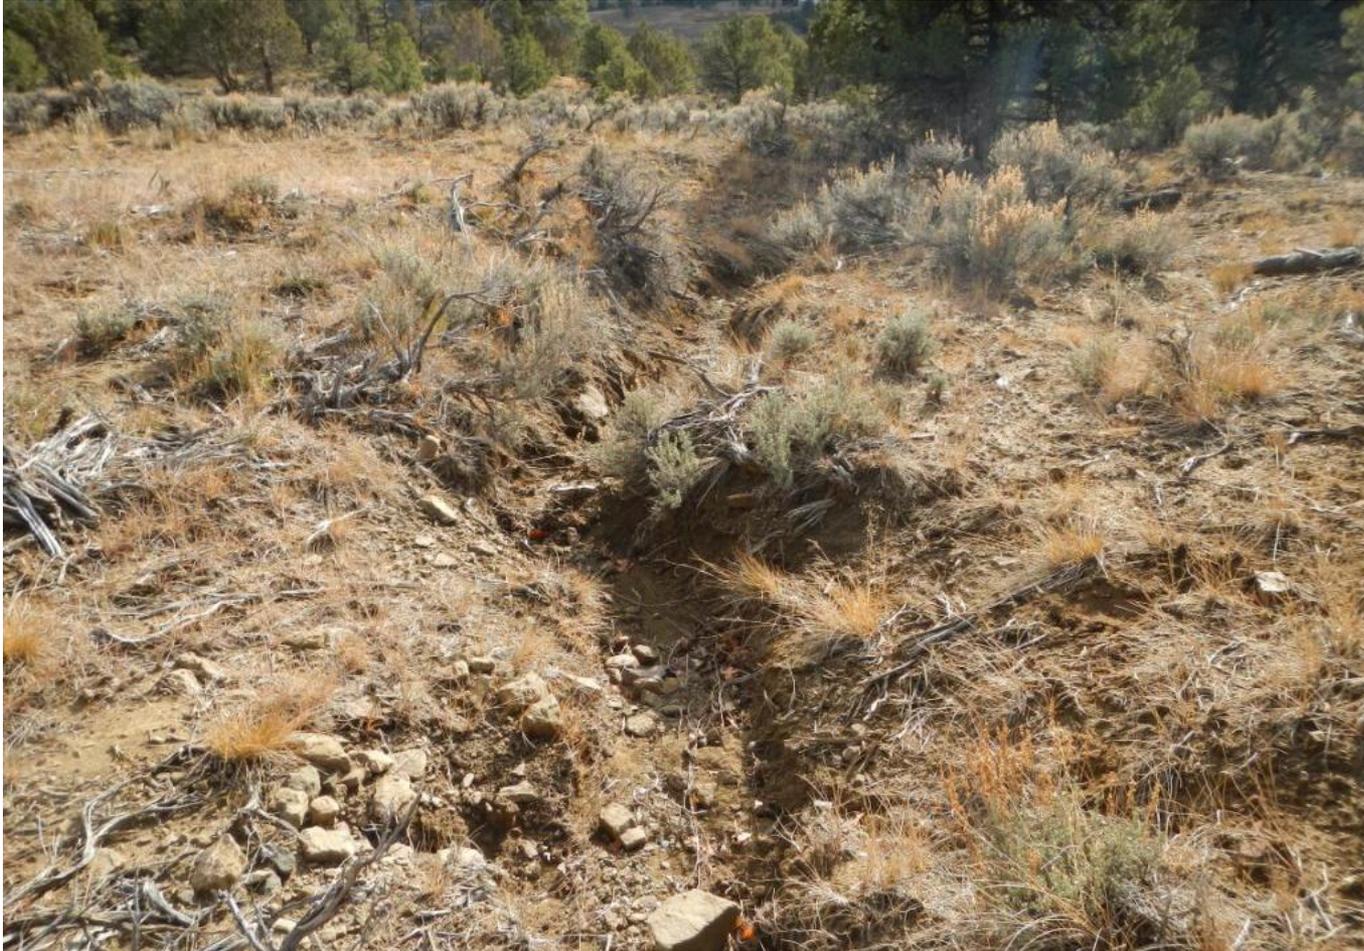
Photo 10. View of erosional channel, downstream from photos 8 and 9, facing downstream (southward). Erosion in channel appears to be accelerated by stormwater runoff from the well pad.

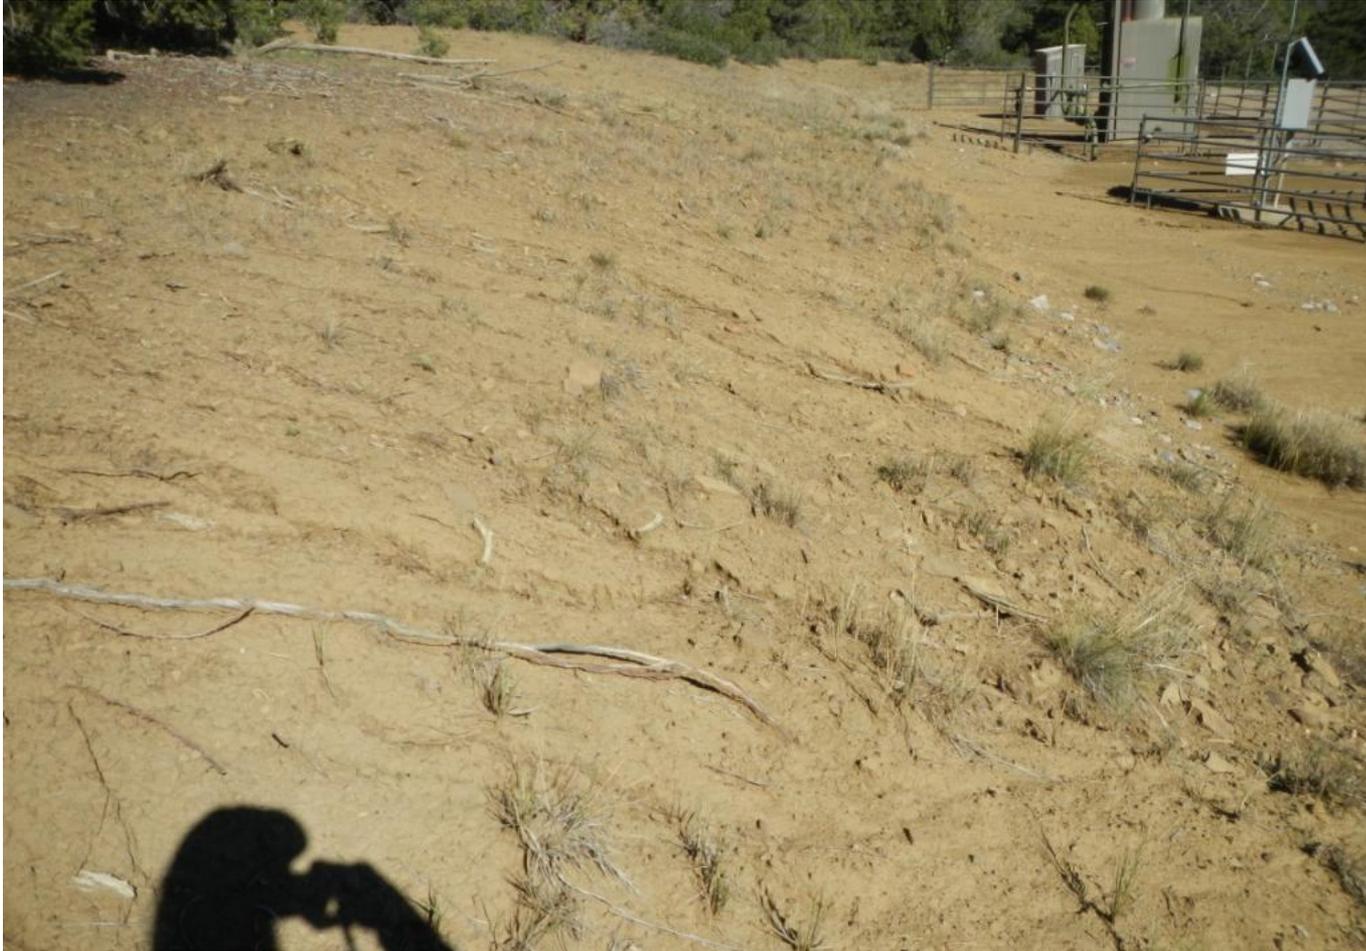
Photo 11. View of rill erosion on northern cut slope from northwestern edge facing eastward. Photo from October 2, 2014 inspection.
