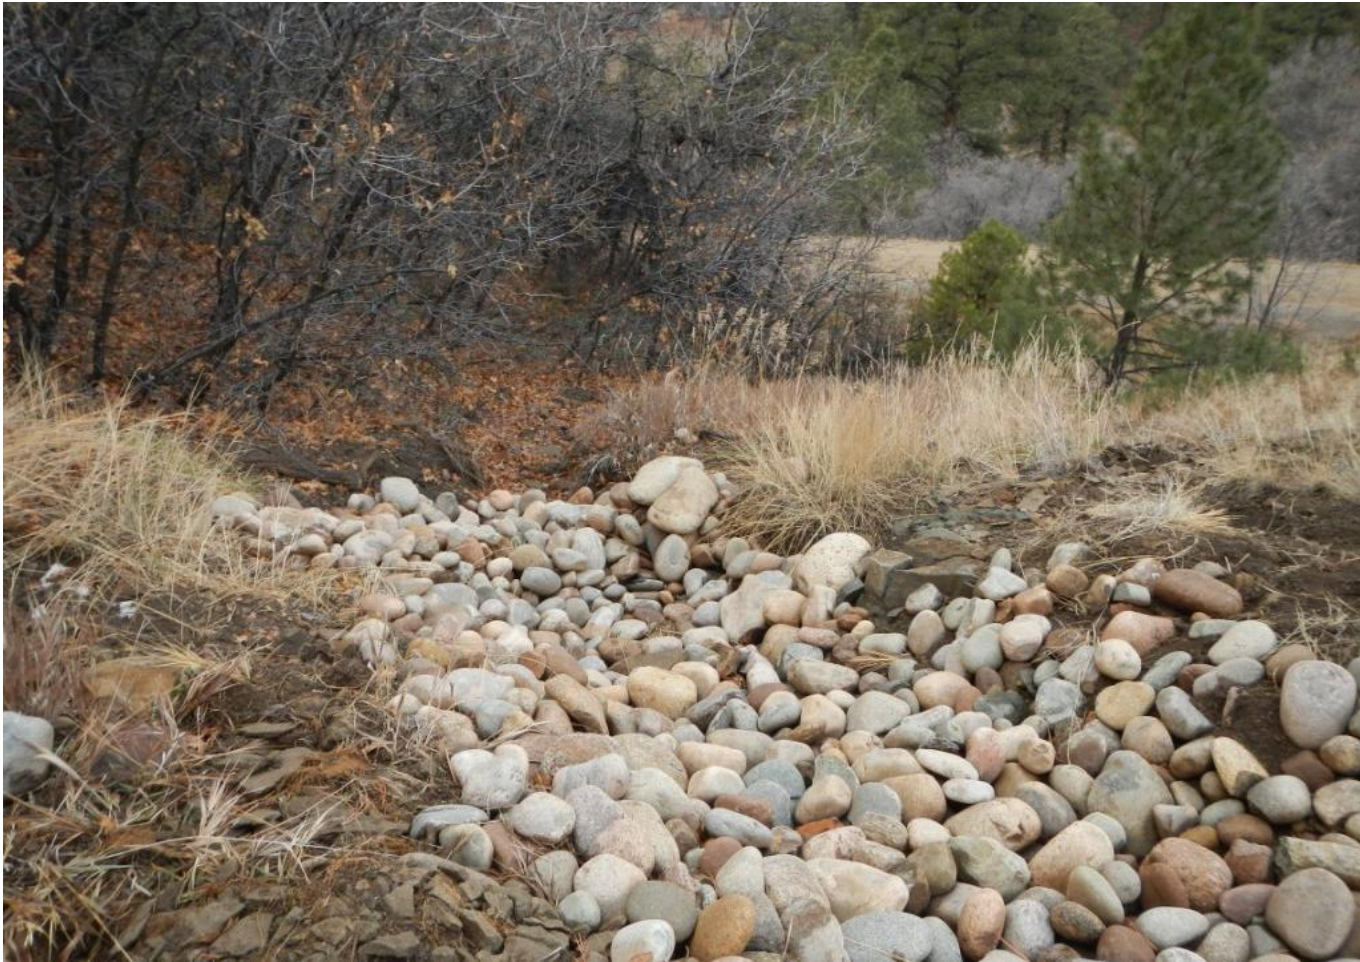
Photo 1. View of new cobble placed in gully from top of slope facing downstream.

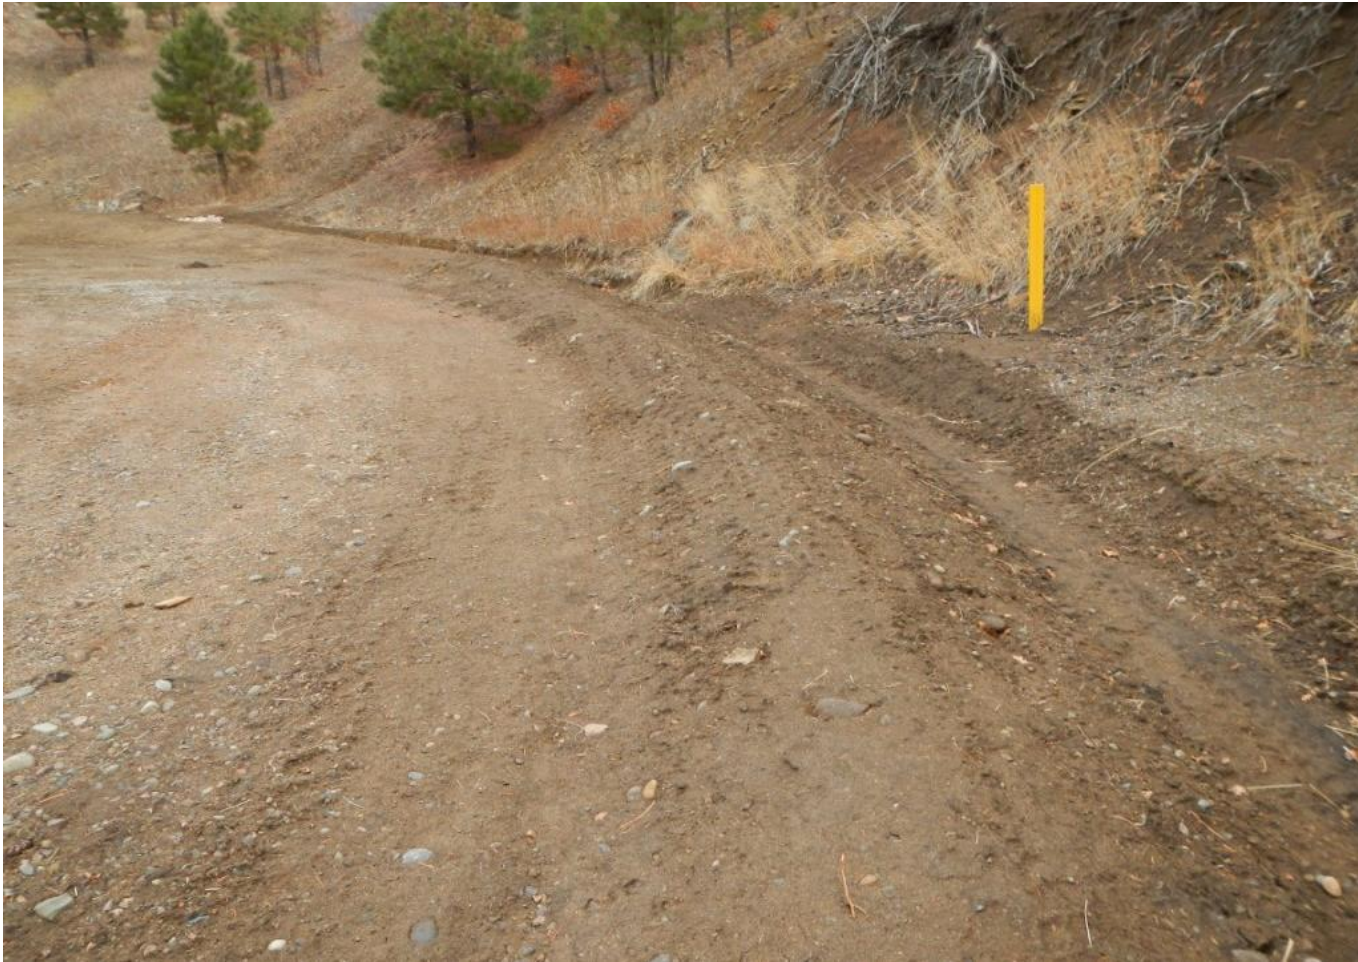
Photo 2. View of newly graded diversion on eastern edge of project area.

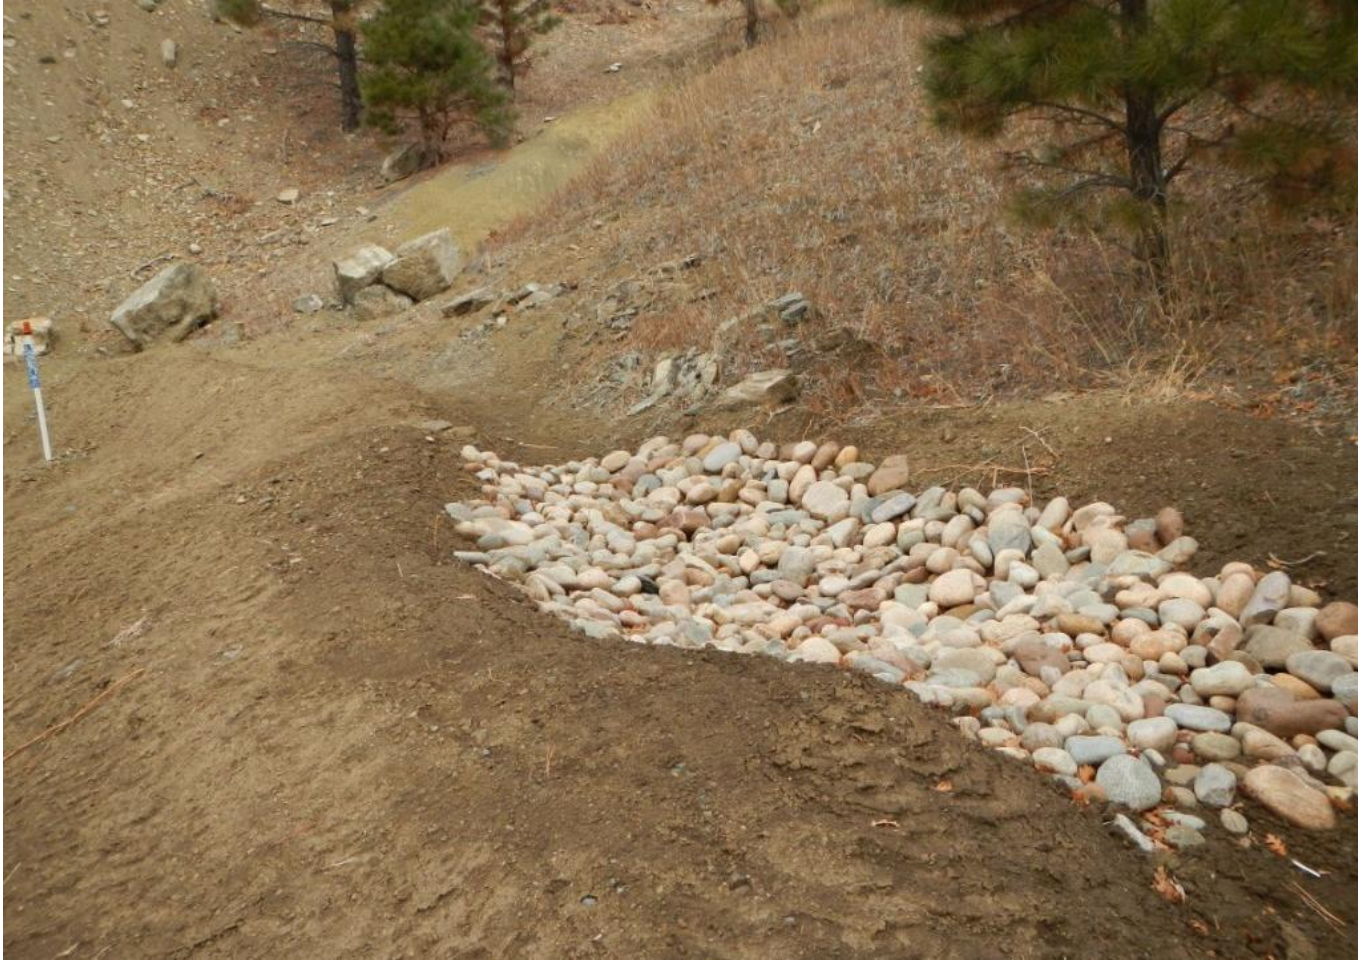
Photo 3. View of new silt trap in northeastern corner of project area.

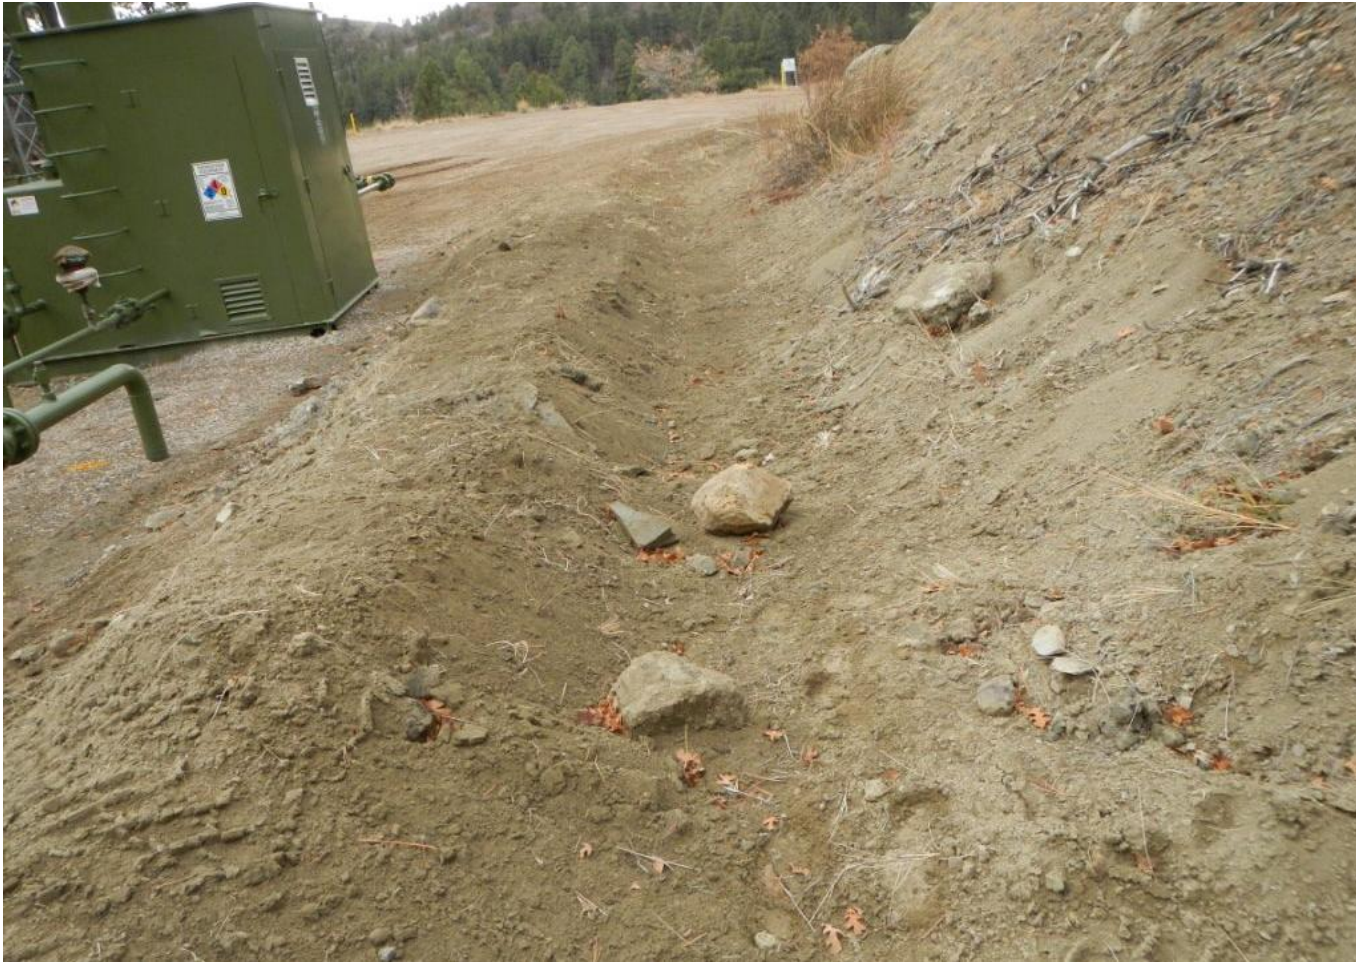
Photo 4. View of new diversion and berm in northern portion of project area facing northwestward.

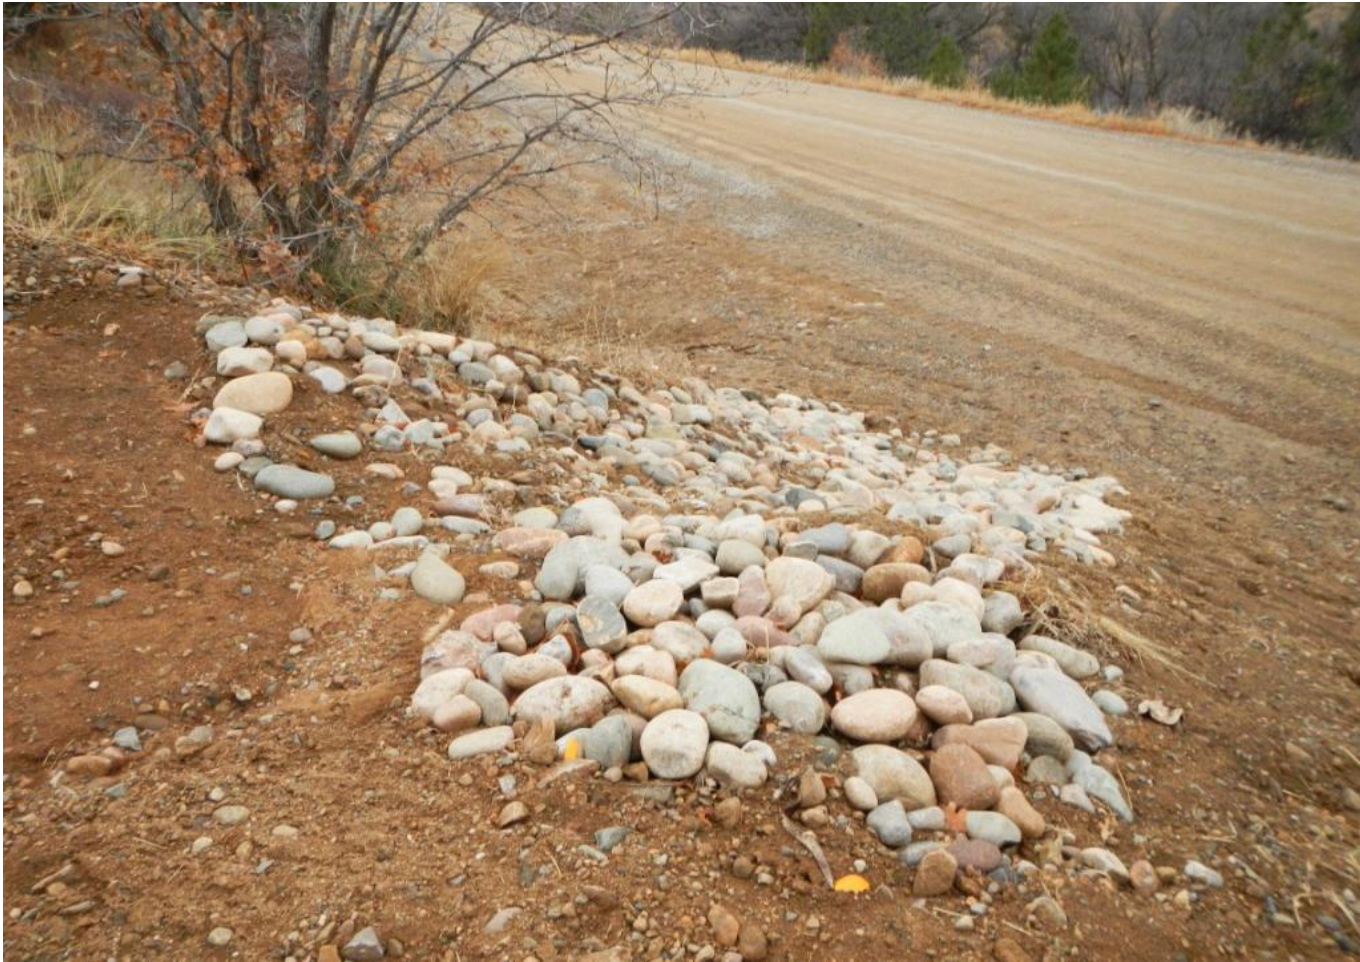
Photo 5. View of new cobble placed near entrance of access road.

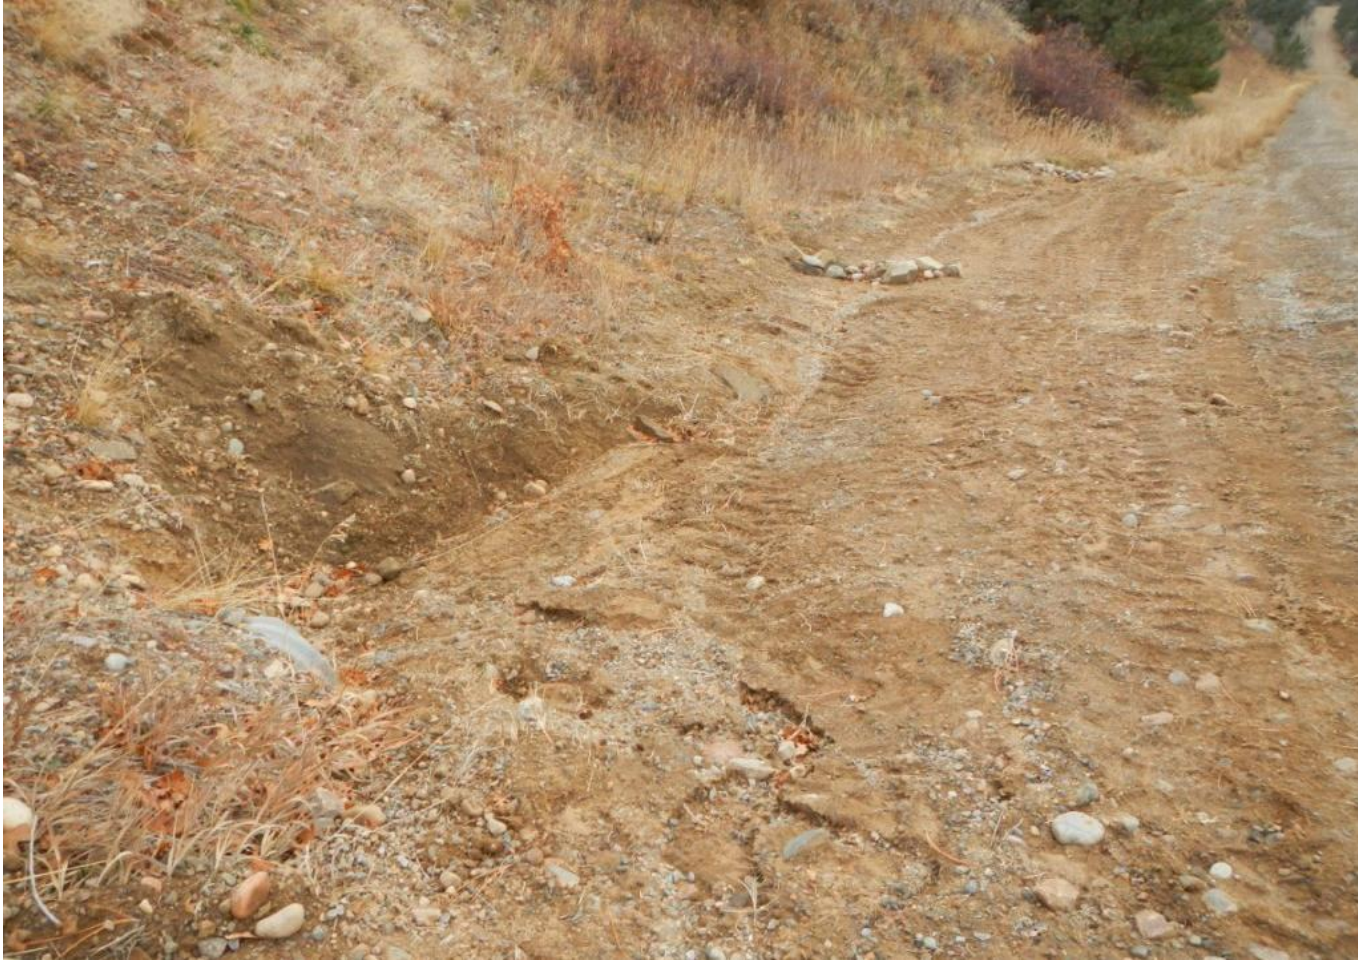
Photo 6. View of culvert outlet with rock filter dams placed downstream of project area below culvert outlet at access road entrance facing downstream.
