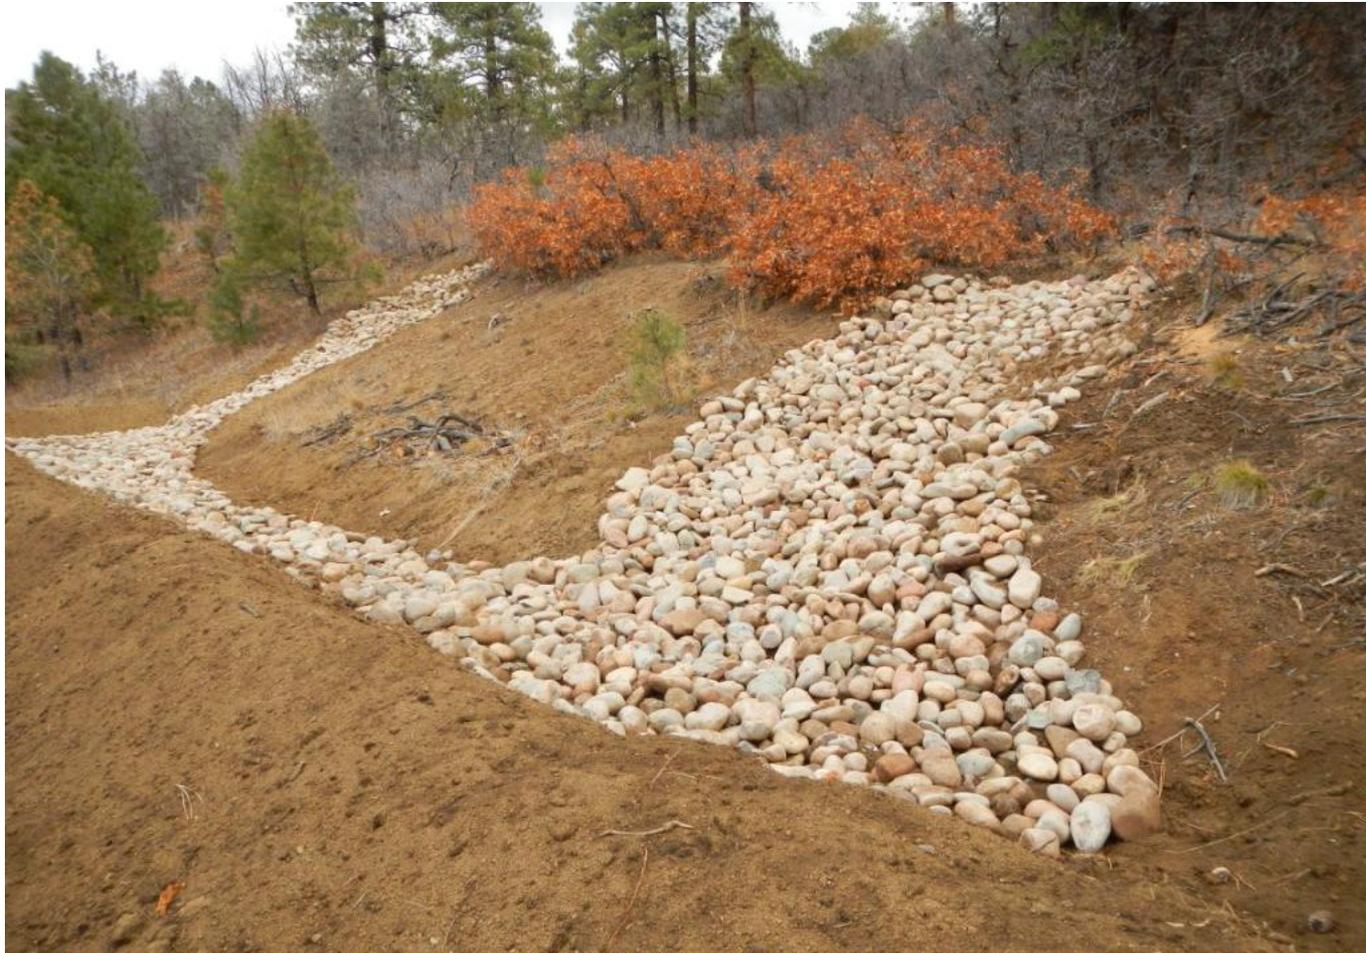
Photo 1. View of new of cobble and earthen berm placed in eastern portion of project area.

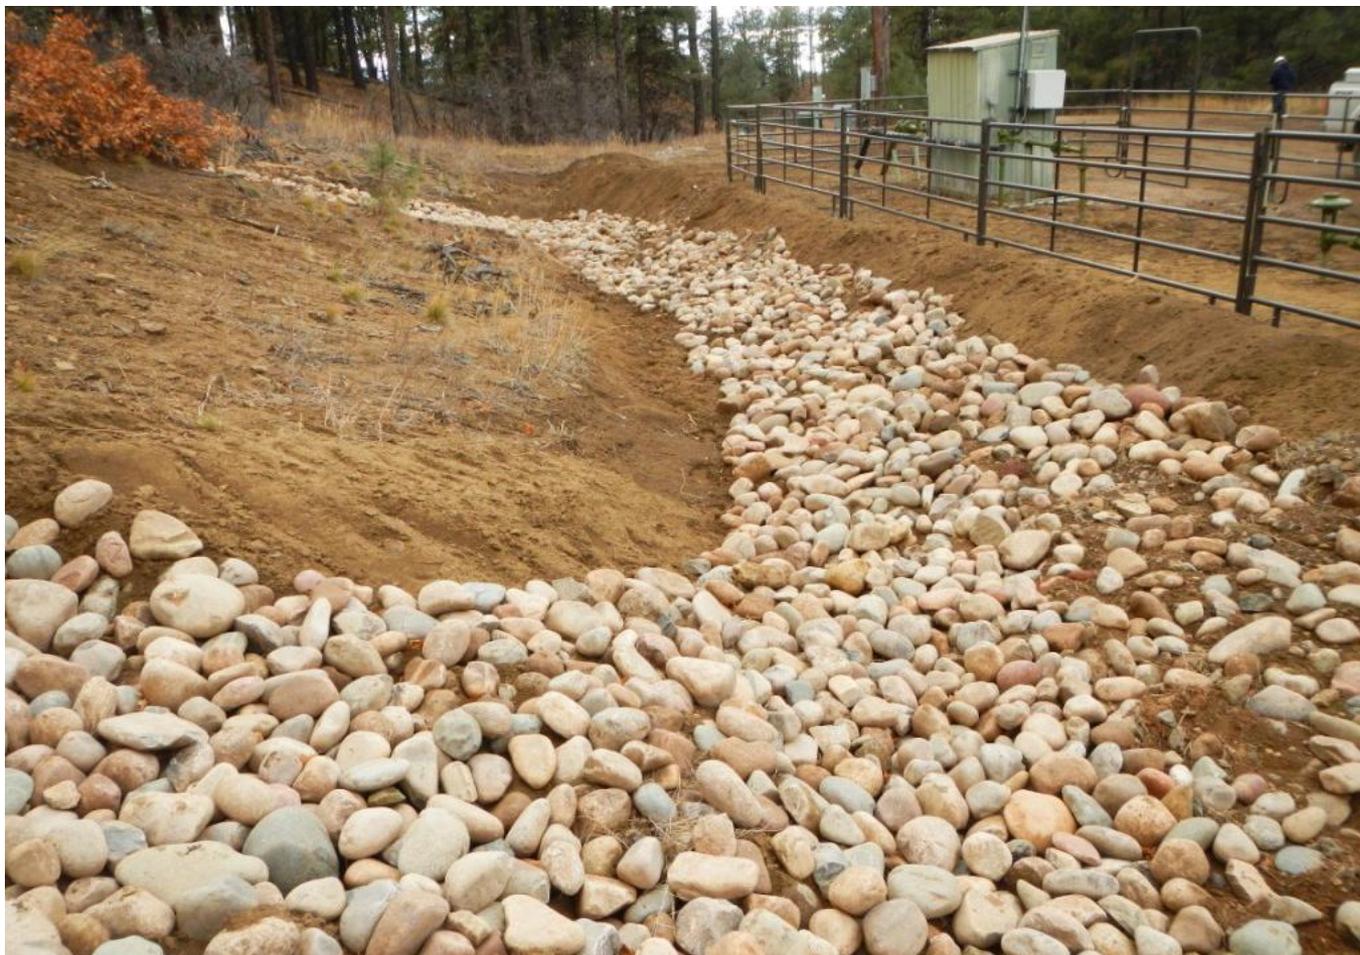
Photo 2. View of newly installed cobble and berm along eastern edge of working area.

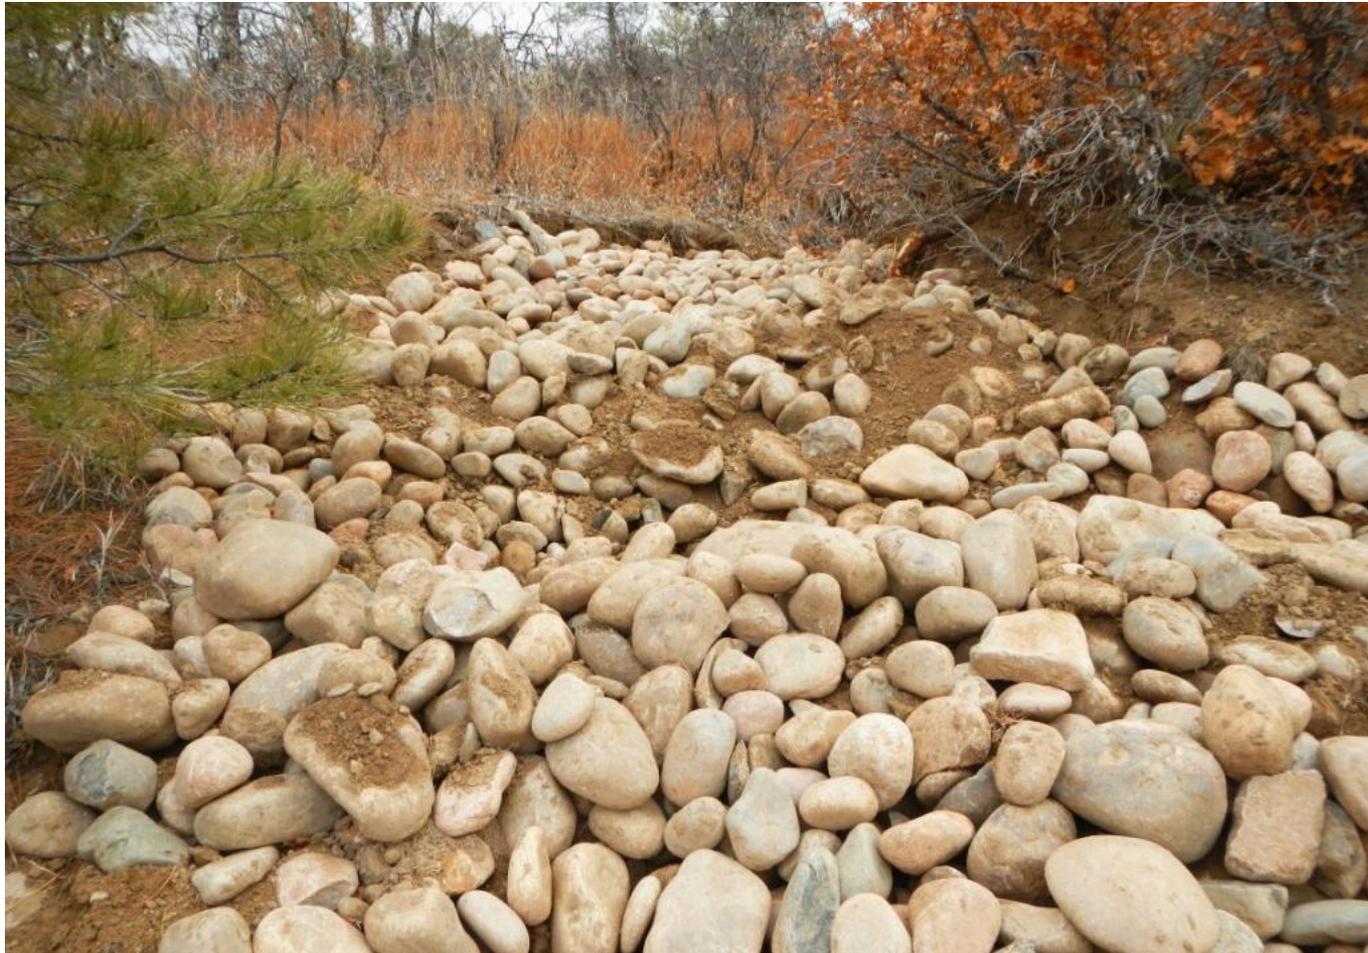
Photo 3. View of cobble placed in head-cut erosional feature.

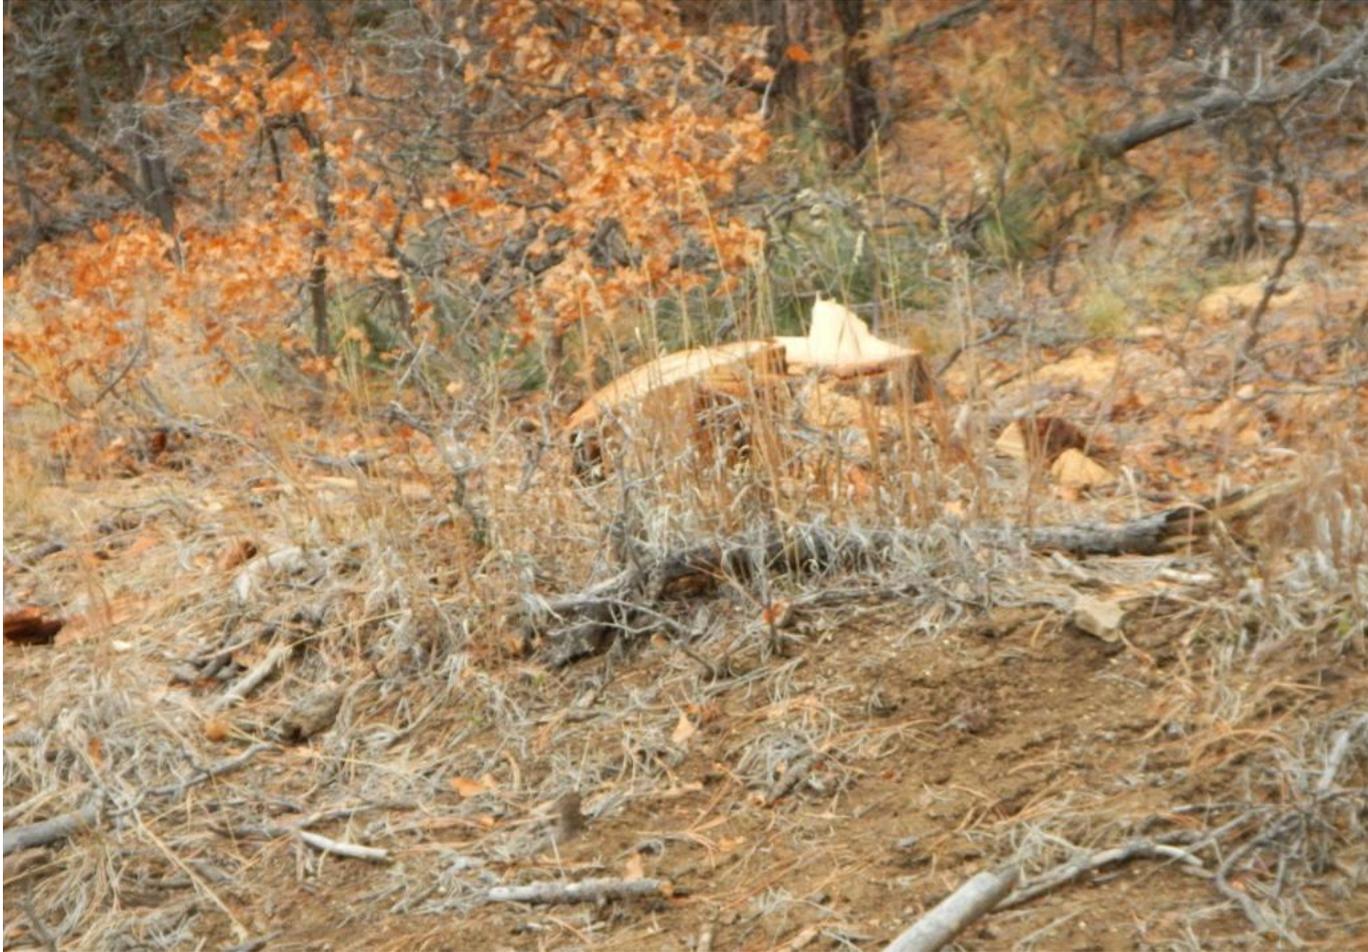
Photo 4. View of tree stump from dead tree that was removed.
