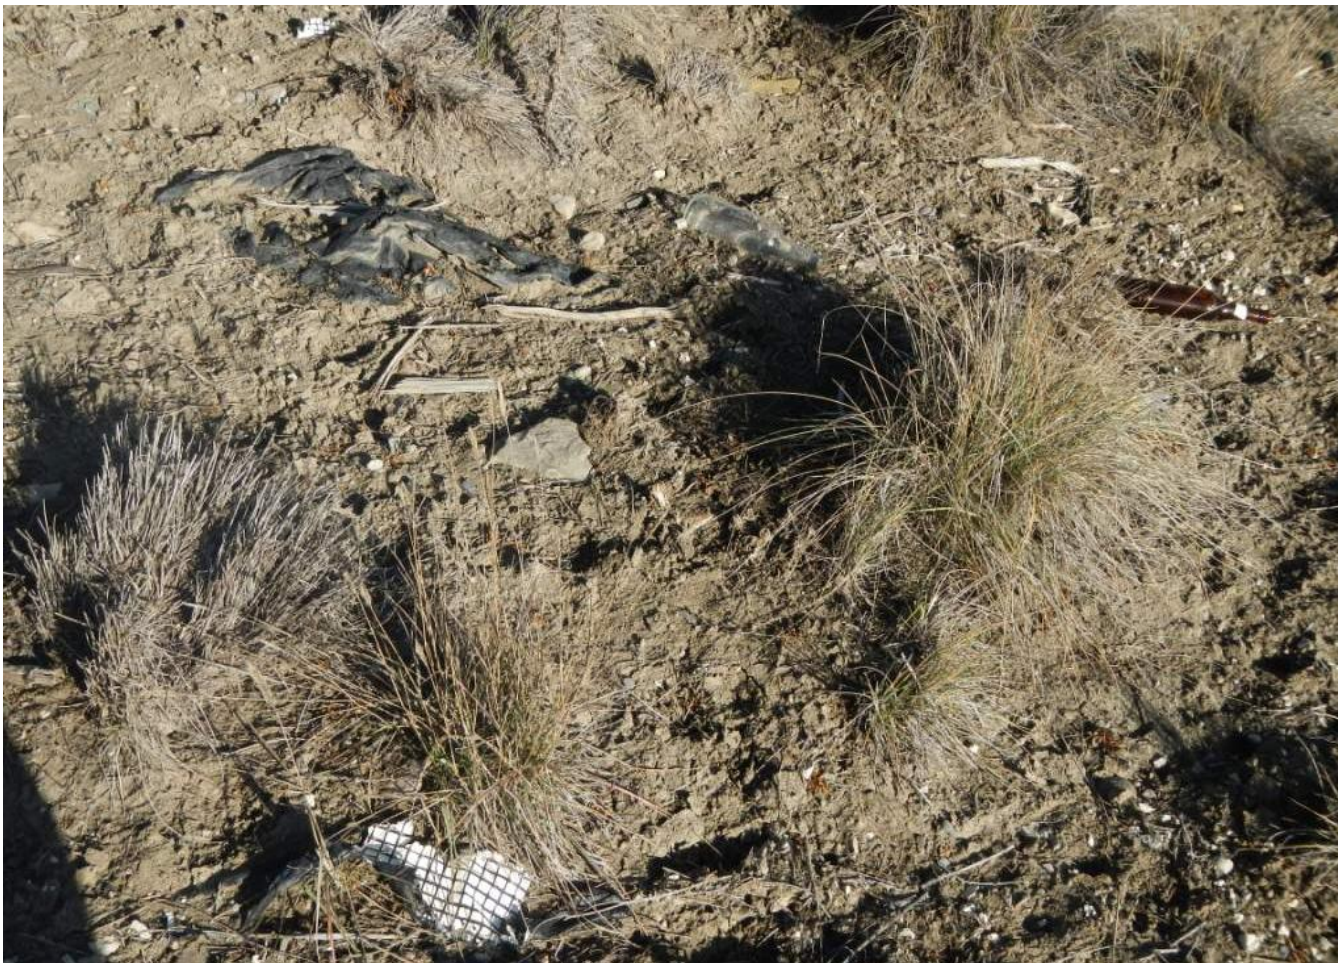
Photo 1. View of liner material and trash seen in interim reclamation area.

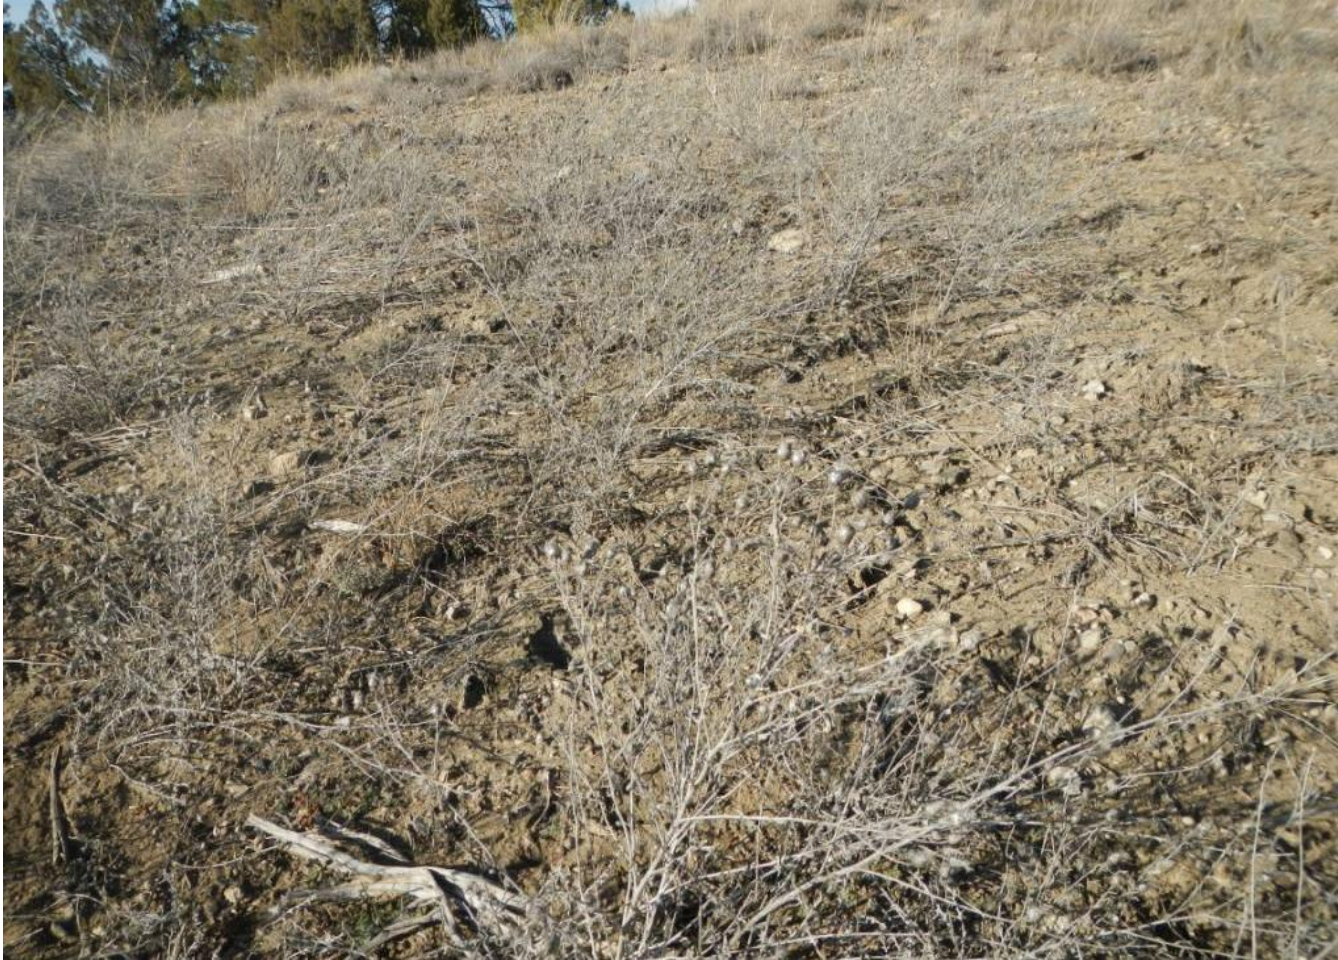
Photo 2. View of knapweed (likely *Acroptilon repens*) infestation on northern slope within interim reclamation area.

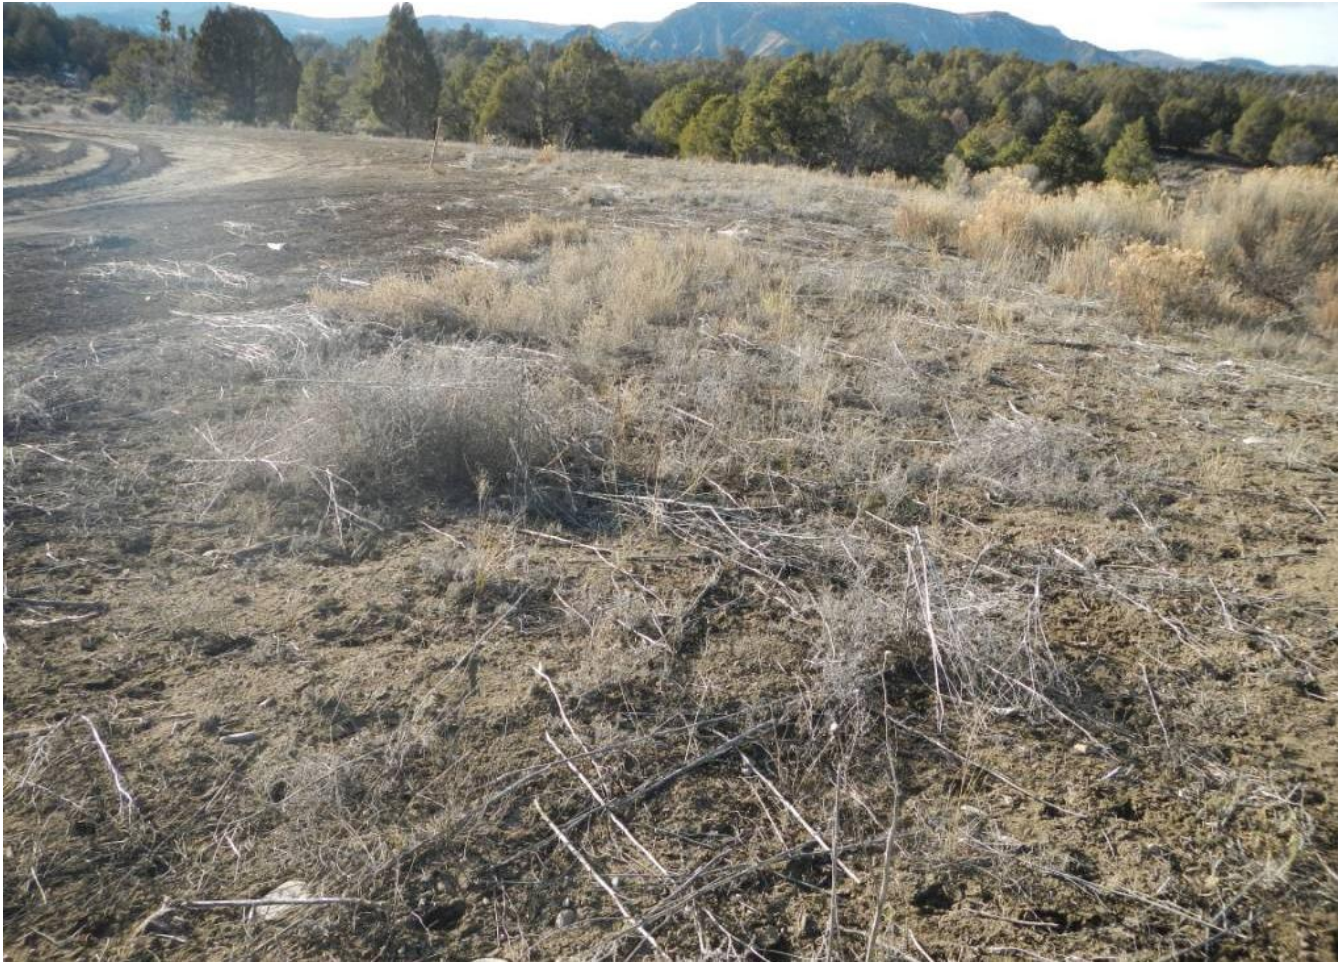
Photo 3. View of western portion of project area from northern edge facing westward. Most of the vegetation is weeds such as knapweed and Russian thistle (*Salsola tragus*).

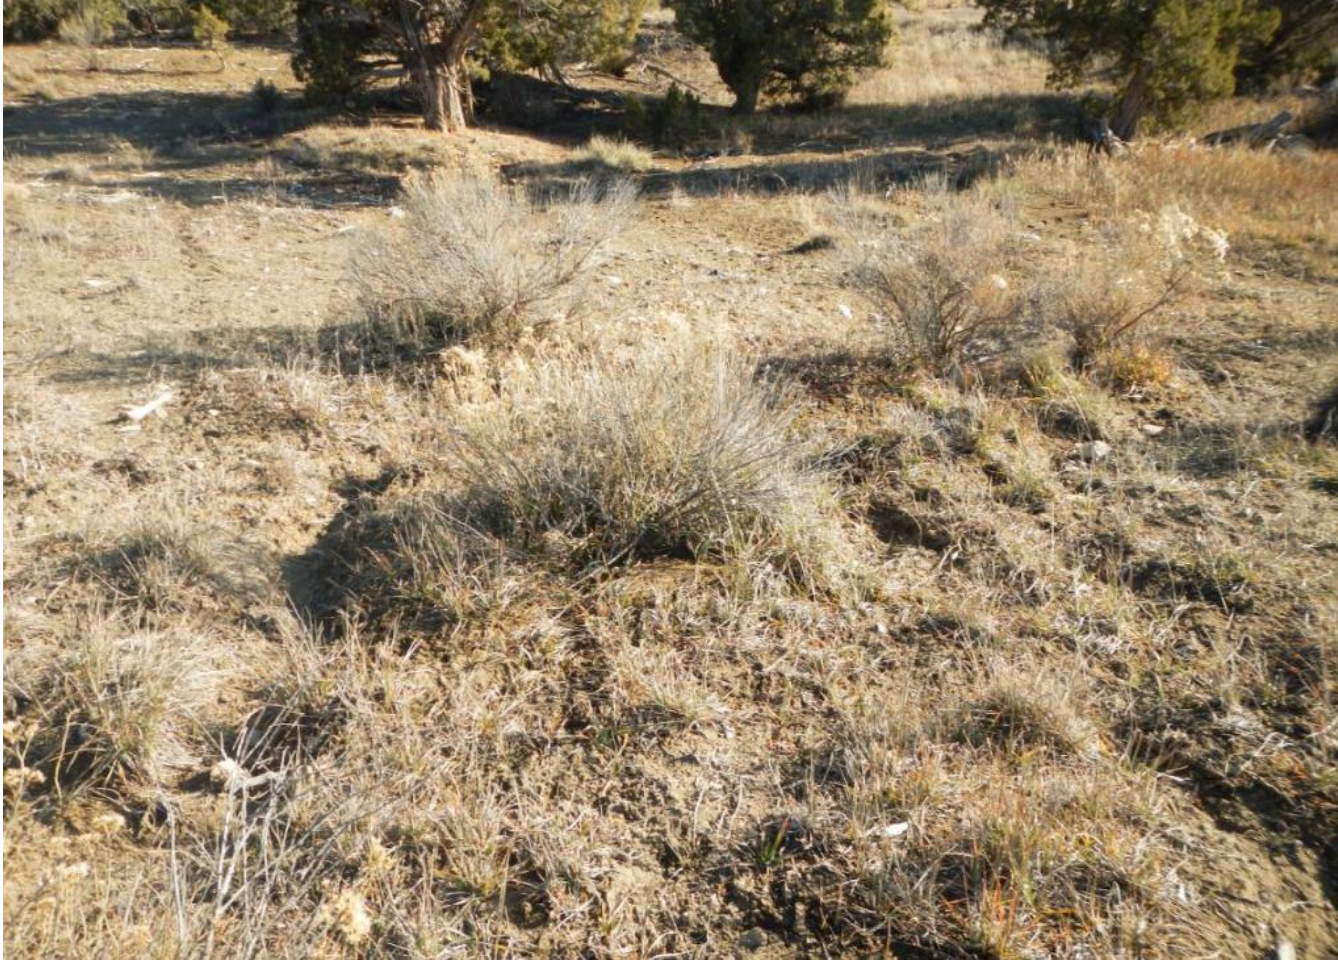
Photo 4. View of erosional channel in northeastern portion of project area. Channel somewhat obscured by vegetation in photo, but flows from lower left hand corner of photo diagonal toward the upper right hand corner.
