WPX Energy

Unocal GM 11-2

Location # 334771

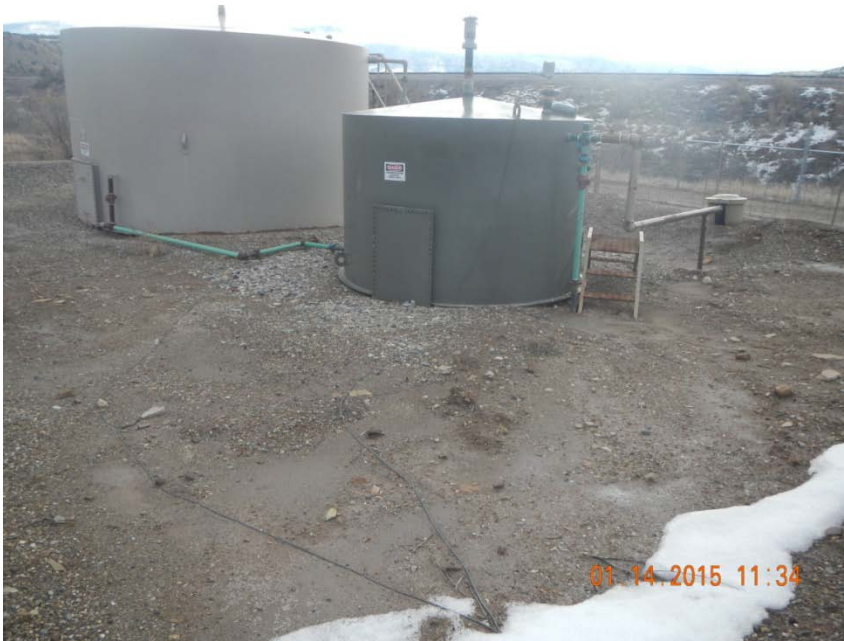
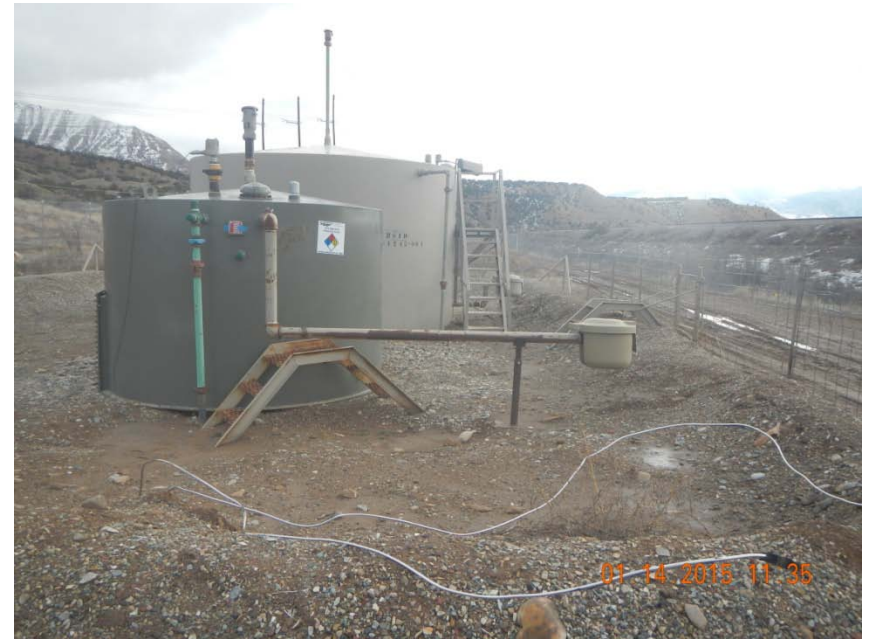
Subsidence of base

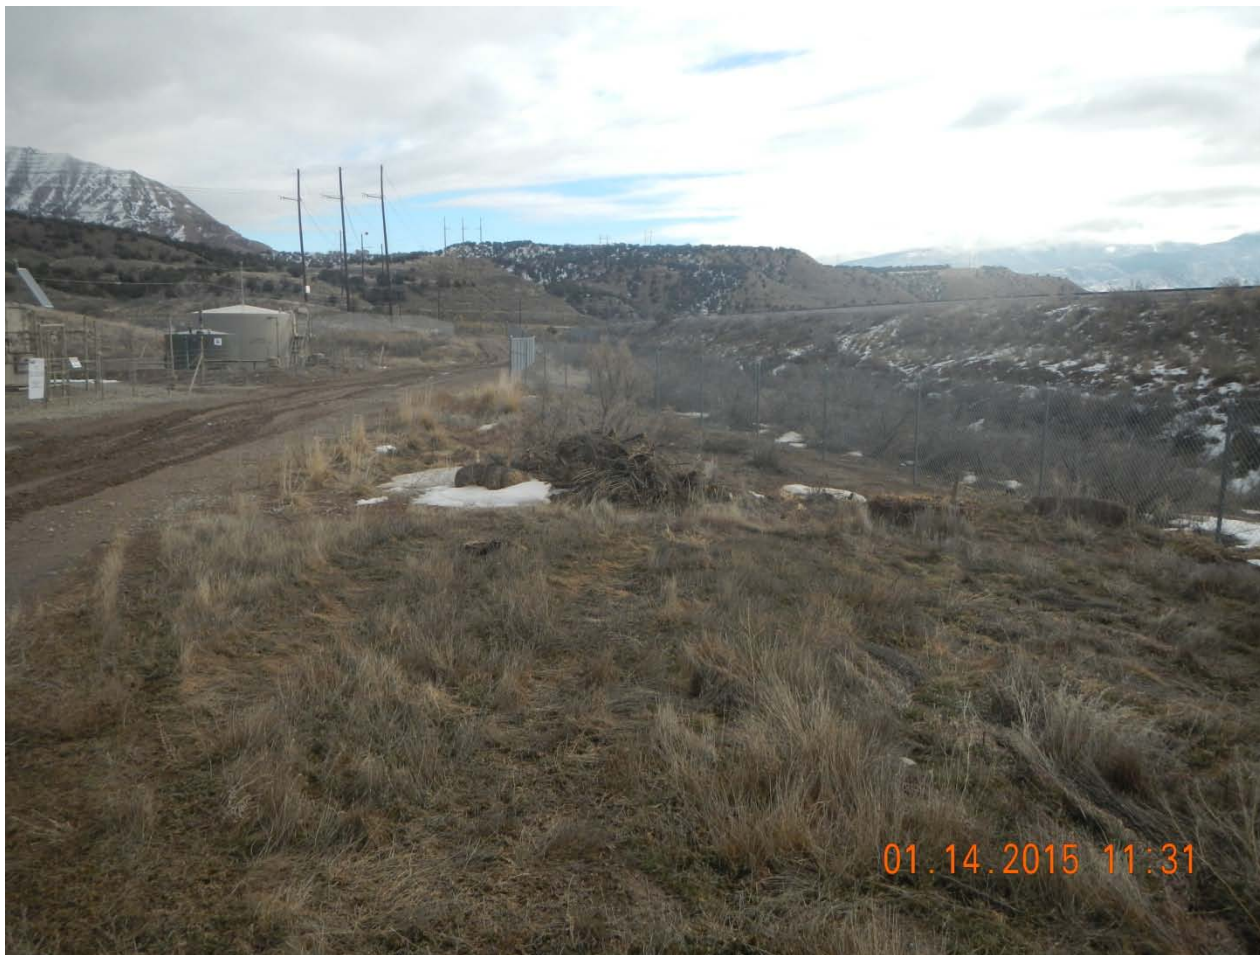
Damaged Straw Bales

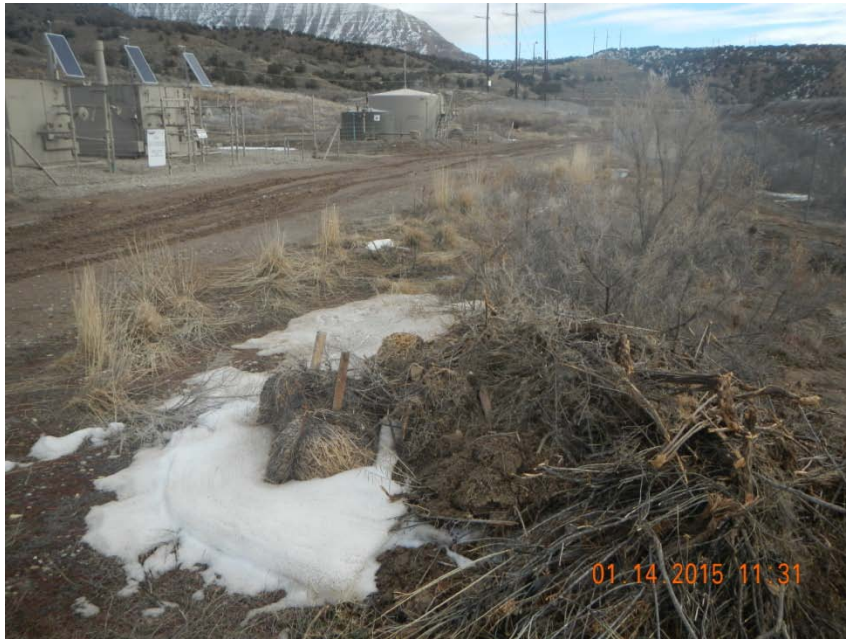
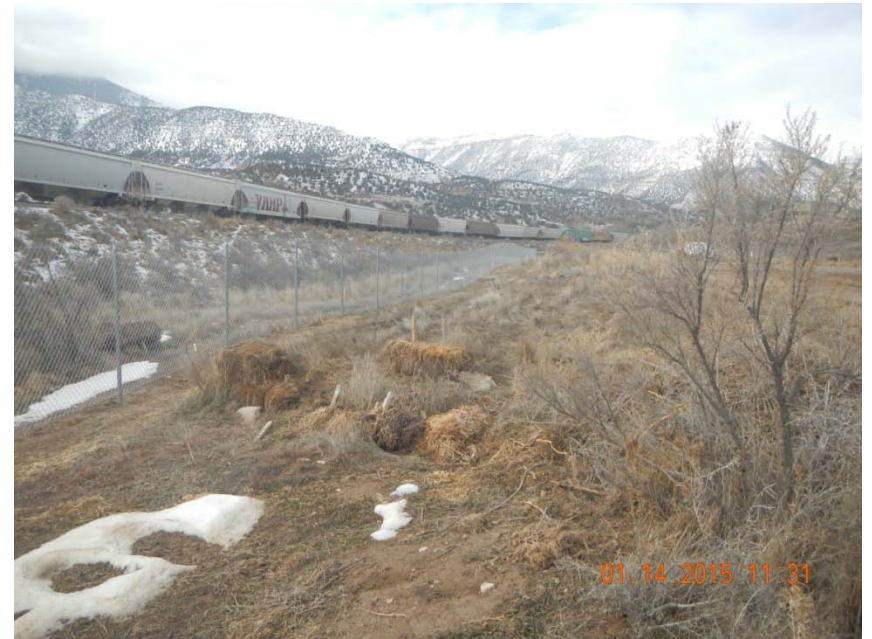
Damaged straw bales and debris

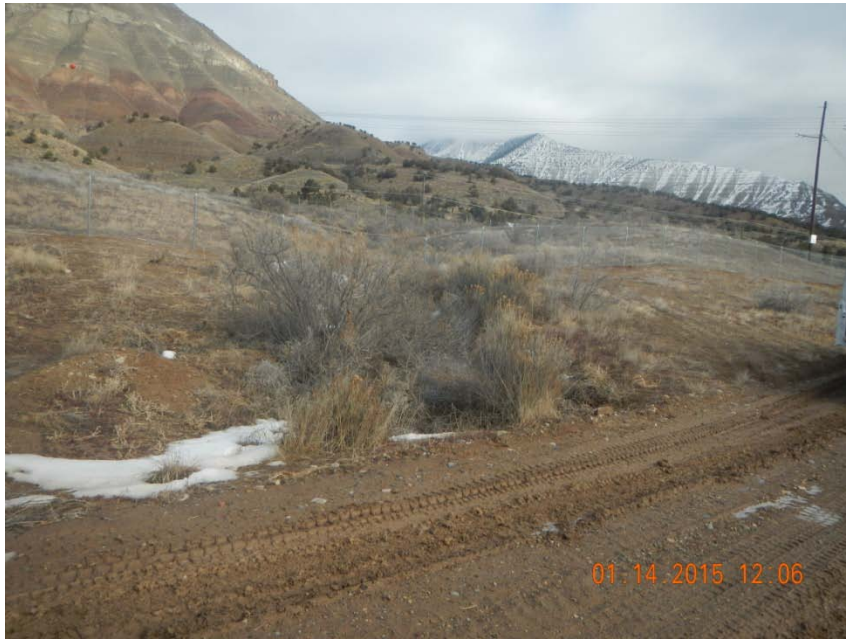
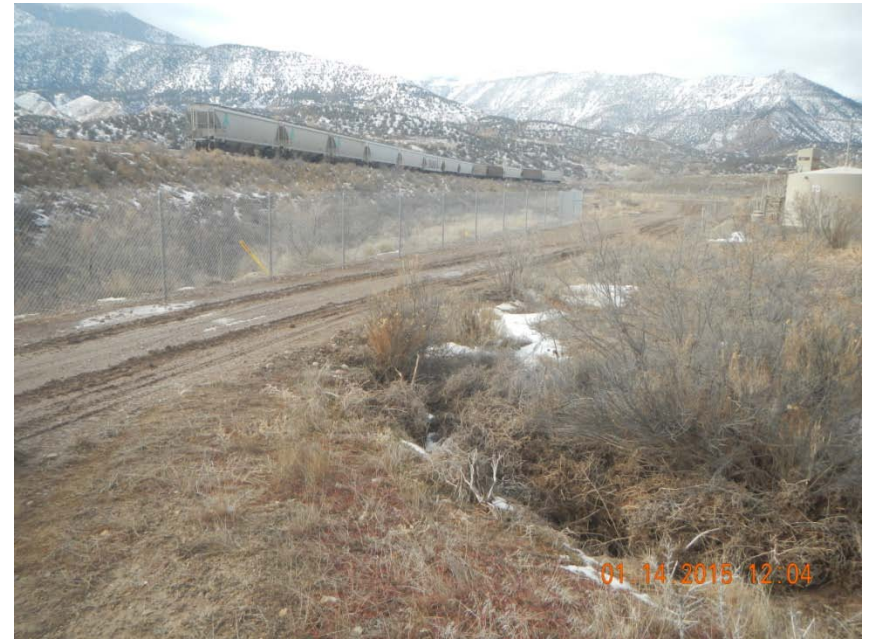
Ditch with weed debris. No culvert seen running under road.

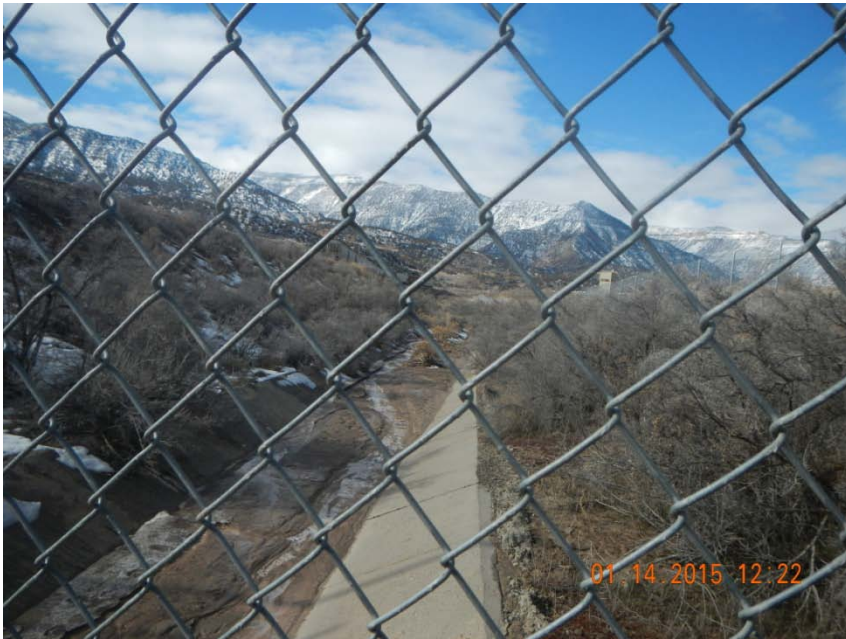
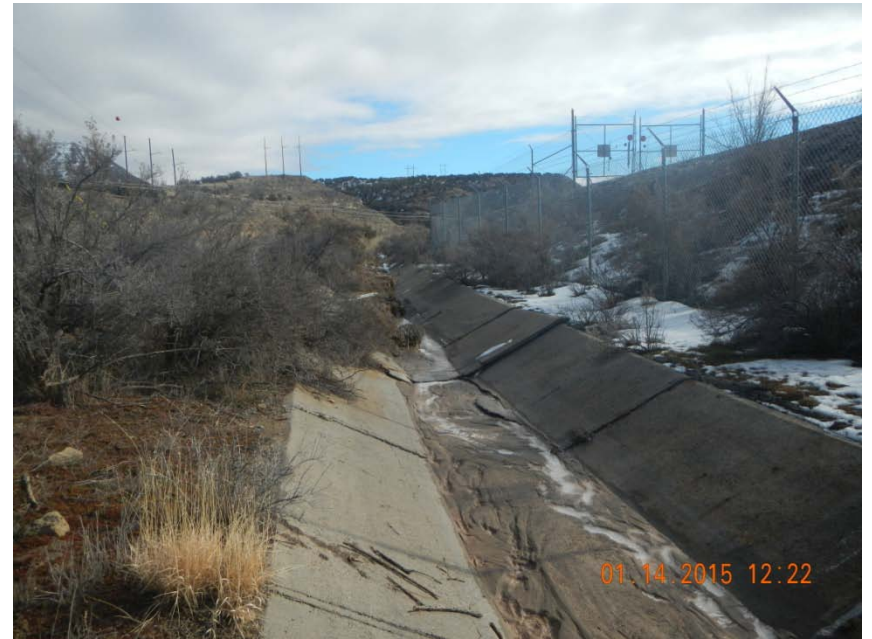
Cement ditch with sediment

Looking up fenced section between location entrance and rail road.

Looking east from chain-link fence.

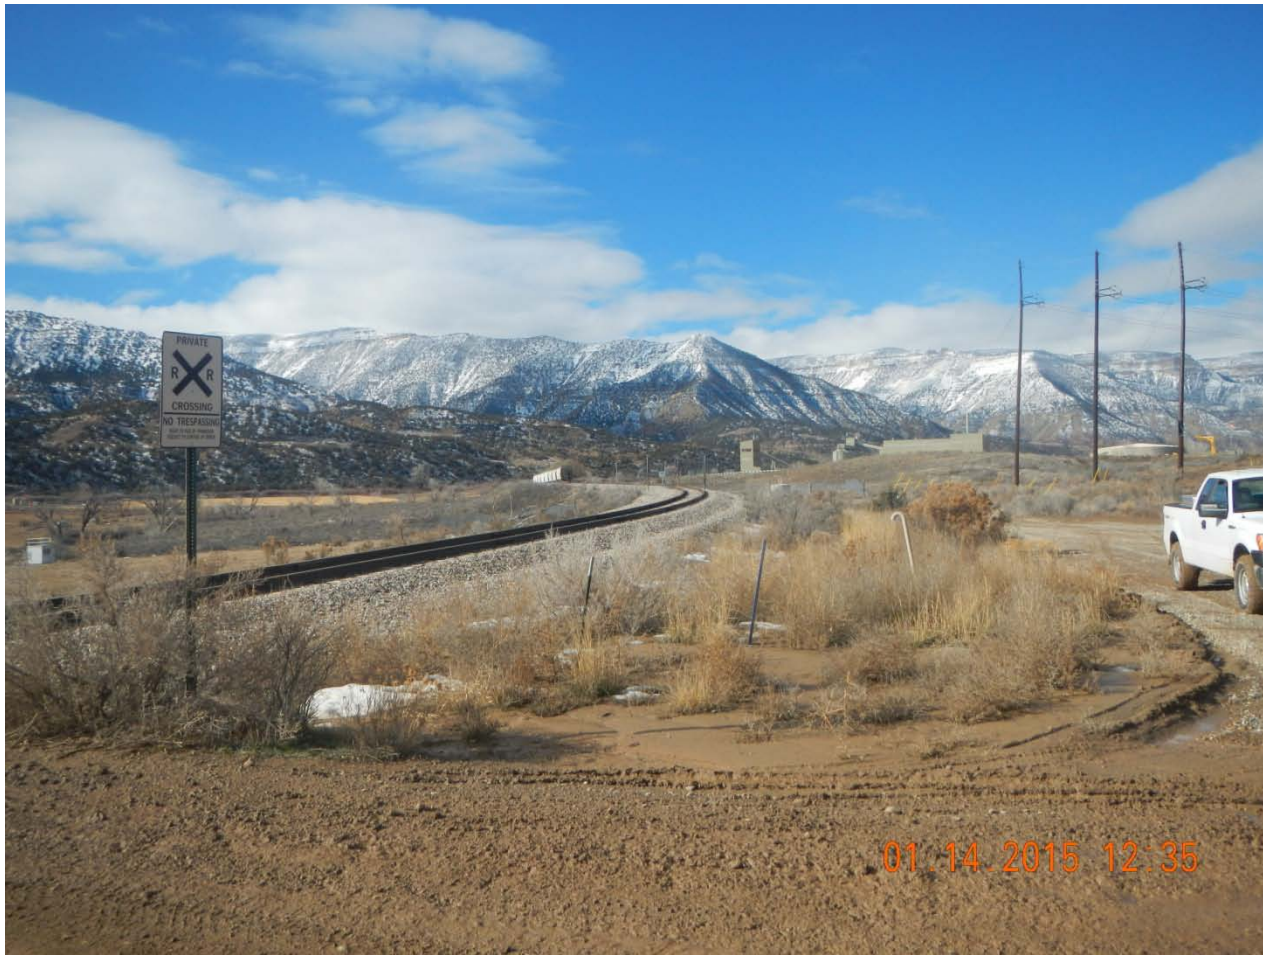
Ditch beginning at intersection

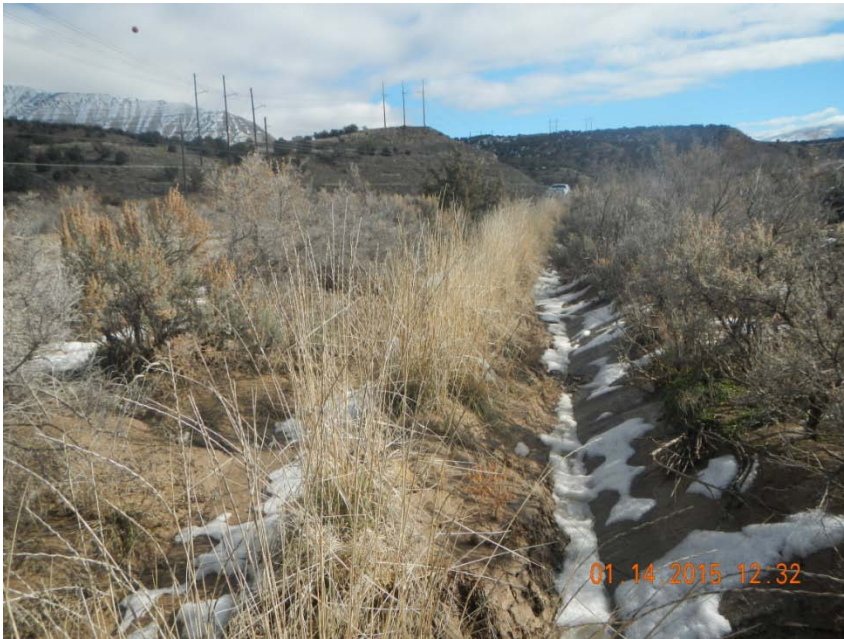
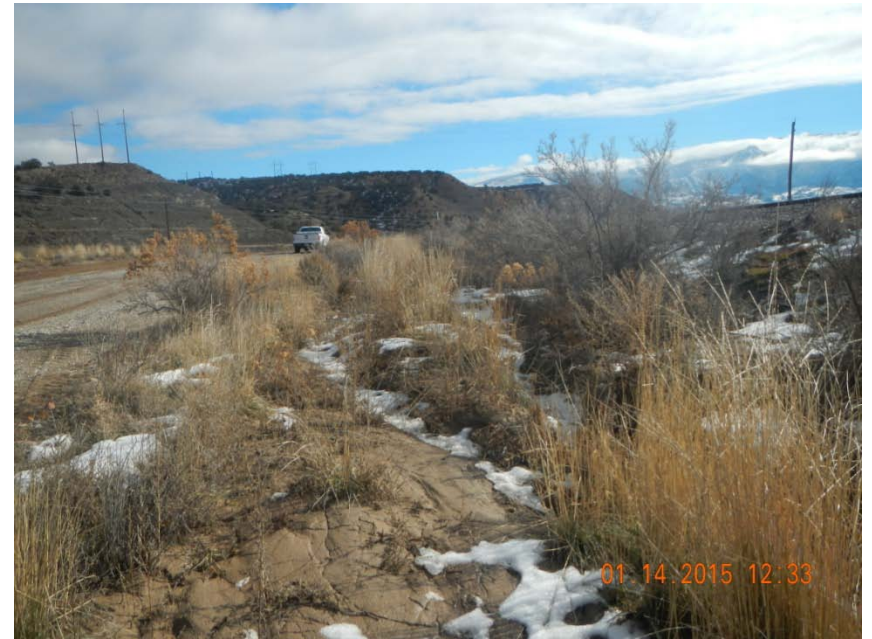
Looking eastward up cement ditch along rail road.

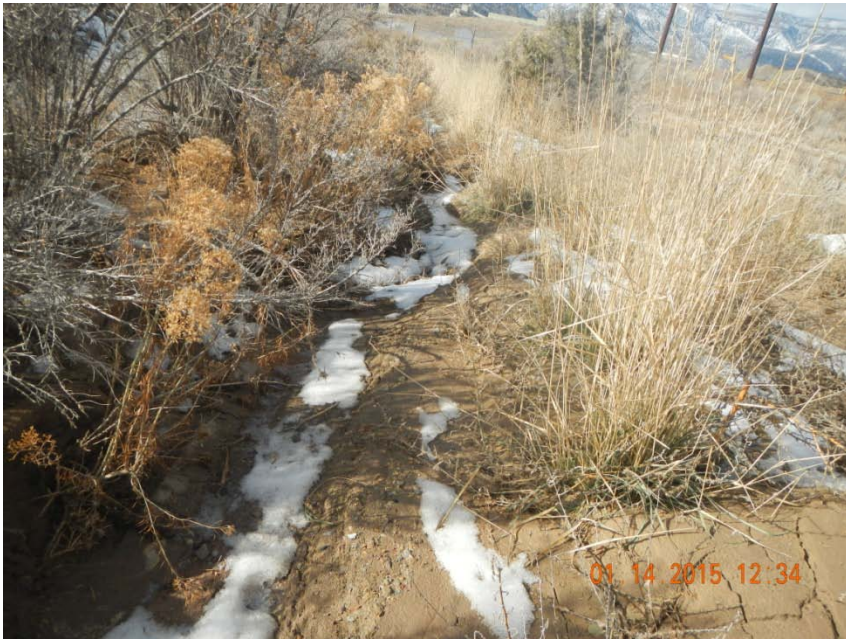
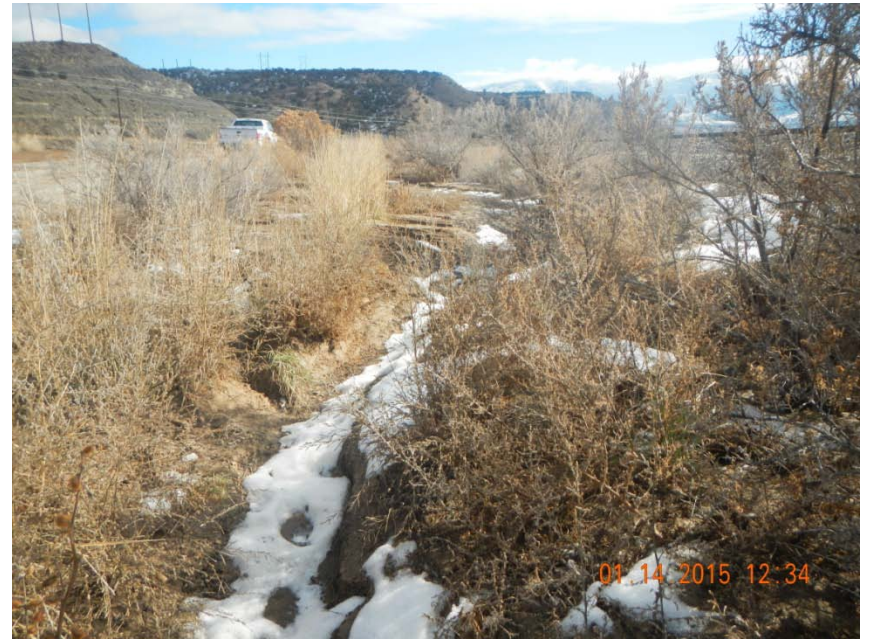
Looking eastward up cement ditch along rail road.

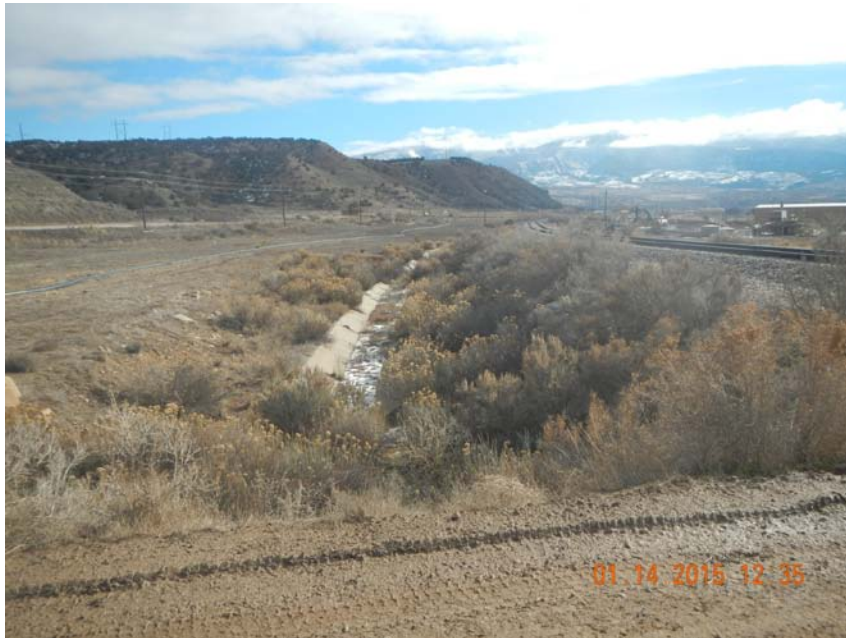
Looking east from intersection

Cement ditch on both sides of road.

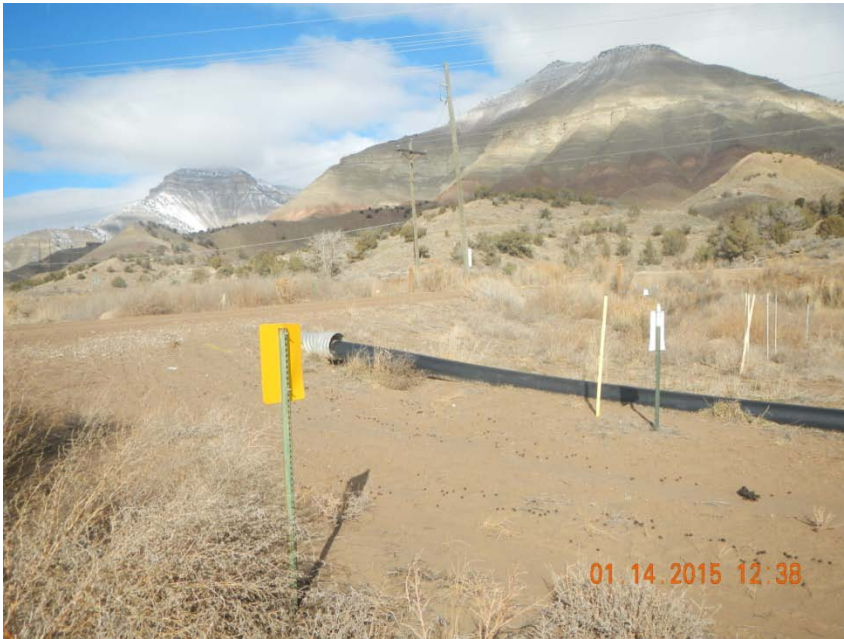
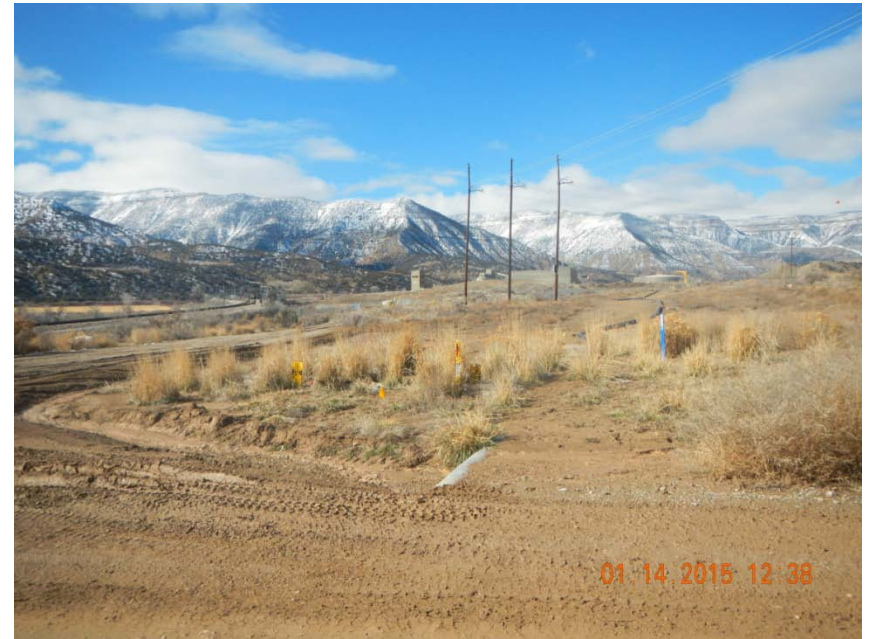
Culvert with water line running thru it.

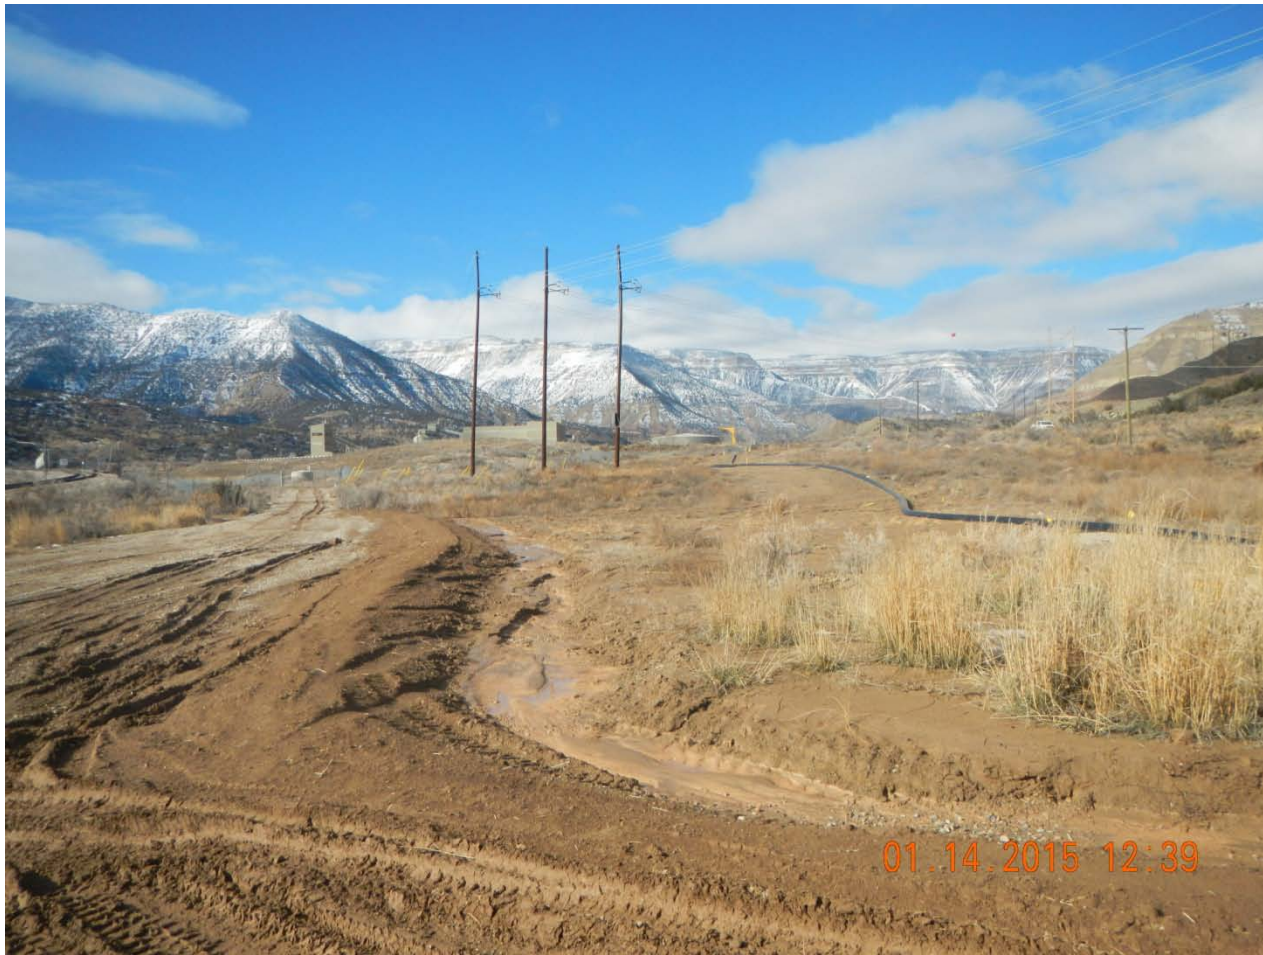
Ditch on north side of road and cleared area along waterline.

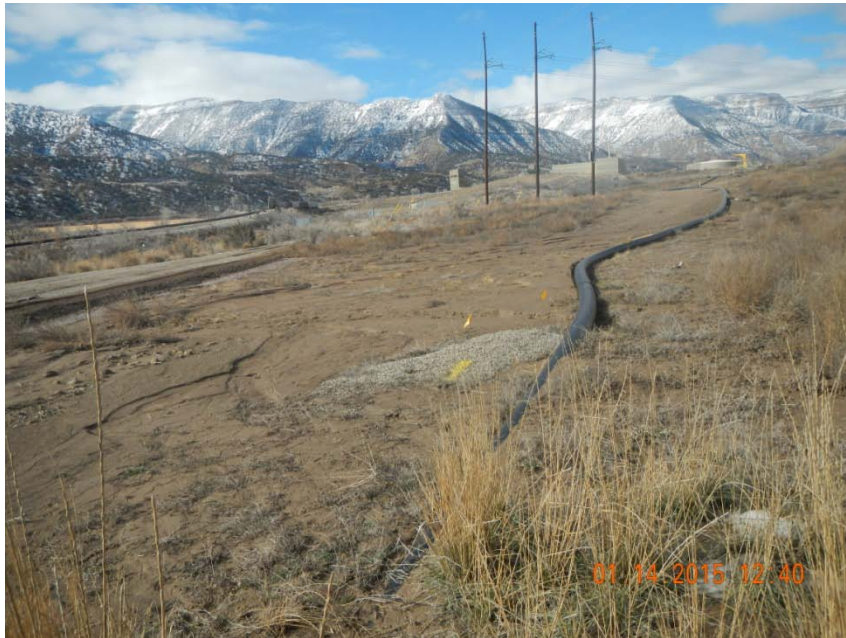
North side of access road

Washing of cleared area along waterline.

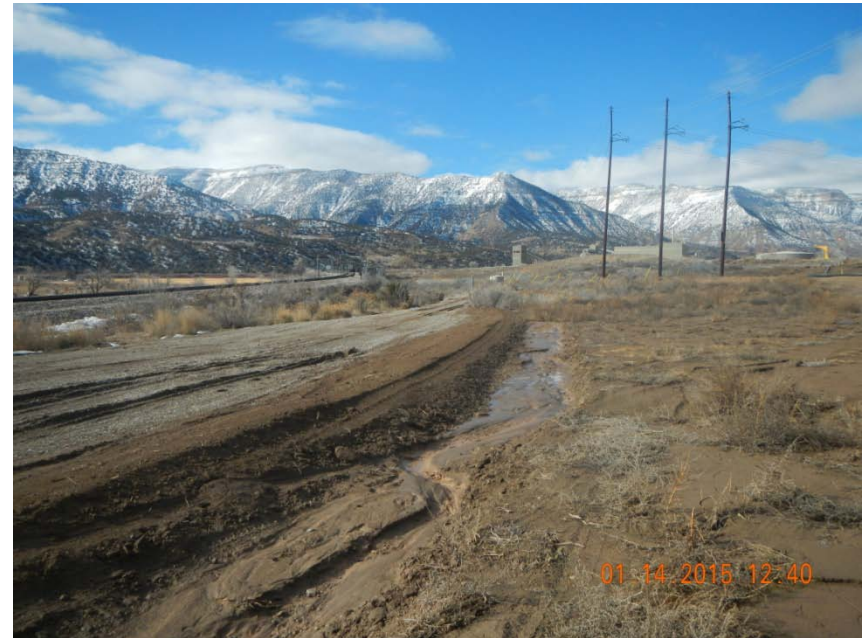
Ditch collecting sediment

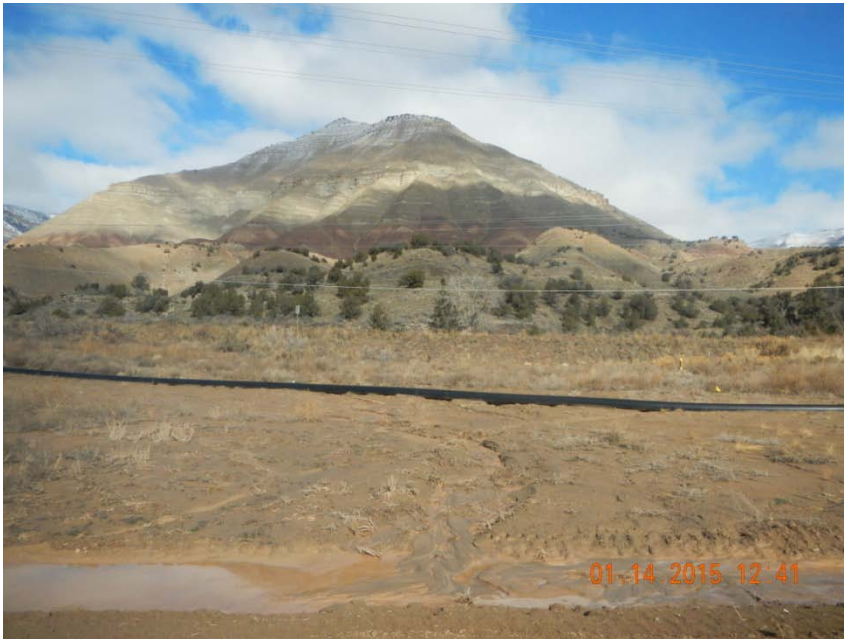
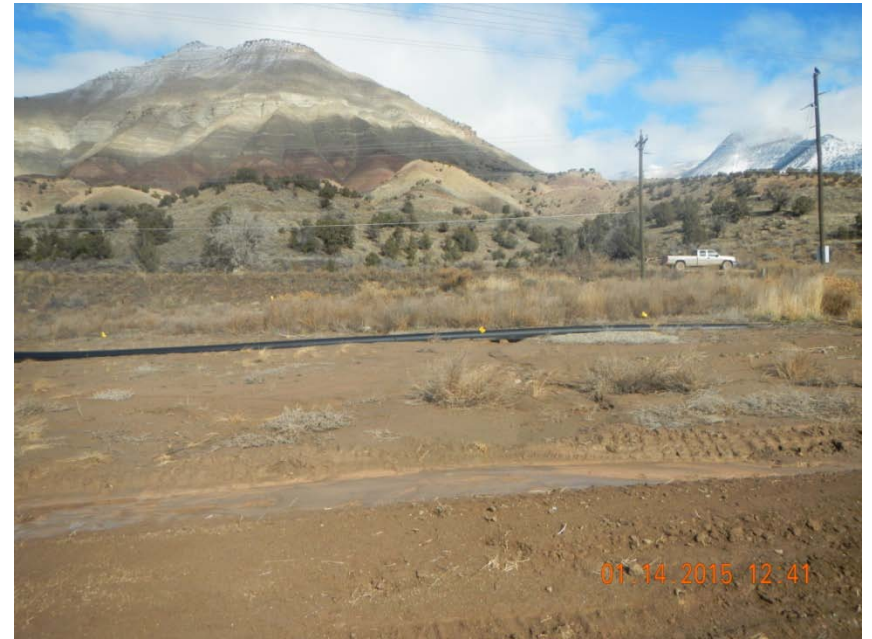
Washing sediment from cleared area along waterline
