**SENSITIVE AREA DETERMINATION
RICE LEASE - SITE SPECIFIC
SUBSURFACE INVESTIGATION REPORT
REMEDATION #8461**

**CM PRODUCTION, LLC
CLIFF UNIT— RICE LEASE PRODUCED WATER PITS
SECTION 33, T12N, R54W, 6TH P.M.
LOGAN COUNTY, COLORADO**

JANUARY 2015

OLSSON PROJECT No. 014-0704

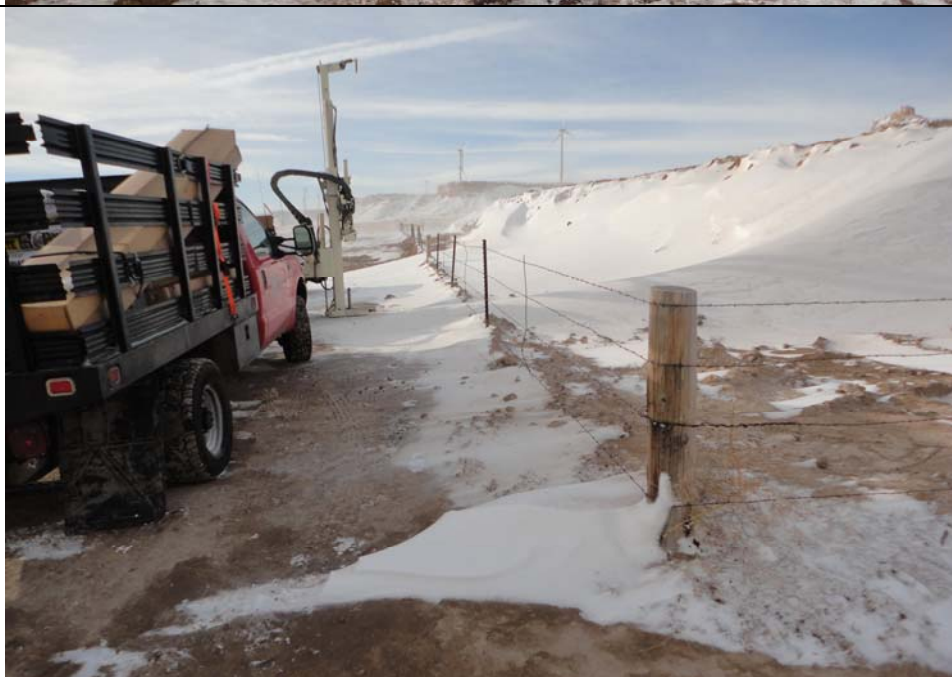
Moist sediment was encountered at 5 feet and became wet at 7 feet. The upper foot was wet in the interval from 10 feet to 14 feet; however, the remainder of the boring was dry, as based on observed in the Geoprobe® soil sample intervals and the auger cuttings. This moisture and water appeared to be related to seepage from the pit and not groundwater.

Subject: Photograph shows the location of the test hole for monitoring well, MW-1, located on the southeast corner of the south produced water pit. The berm for the south pit is shown on the right.

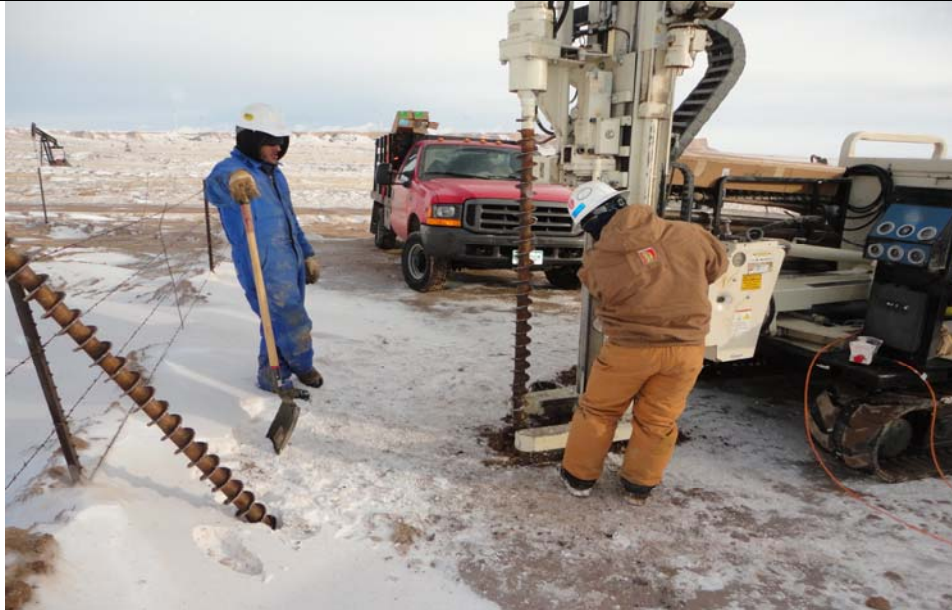
Subject: Site Services used 3-inch diameter solid stem augers to advance the test holes for the monitoring wells once probe refusal occurred. Photograph shows the test hole drilling for monitoring well MW-1 on the southeast side of the south produced water pit.

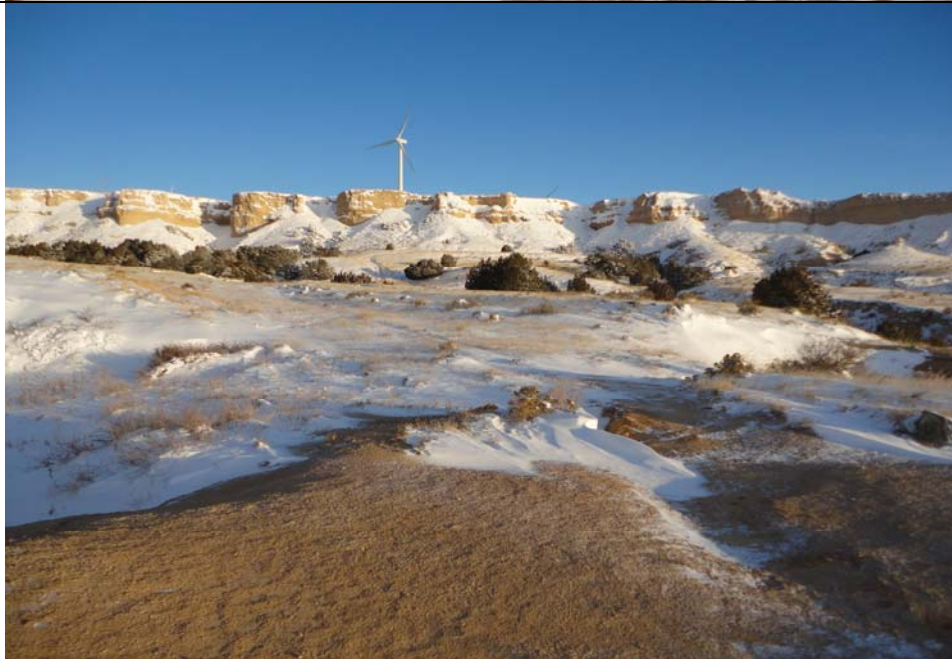
Subject: Photograph shows the location of monitoring well MW-2 and the Chalk Bluffs of the Chimney Canyons.

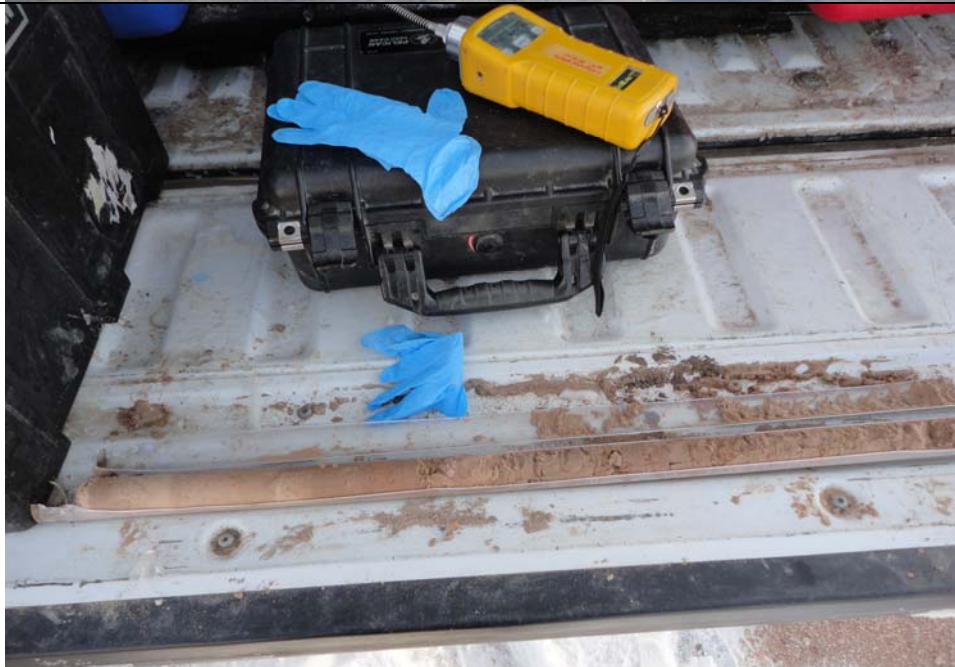
Siltstone and claystone subcrop was noted at the surface near the MW-2 test hole location. The sediments observed in the first sample sleeve from 0 to 3 feet, consisted of silty clay that hyperaccumulated in the sleeve and the polyacetate sleeve was twisted at the bottom. Subangular blocky parting was noted in the bottom part of the 0 to 3 feet sample interval.

Subject: Photograph shows the silty clay lithologies encountered in the test hole that was completed as monitoring well, MW-2. Refusal was encountered at 3 feet bsg, and then again at 12 feet bsg, after augering down using the 3-inch diameter auger. Subcrop consisting of siltstone was observed at the surface.

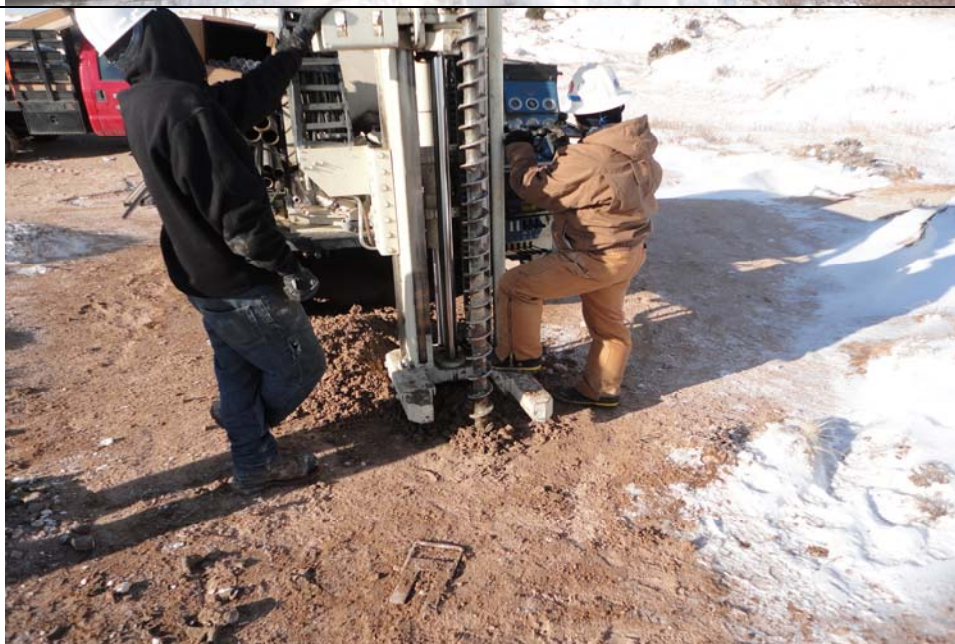
Subject: Site Services used 3-inch diameter augers to advance the test hole for MW-2 to 40 feet bsg.

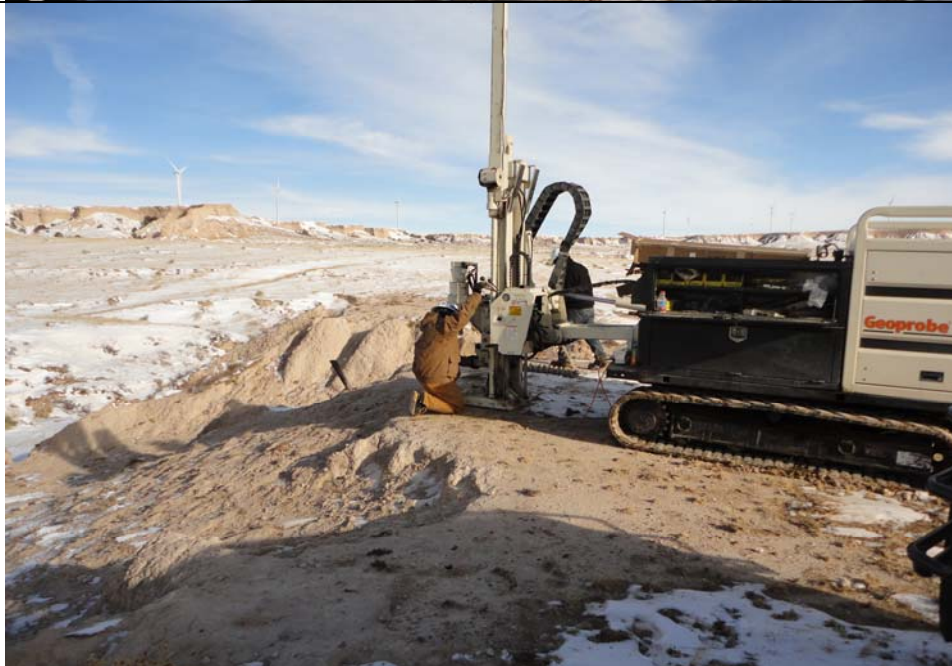
Subject: Photograph shows the location of the test hole for down gradient monitoring well, MW-3, on the north side of the Rice #2 well pad.

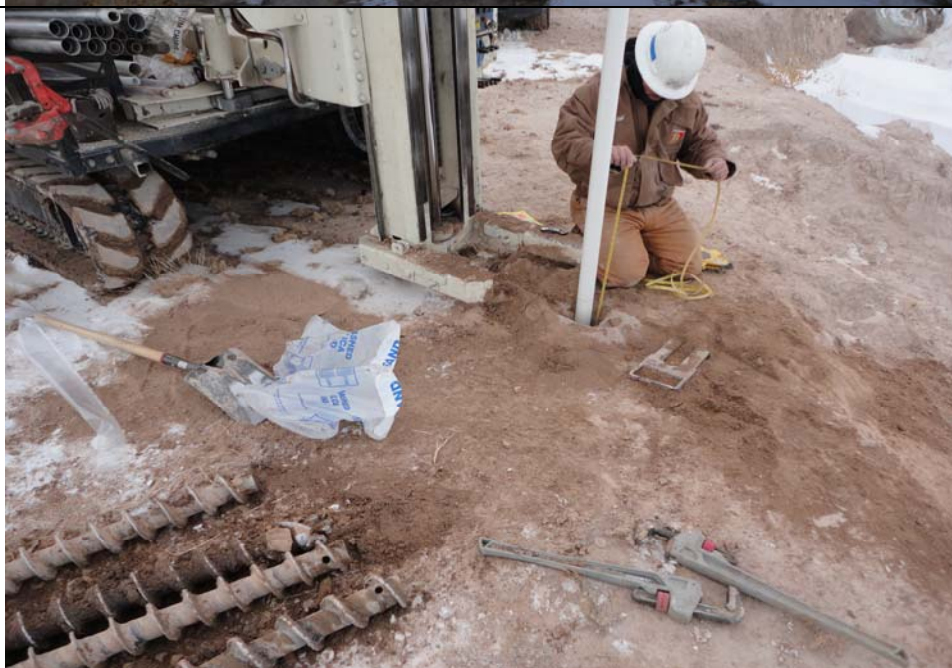
Subject: Site Services setting monitoring well MW-3 after augering down to 43 feet. The test hole collapsed back to 40 feet, which was where the well was set. A sand pack of 10-20 silica sand was placed around the screened interval in the well.

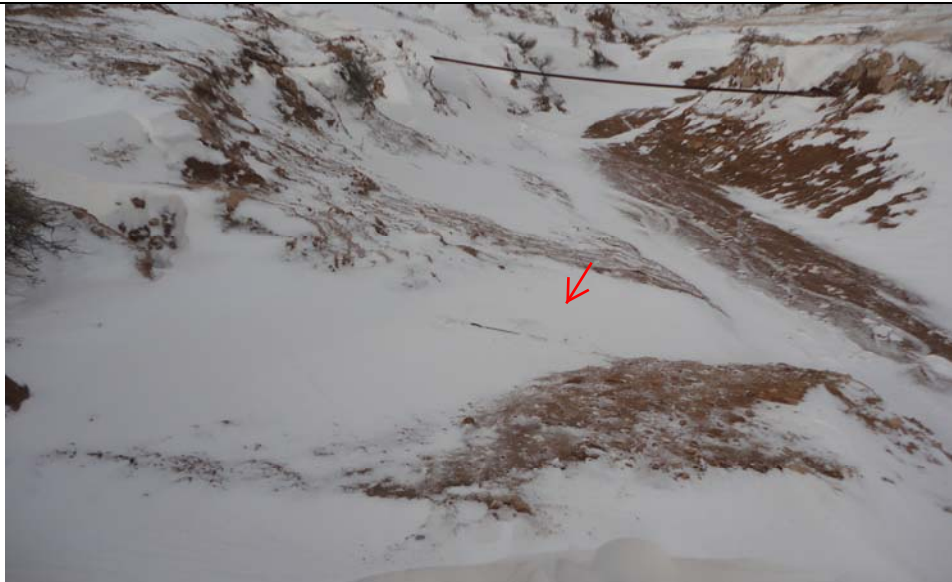
Olsson gauged piezometer, PZ-1, on January 2, previously on December 15, 2014 and July 2014 and during all occasions the piezometer was dry.

Subject: Photograph shows the location of piezometer, PZ-1, and the main drainage down from the southeast pit.

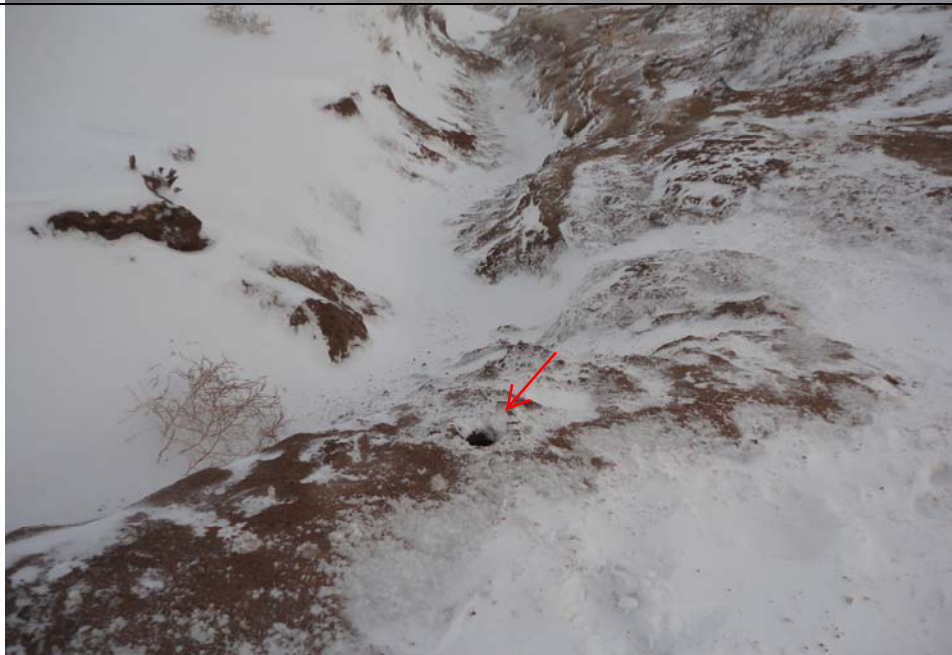
The lithologies encountered in hand auger boring HA-2 consisted of silts, clays, and weathered siltstone similar to that exposed in the sides of the drainage. Hand auger refusal was encountered at a depth of approximately 4.5 feet bsg, which was at the elevation of the bottom of the lateral channel. Water was encountered at the bottom of the boring, but there was not sufficient water volume to enable a sample to be collected. Several attempts to obtain a grab water sample were attempted using a ¾-inch diameter disposable bailer, but there was not any water in the bailer. Moisture or water in the bottom of the boring may be related to snow melt seeping through the lateral drainage.

Subject: Photograph shows the location of hand auger boring, HA-2, (lower center) at the head of the east-west lateral drainage. Auger refusal was encountered at approximately 4.5 feet. The first hand auger boring, HA-1, was attempted on the lower bench near the center of the photograph, but encountered refusal at approximately 1 foot bsg.

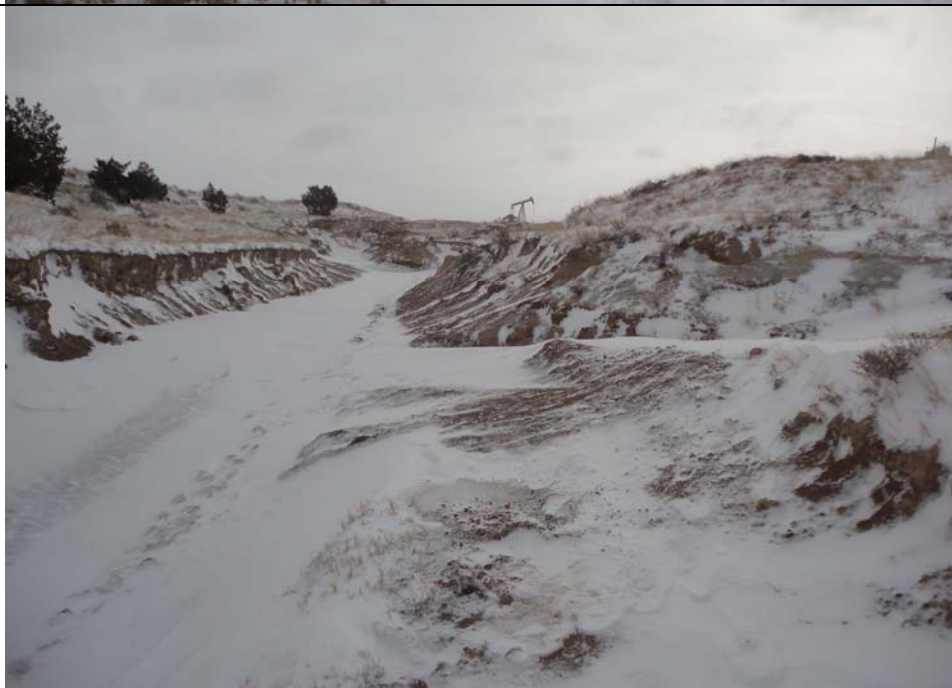
A hand auger boring (HA-3) was also advanced to the north of the site at a point approximately four feet above the elevation of the main north to south channel. Hand auger refusal was encountered at a depth of approximately three feet bsg. Lithologies consisted of silt and clay. Soils were dry in the hand auger boring to refusal depth.

Subject: Photograph shows the location of the up gradient hand auger boring, HA-3, (bottom center) on the west side of the main channel north of the east-west lateral drainages and the north pit.

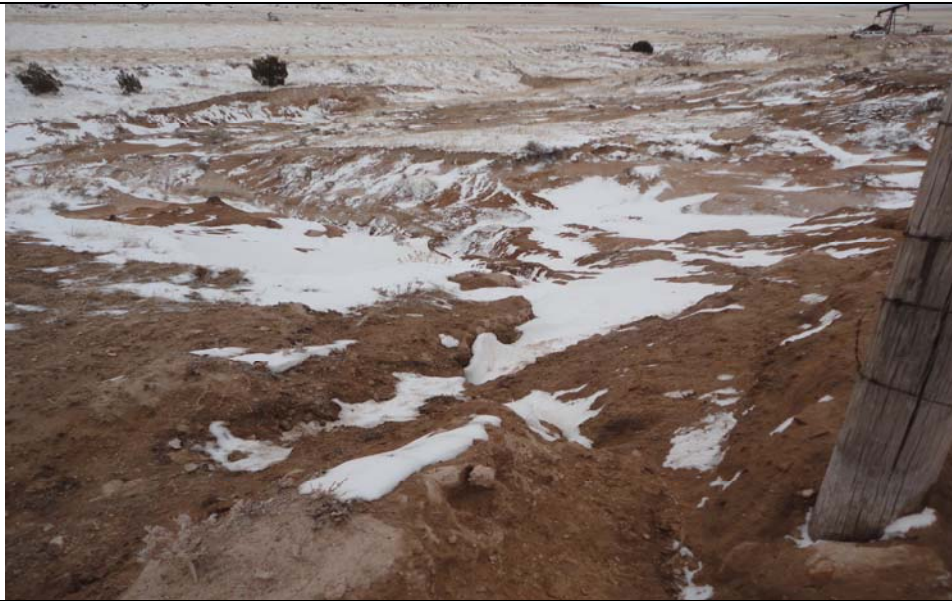
Subject: Photograph shows the east-west lateral channel down from the northeast corner of the north pit. The location of the hand auger boring, HA-2, was located near the center of the photograph where the smaller drainages come together to form the channel for the lateral drainage.

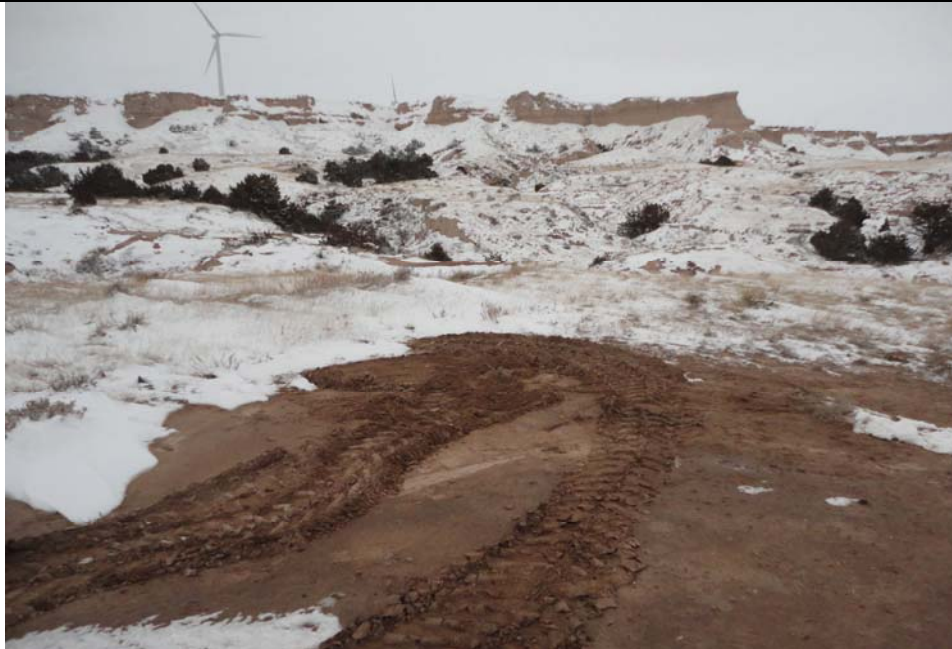
A Geoprobe® soil boring, SB-1, placed on the north side of the lateral drainage and to the north of the north pit, encountered refusal at 9 feet. Lithologies of the boring were dry to bottom and the bottom interval consisted of hard silty clay.

Subject: Photograph shows the location of the Geoprobe® boring SB-1 to the north – northeast of the north pit.

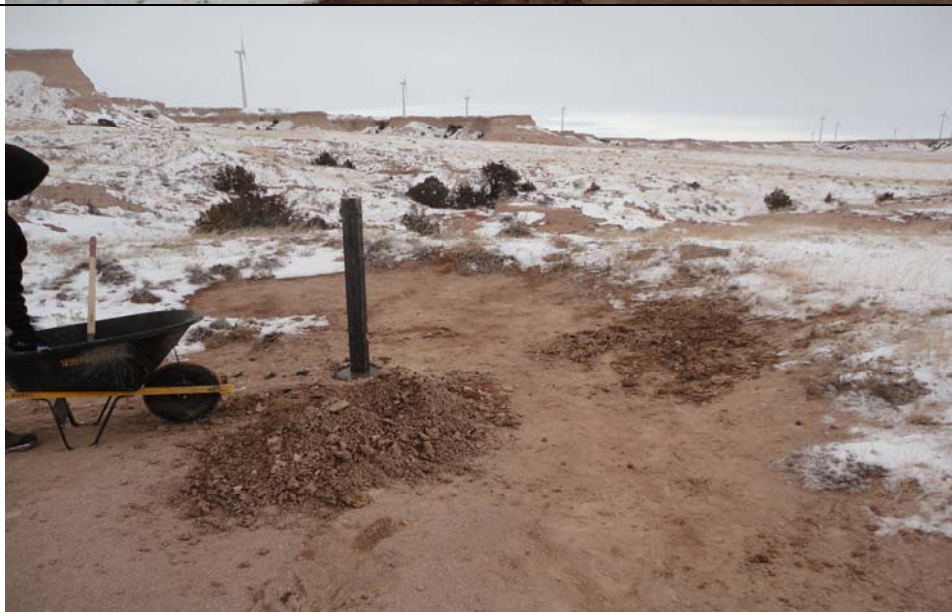
Subject: Photograph shows the steel riser completion for monitoring well, MW-2.
