## E 7 OU Pad

Inspection# 675201065

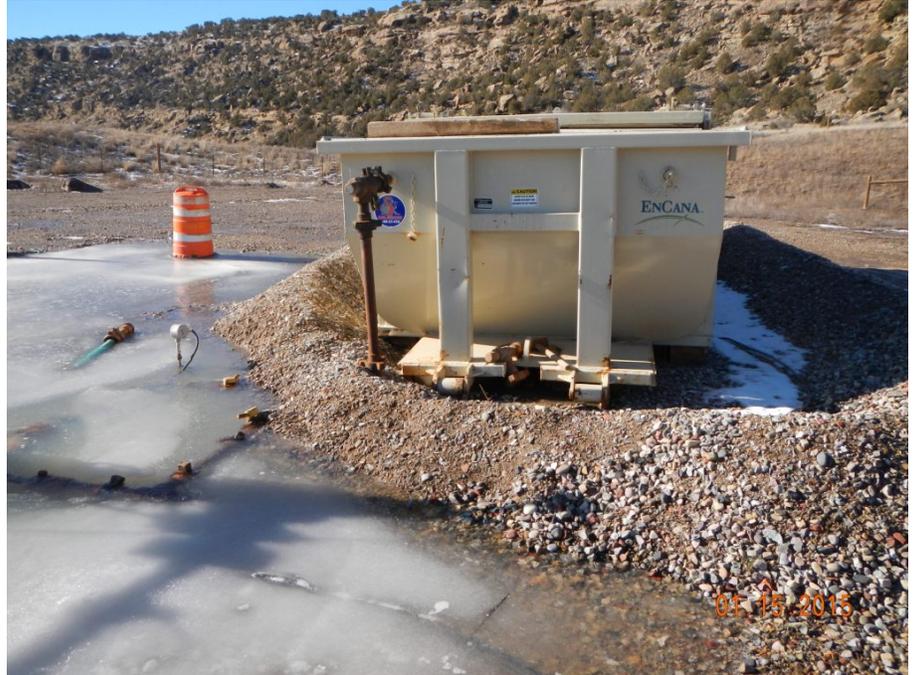
Berm in need of repair.

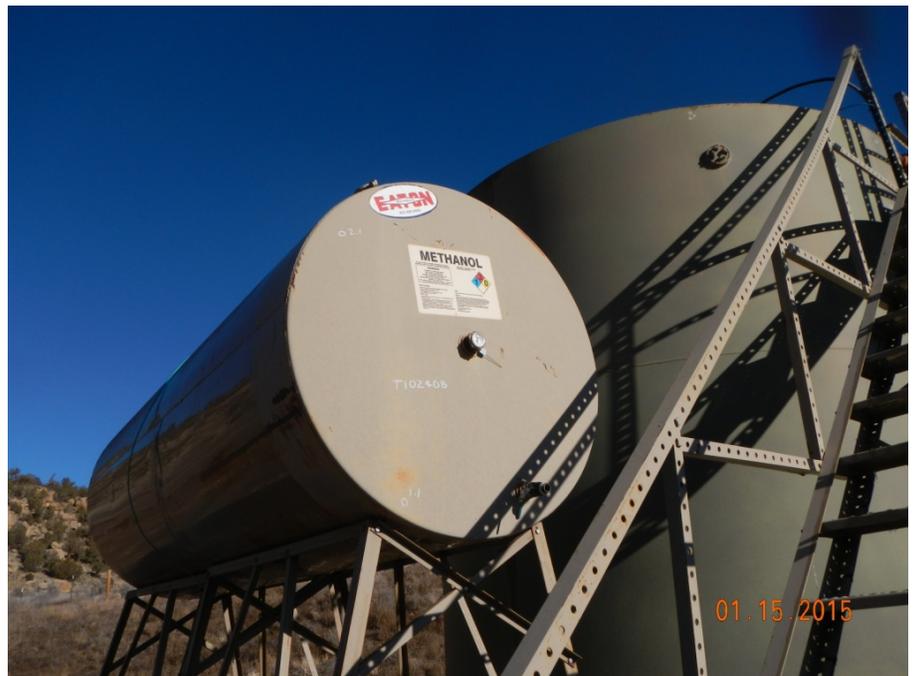
Methanol tank missing capacity.

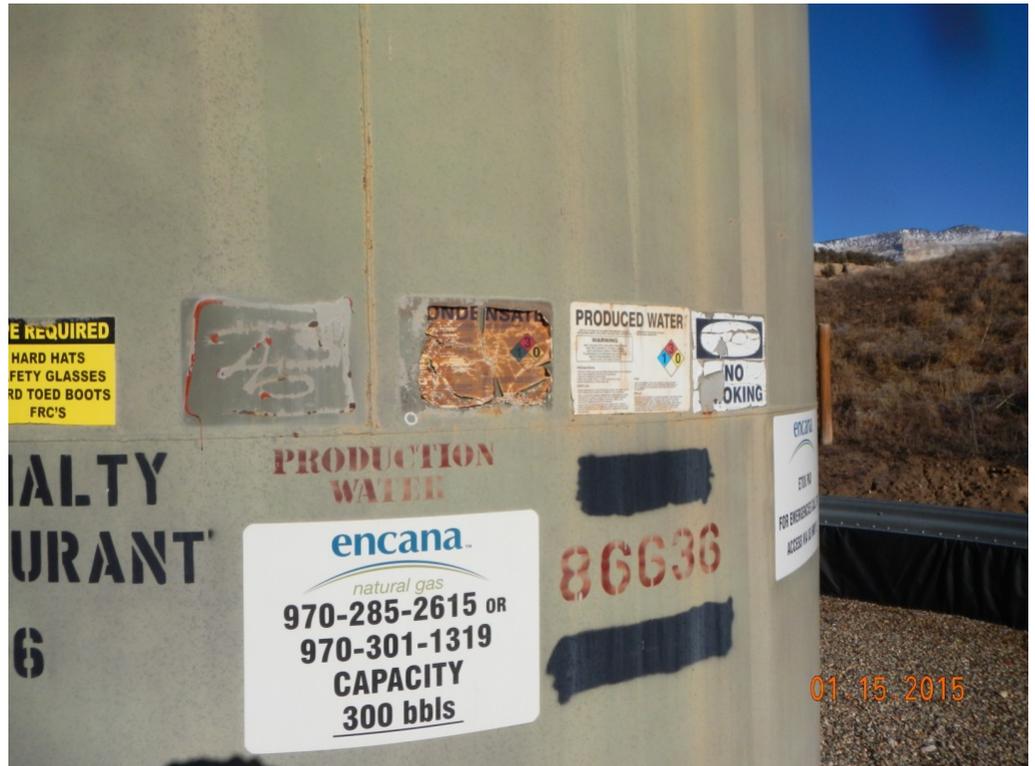
Peeling labels on condensate tank.

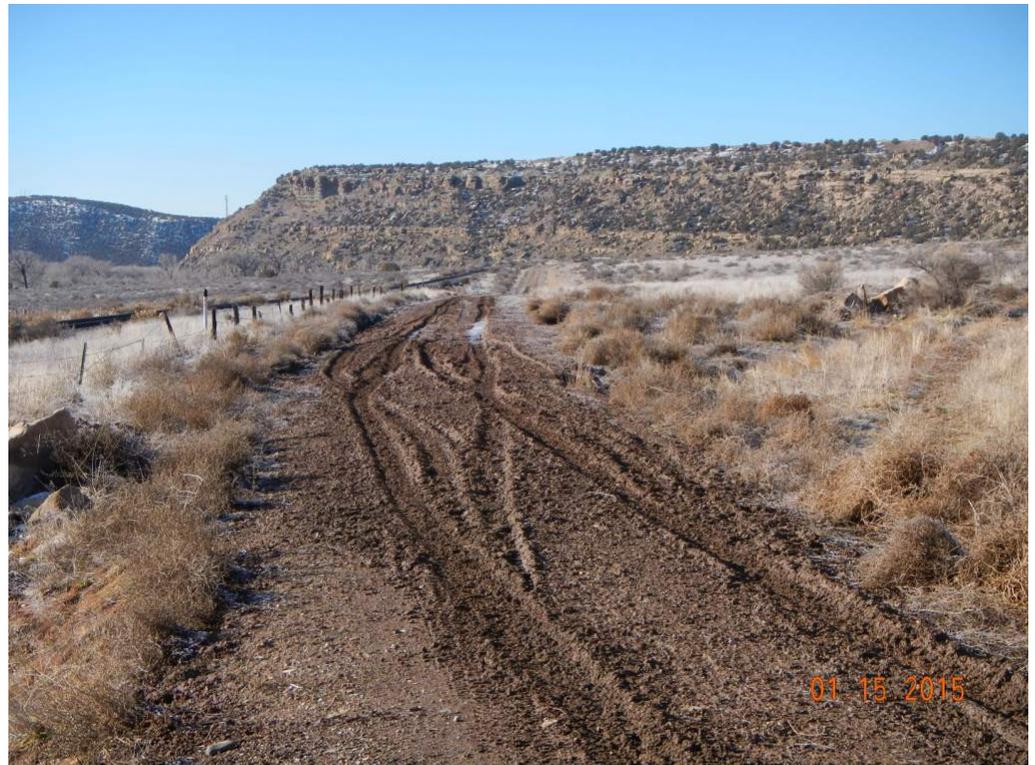
Rutting on road.
