WPX Energy

GV 21-35 Pad

Location # 334743

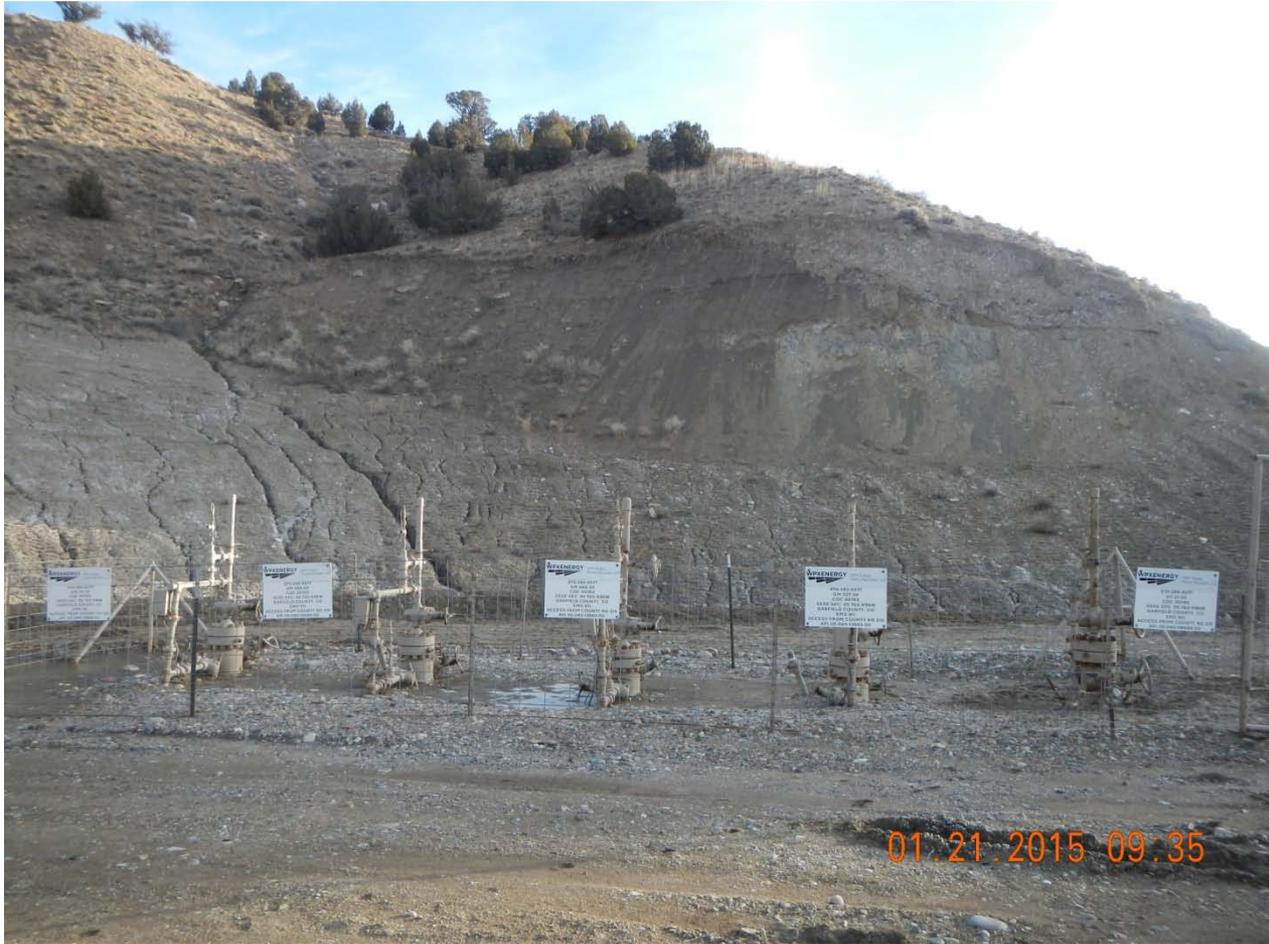
Erosion rills and failed seeding of cut slope

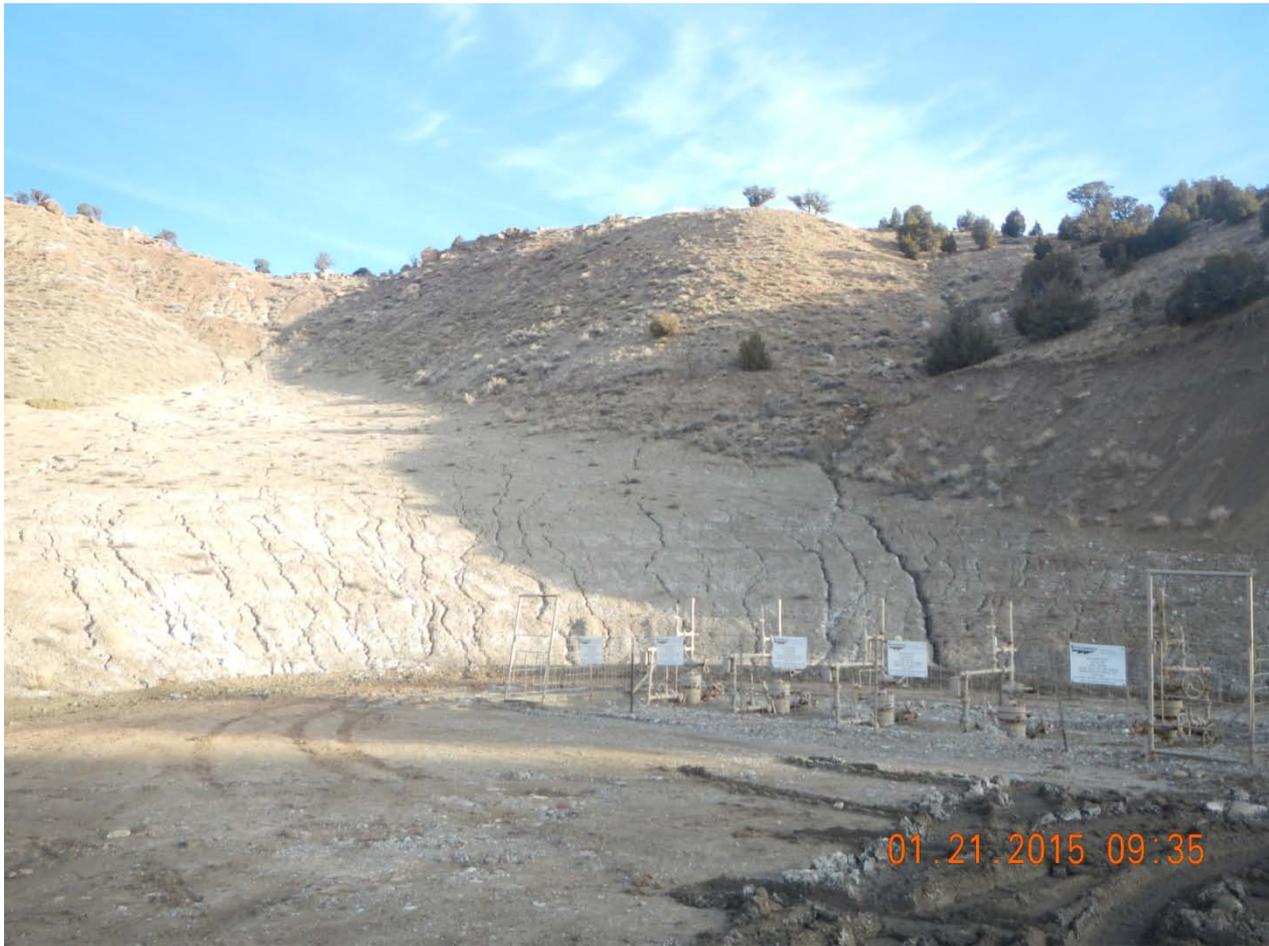
Erosion rills and failed seeding of cut slope

Erosion rills

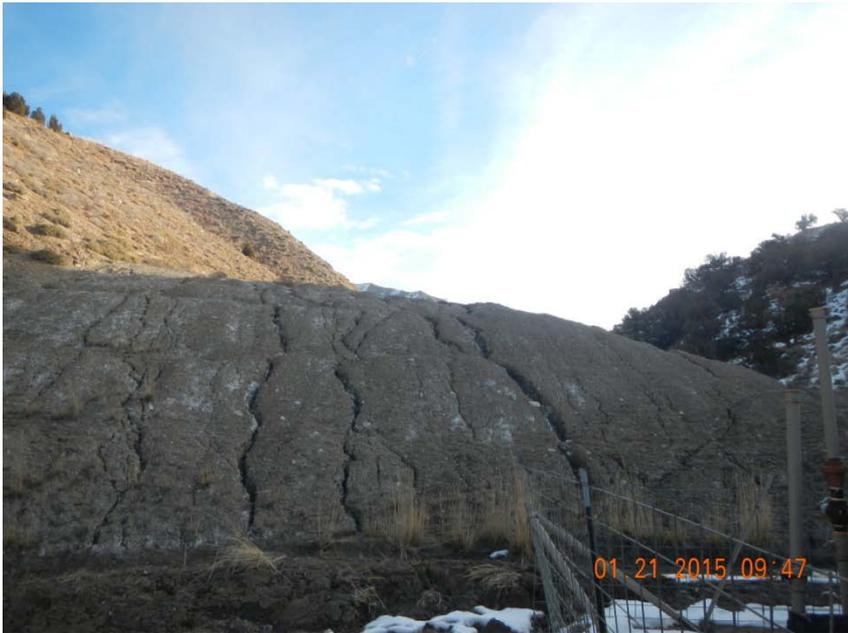
Erosion rills behind separators

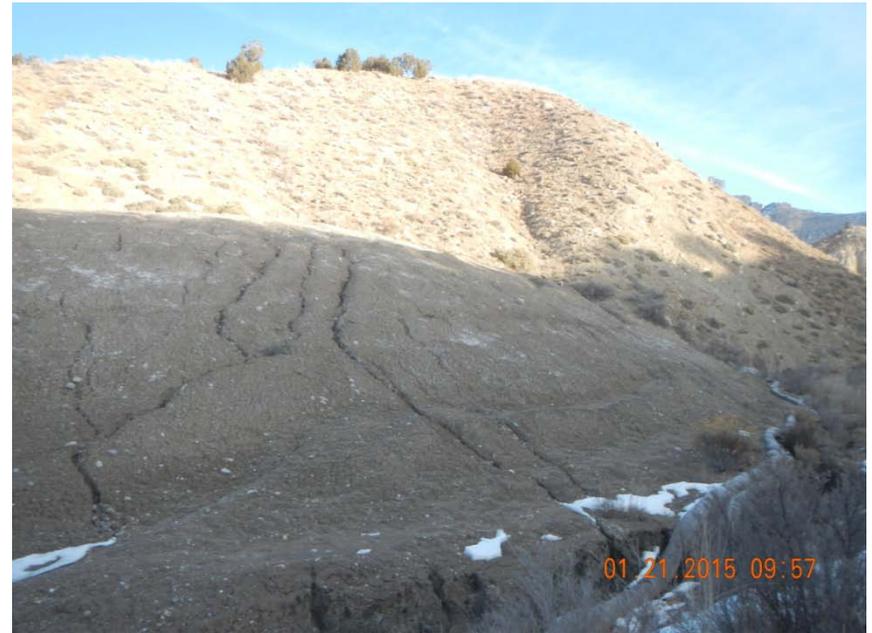
Erosion rills other side of hill behind separators

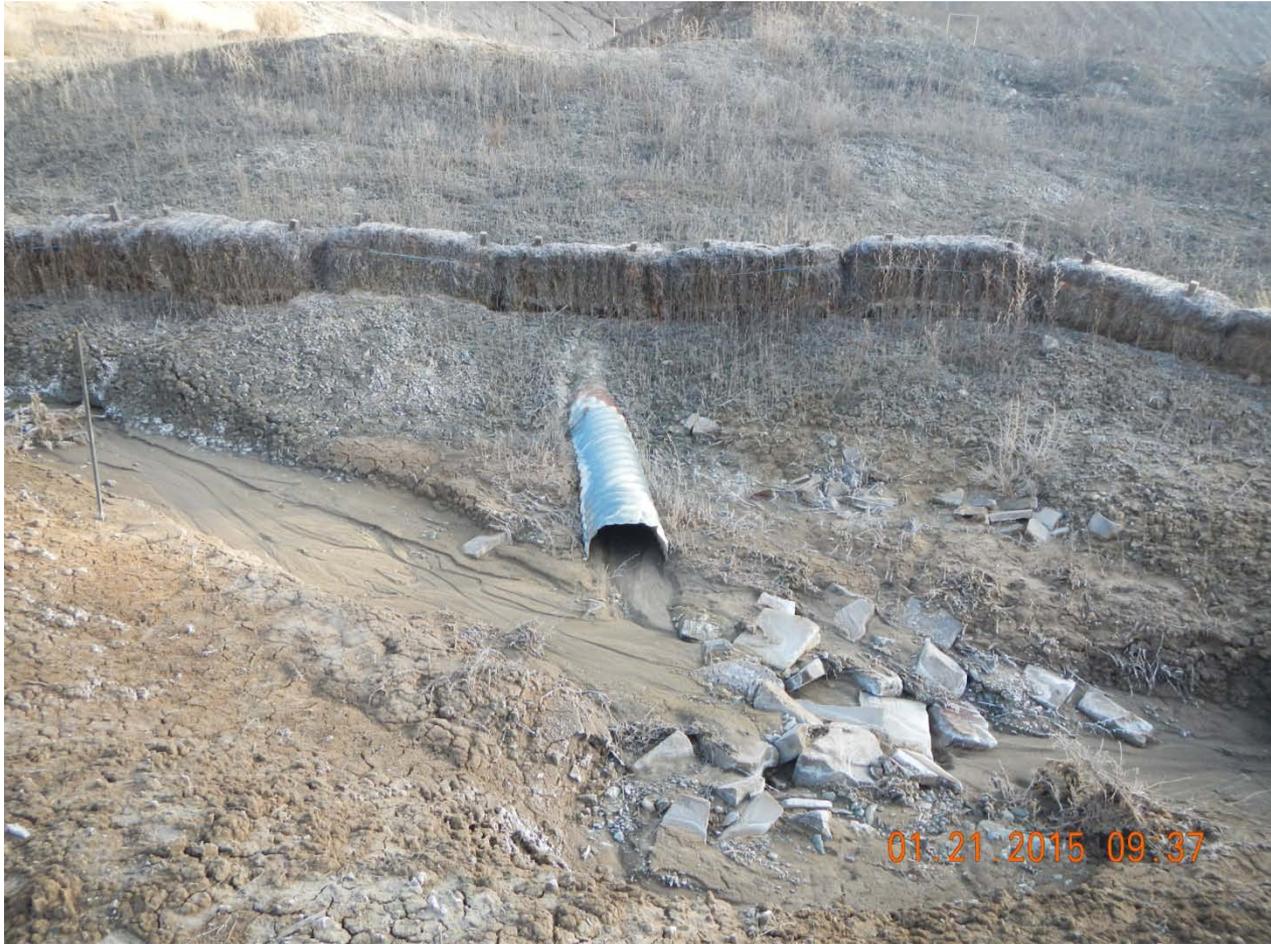
Sediment build up in the out let of culvert.

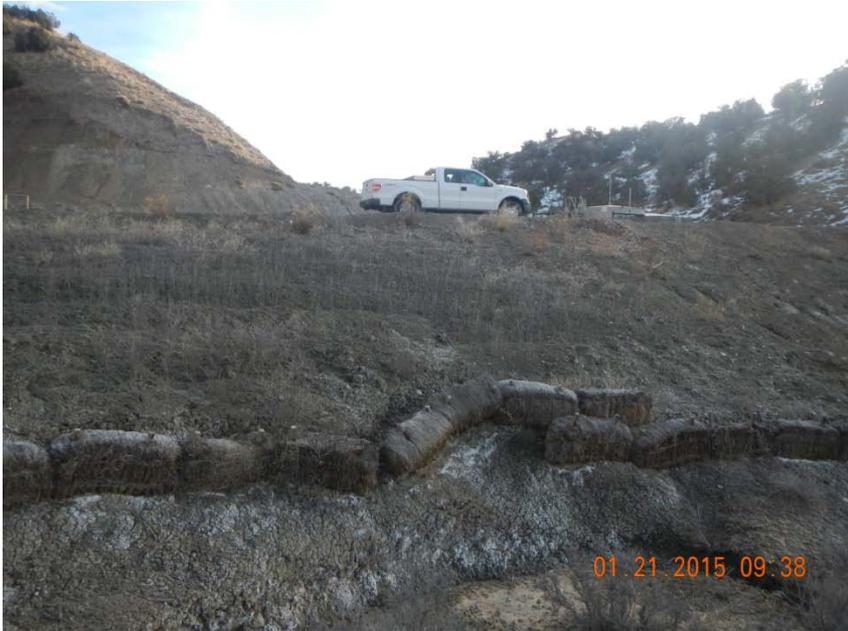
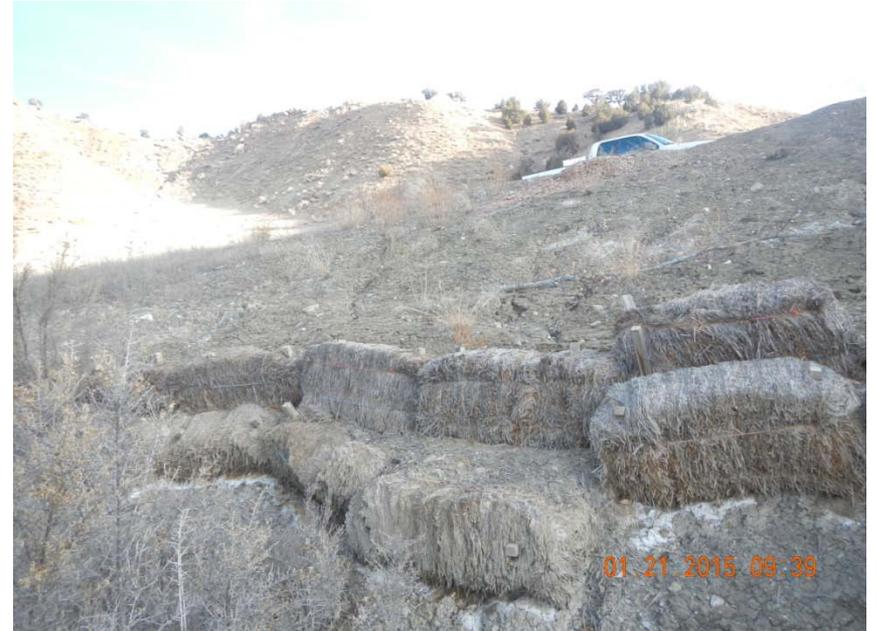
Unmaintained bales and failed seeding

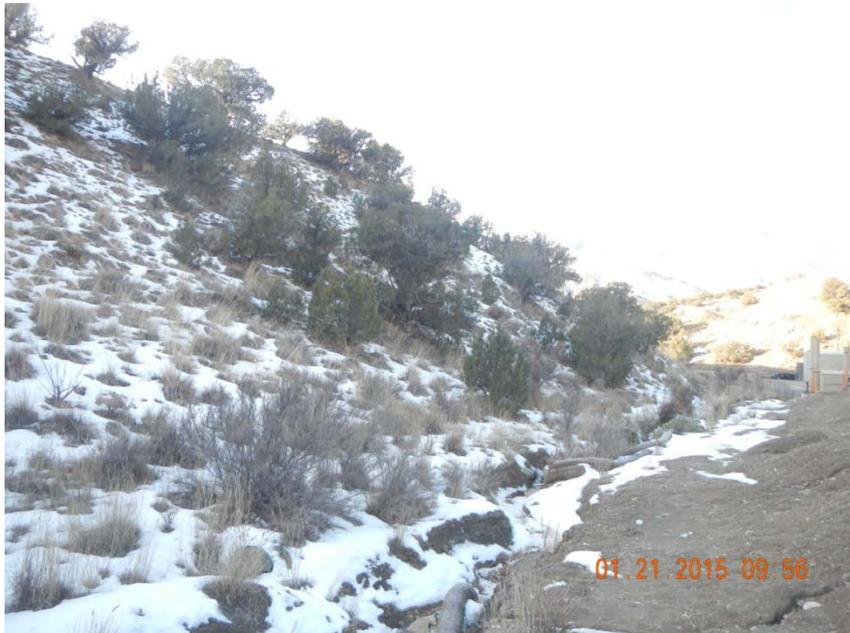
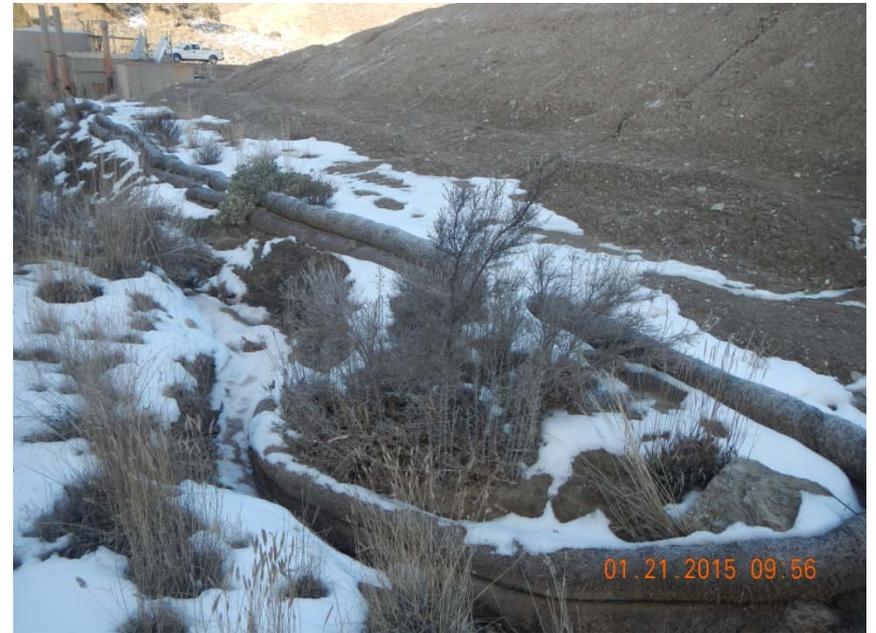
Unmaintained waddles washed out of place and into ditch
