WPX Energy

PA 11-35 Frac Pad

Location # 335391

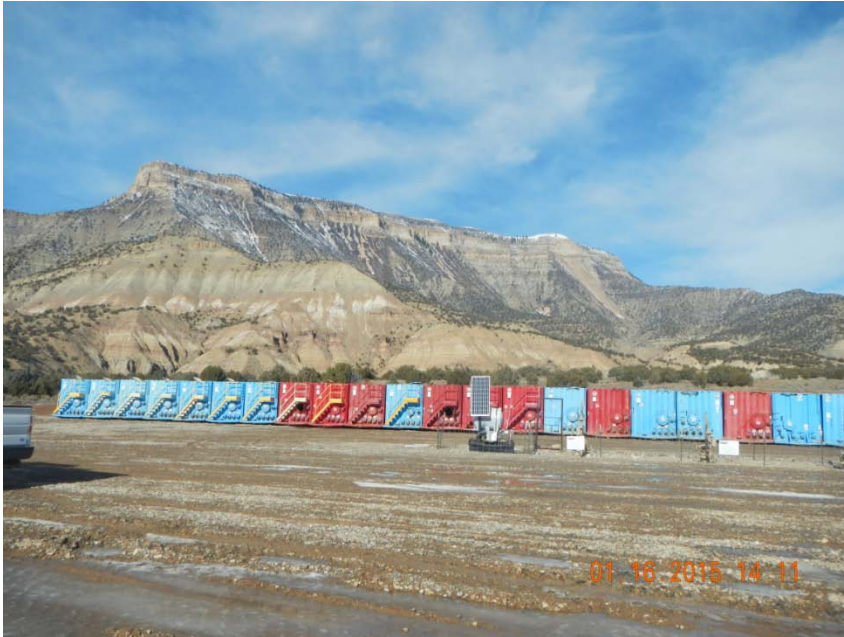
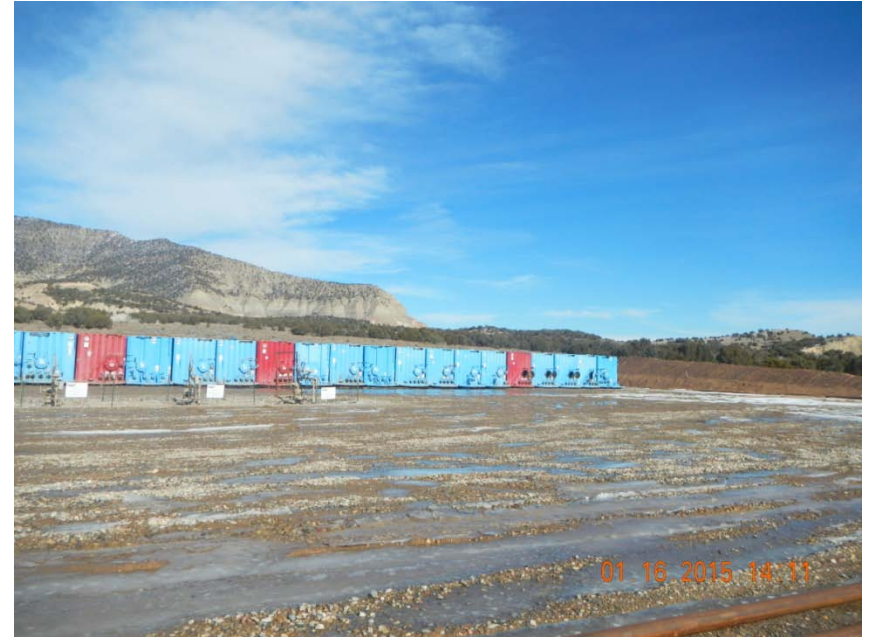
No berm around tanks.

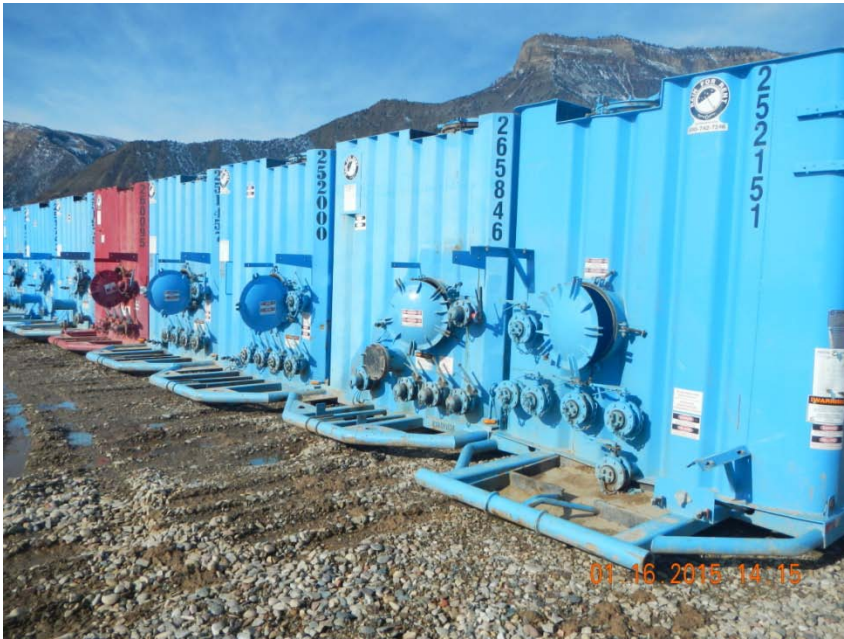
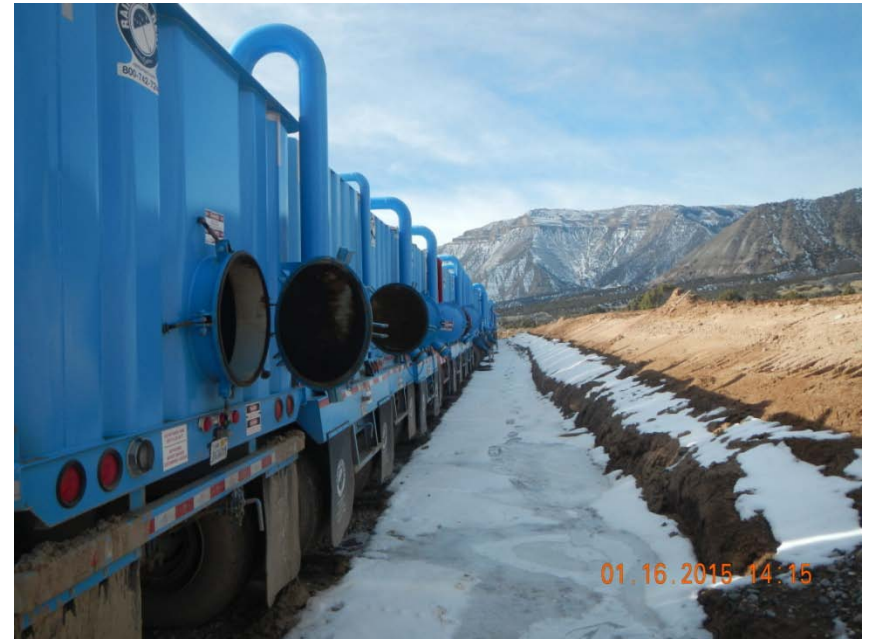
Tank hatches open on front, back and top of tanks

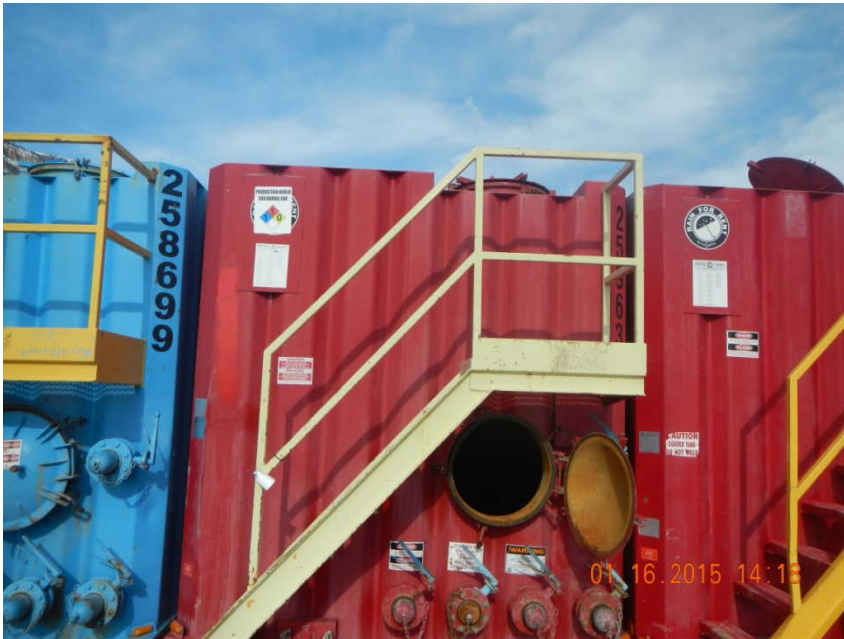
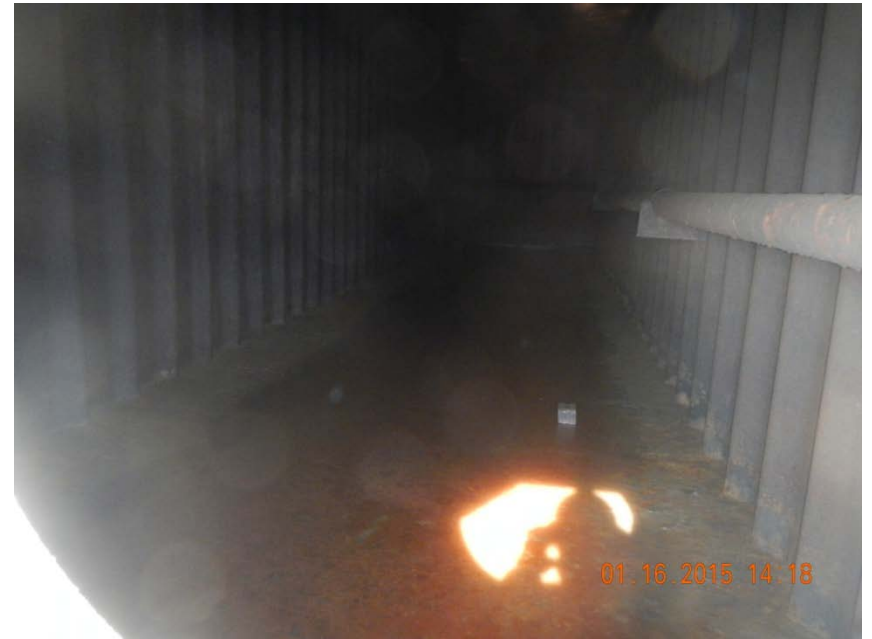
Produced water tank with hatch open

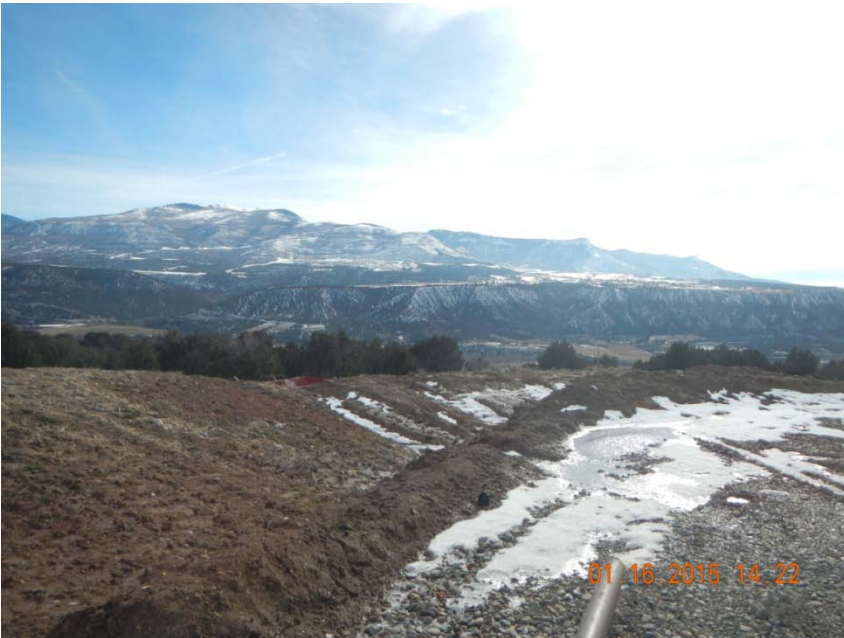
Perimeter Berm

Traffic damaged berm

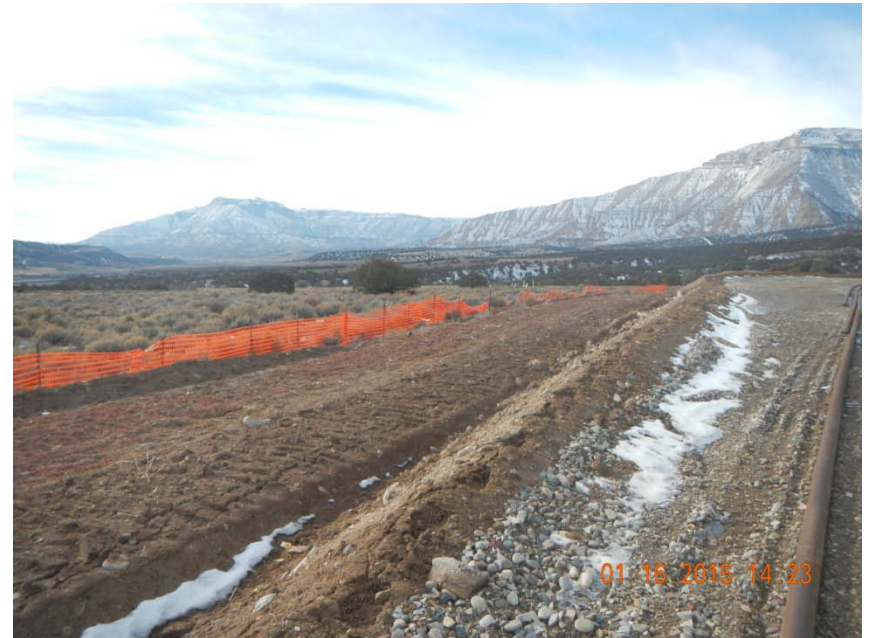
Loose compaction of berm

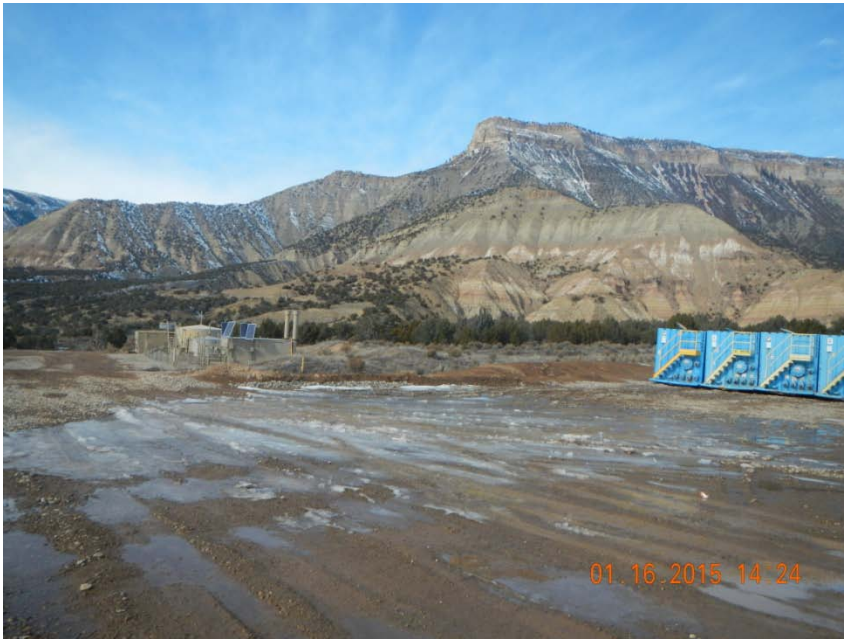
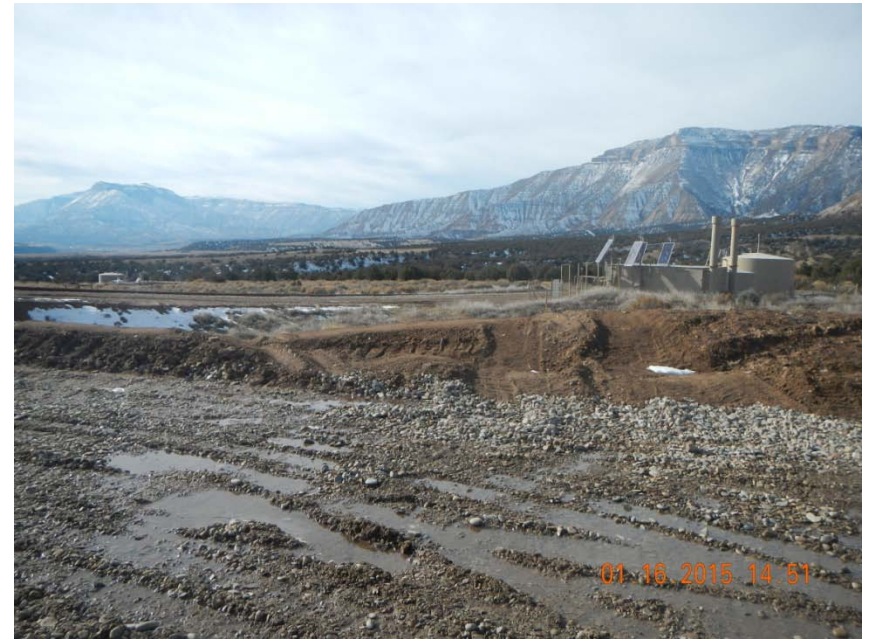
Traffic damaged berm at end of tanks

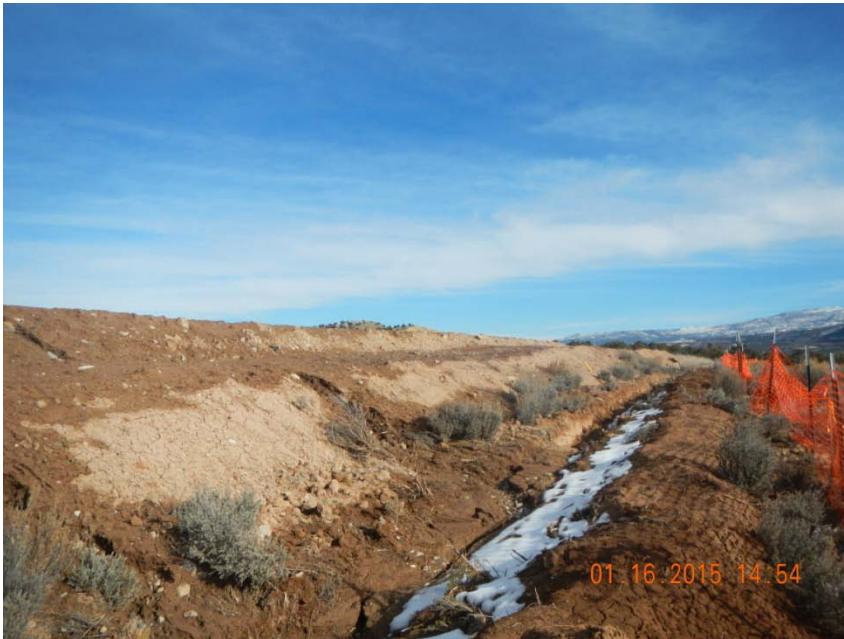
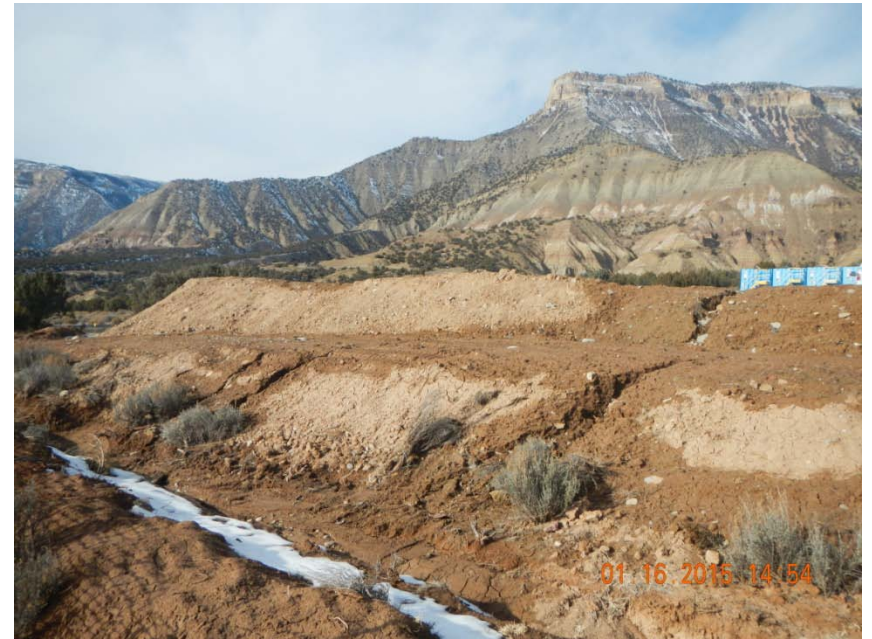
Erosion and movement of sediment off bank of location.

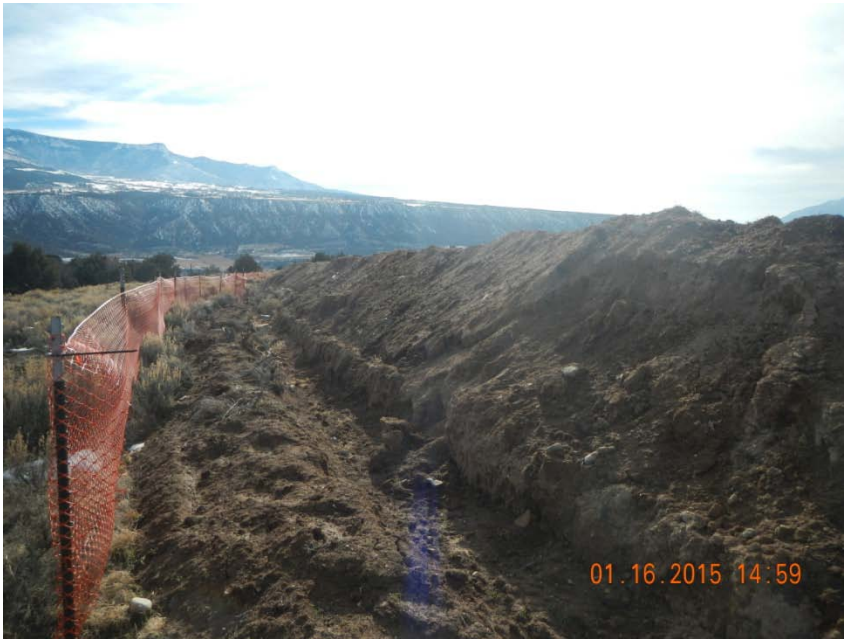
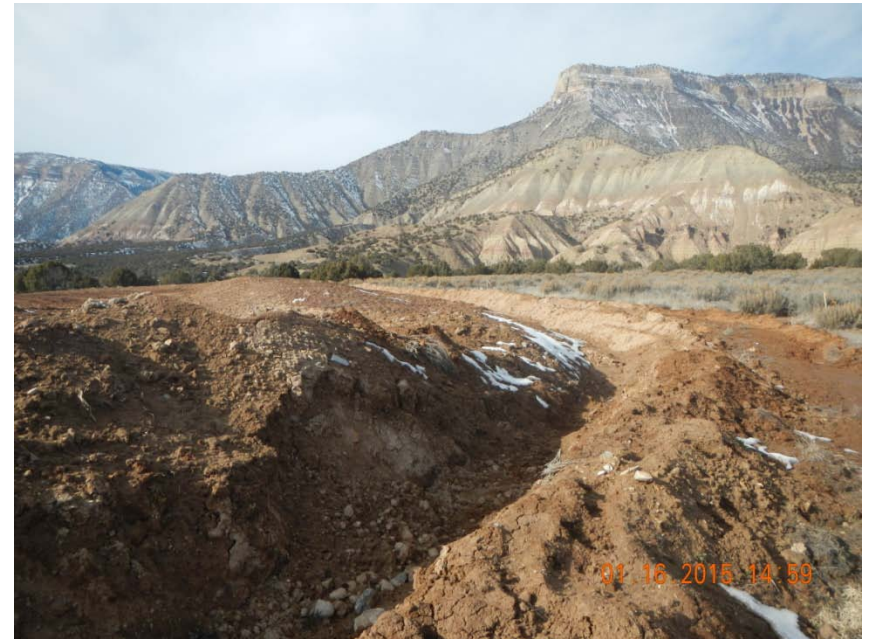
Loose compaction of ditch

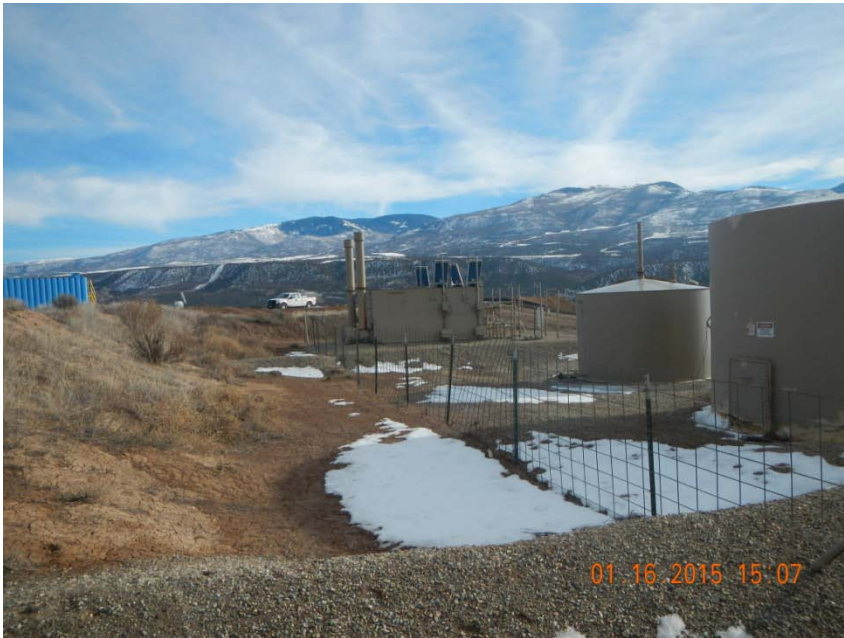
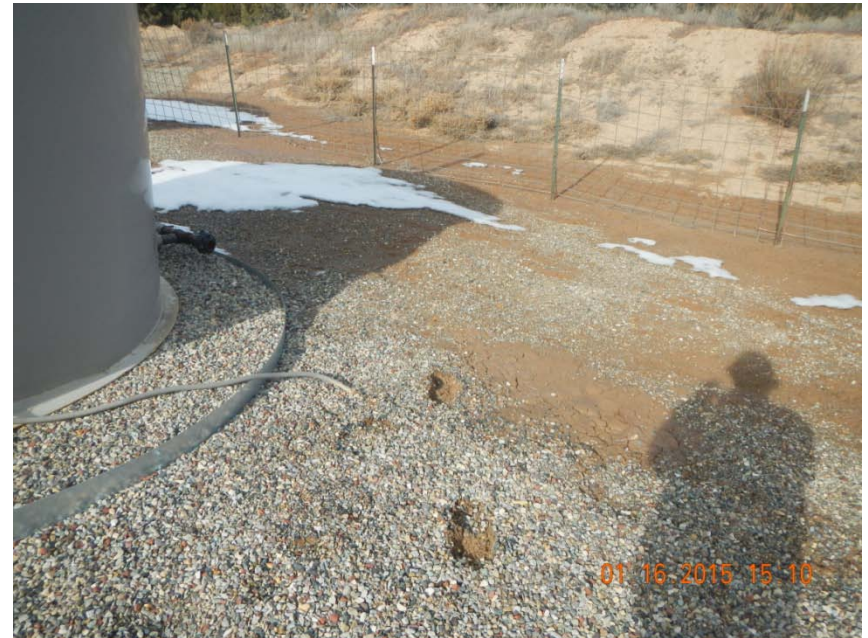
Tank berm into slope wall

Tank berm built into slope wall allowing run on storm water and sediment to collect in berm.

Poor compaction of berm base. Base is soft and spongy from storm water.
