Site Photos: API# 05-009-06014

Date: January 20, 2015

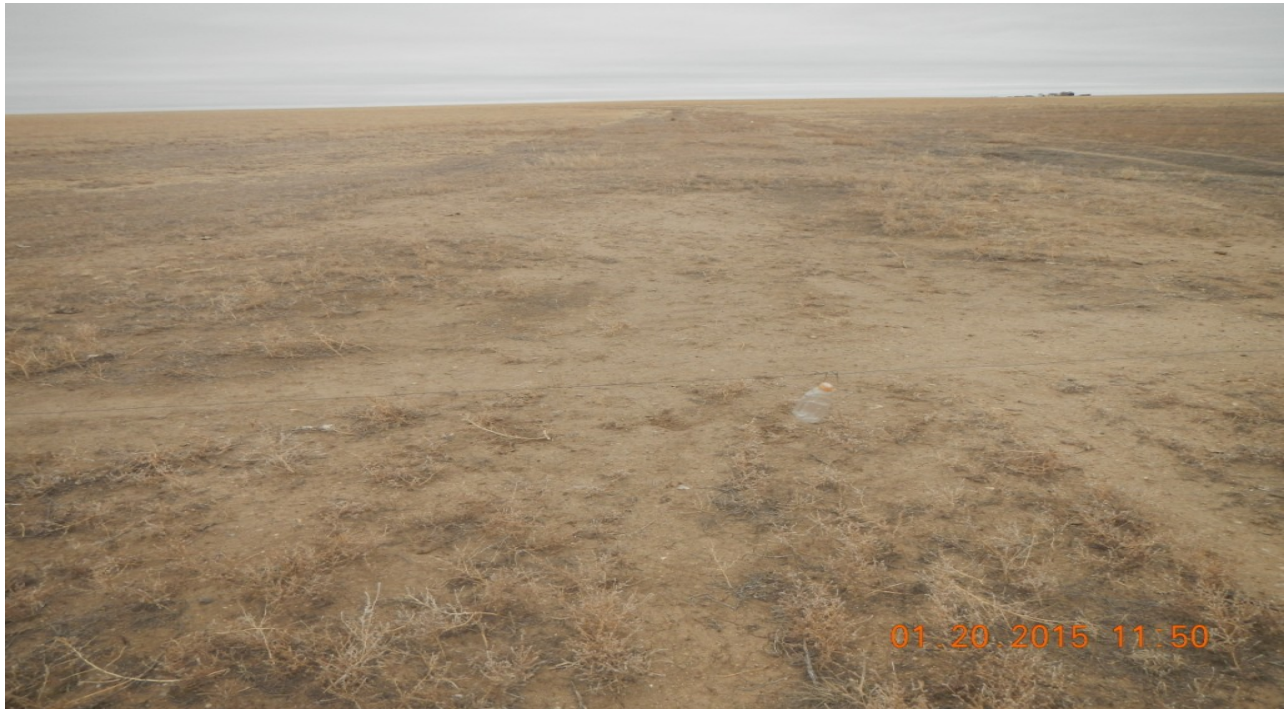
**photo 1:** Facing south towards the location along the access road.

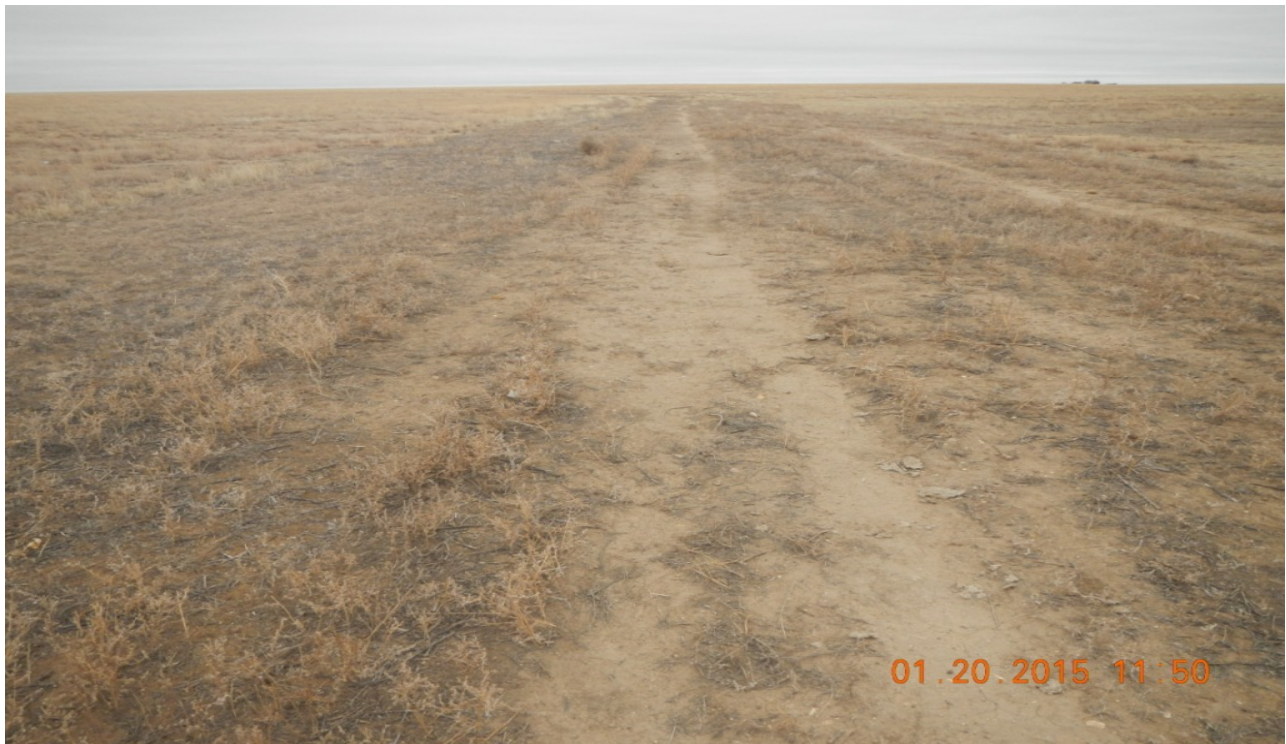
**photo 2:** Facing south towards the location along the access road. Access road does not have adequate vegetation and has weed growth (kochia).

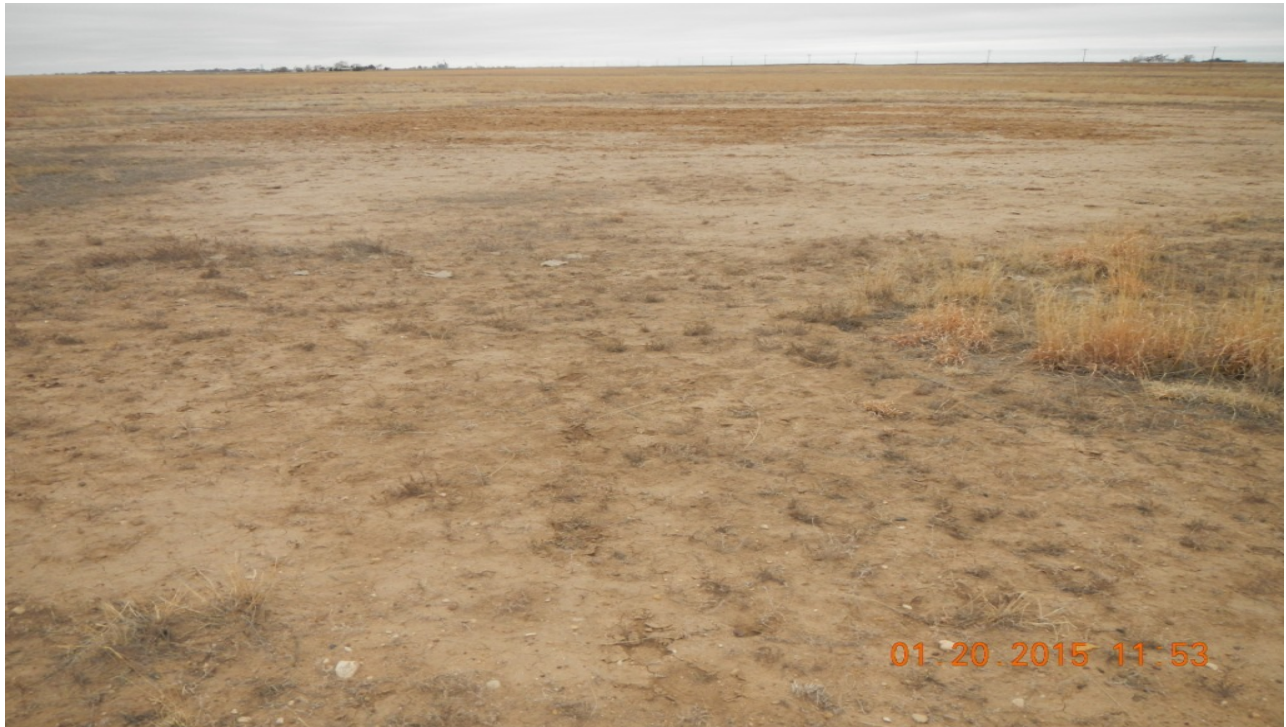
**photo 3:** East side of location facing west. Location bare of vegetation approx. 120'x120'.

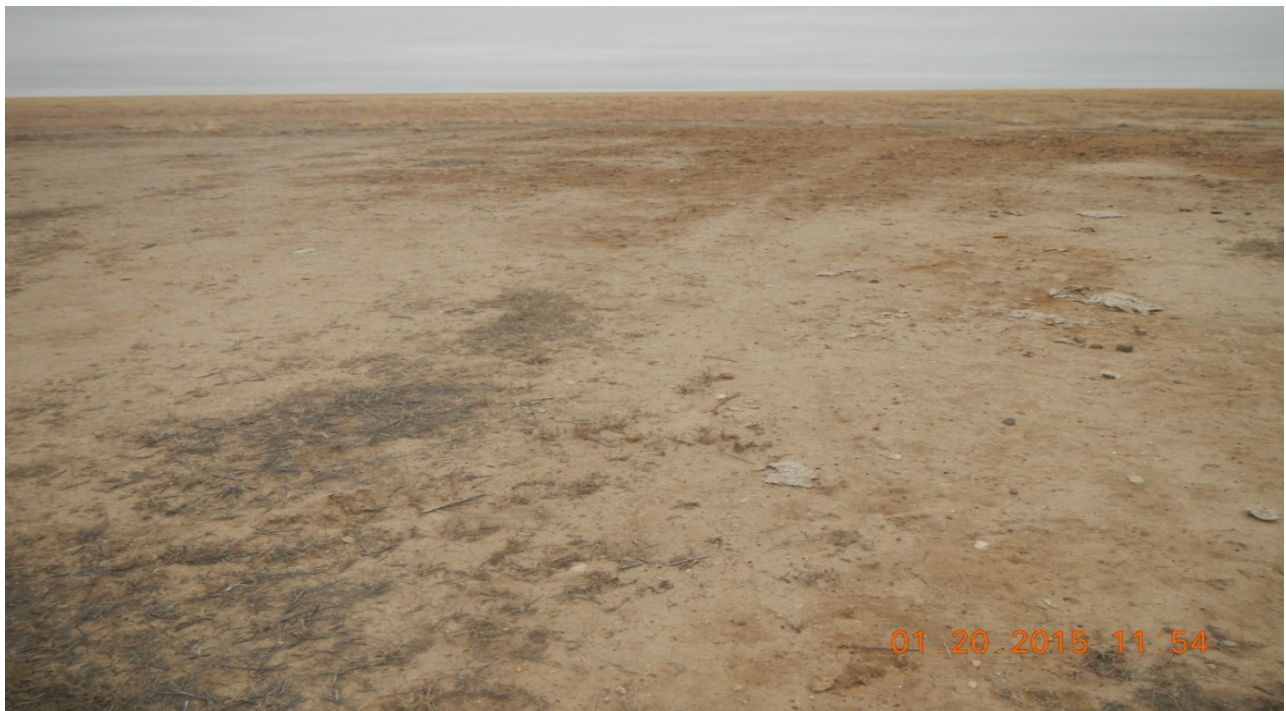
**photo 4:** West side of location facing east. Location bare of vegetation approx. 120'x120'.

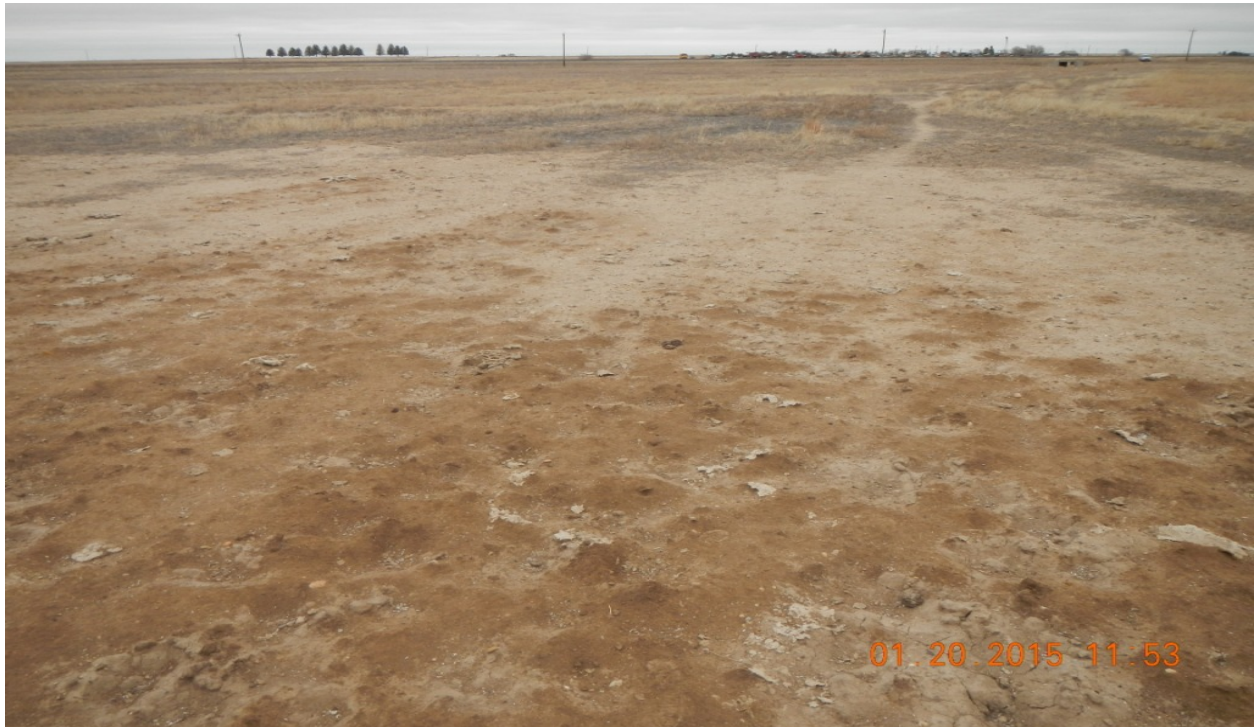
photo 5: Center of the location facing north.

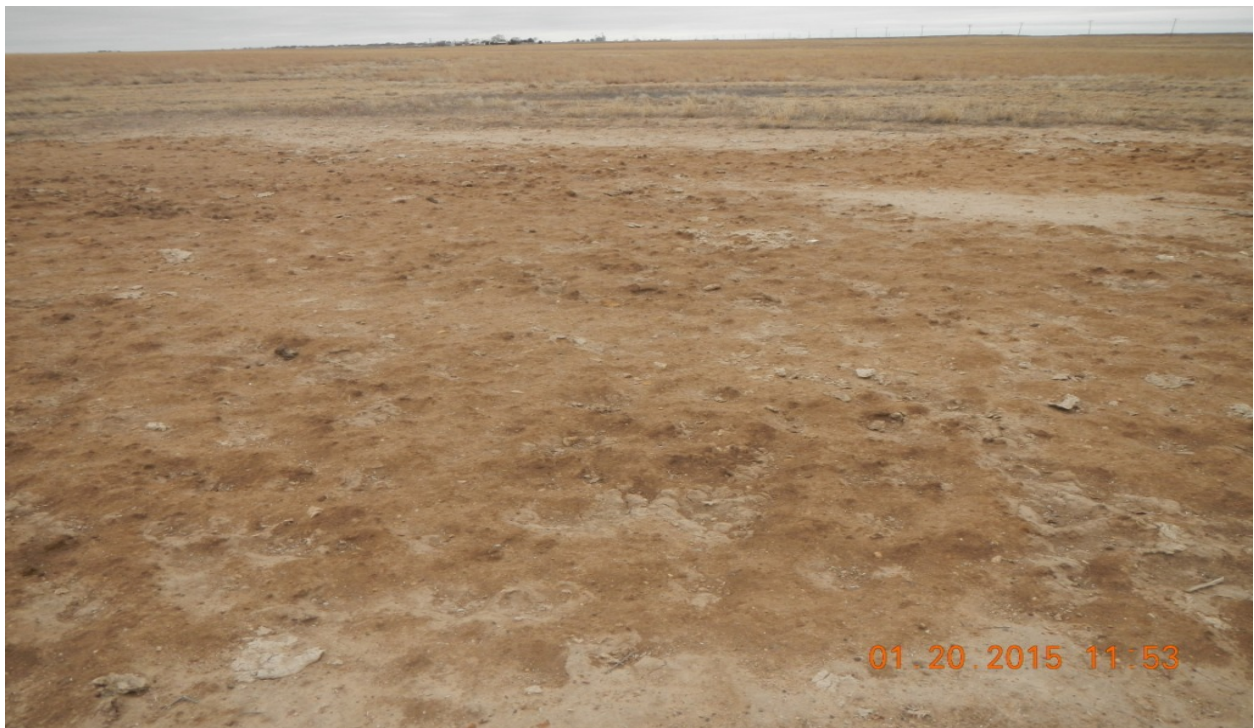
photo 6: Center of the location facing west.

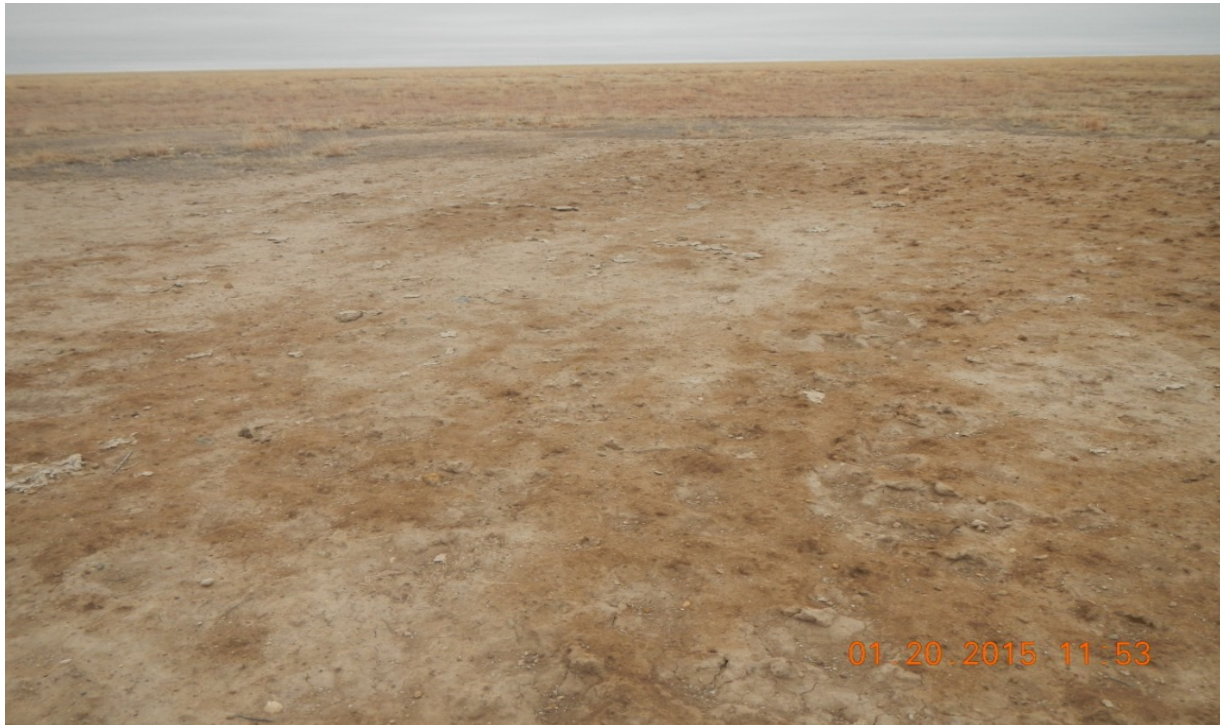
**photo 7:** Center of the location facing south.

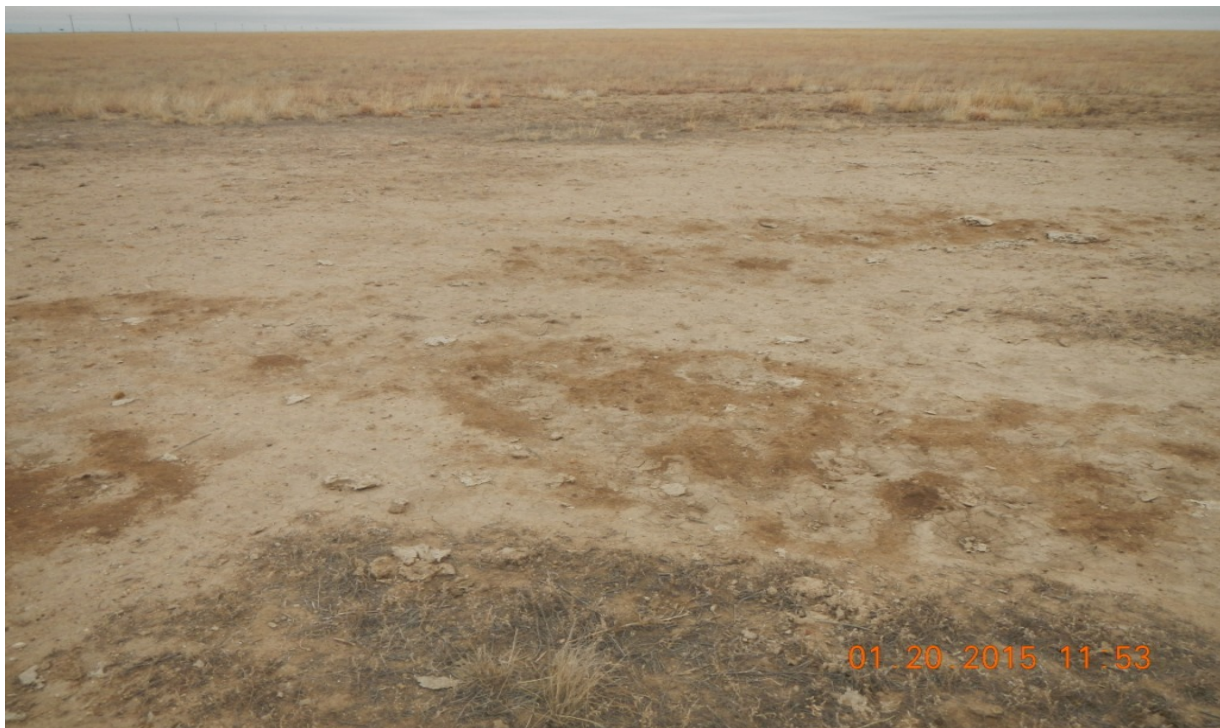
**photo 8:** Center of the location facing east.

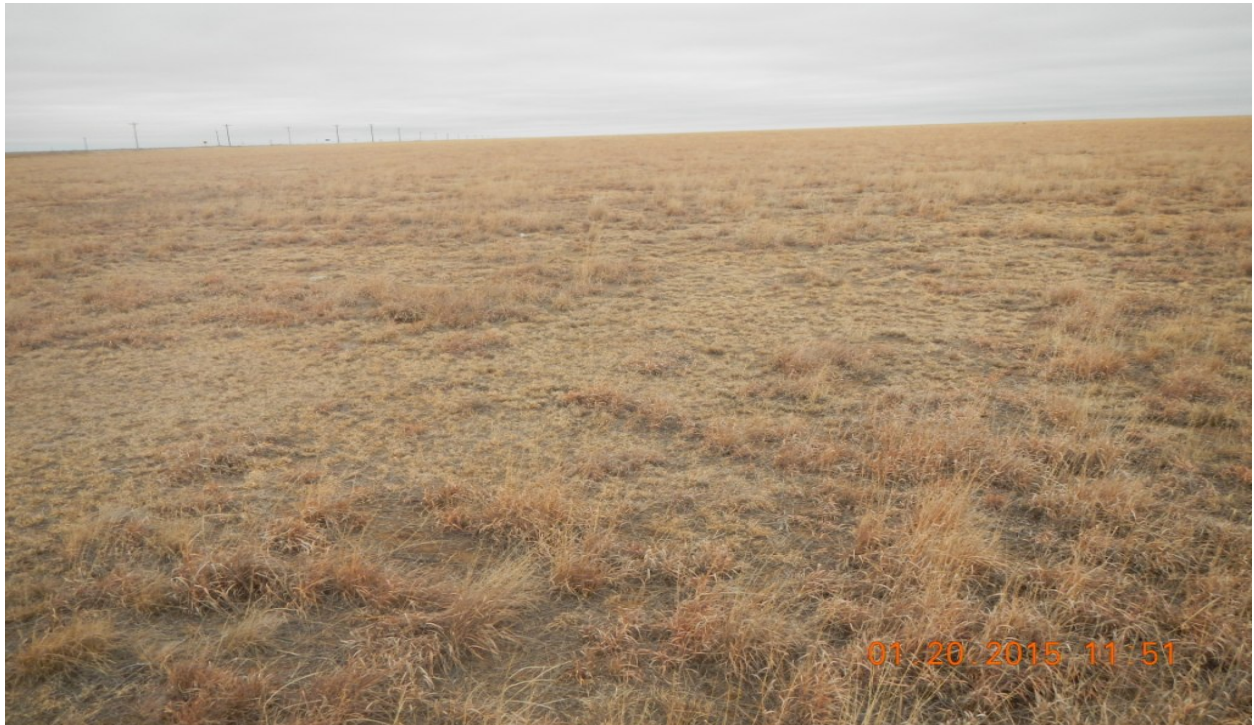
**photo 9:** Facing east, surrounding vegetation around the access road.

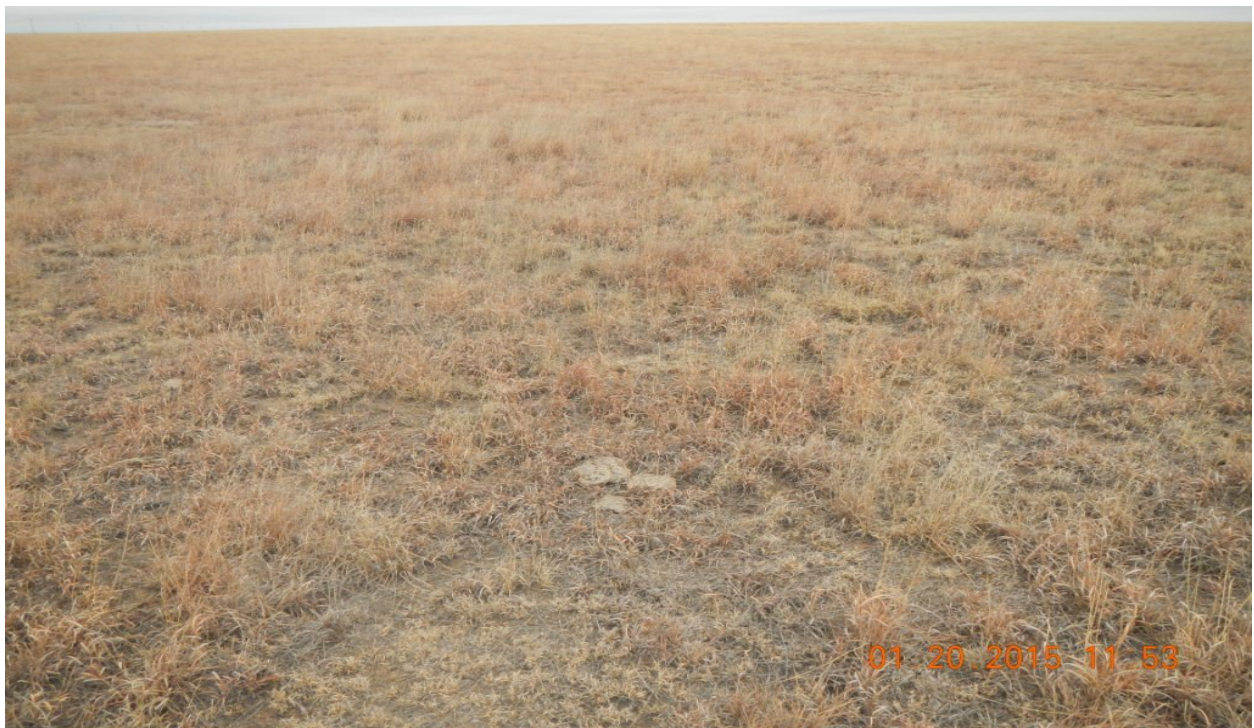
**photo 10:** Facing east, surrounding vegetation around the location.
