Location # 324124 Operator: WPX ENERGY ROCKY MOUNTAIN LLC

Inspection Photographs (12 total) 1/20/2015

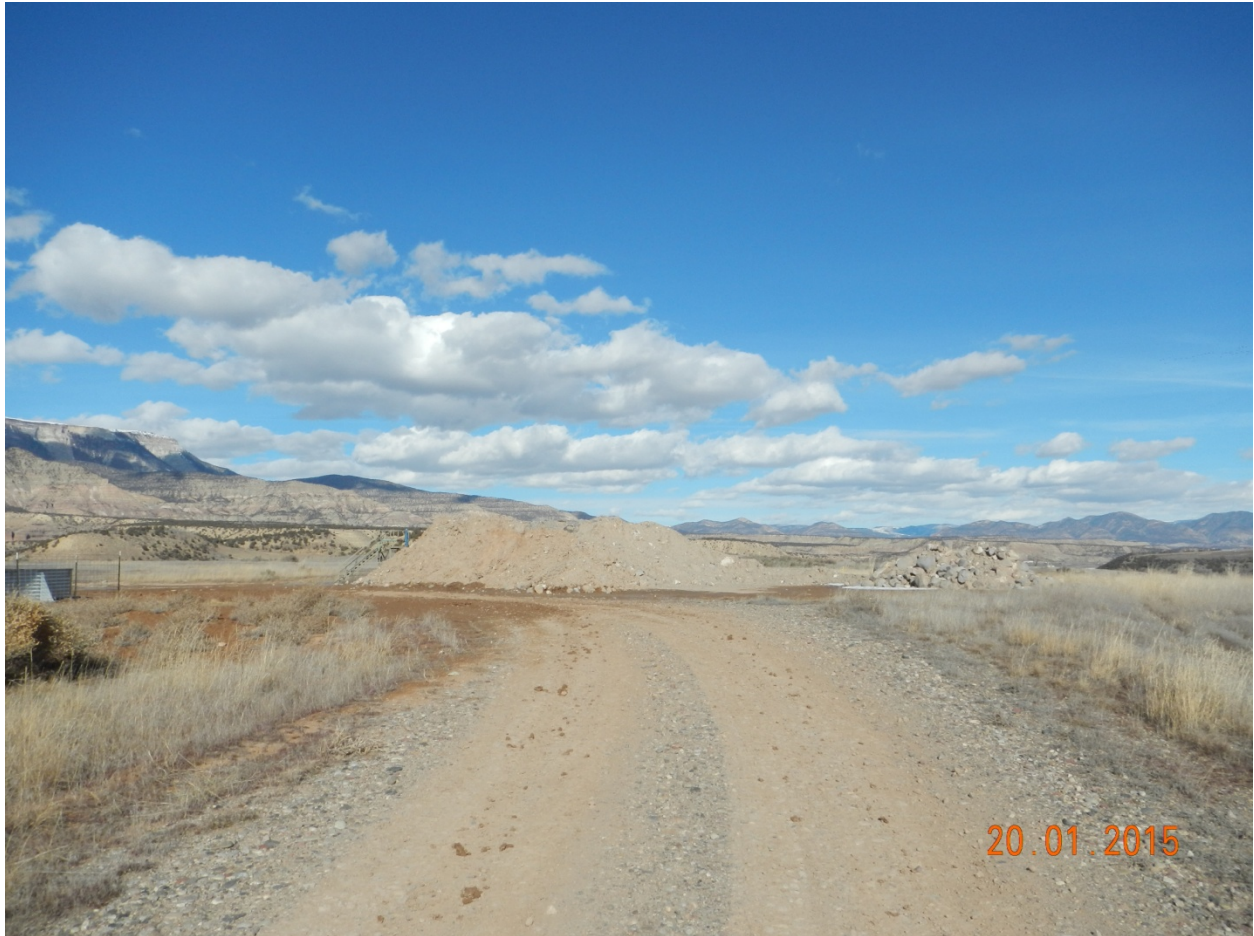
2. Location entrance (soil pile in background), viewed North.

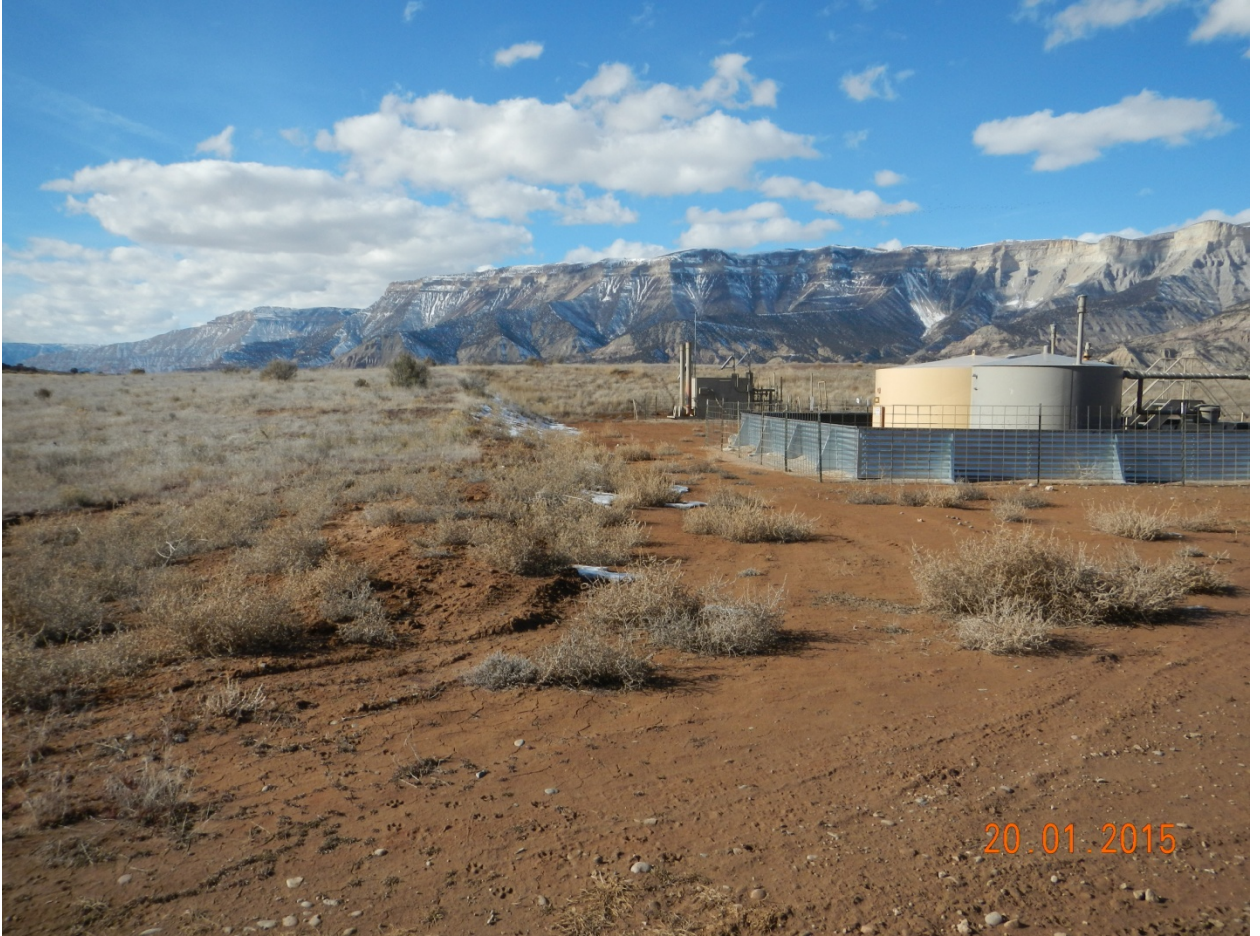
3. Location Southern perimeter. Interim area is mainly Kochia and Russian Thistle weeds.

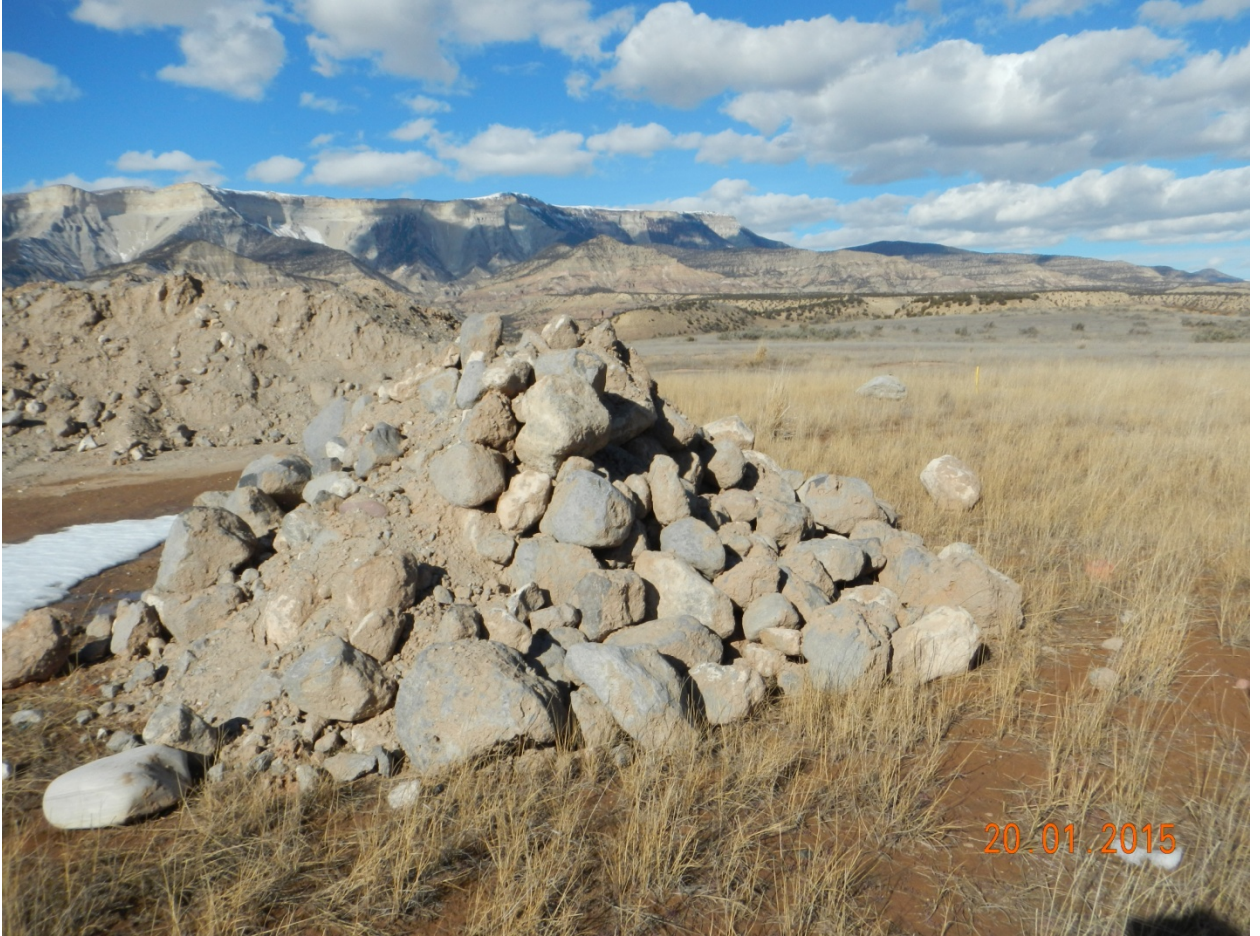
4. Rock pile on Location SE corner, viewed North.

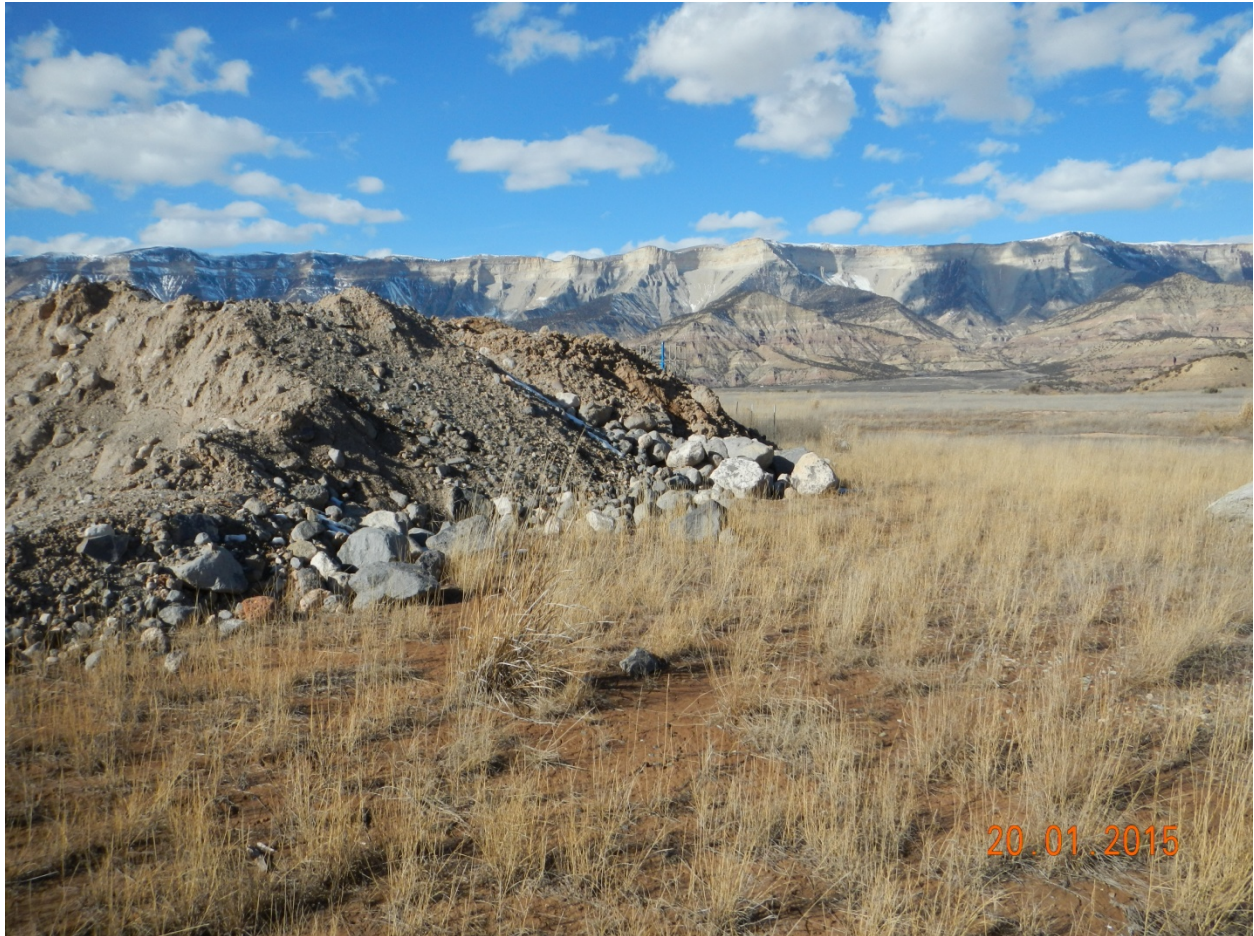
5. On Eastern portion of the pad, soil pile is intruding on interim reclamation, without stormwater BMP controls in place.

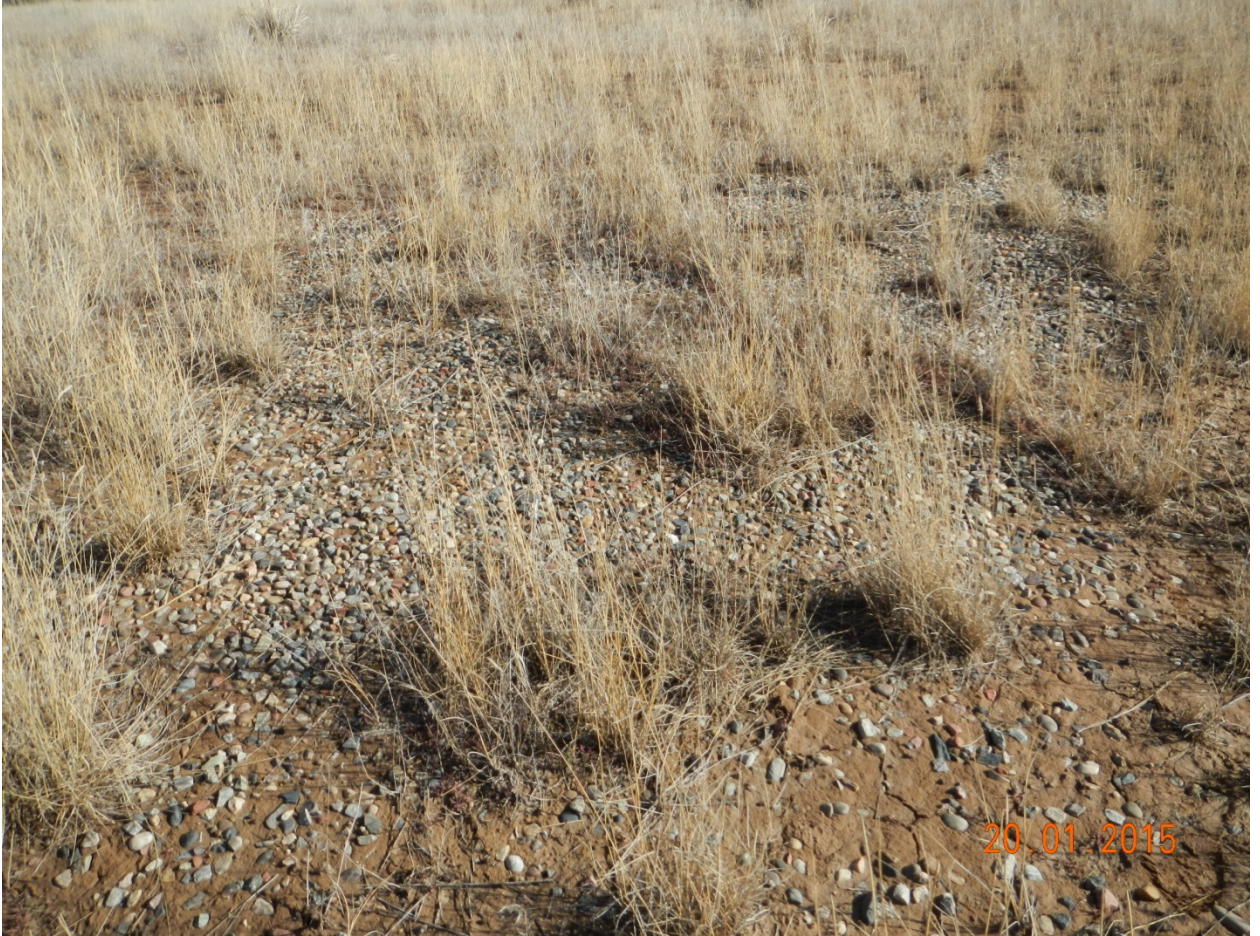
6. Excessive gravel in interim reclamation areas, (it does not appear that gravel was removed prior to reclamation).

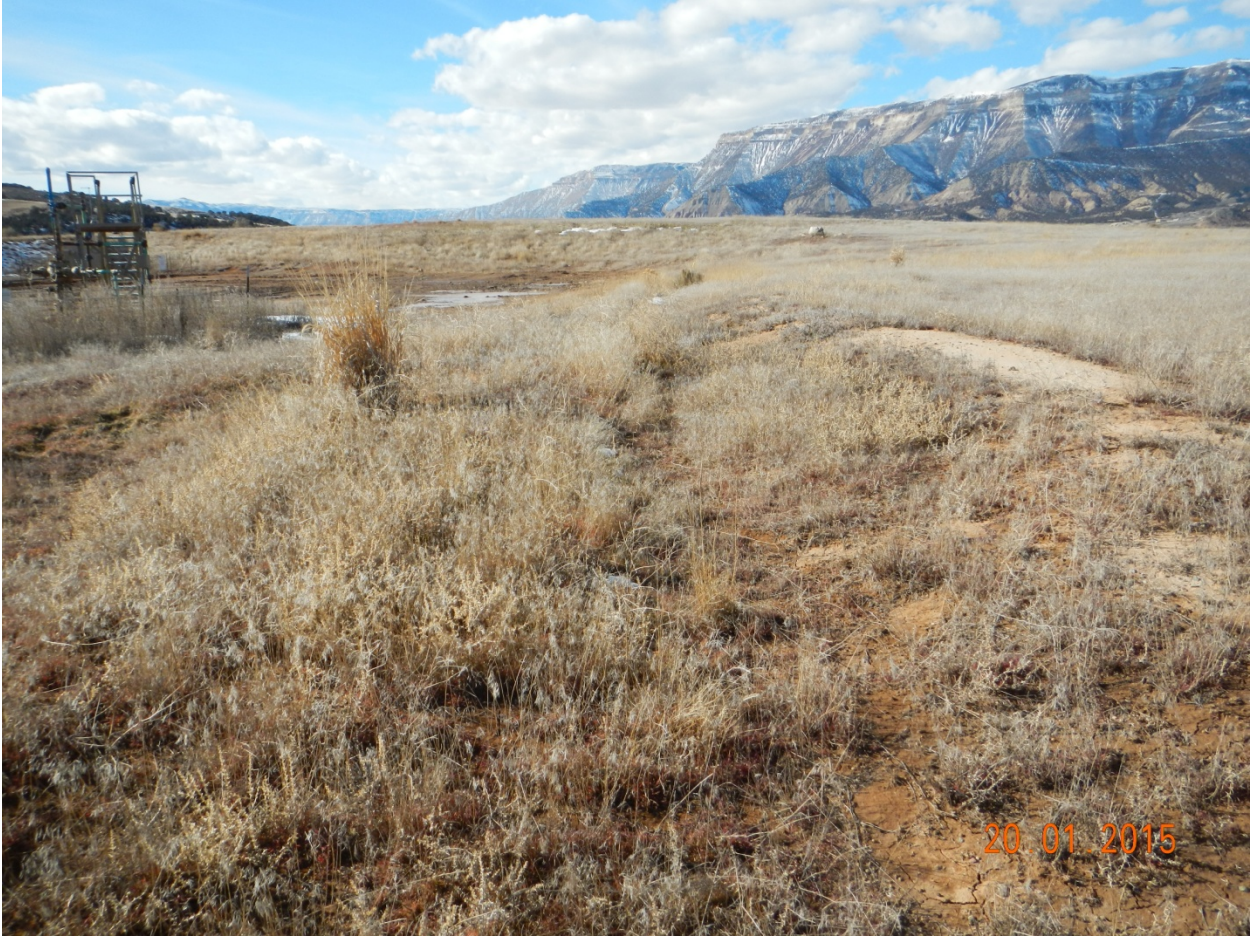
7. NW location interim reclamation area (2 bare spots at 5' x 5' and 12' x 2'). Area is not completely re-contoured.

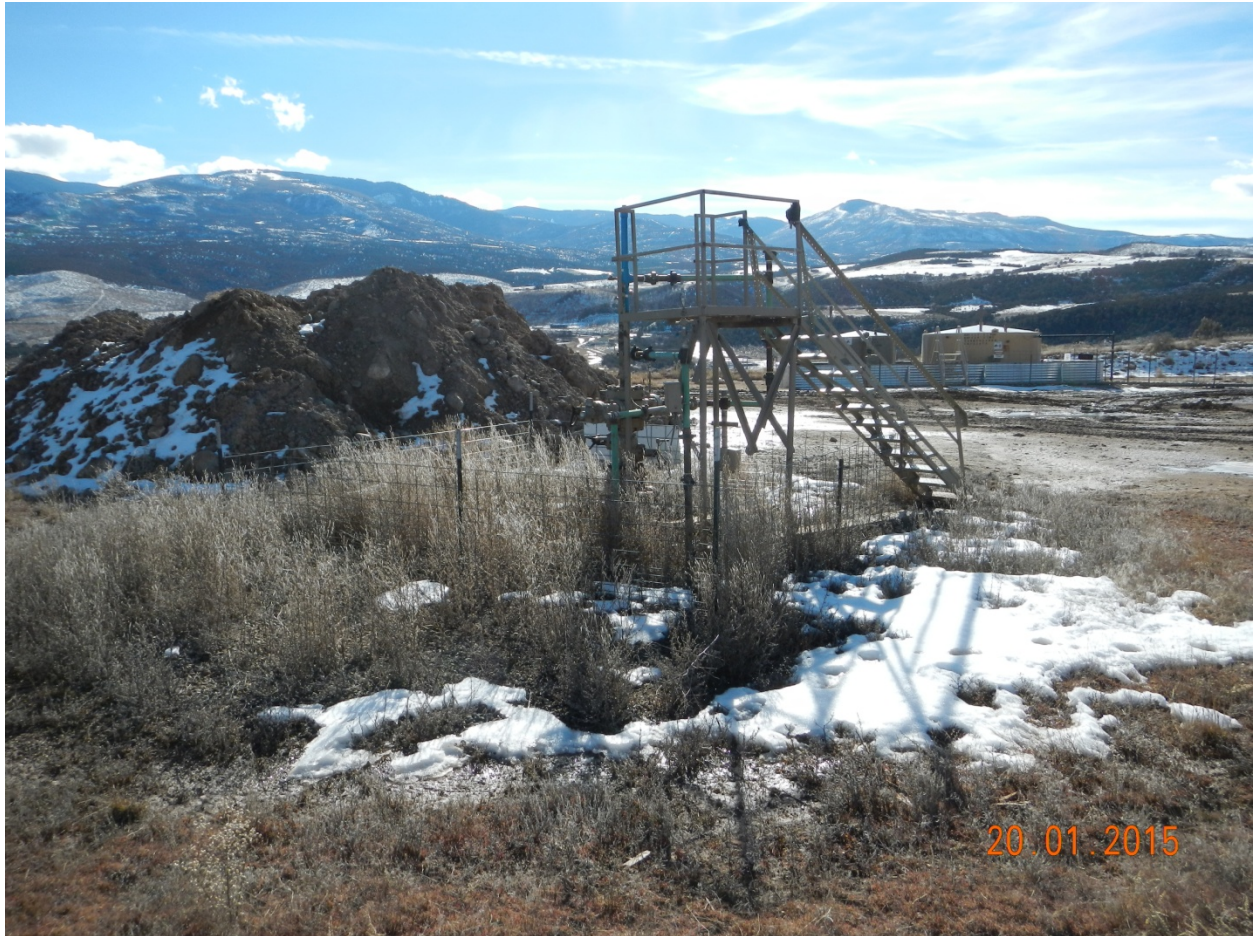
8. Area around well head is weedy with Kochia.

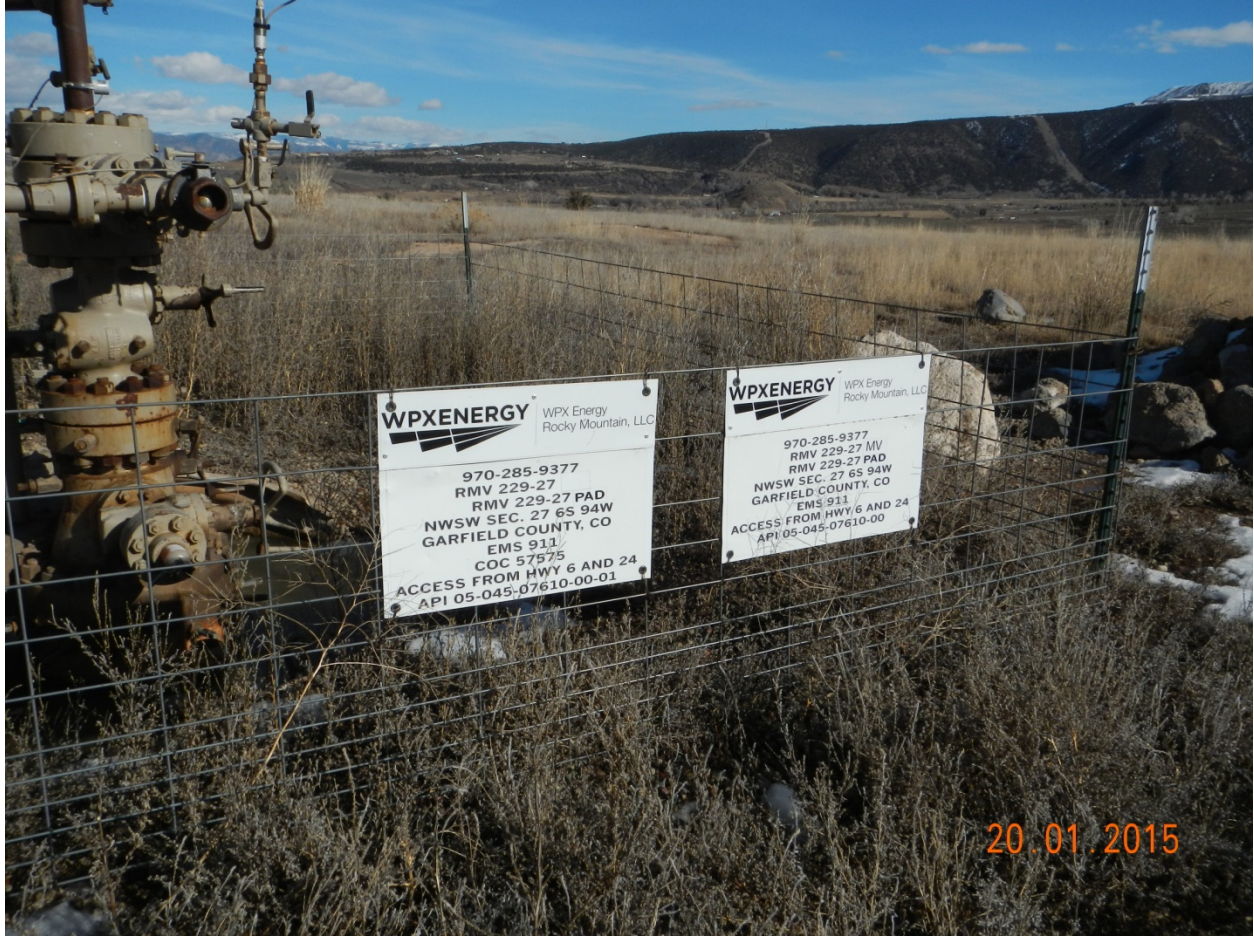
9. Well head signs meet standards.

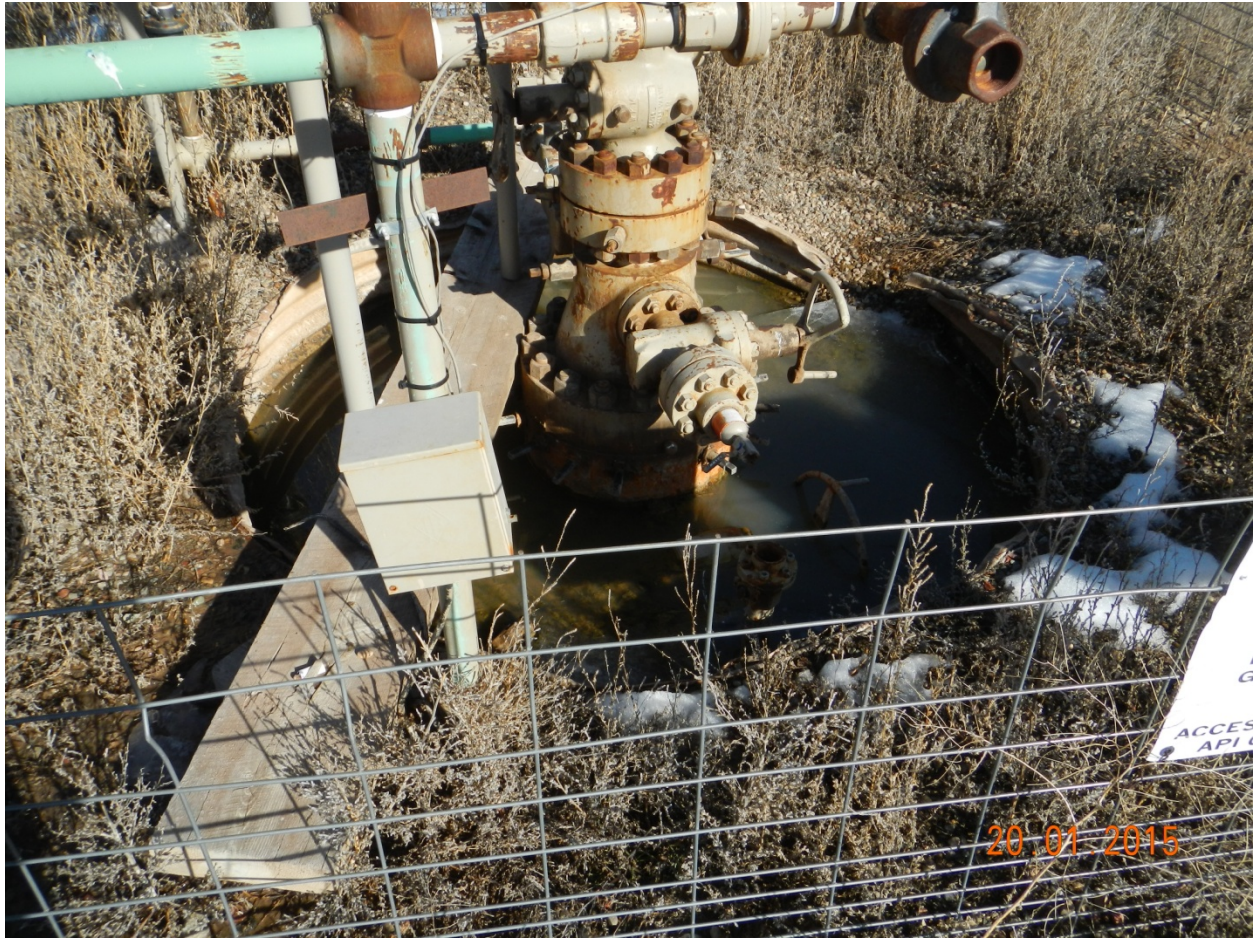
10. Well head cellar hole retaining water.

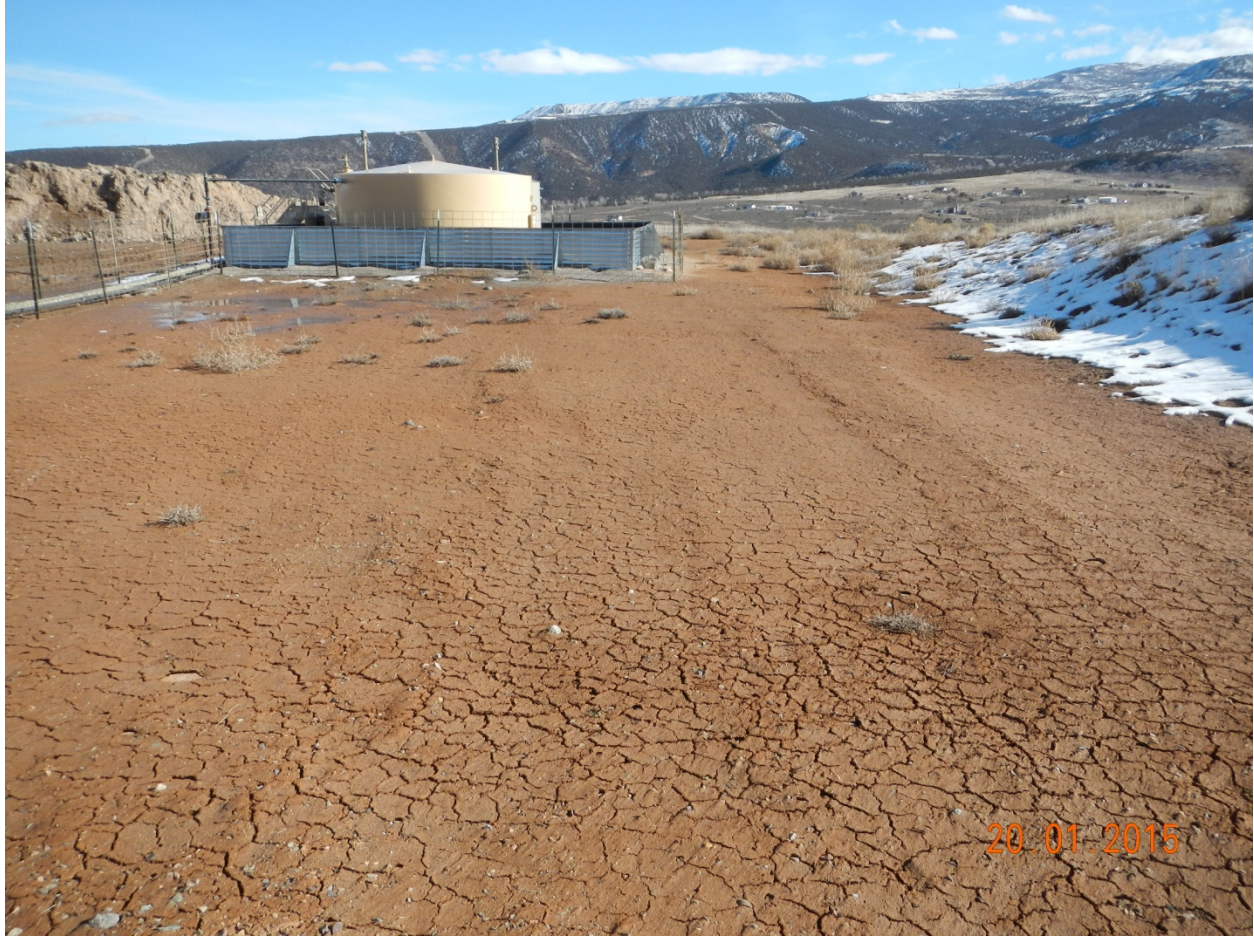
11. Approximately 40' x 70' on Southern side of separators area void of vegetation.

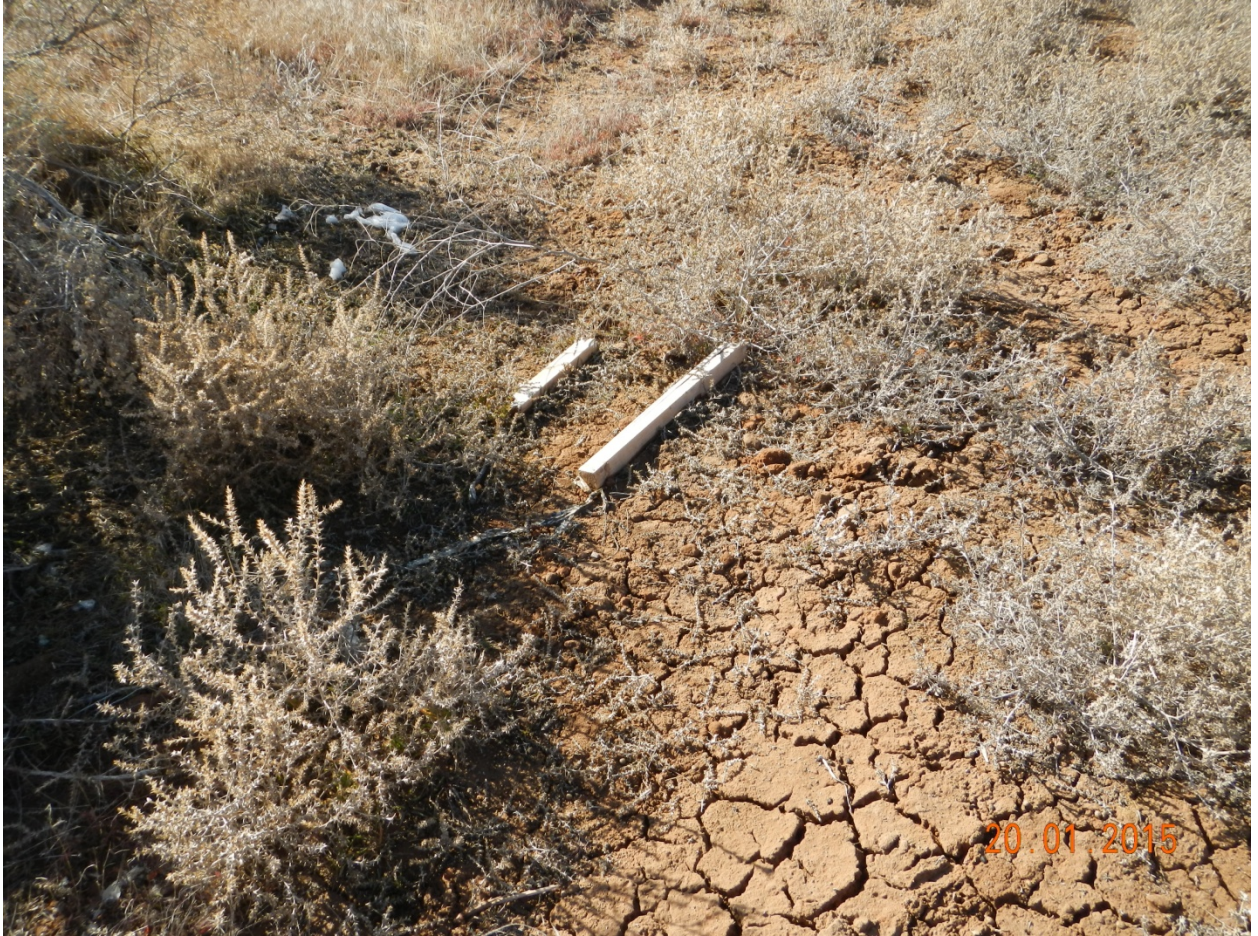
12. Debris by entrance.
