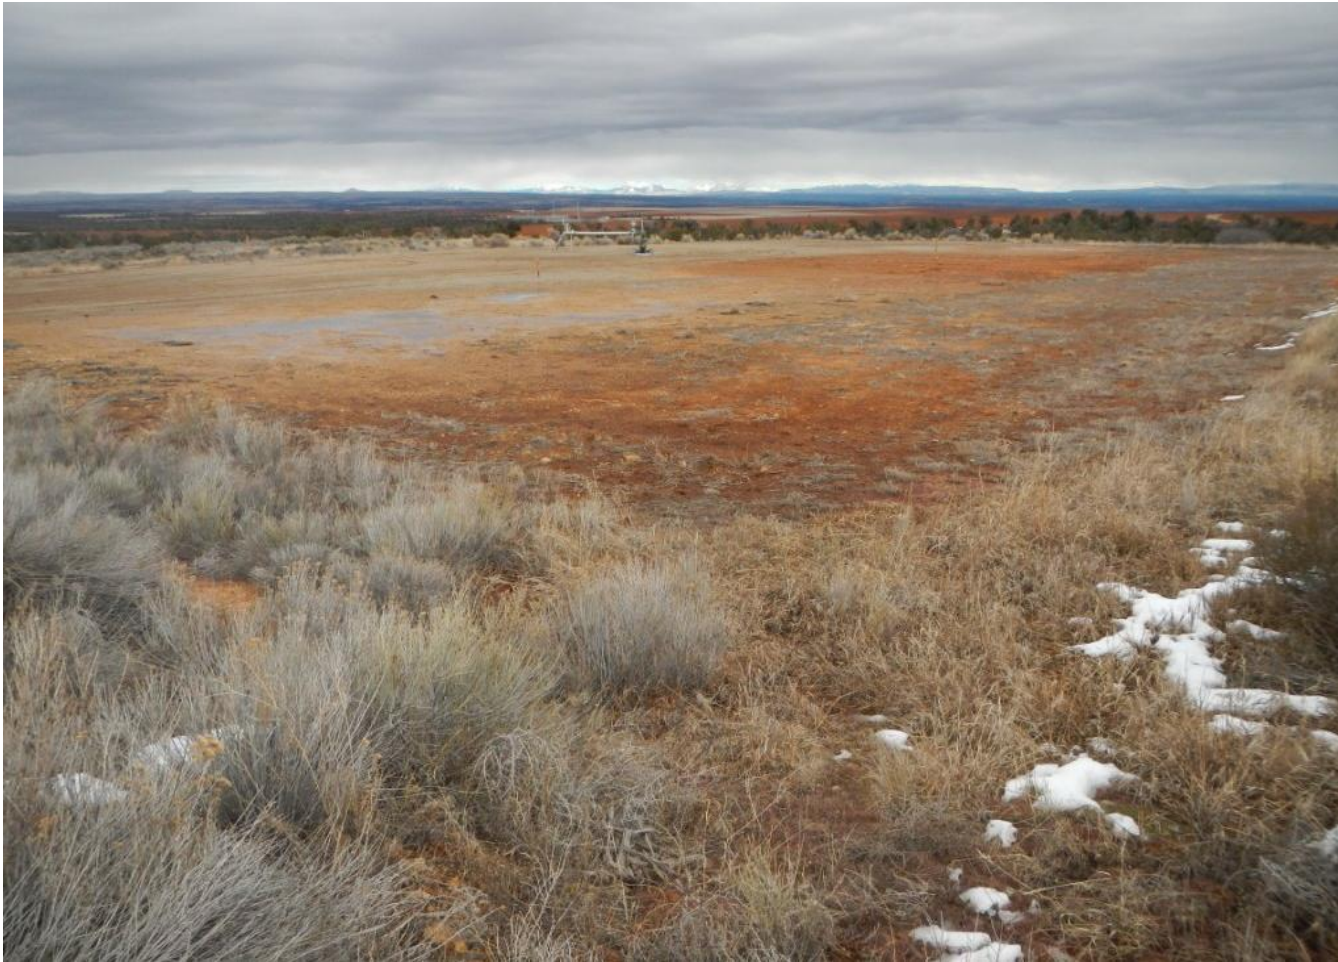
Photo 1. View of well pad from southwestern corner toward center, overlooking area in southern portion of well pad with poor revegetation.

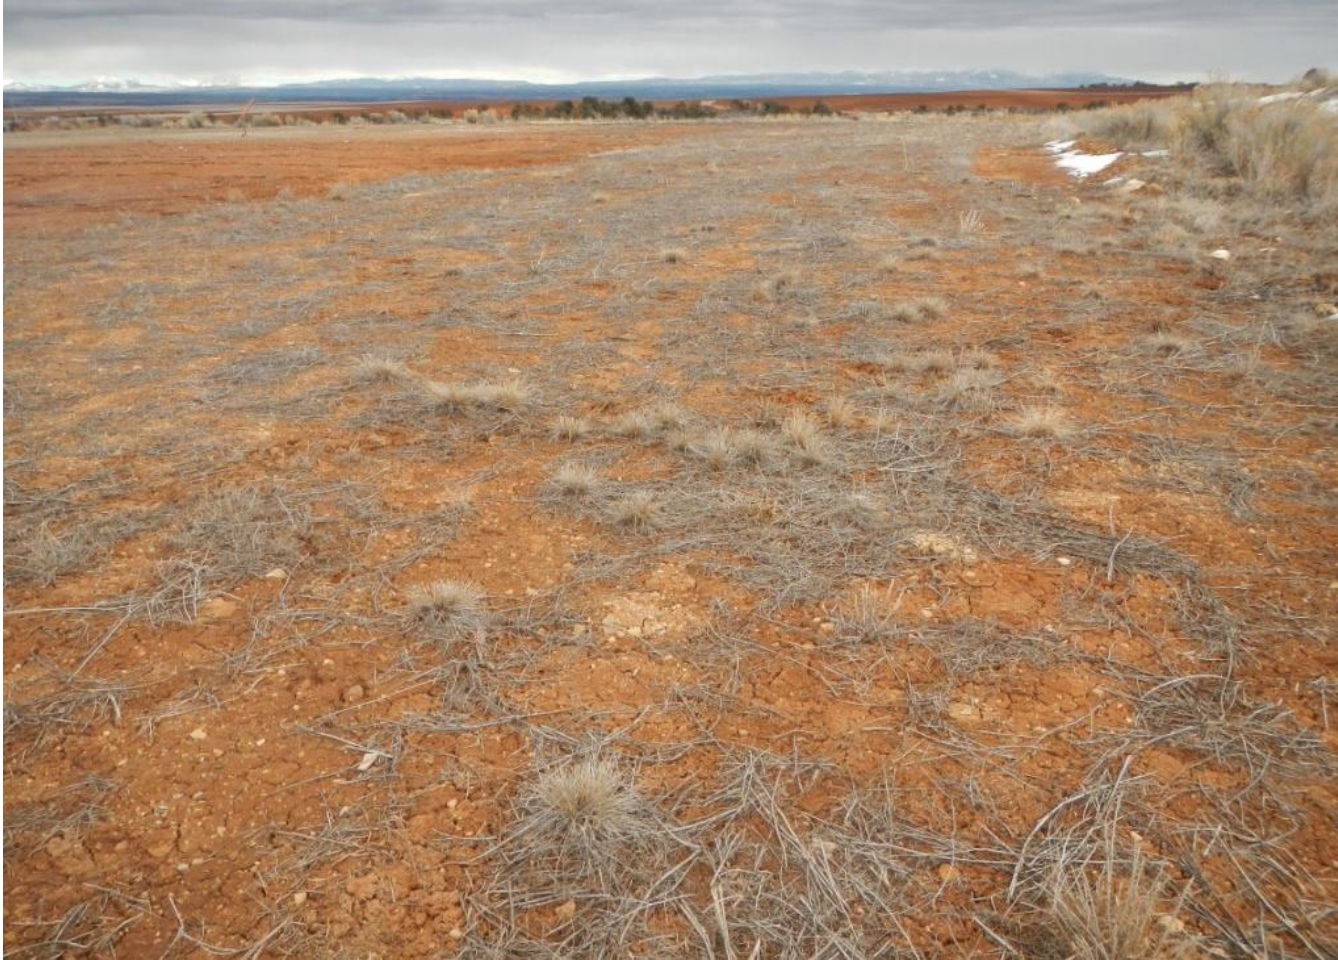
Photo 2. View of area in southern portion of well pad with poor revegetation that needs monitoring. From southern portion facing eastward.

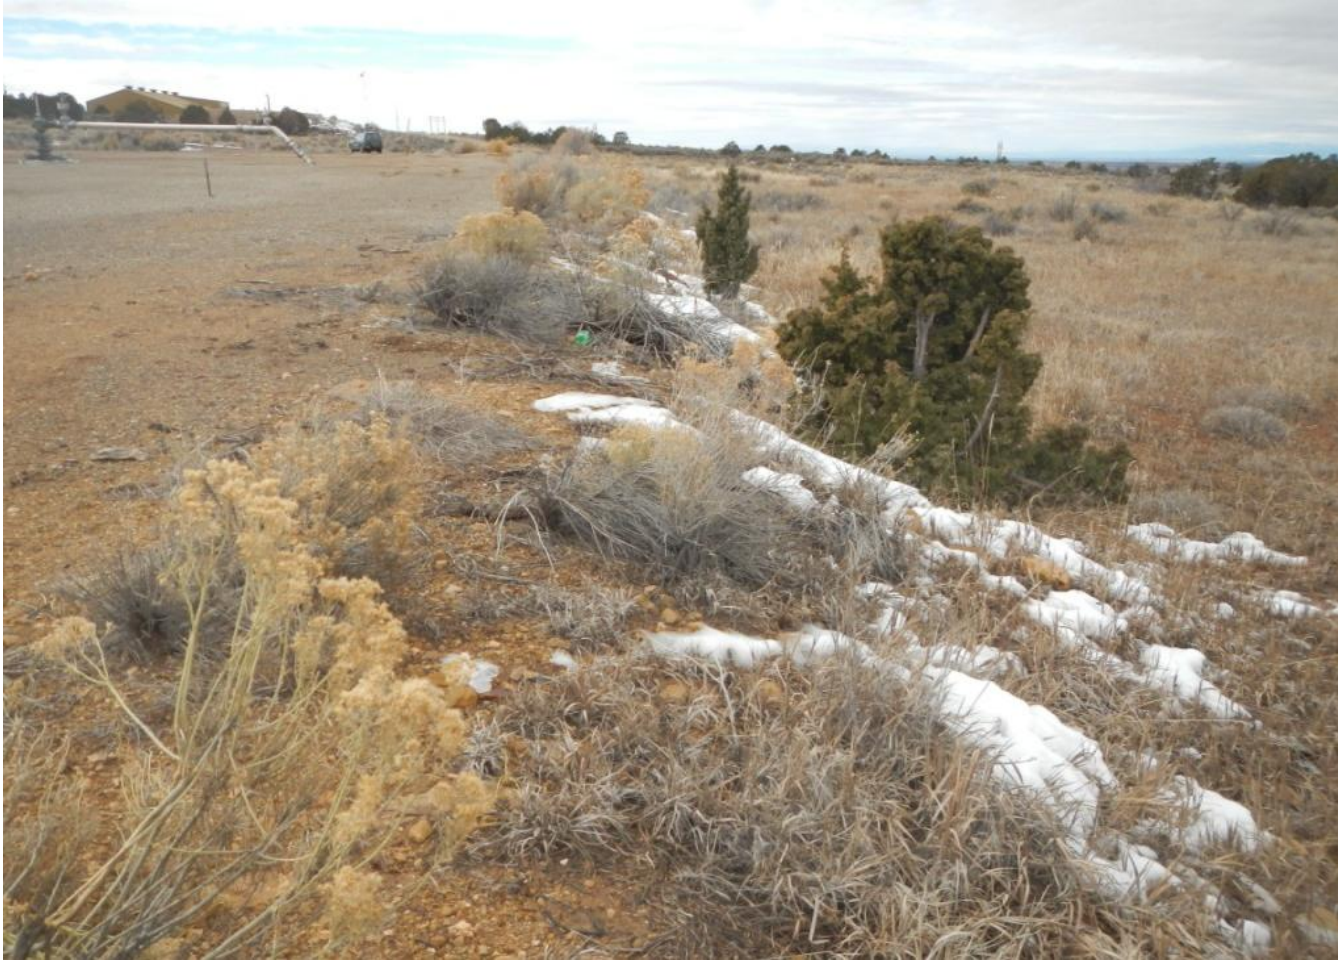
Photo 3. View of vegetation progressing in northern portion of project area from northeastern corner facing westward.

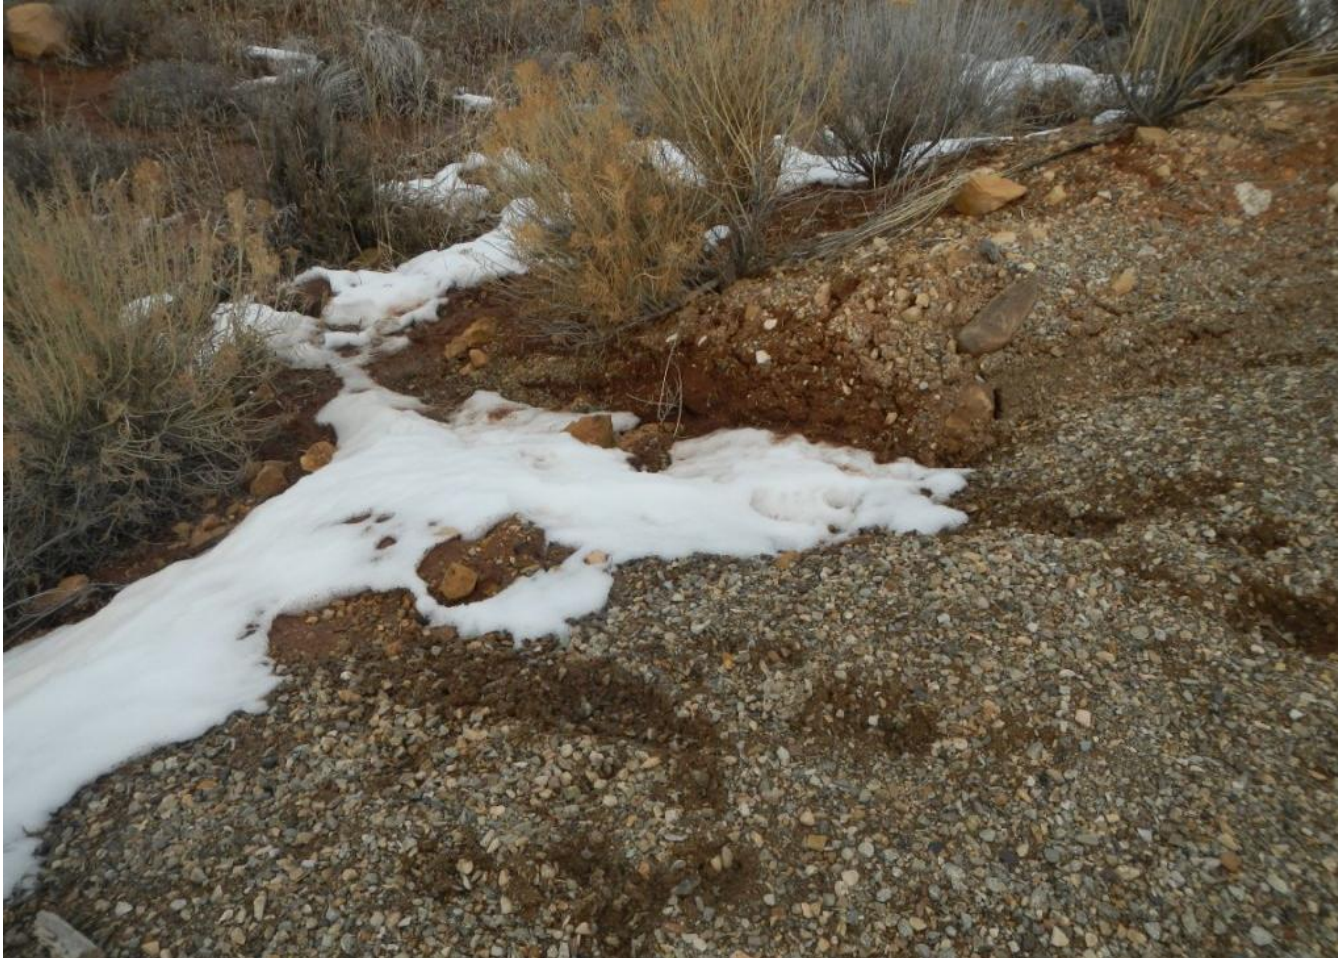
Photo 4. View of rill erosion that needs to be monitored in northwestern edge of project area.
