**Inspection Conducted on January 30, 2015**

**Encana Truck Rollover Spill into Dry Creek**

**County Road 319 (West Mamm Creek Rd)  
Truck coming from Encana Facility ID #335163**

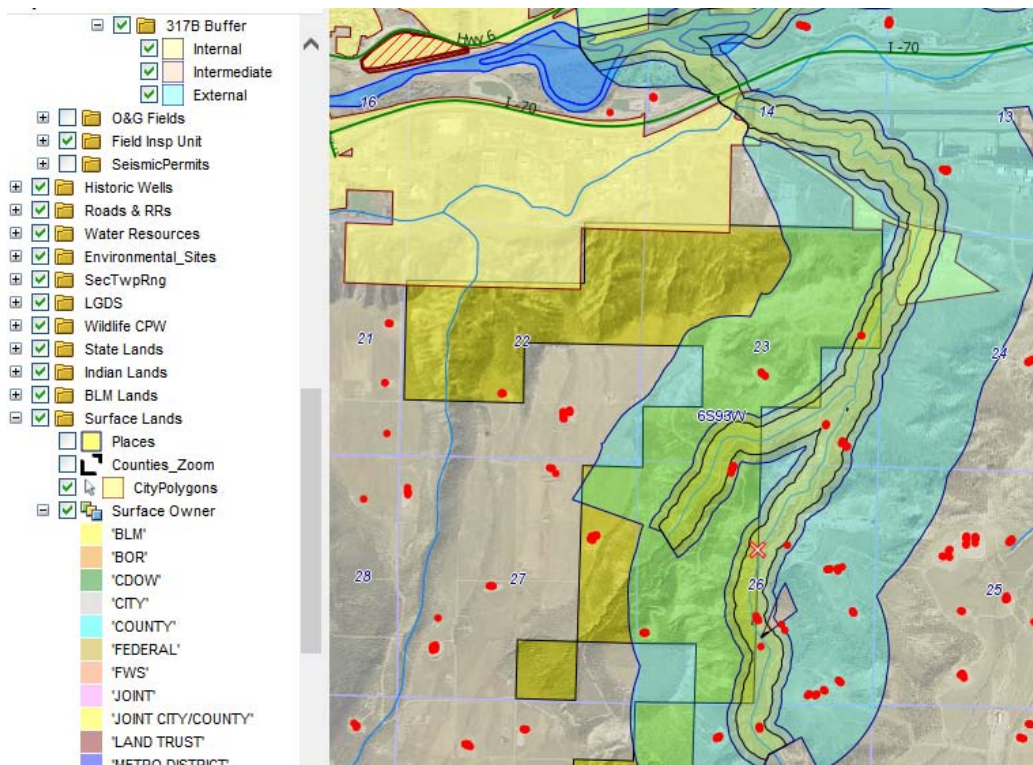
Spill occurred on private land, immediately on the border with BLM land. The spill occurred within the internal area of the 317B buffer, flowing into Dry Creek, which is a tributary of the Colorado River. Spill location is identified with a red X.

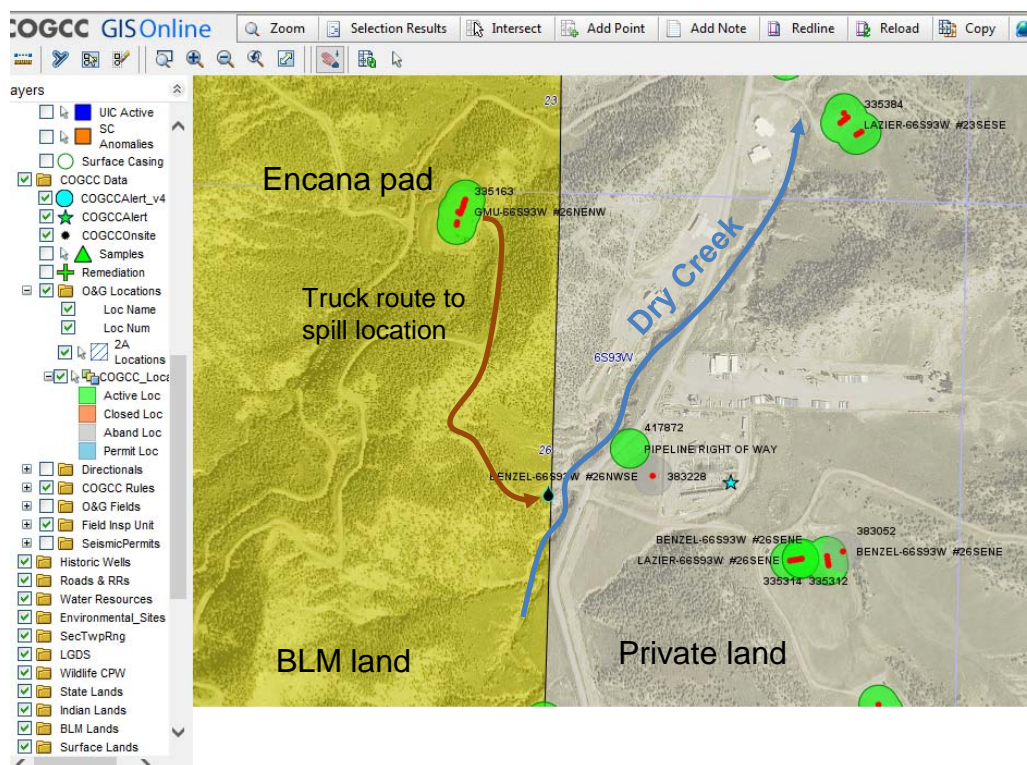
Truck was transporting produced water from Encana Location Facility ID #335163. Dirt road was muddy. Driver apparently lost control taking a turn. Approximately 80 bbls were spilled.

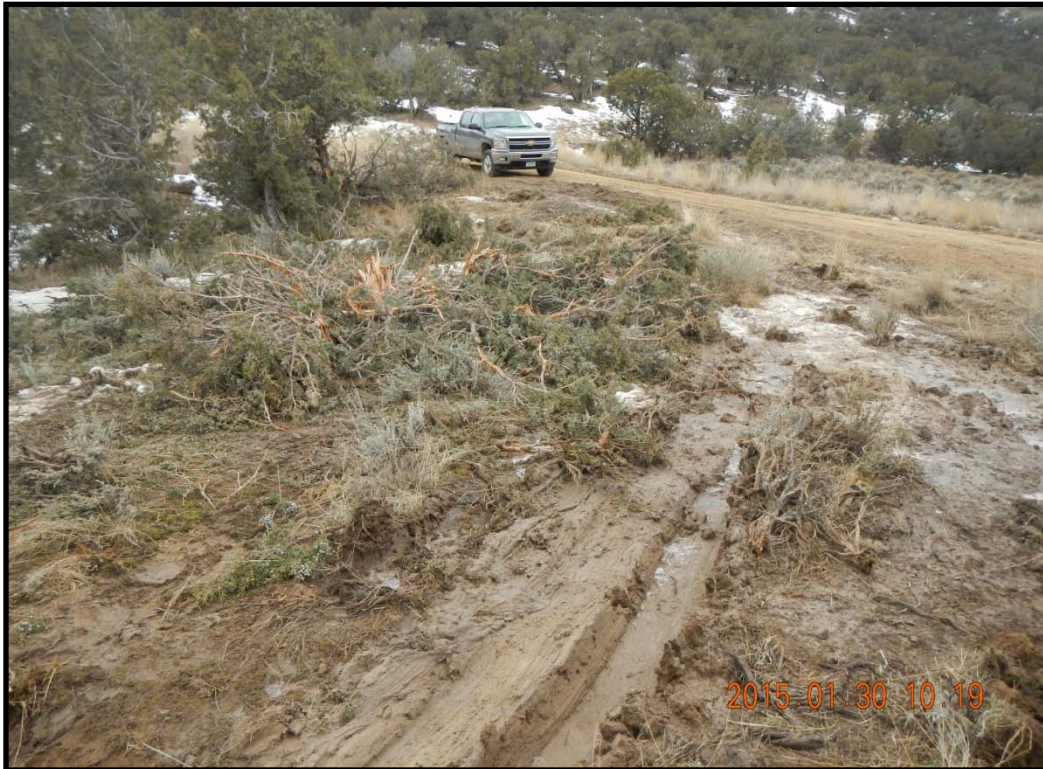
Truck was coming down and missed the turn. The truck rolled over and about 80 bbls of produced water were spilled.

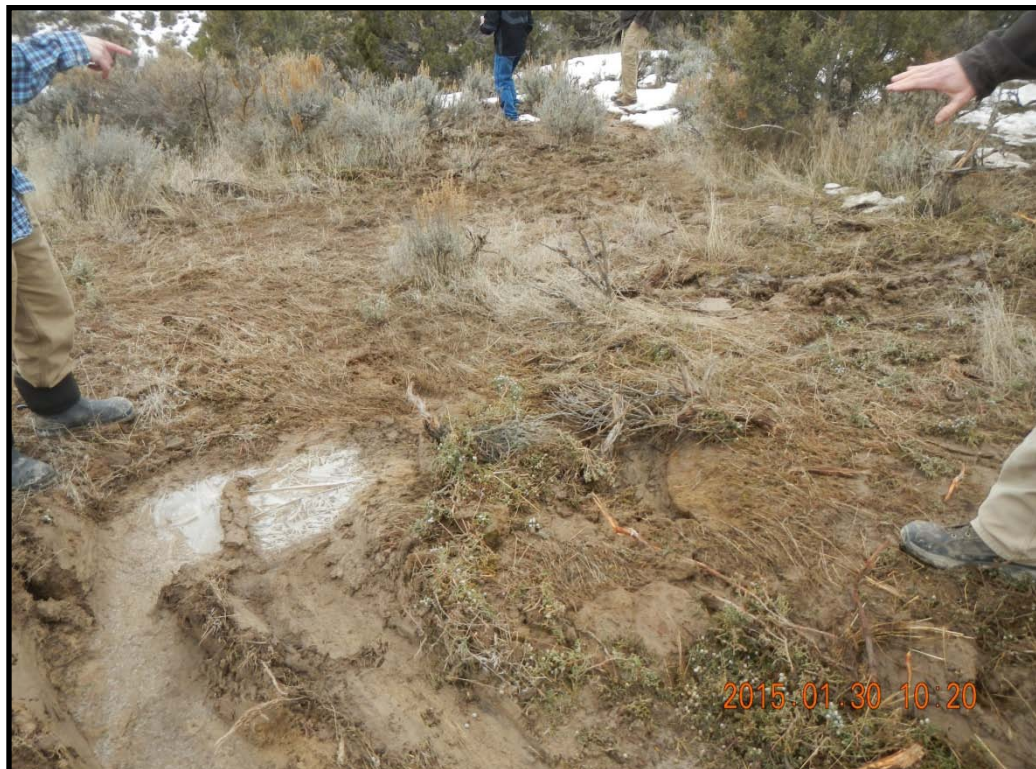
Location of the spill. Clayey soil saturated from snow melt. Minimal retention time. Produced water flowed down toward and into the creek. Encana took soil samples at the source and at several location of the streambed (upstream, spill location, downstream).

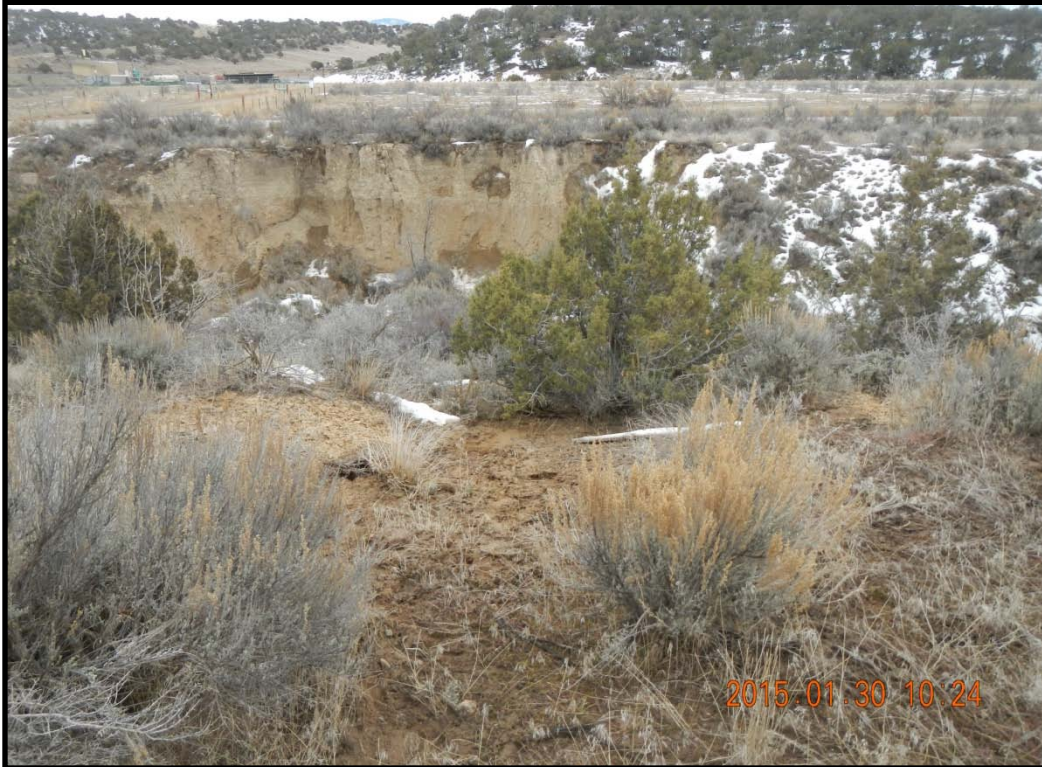
Looking East toward Dry Creek.

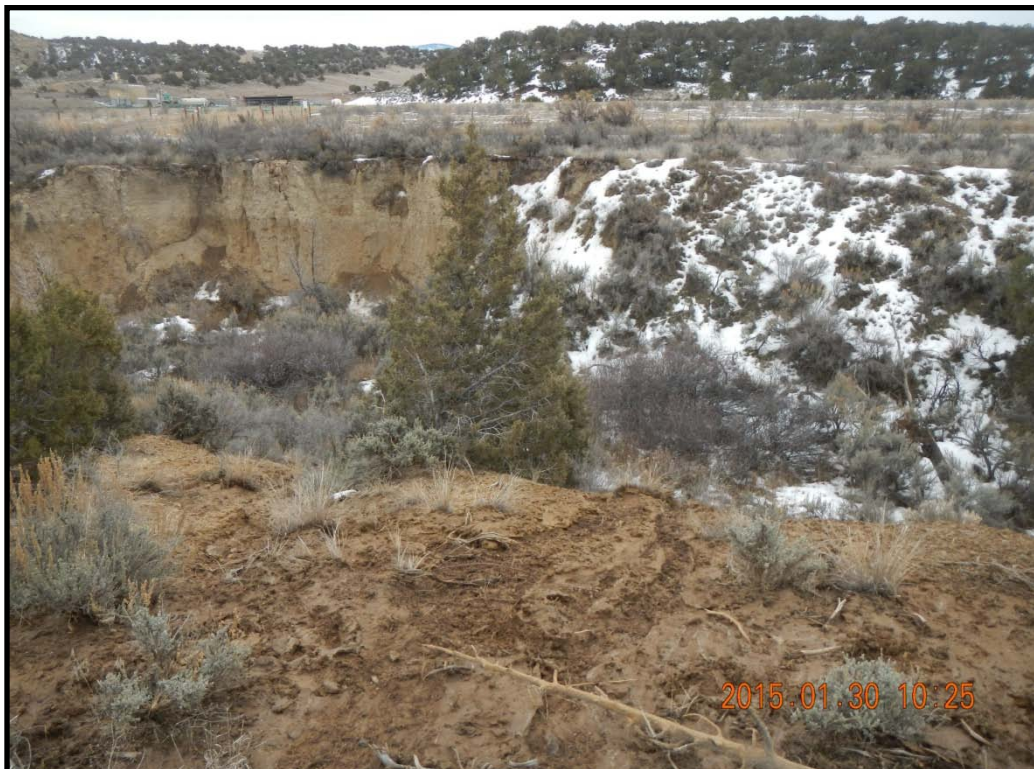
Looking East. Produced water flowed downhill into Dry Creek.

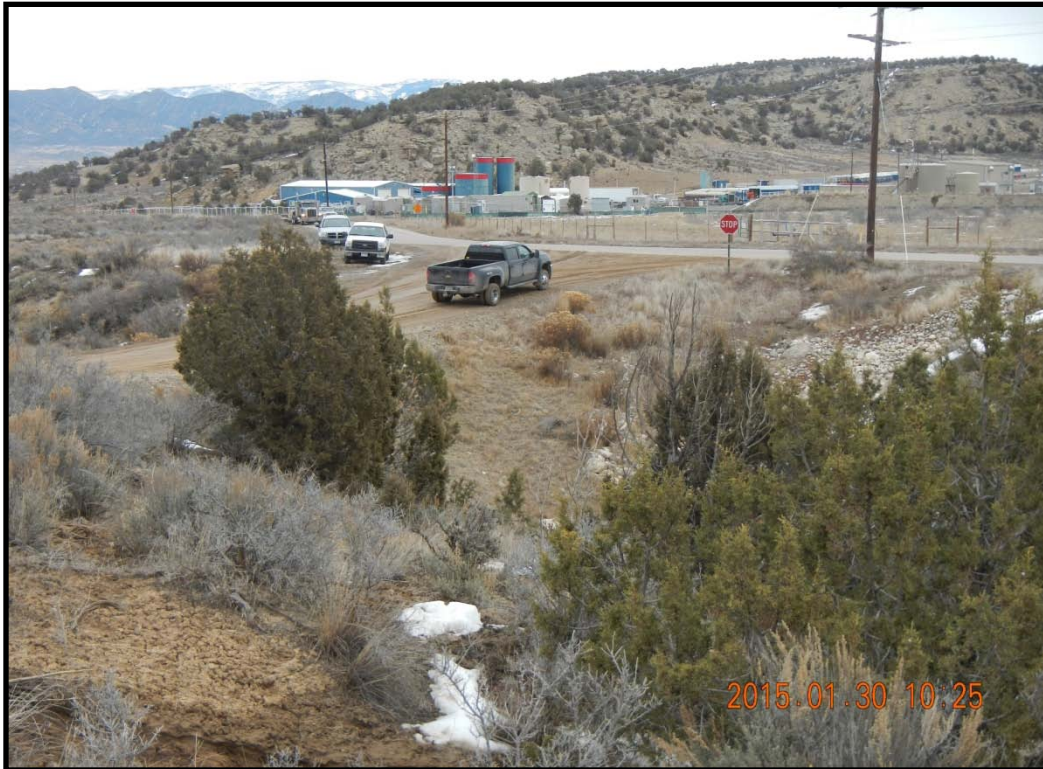
Dry Creek flowing North to the Colorado River. Across County Road, Encana Centralized E&P Waste Management Facility # 149004.

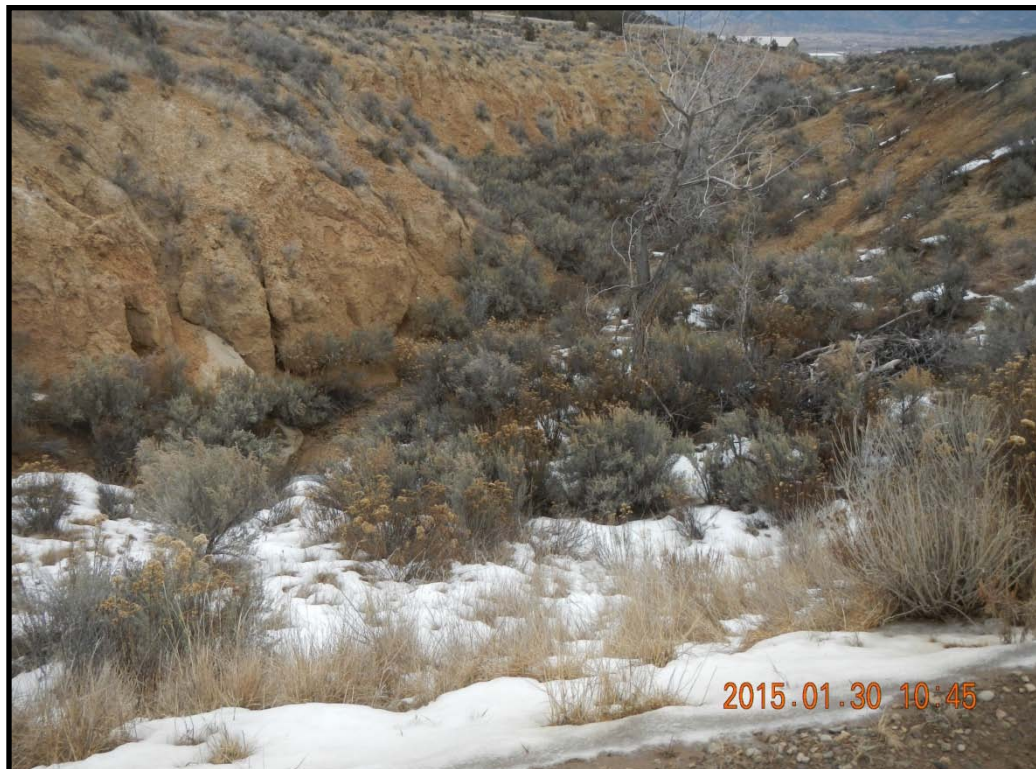
Dry Creek flowing North. View from dirt road. Exit side of culvert. Soil sample downgradient of the culver and around the curve as a compliance point.

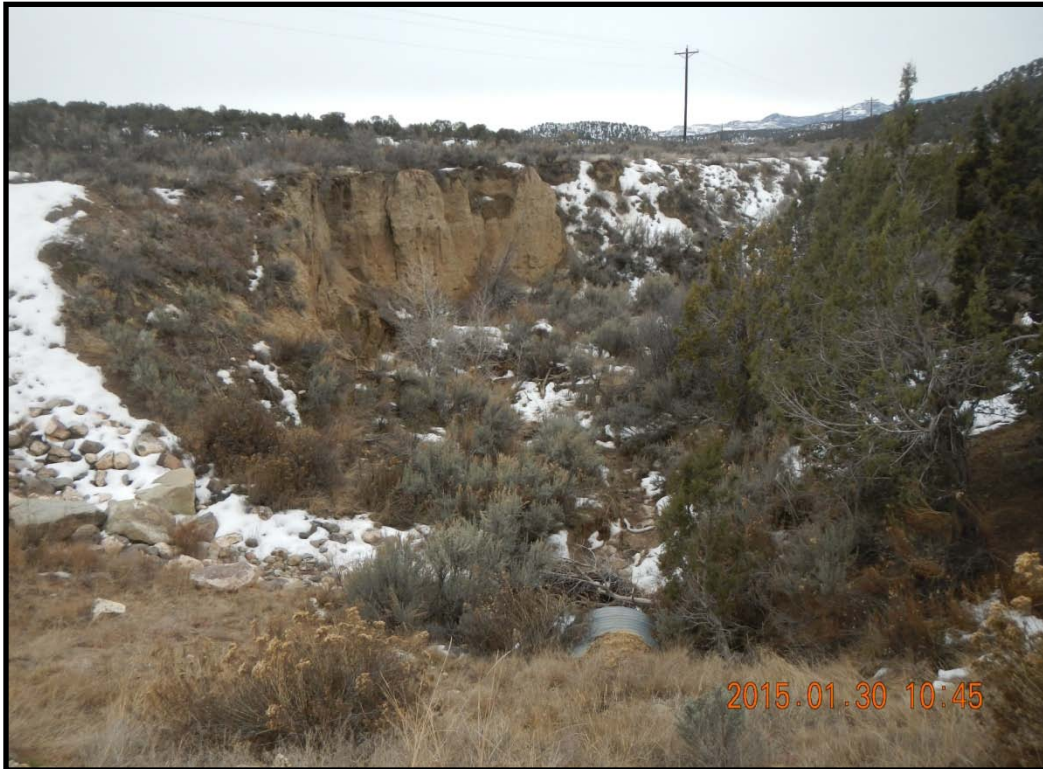
Dry Creek. View upstream. See culvert inlet

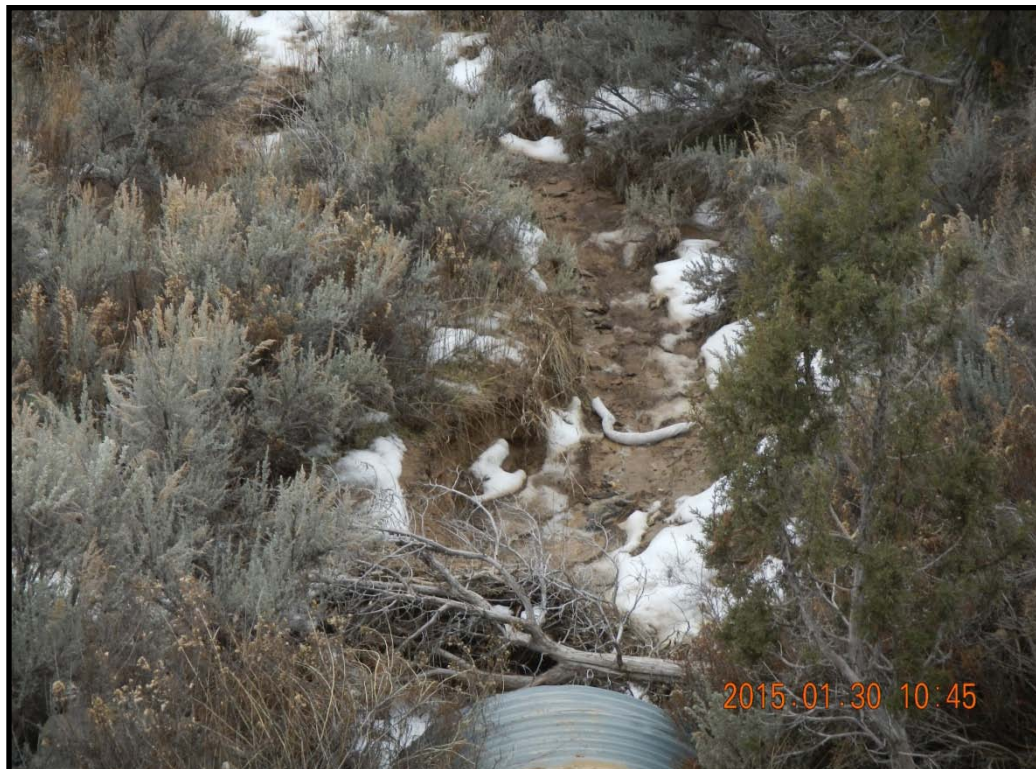
Dry Creek. View upstream. Ephemeral streambed is about 3 feet wide. Almost fully vegetated. One soil sample was taken upstream of the culvert and one further upstream of the spill location.
