Knight PA 21-4

Inspection# 675201126

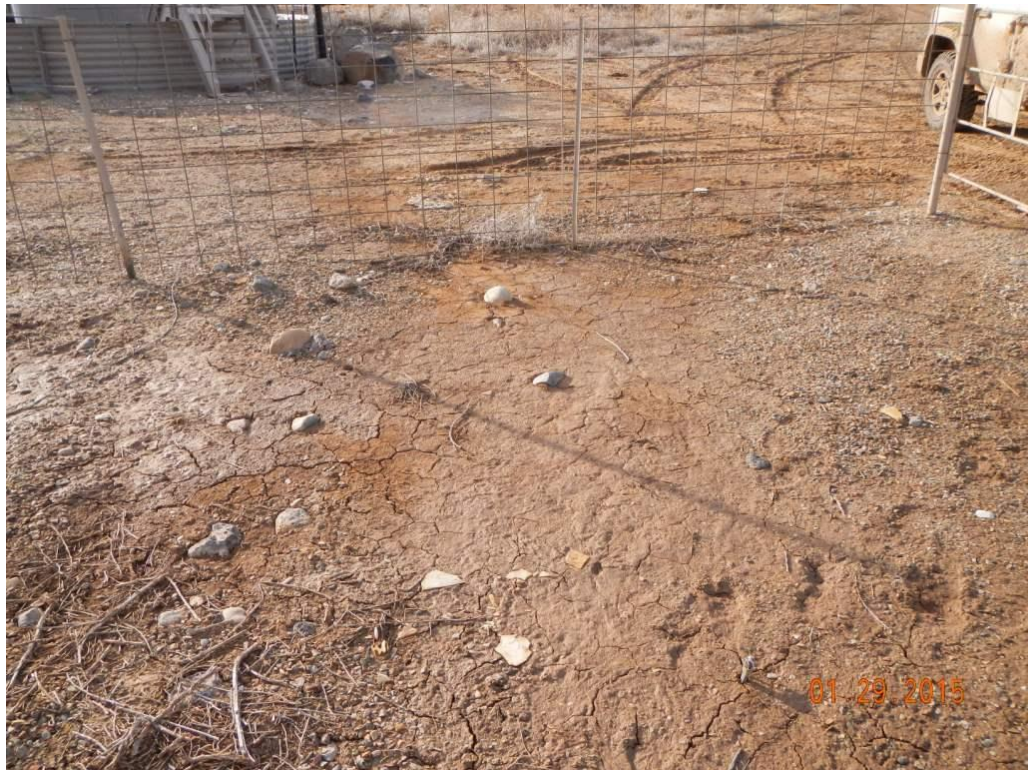
Sediment migration by
separator.

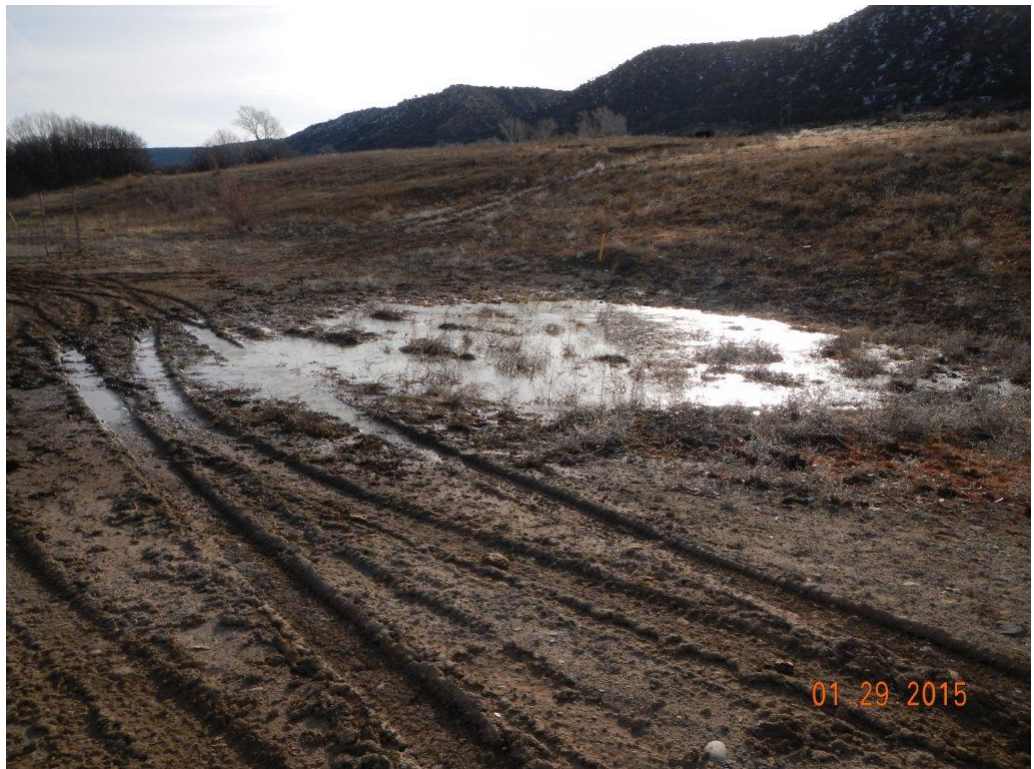
Rutting and pooling on
wellhead location.

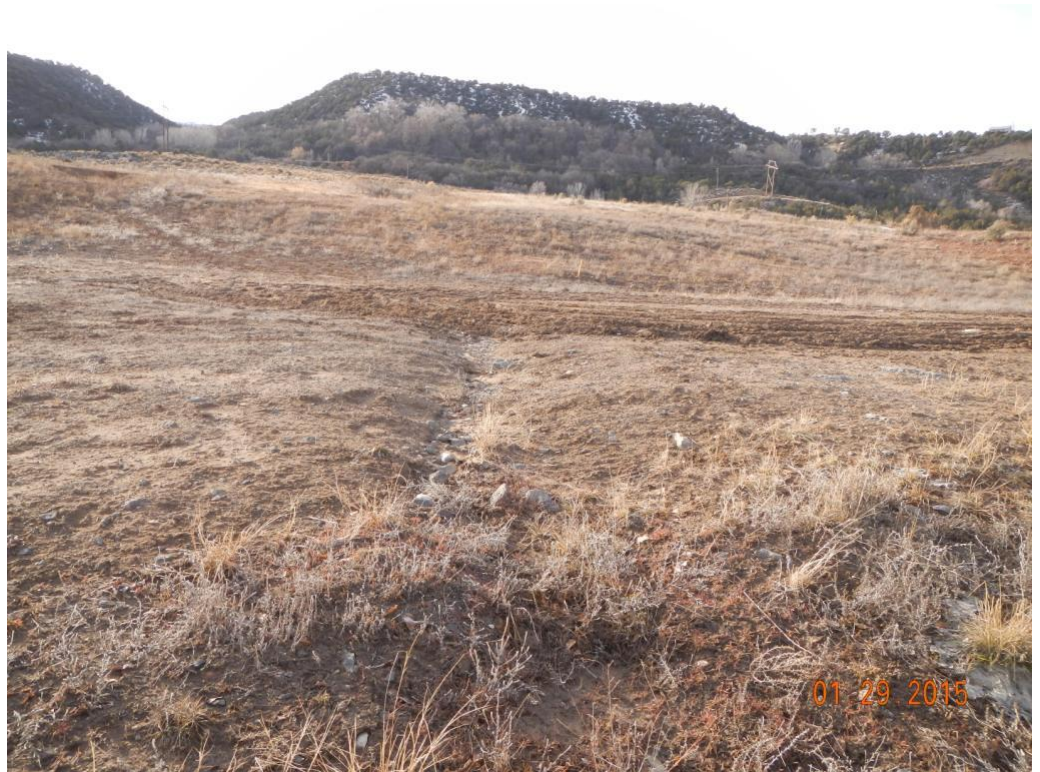
Erosion across location.

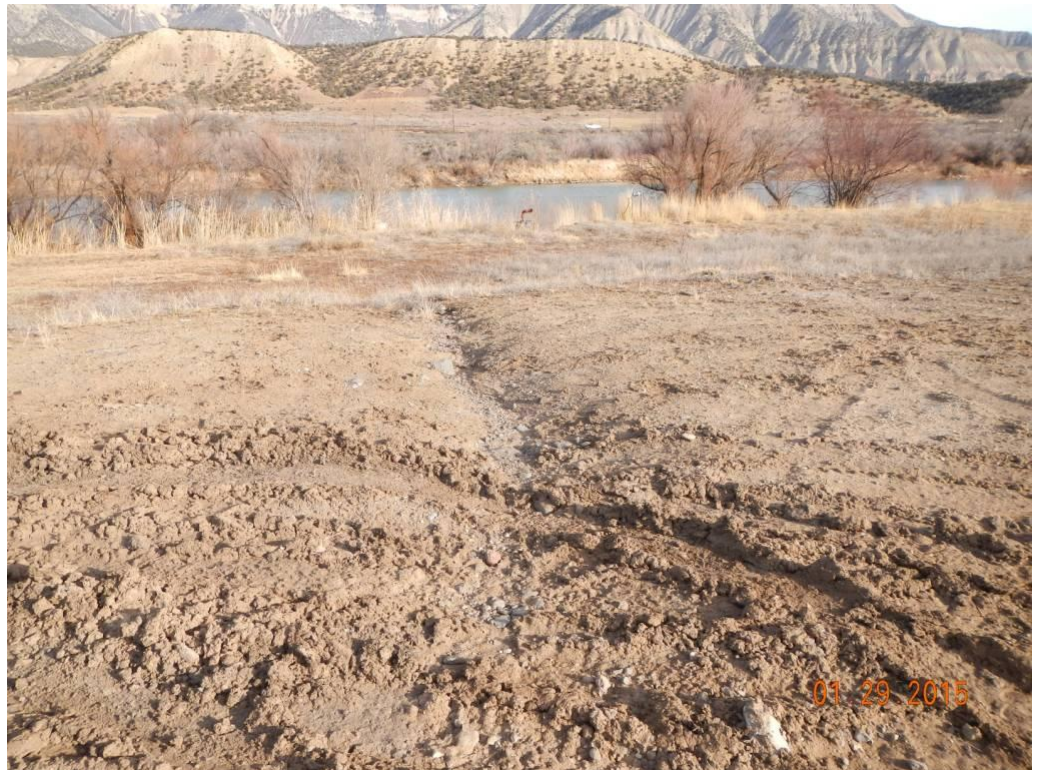
Erosion channel towards
Colorado River.

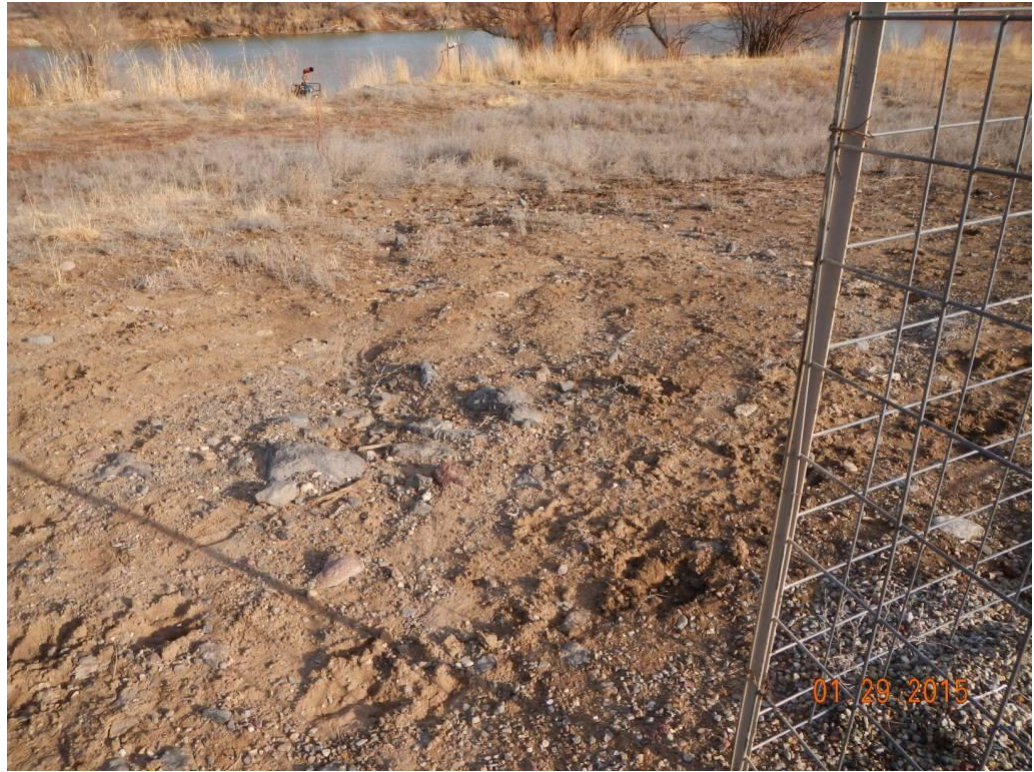
Erosion channels from
wellhead towards Colorado
River.

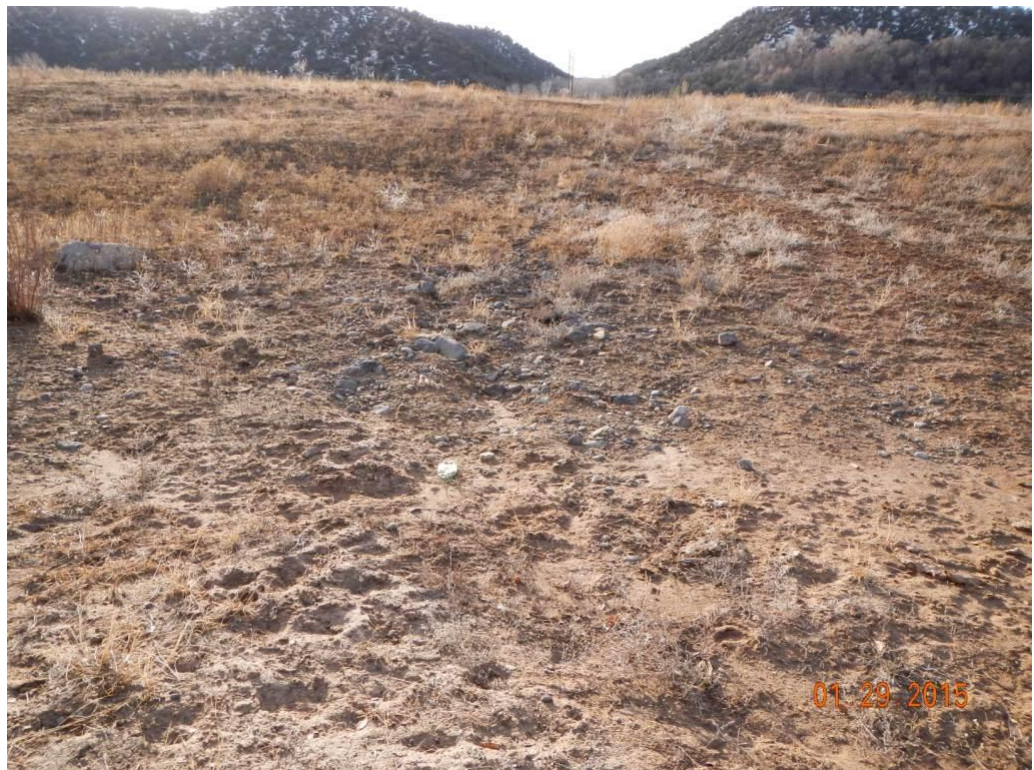
Erosion and sediment
migration on south side of
location.

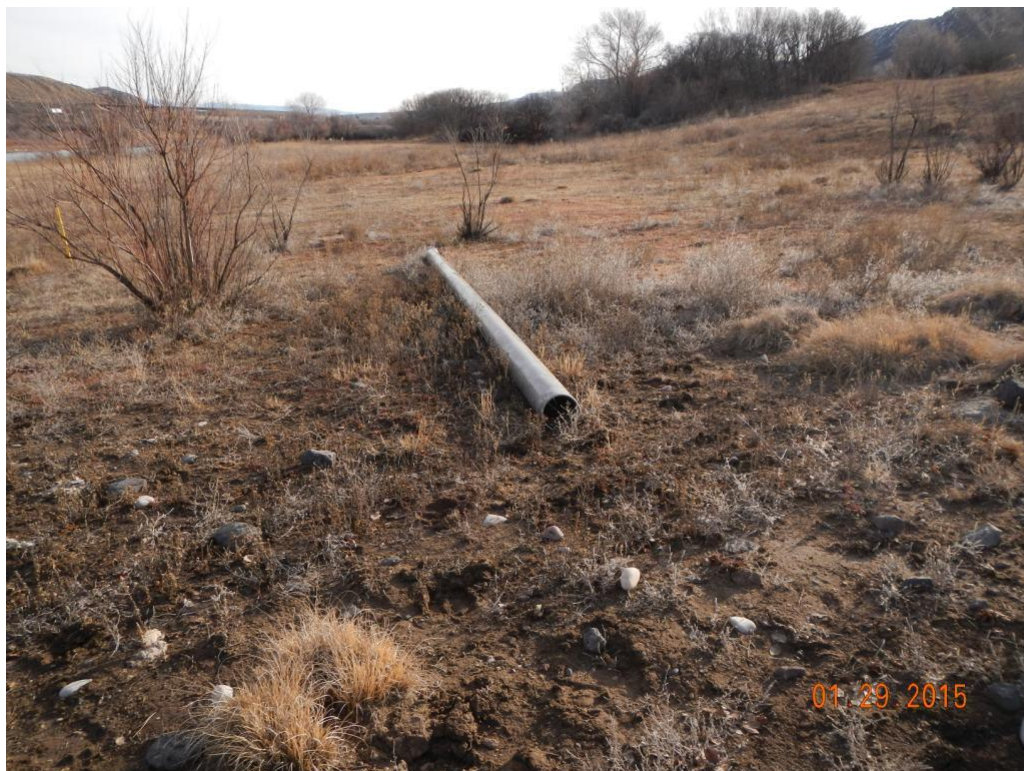
Unused equipment.

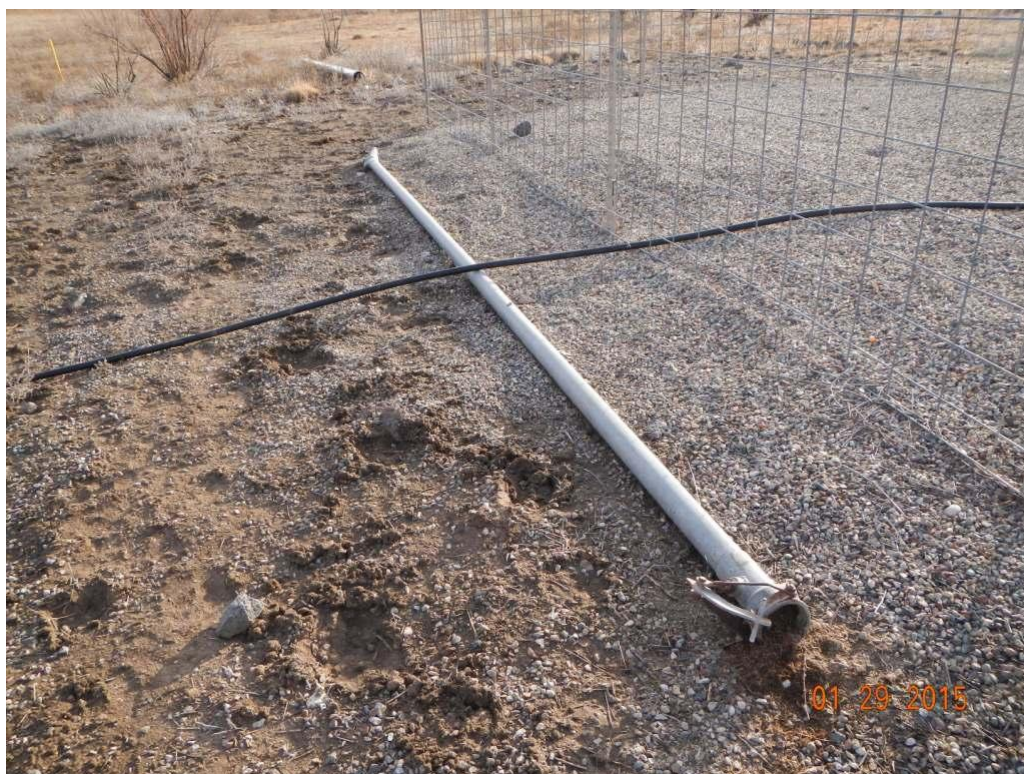
Unused equipment.
