Knight W 6-4 Pad

Inspection# 675201127

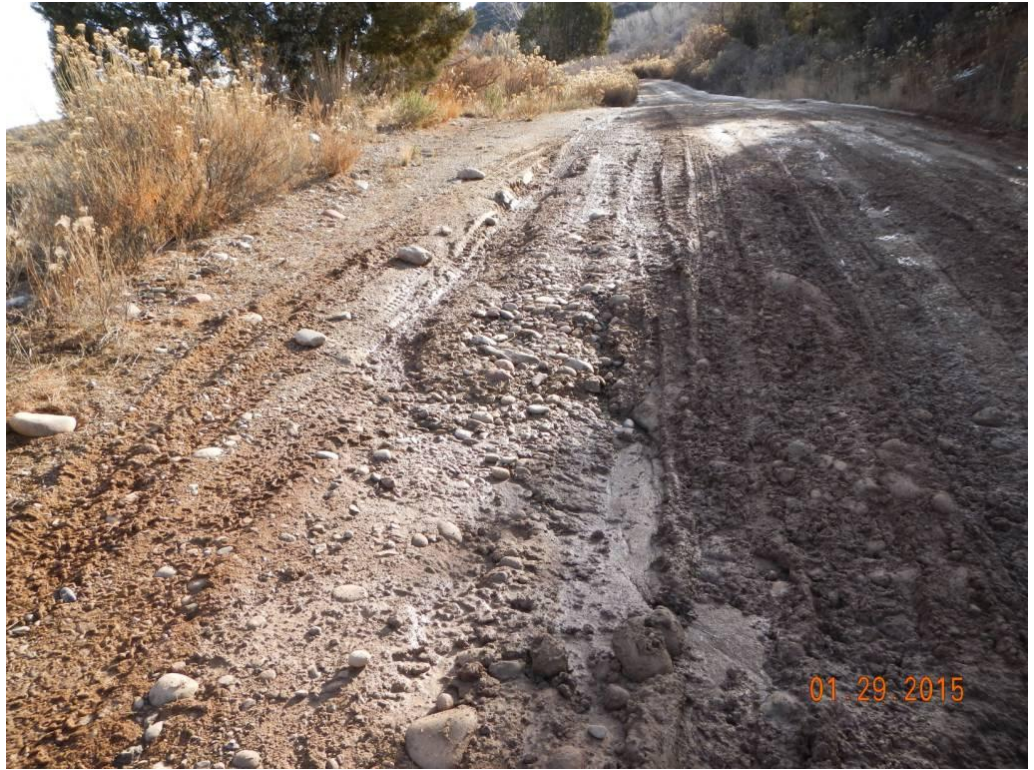
Erosion in main road way.

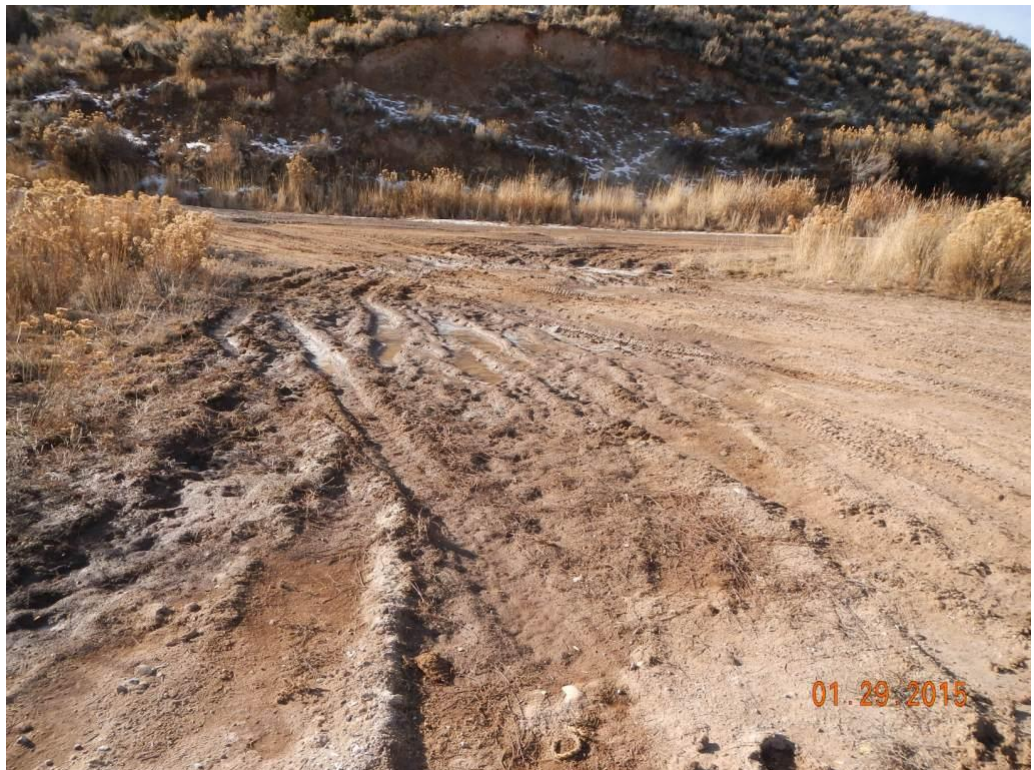
Rutting and rilling at entrance to location.

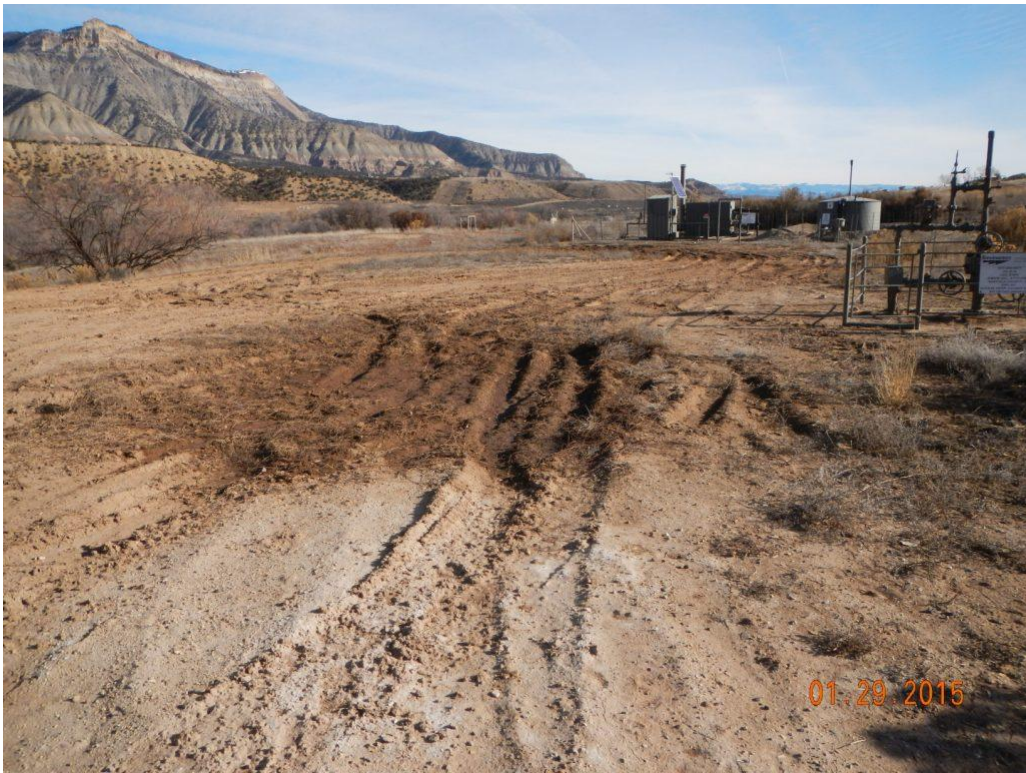
Subsidence on location.
