## GV 64-5 Pad

Inspection# 675201130

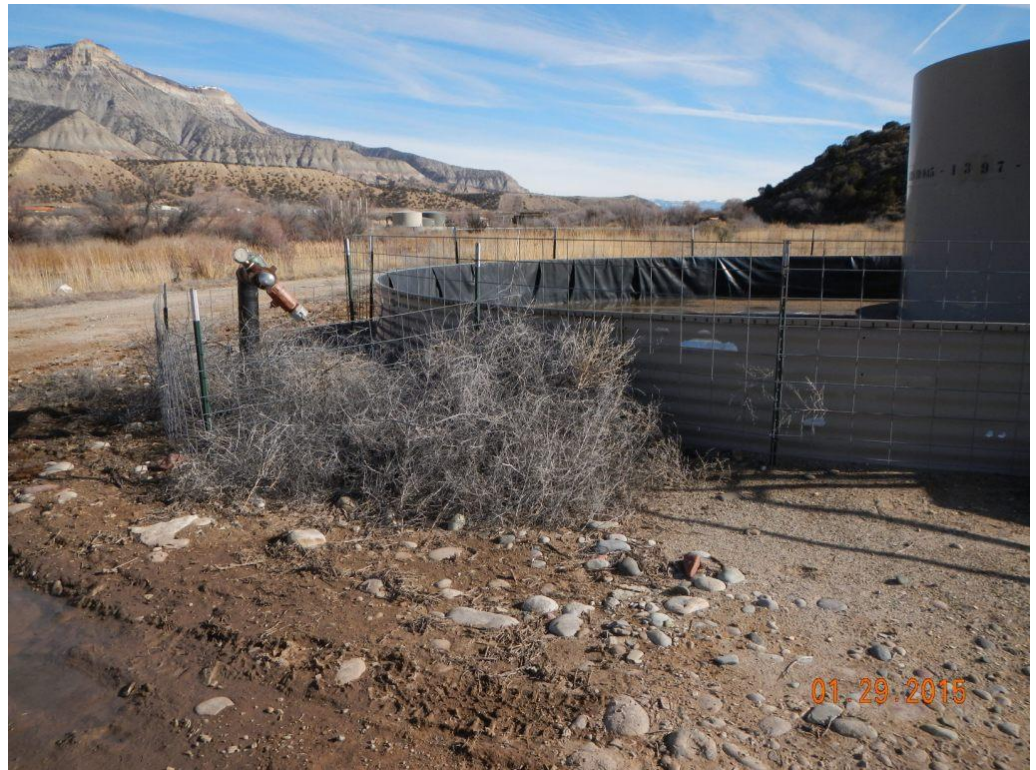
Debris by tank.

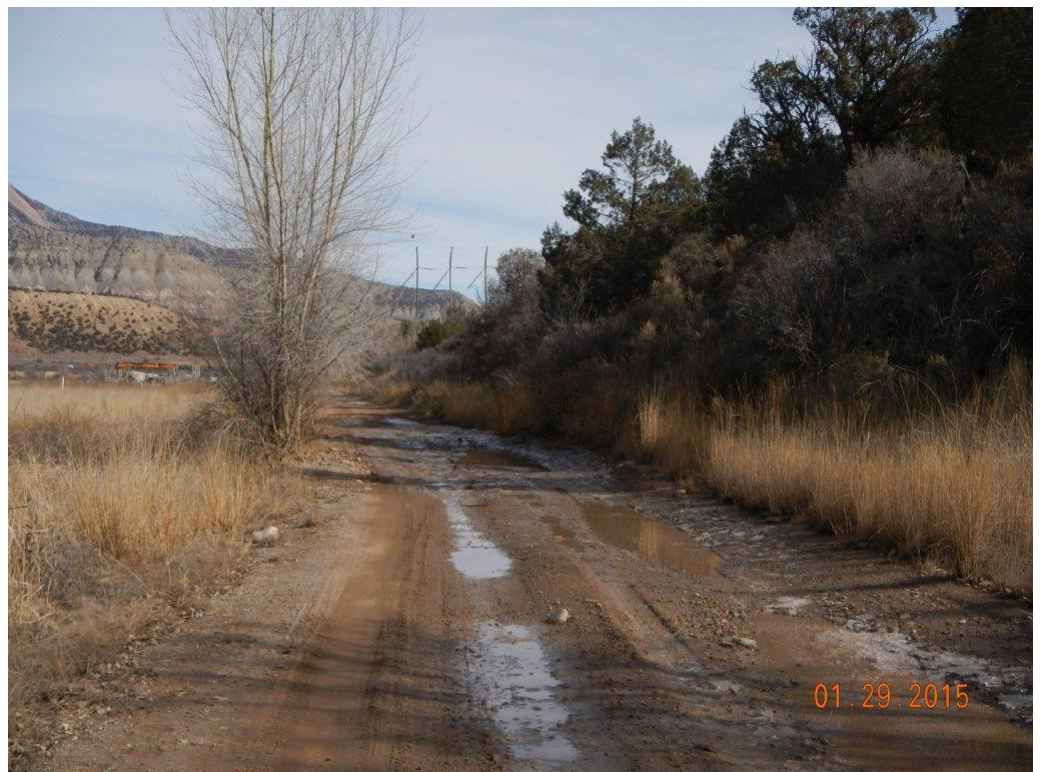
Access road with pooling.

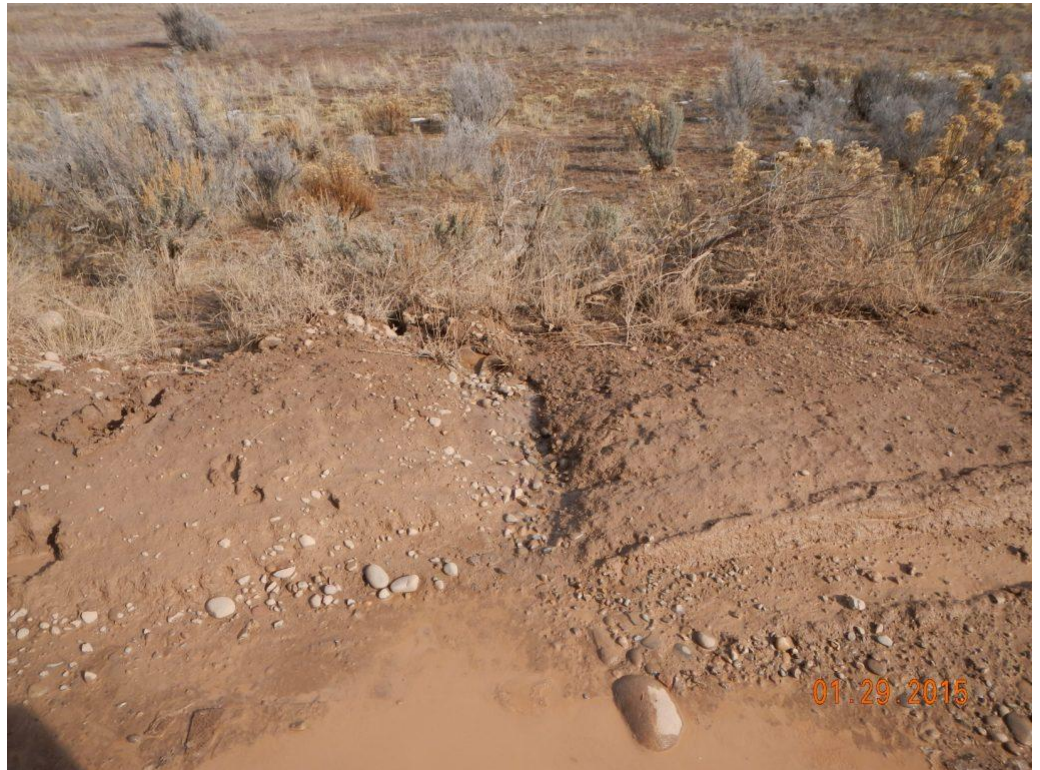
Erosion along roadside from  
exit point of roadway  
pooling.
