# WPX Energy

GM 13-3 Pad

Location # 334788

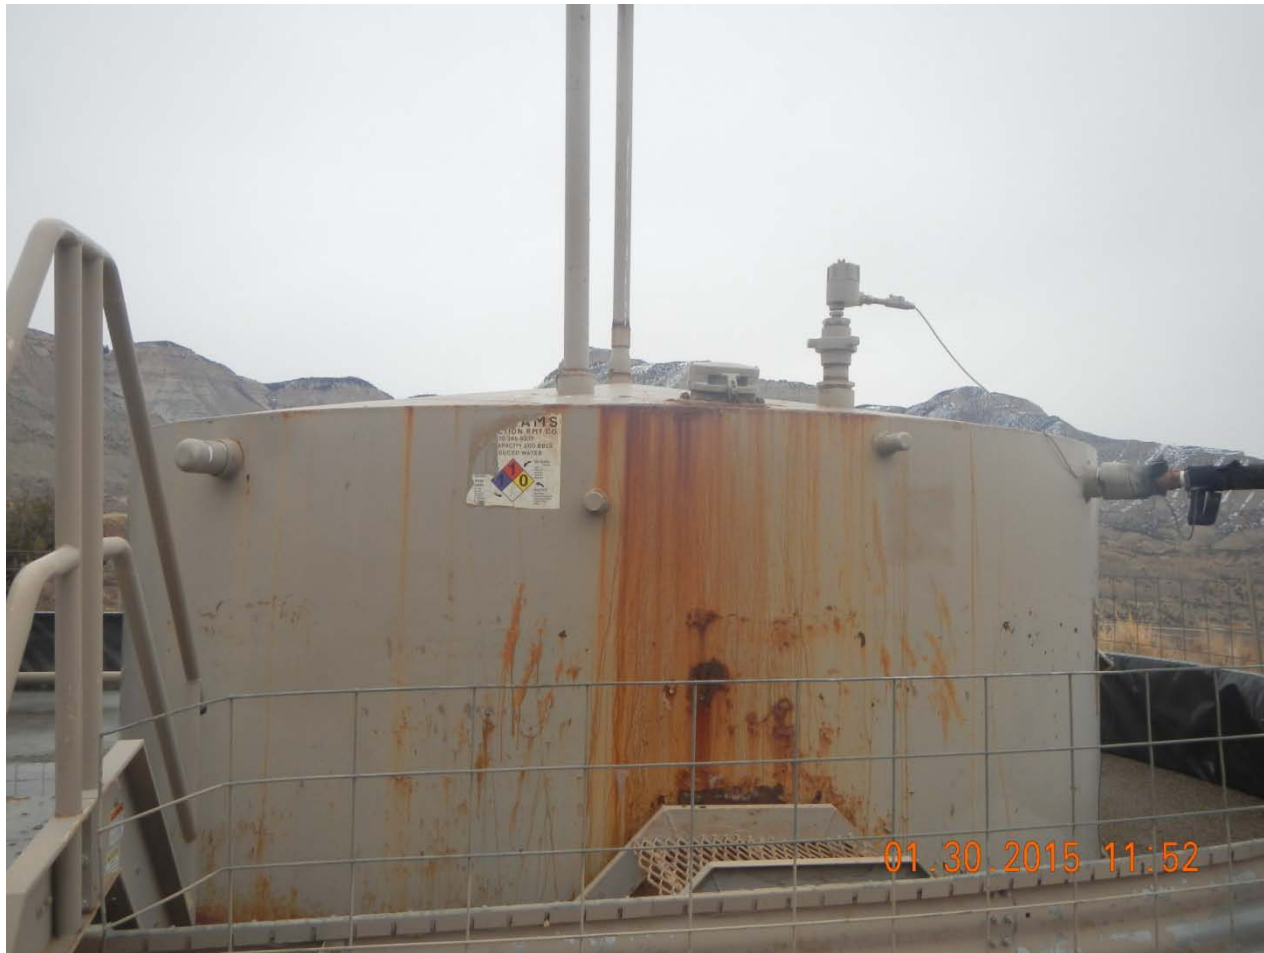
# Peeling label and rust on tank.

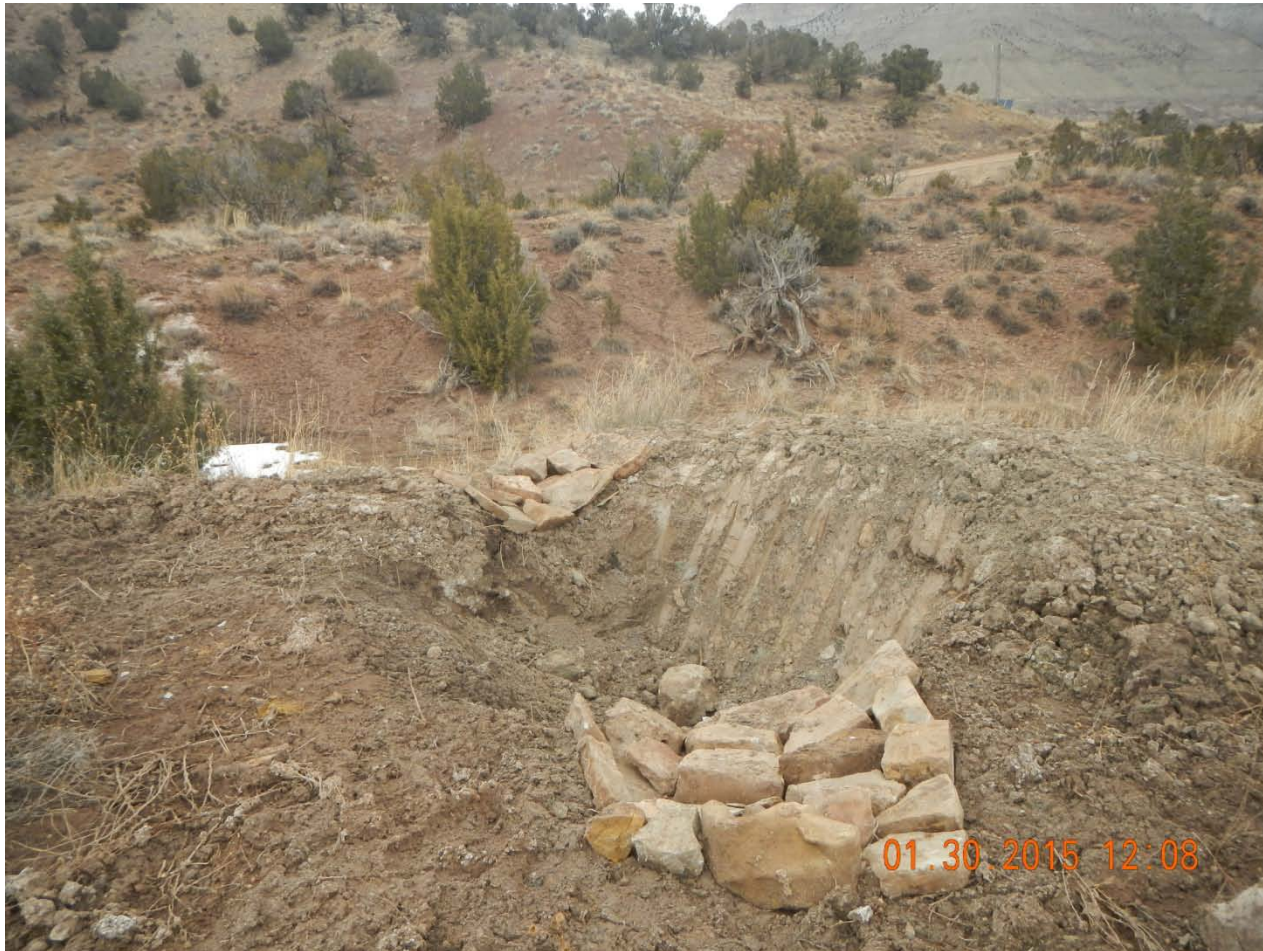
# Unfinished check dam

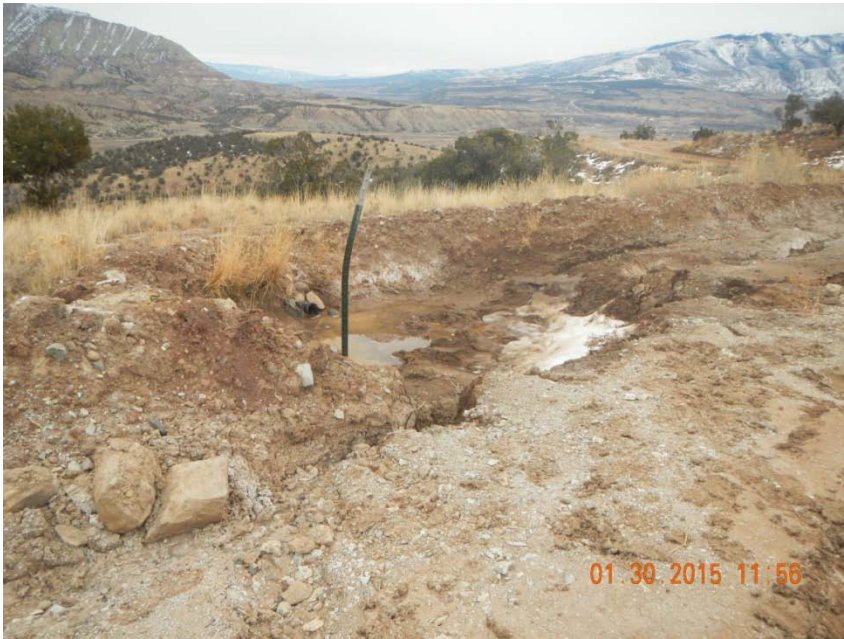
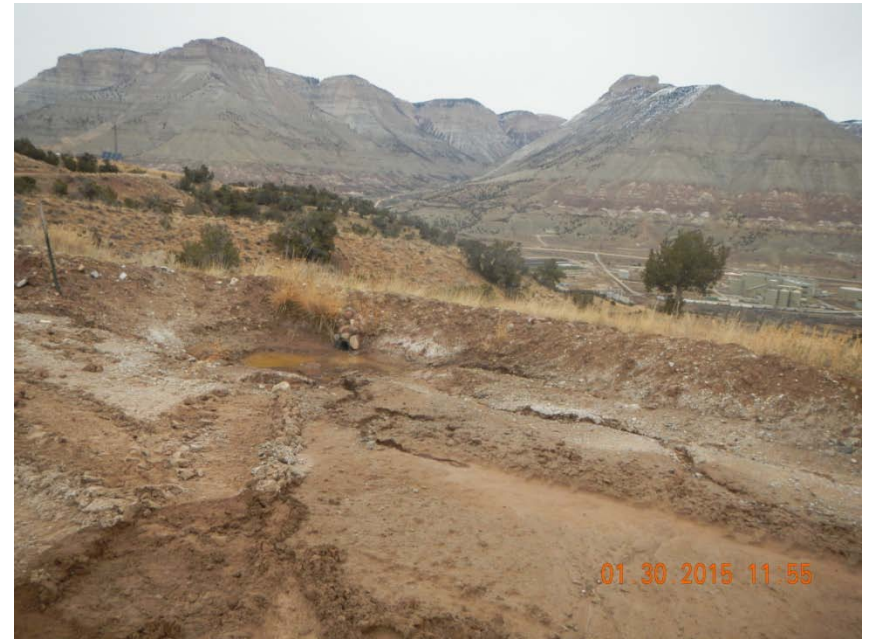
# Erosion of trap and surrounding ground surfaces

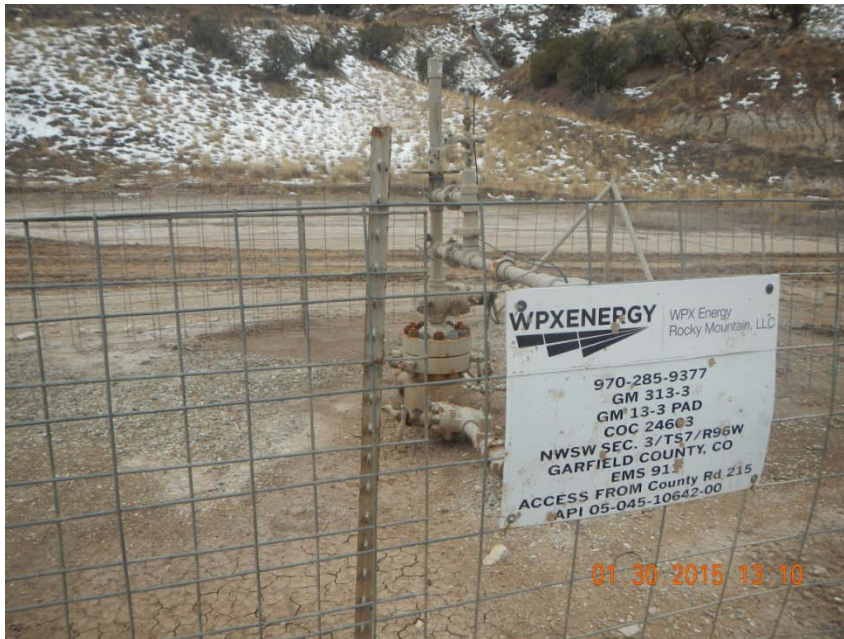
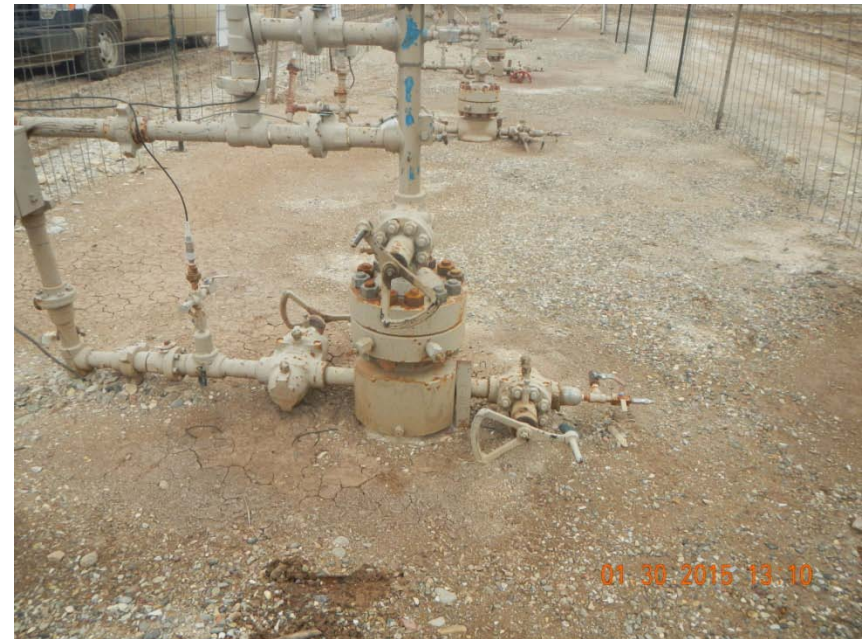
# GM 313-3 No braden head line
