Site Photos: API# 05-121-10874

Date: January 28, 2015

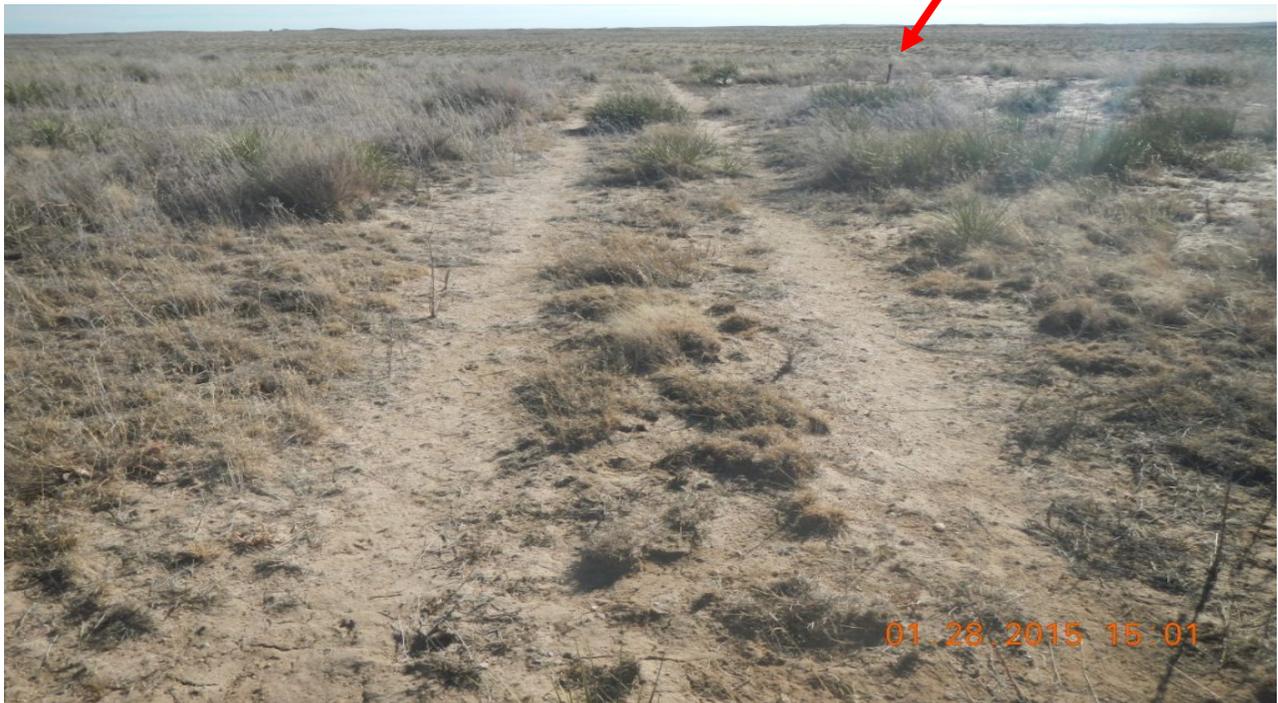
photo 1: Access road south towards the location.

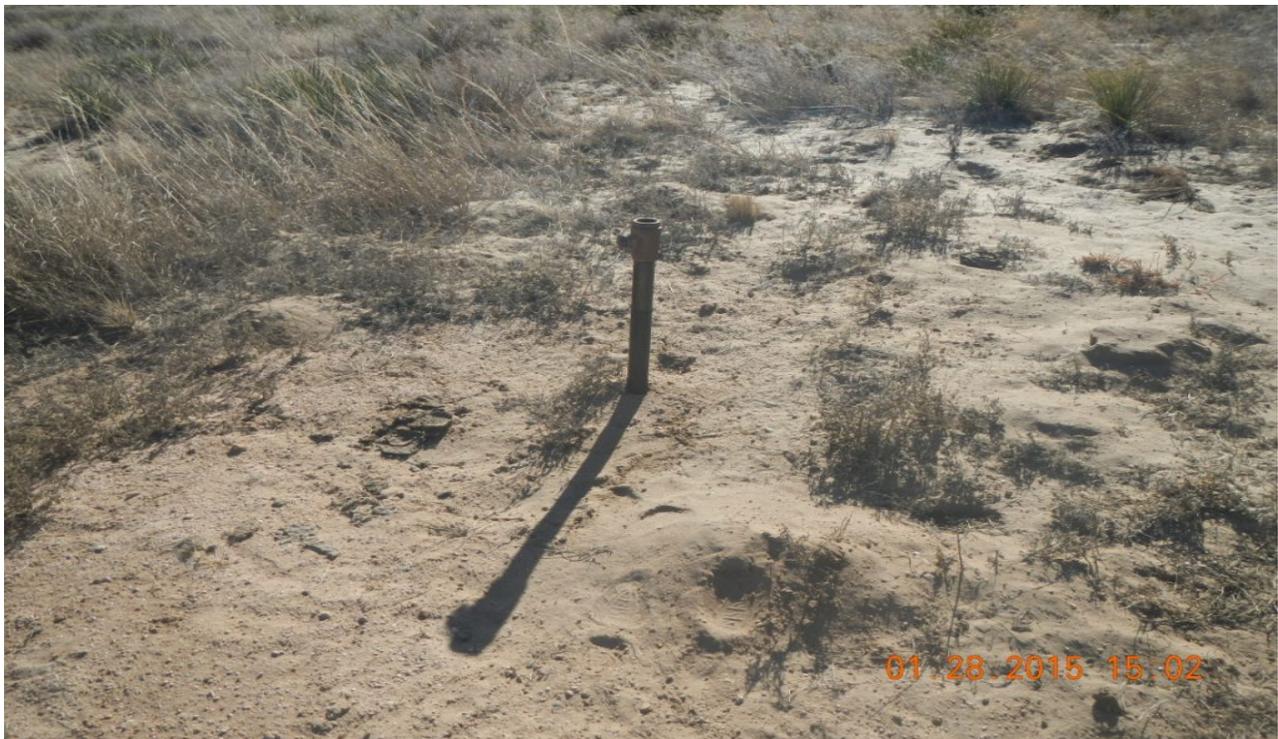
photo 2: Pipe Riser was found along the west side of the access road. 39.83686/-102.85991

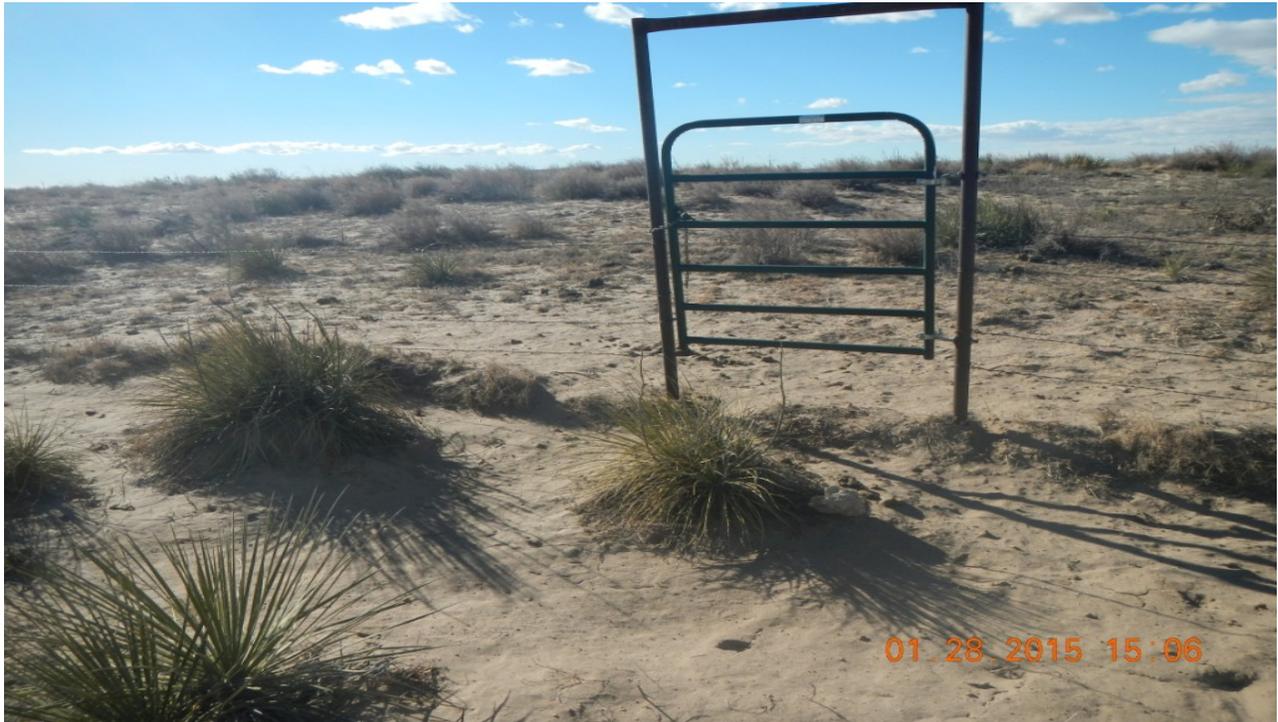
**photo 3:** Gate and perimeter fence remain around the location.

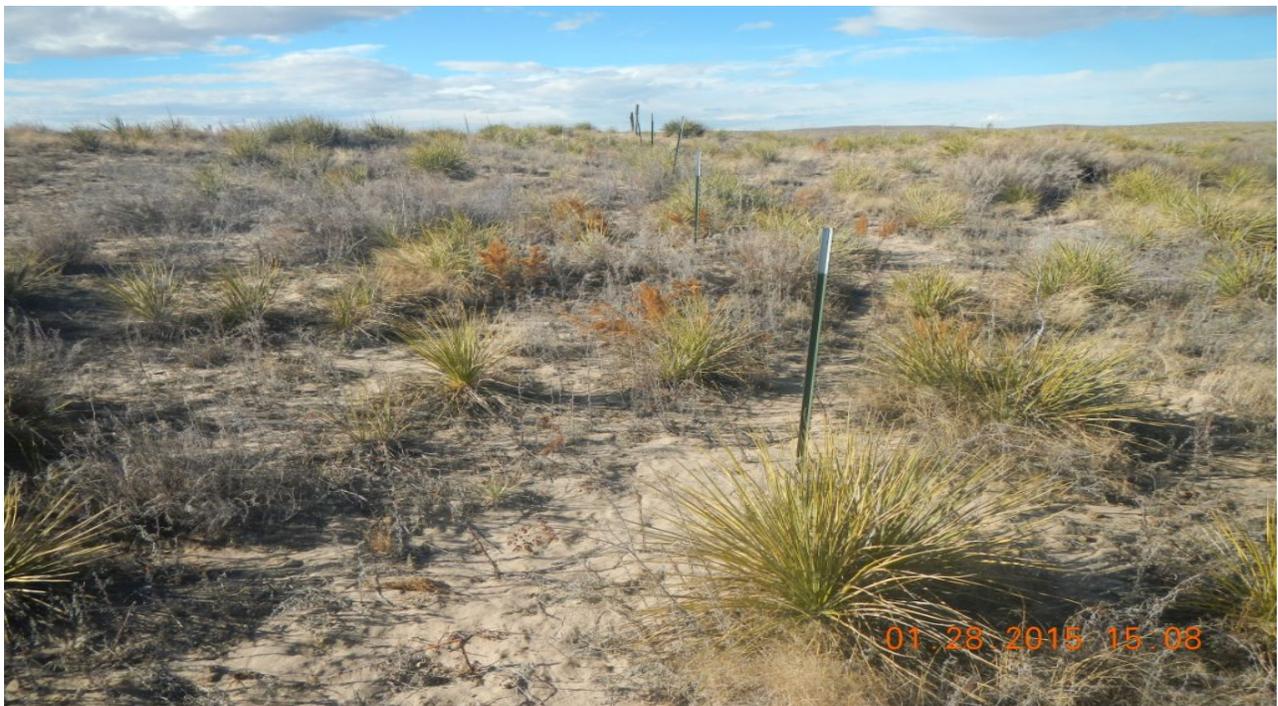
**photo 4:** There was no wire/fencing along the northeast side of the location

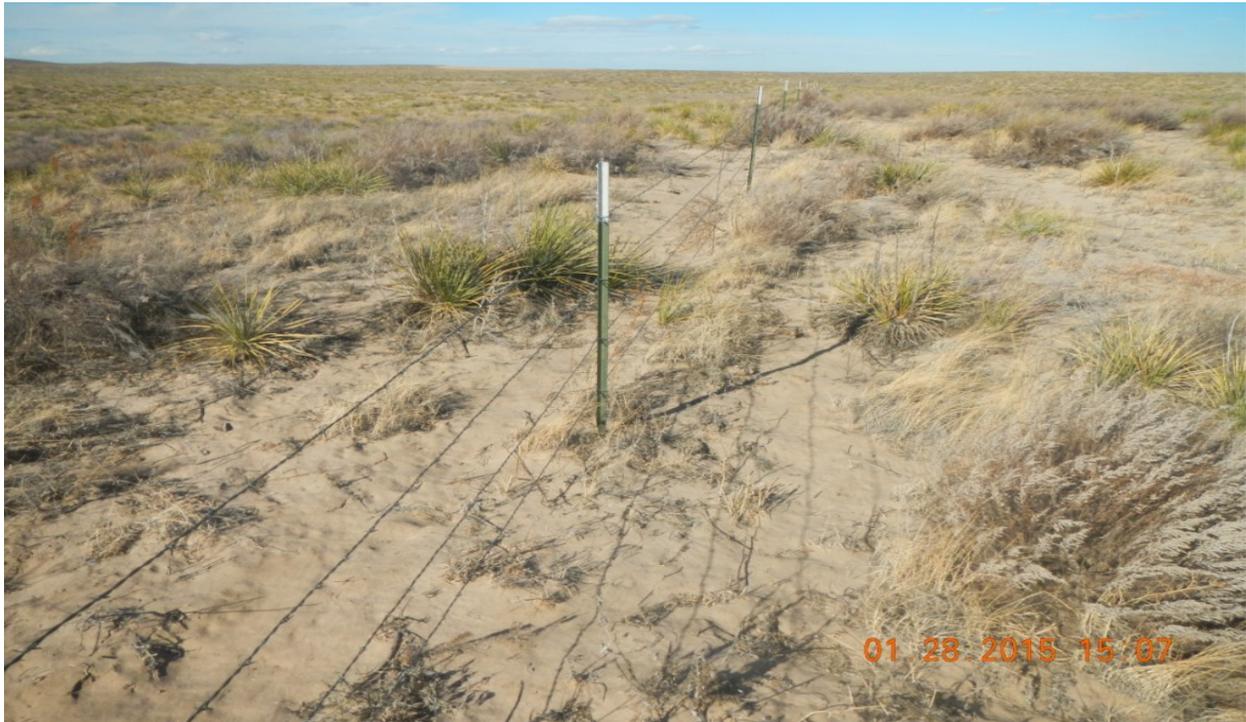
photo 5: Fence appeared to be in good condition on the west side of the location.

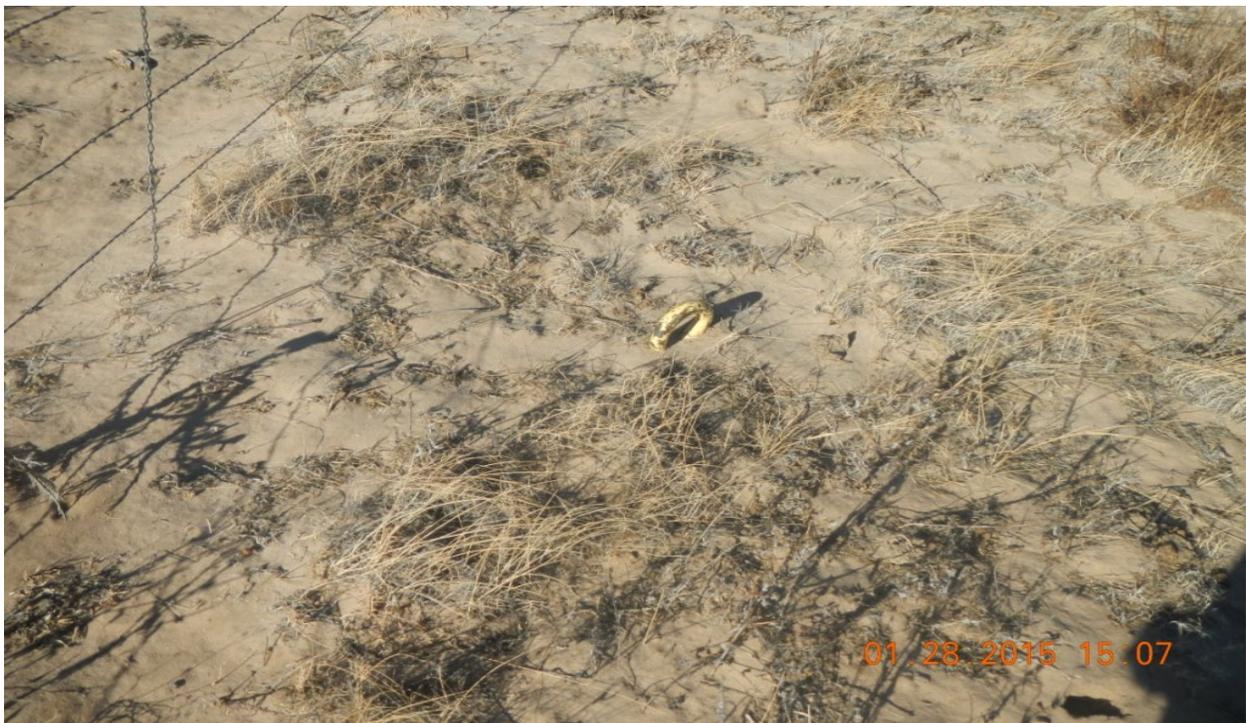
photo 6: Guy line anchor was found at the west side of the location at 39.83344/-102.86319

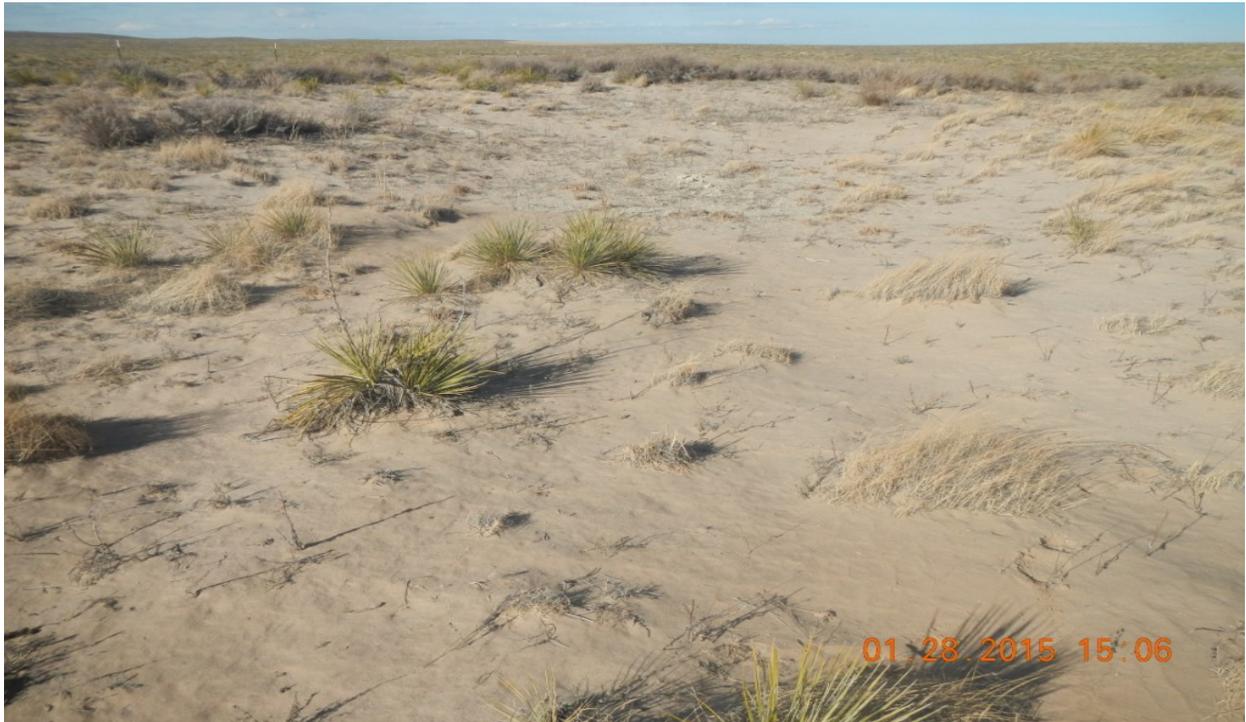
**photo 7:** Area in the center of the location had sparse vegetation approx. 100'x50' in size.

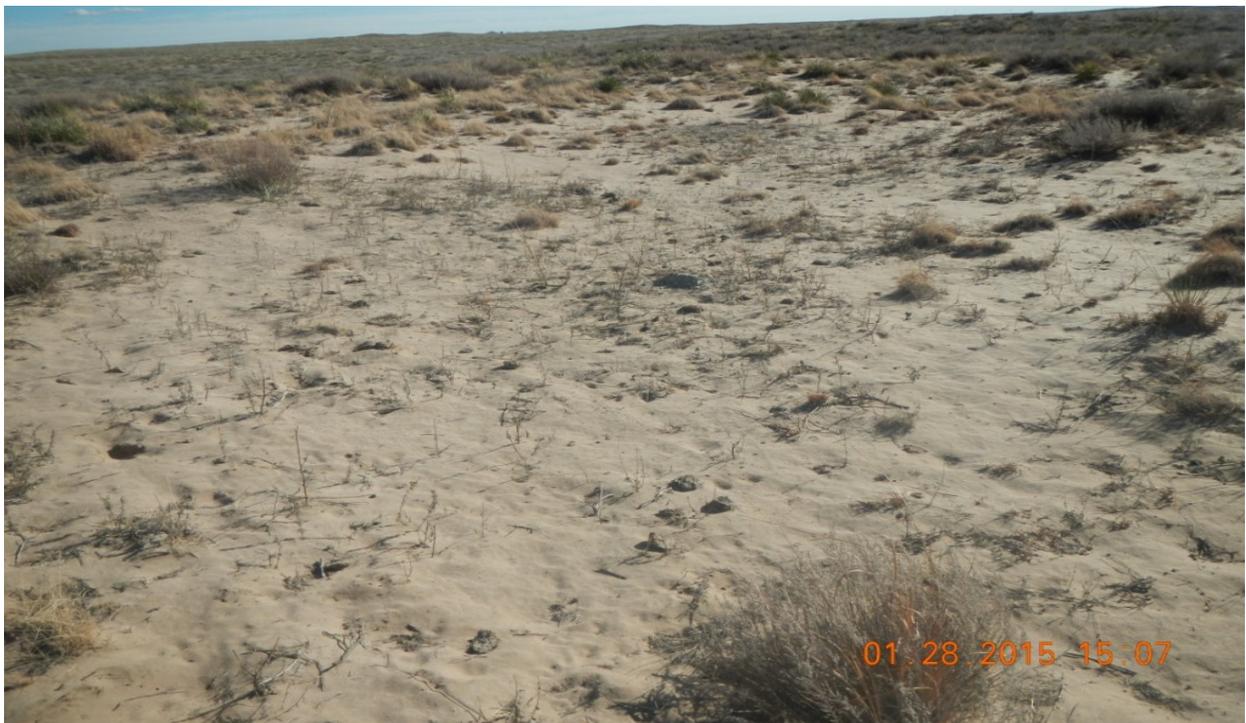
**photo 8:** Facing south at center of the location. Bare are with sparse vegetation 100'x50' in size.

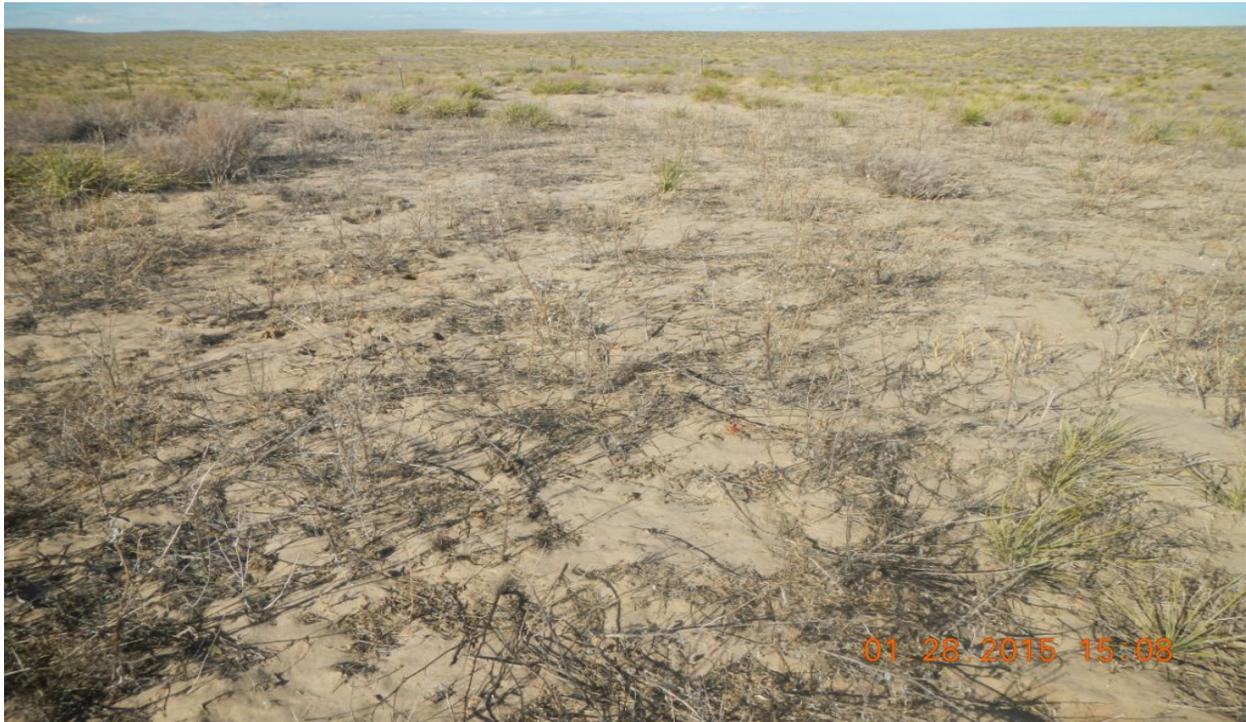
photo 6: North side of the location has sparse inadequate vegetation cover.

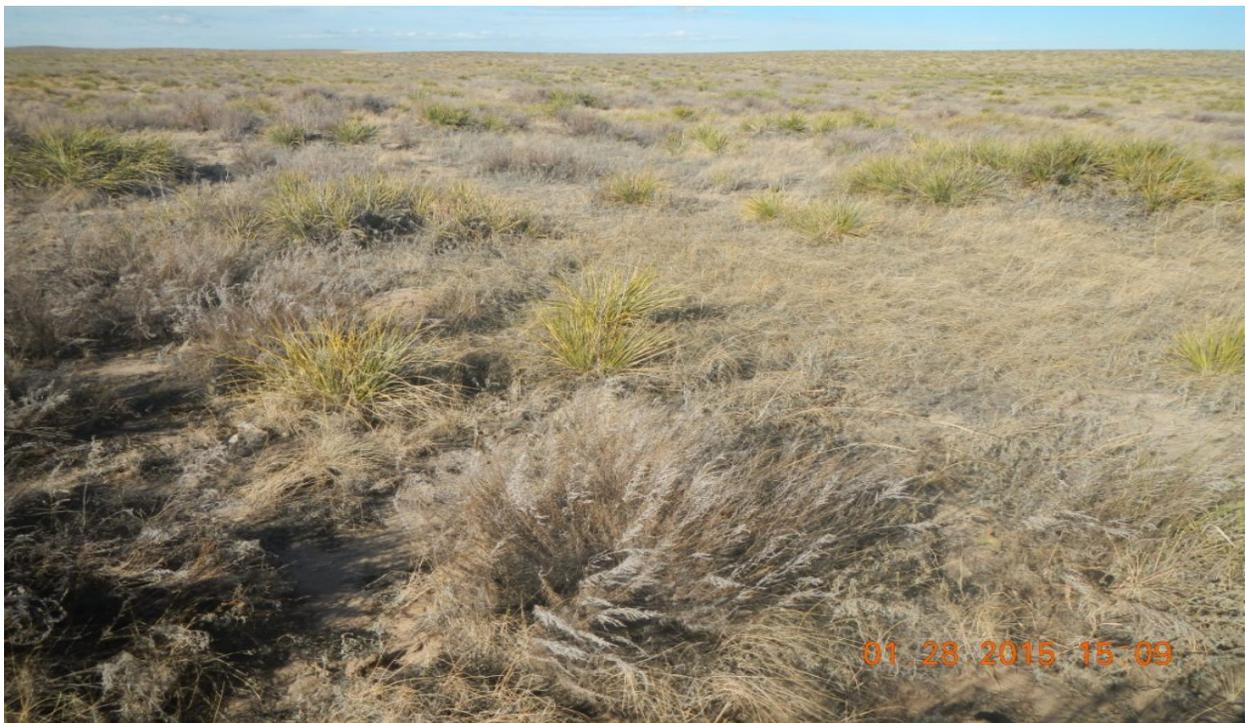
photo 6: Facing north, surrounding vegetation outside of the location.
