XTO Energy
Hein 1-2 API 067-09816
Field Inspection Photos 2/4/15

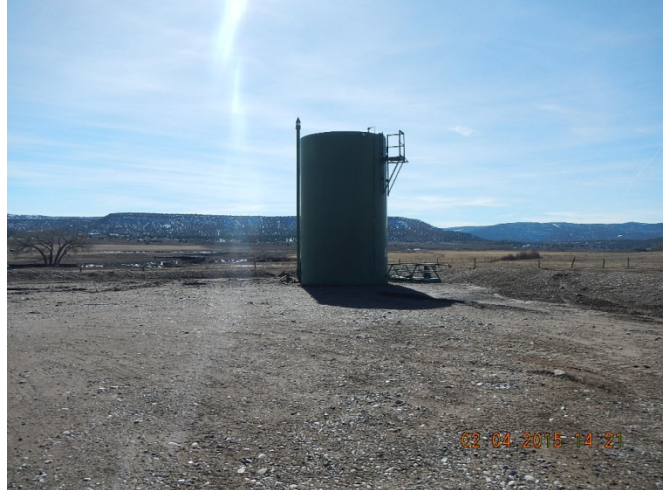
Out of service/ 500 bbl produced
water tank.

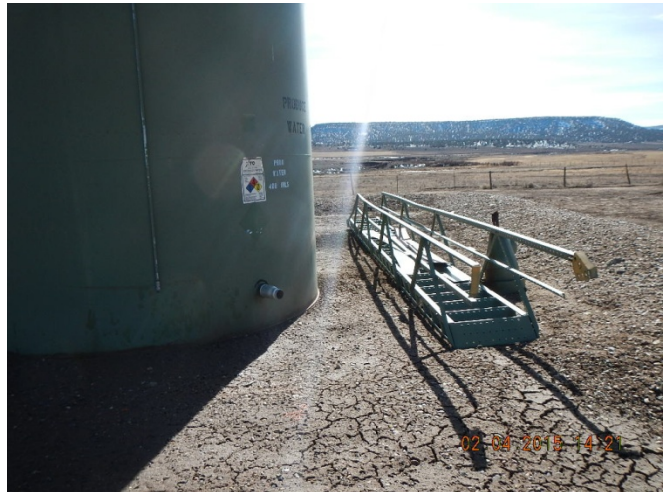
Unused equipment on well pad; Tank,
stairs, etc.

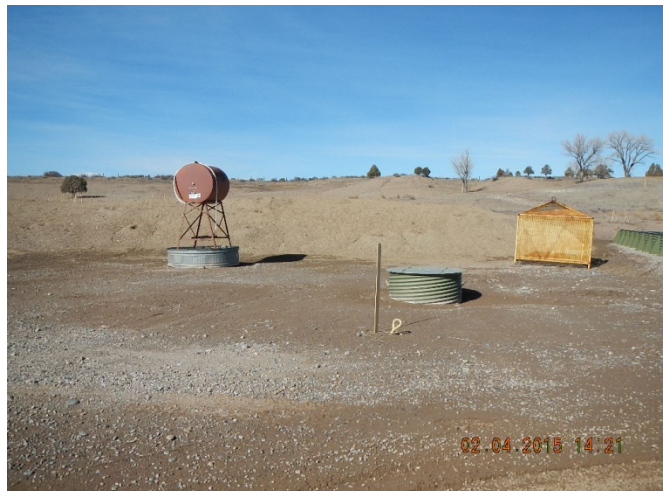
Unused equipment on well pad.
Methanol tank, etc.

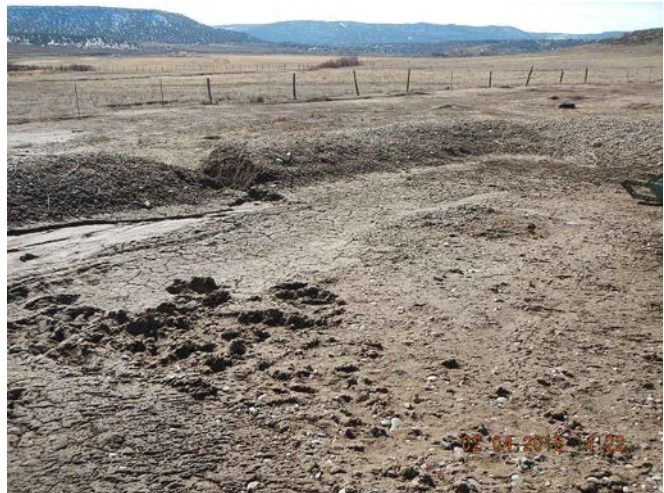
Breech in location berm; repair needed.

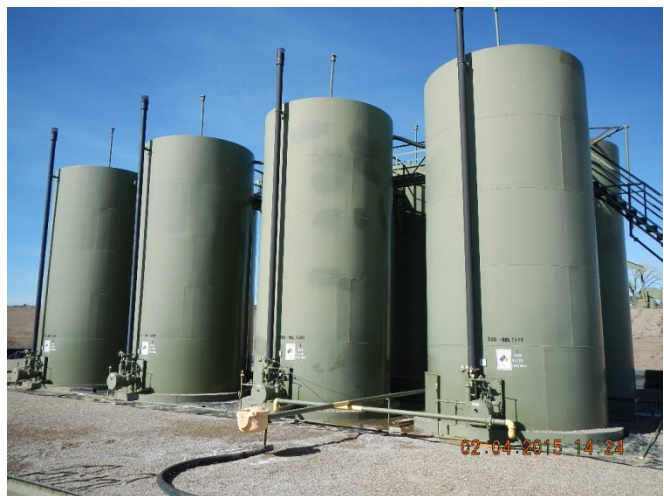
Tank signage needs to be added at battery; to include all components of 210d and list of individual wells being serviced by battery.

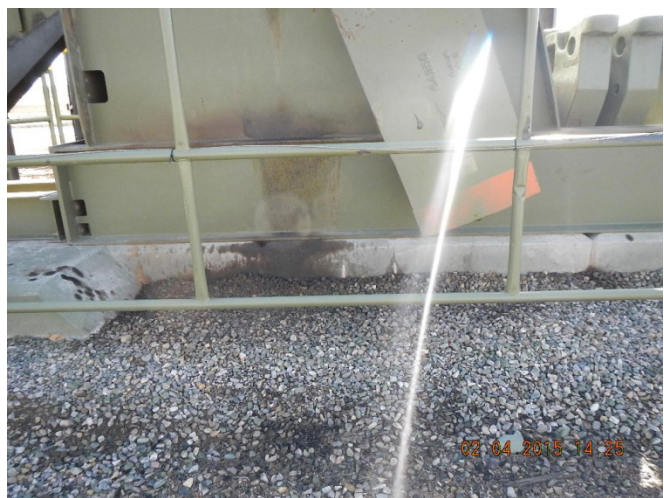
Stained gravel under leaking gear box
