# WPX Energy

Federal GM 32-34 Pad

Location # 335164

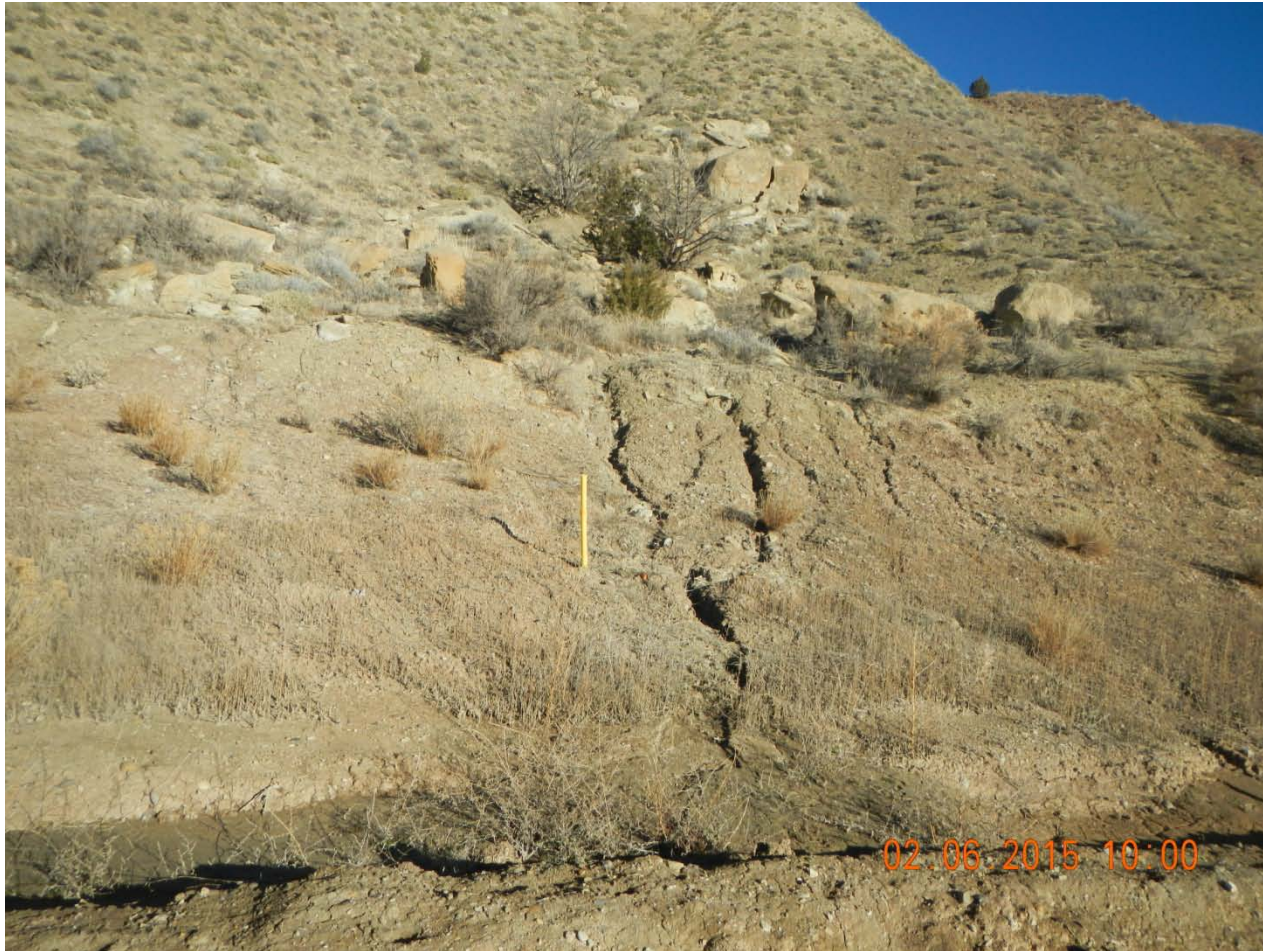
# Erosion rills on slope

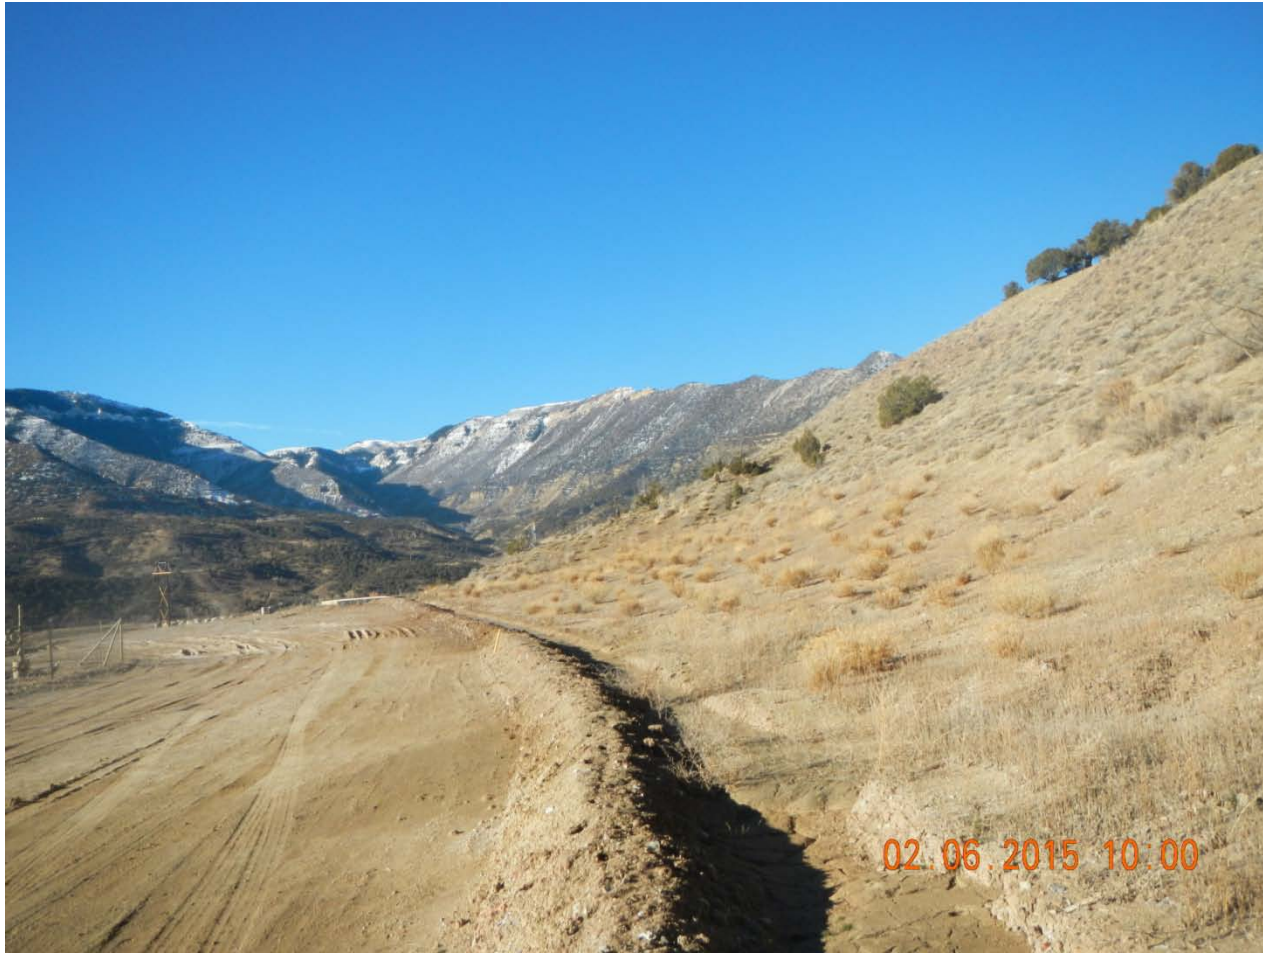
# Sediment build up in run on ditch

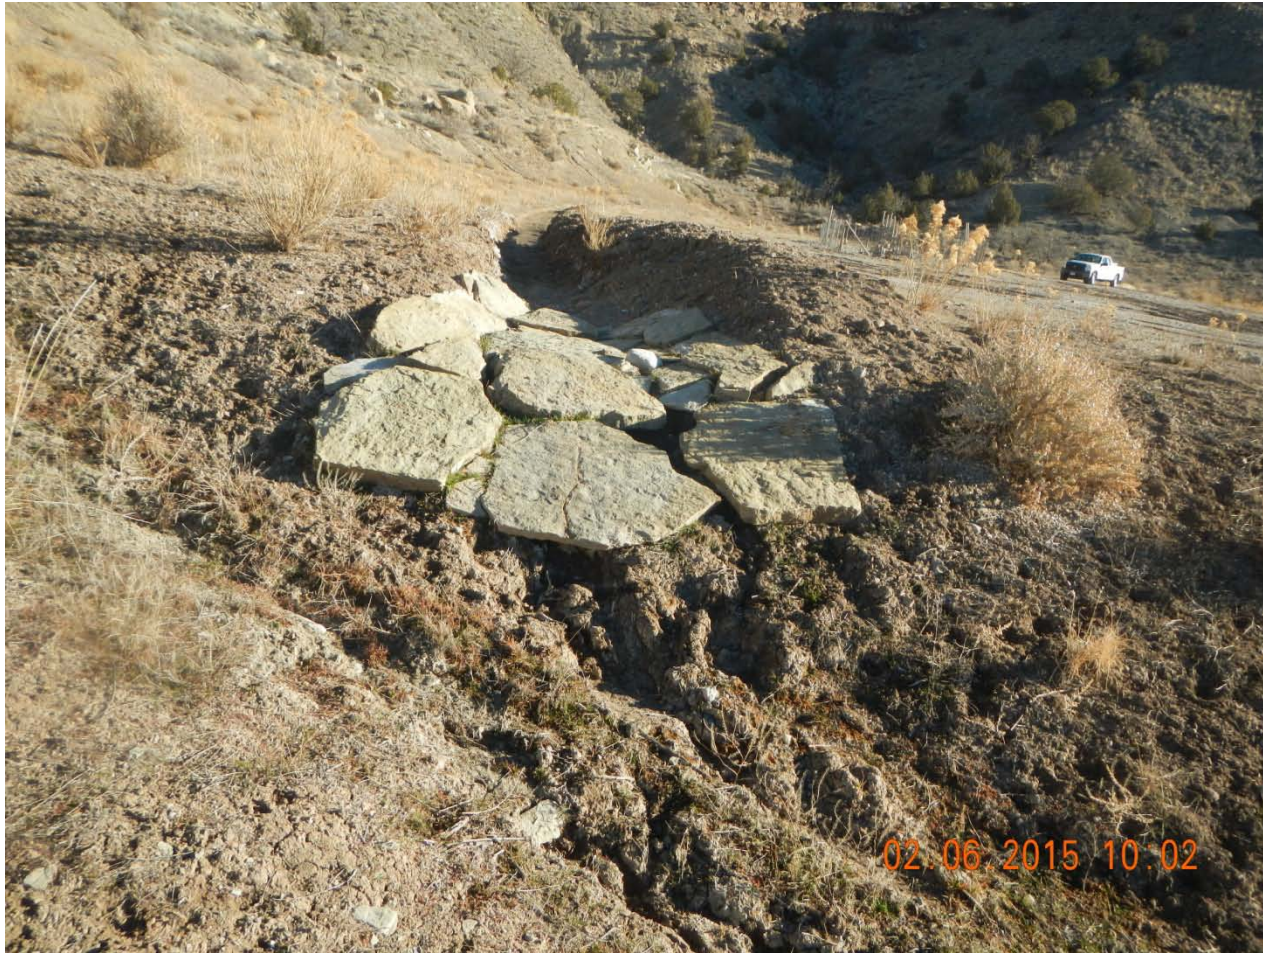
# Erosion rills at outlet of run on ditch

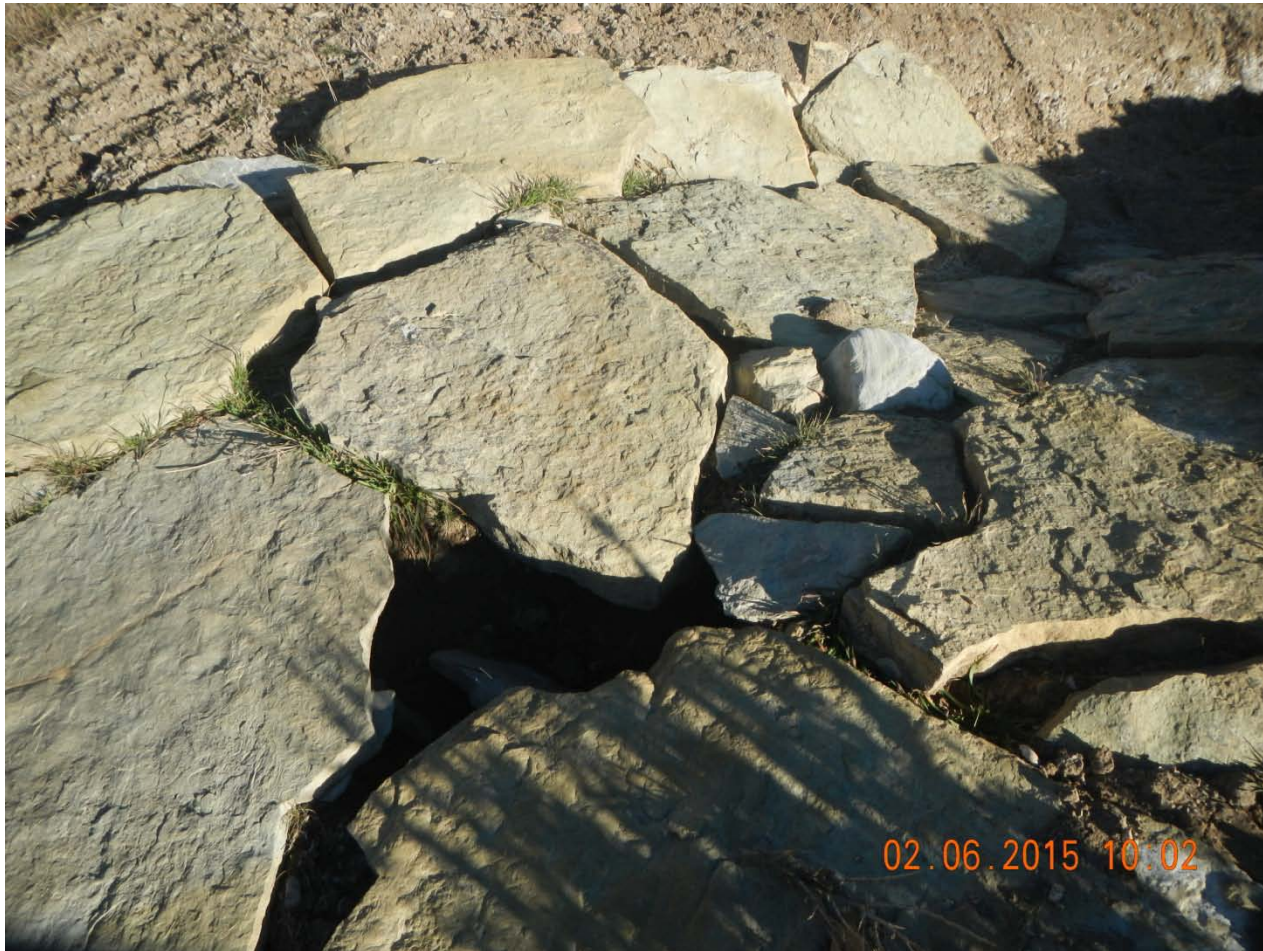
# Erosion under riprap.

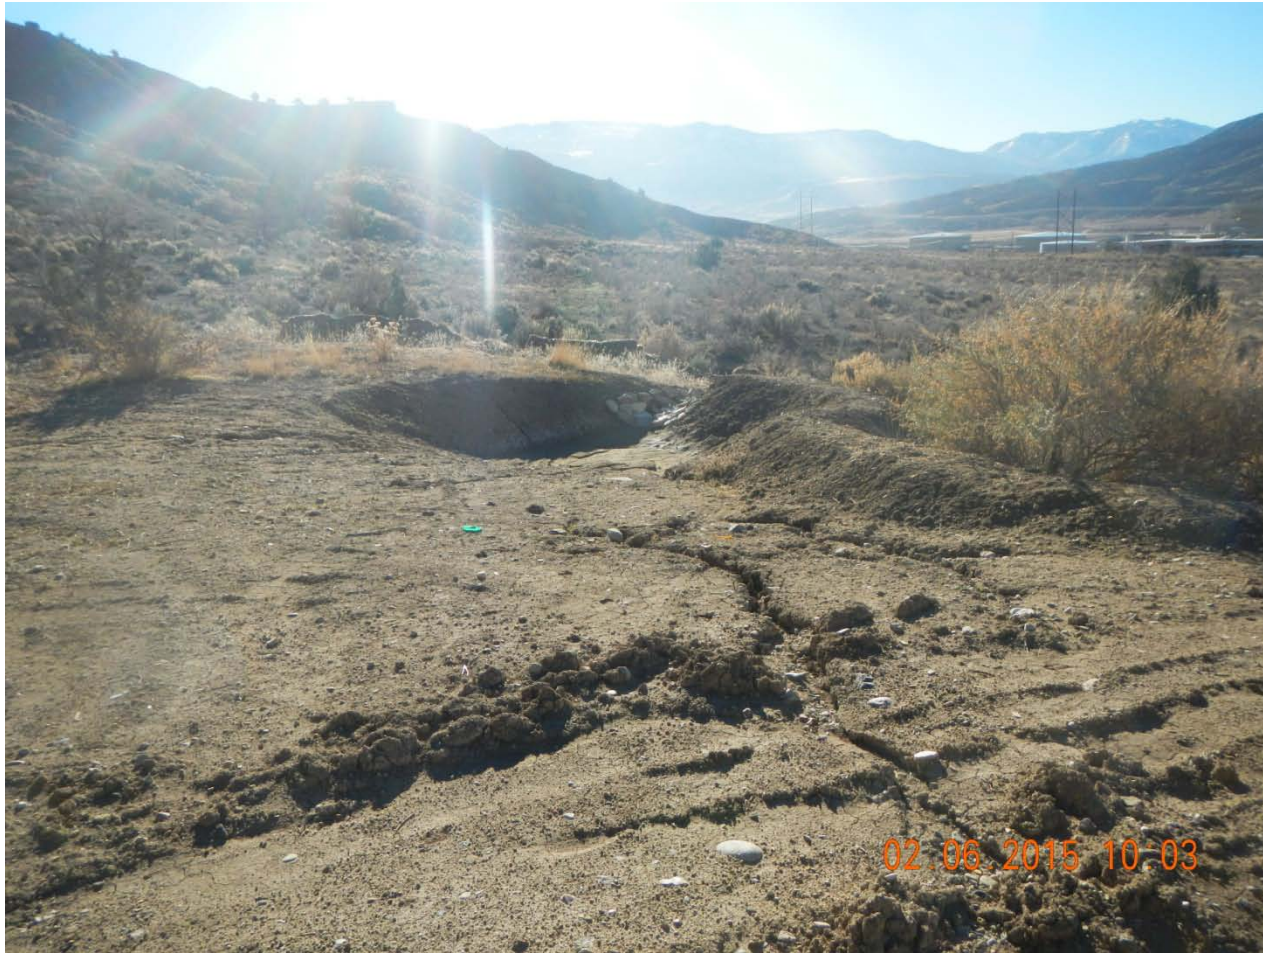
# Rills running into check dam.

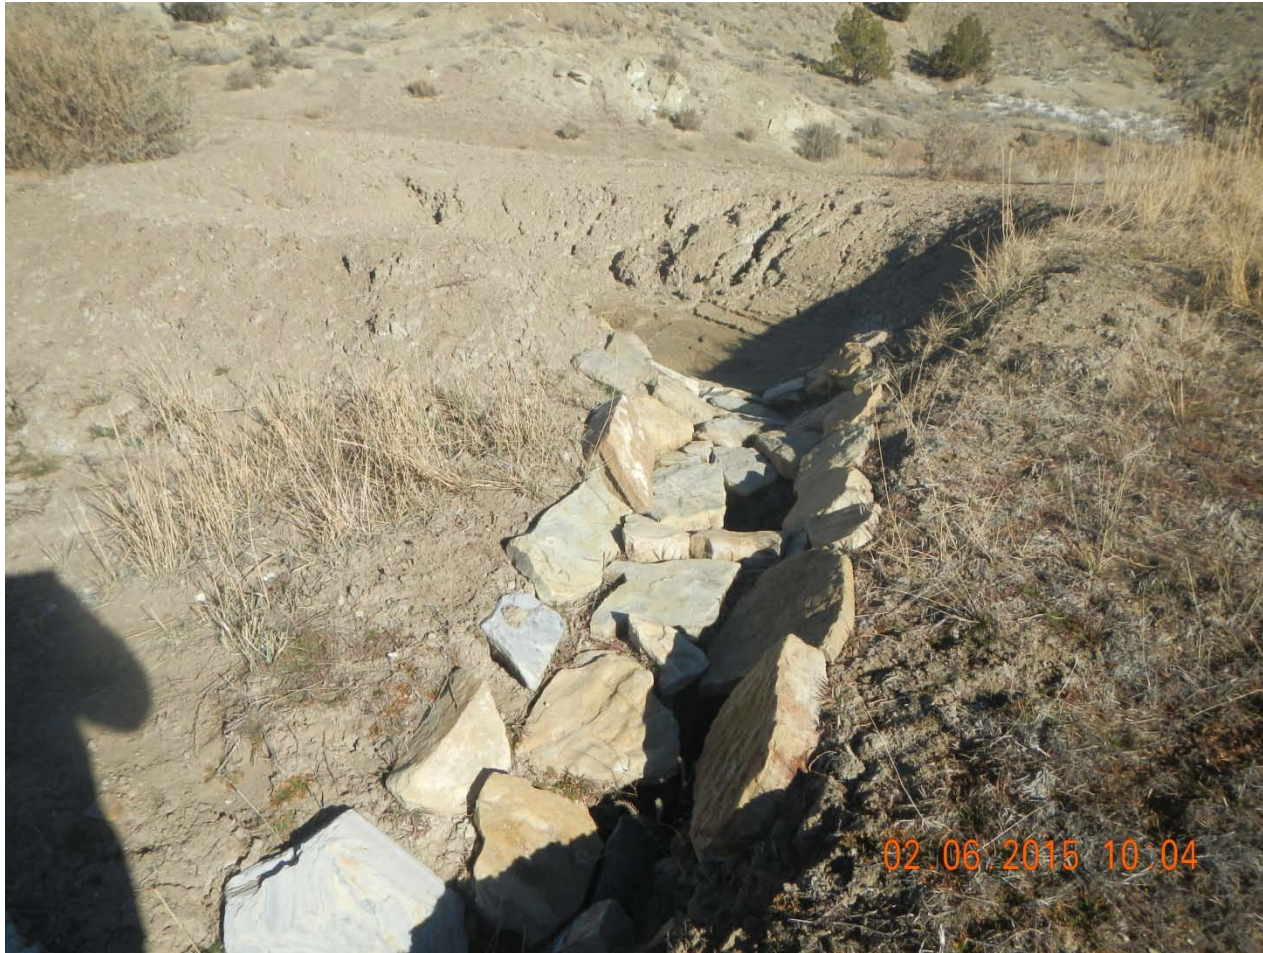
# Erosion under rip rap of the outlet

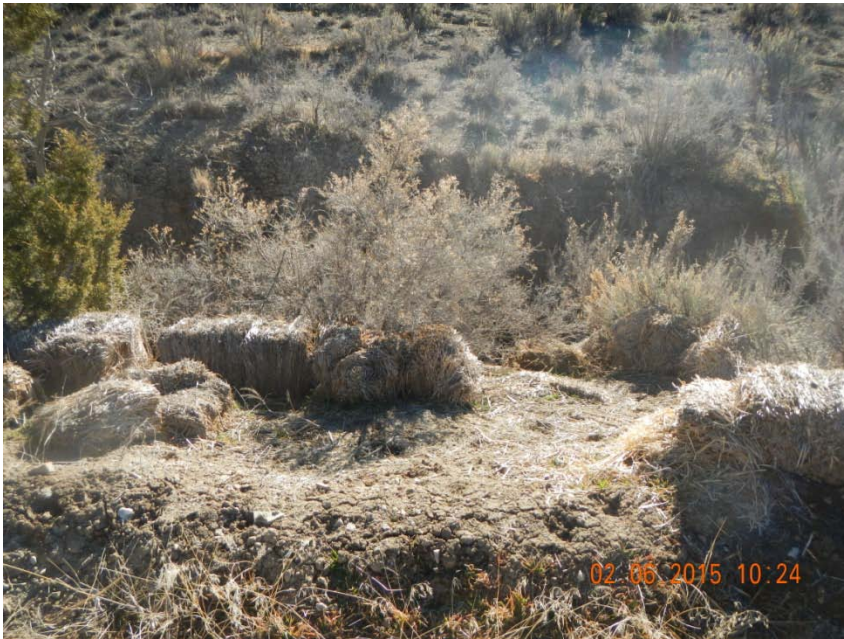
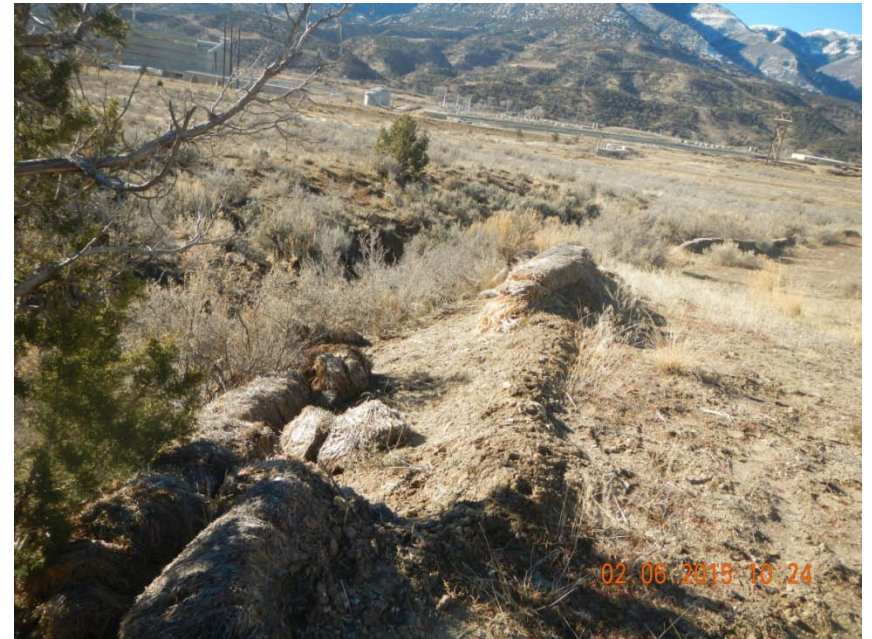
# Damage and displaced straw bales
