WPX Energy

GM 235-34

Location # 324105

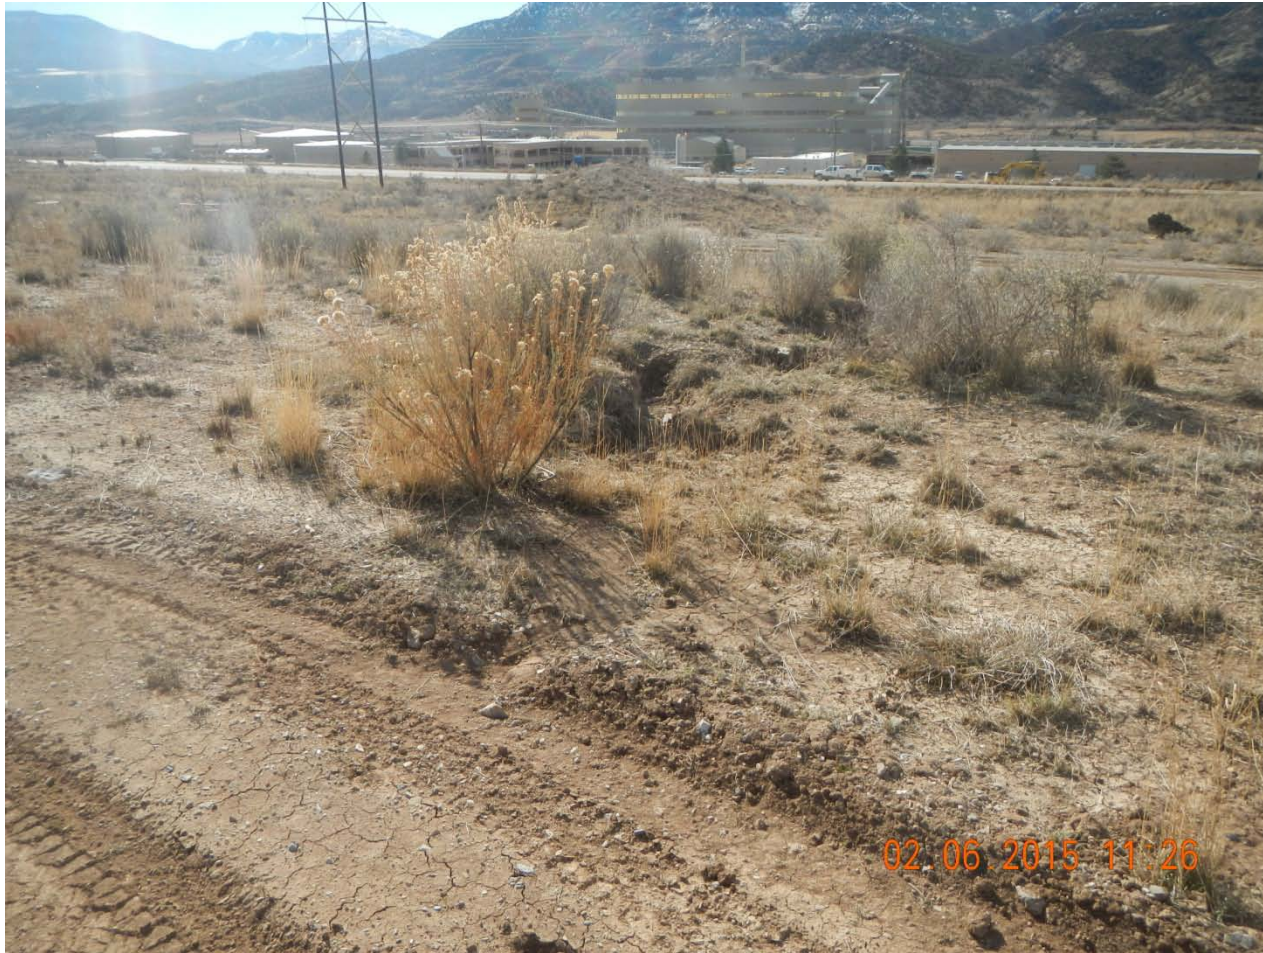
Erosion rill running off location

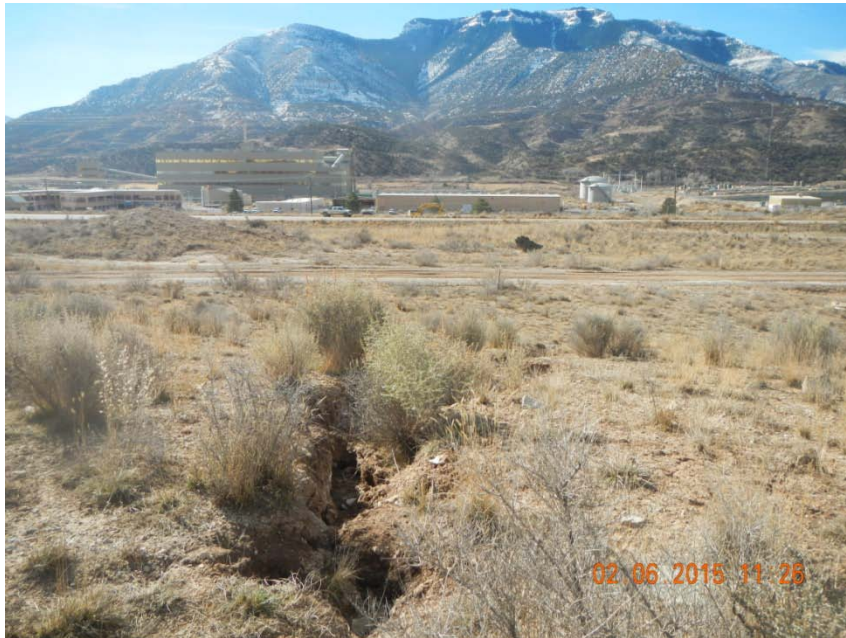
Erosion rill running off location

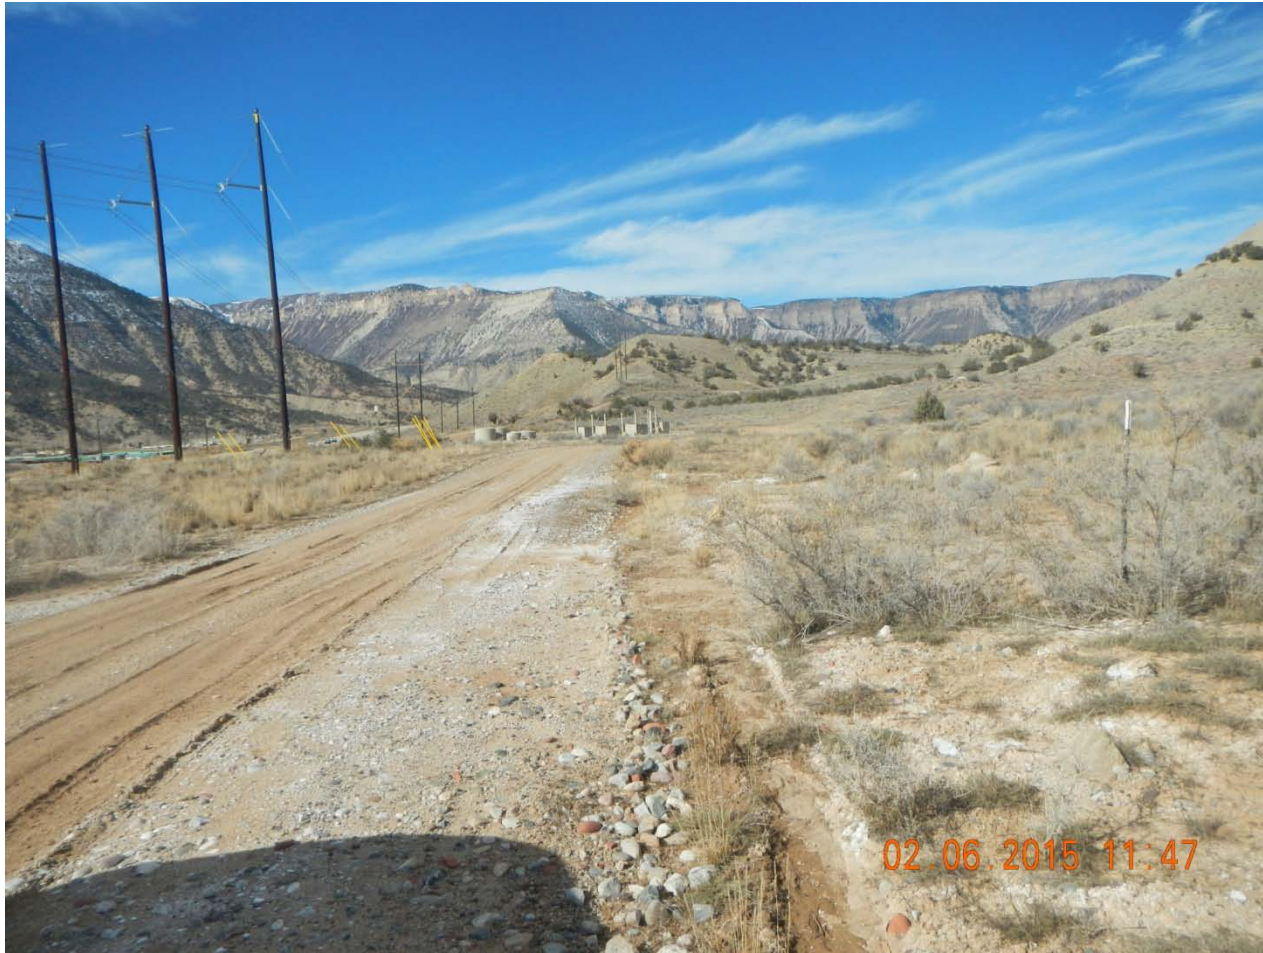
Ditch filled with sediment

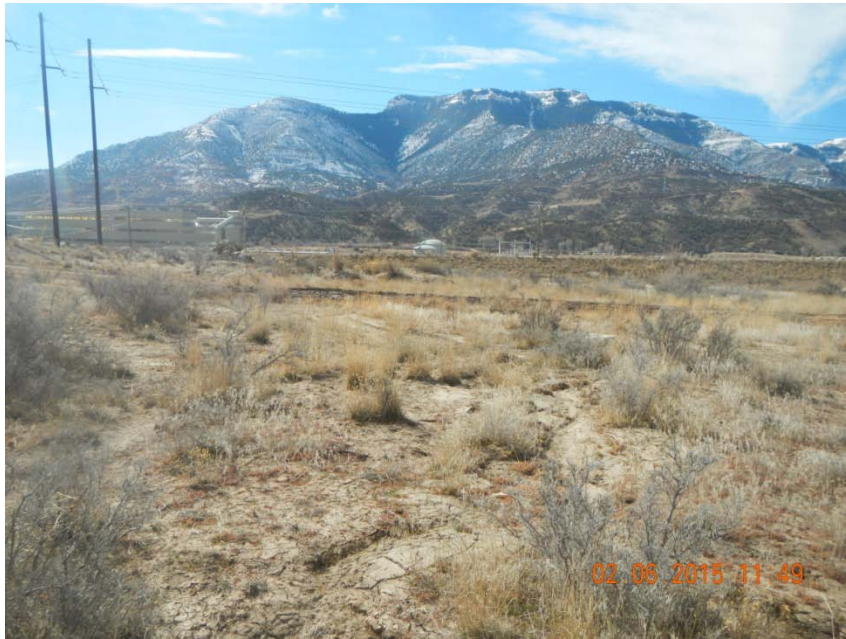
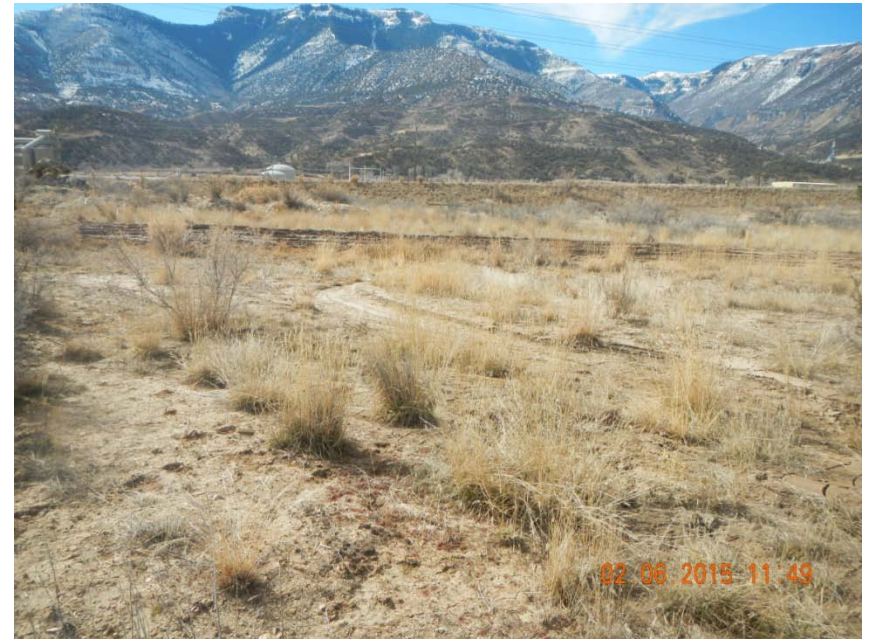
Sediment flow headed to access road.

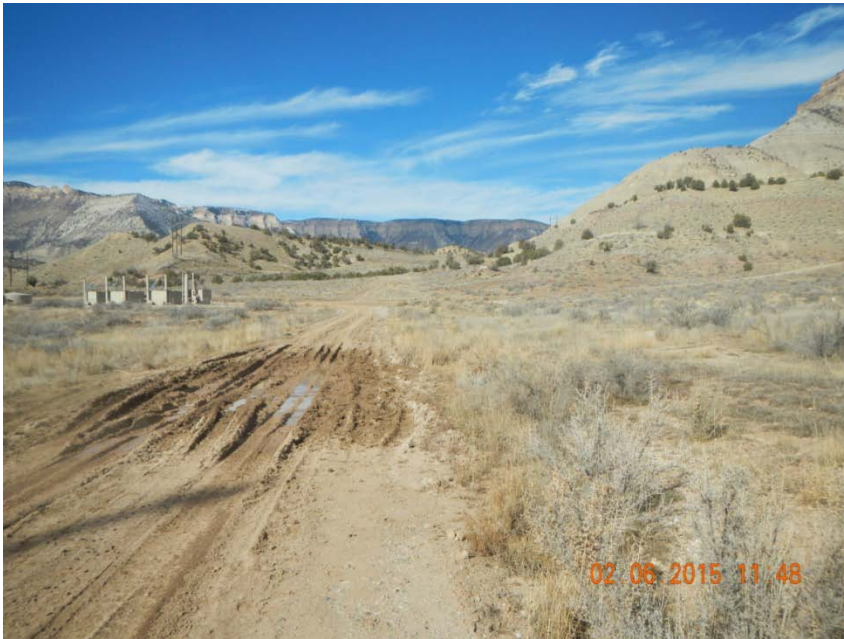
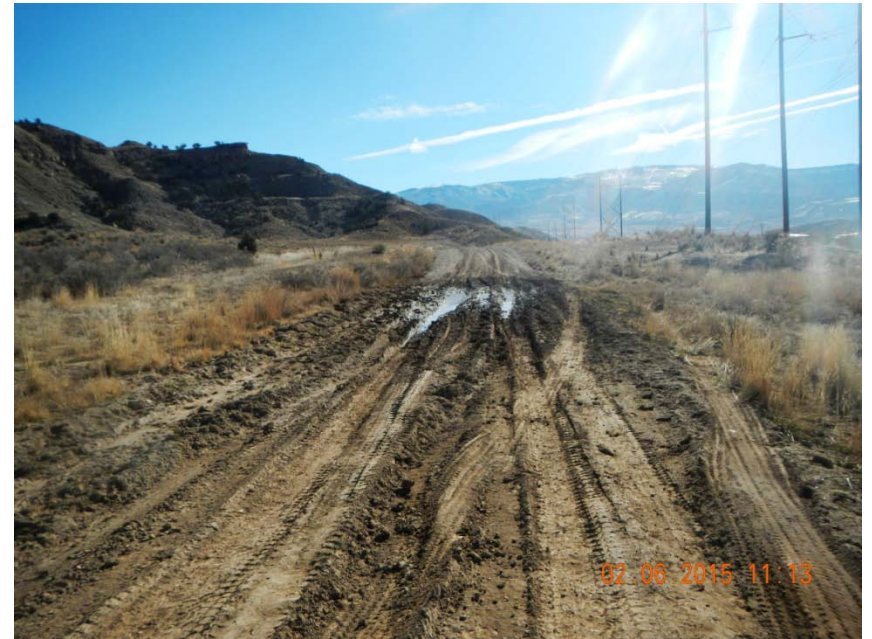
Mud hole in road from storm water flow over road.
