WPX Energy

GV 23-34 Pad

Location # 335261

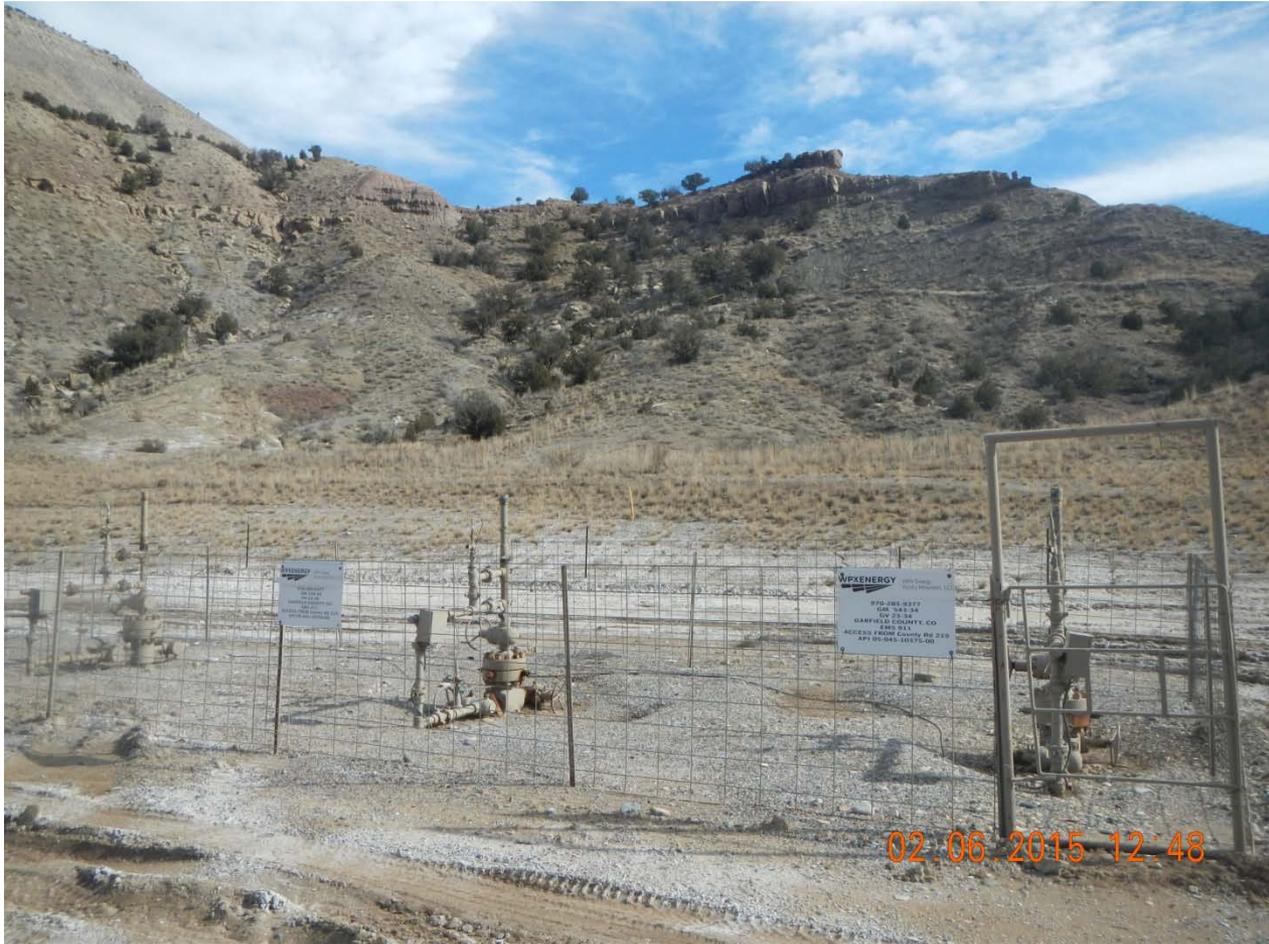
No BMPs to prevent storm water flow from seeded slope

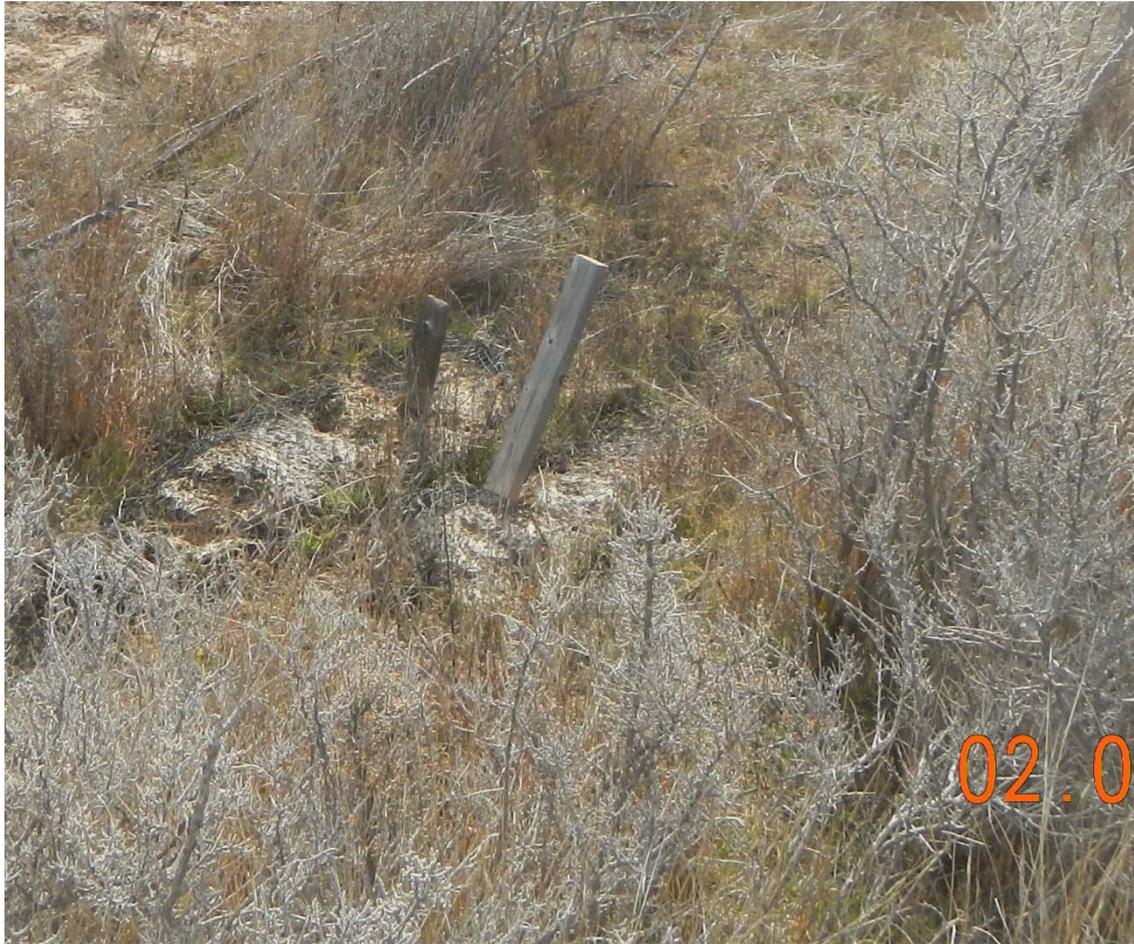
Waddles are deteriorated

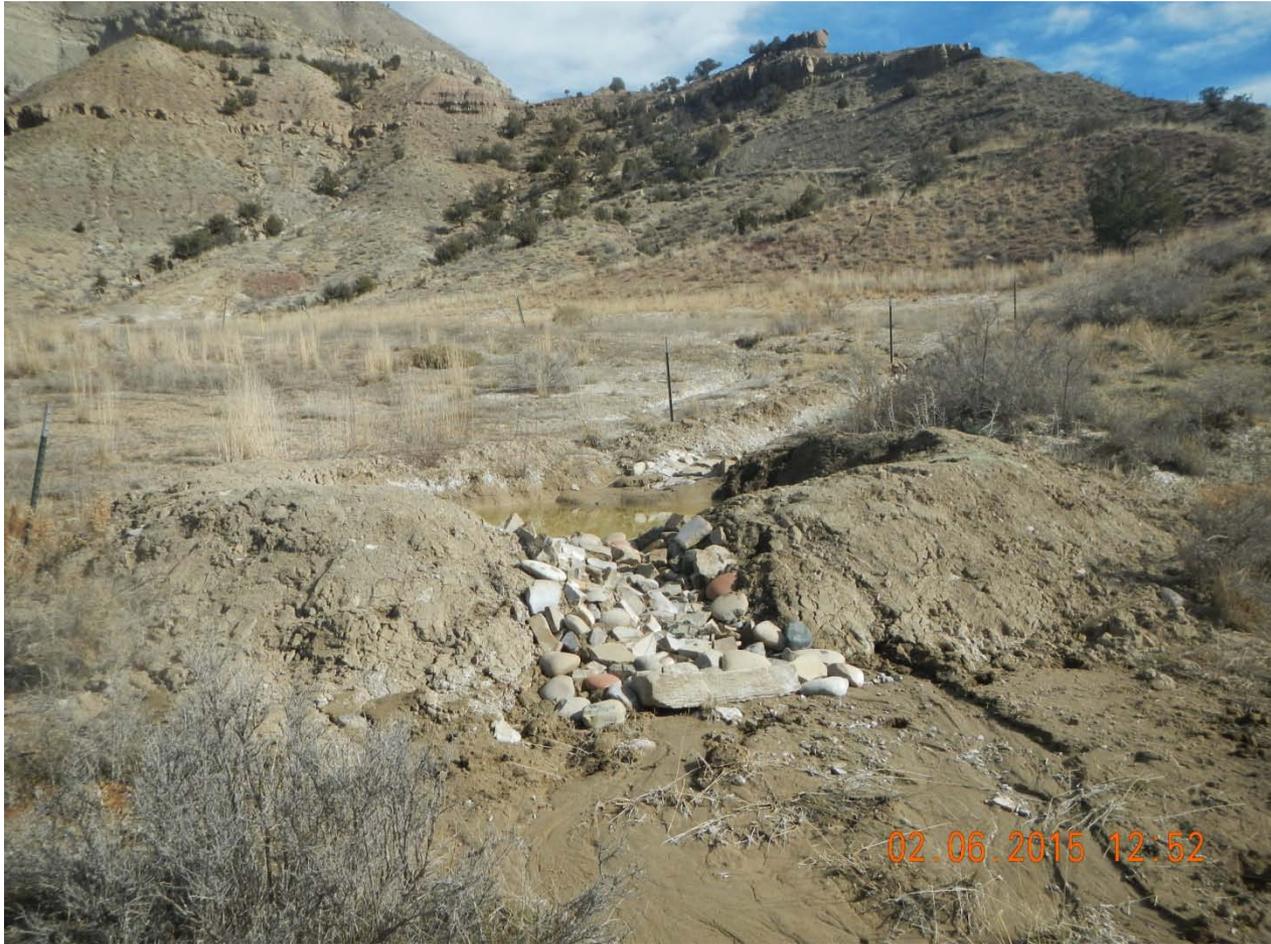
Loose compaction of check dam

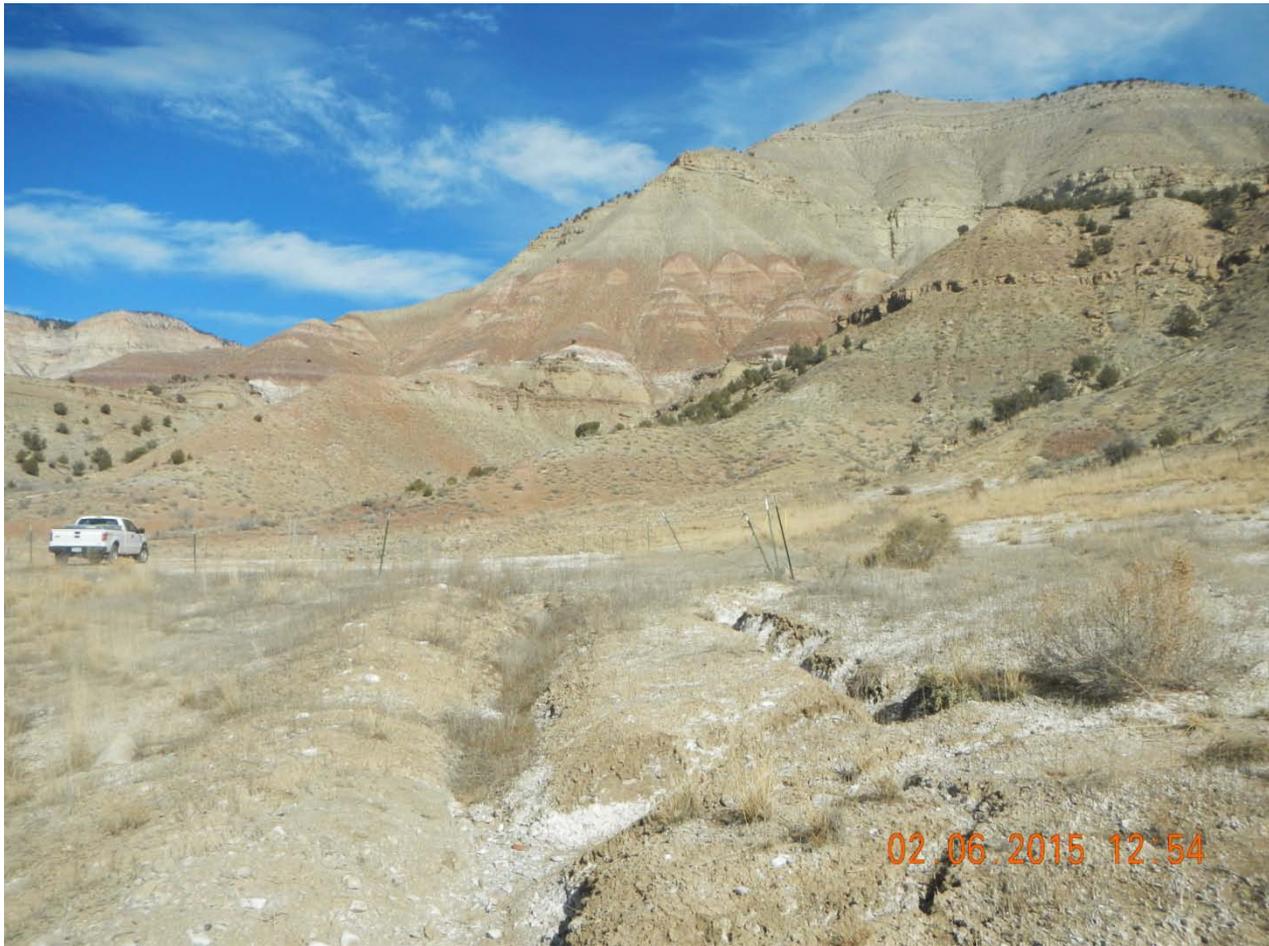
Erosion rills and erosion of ditch

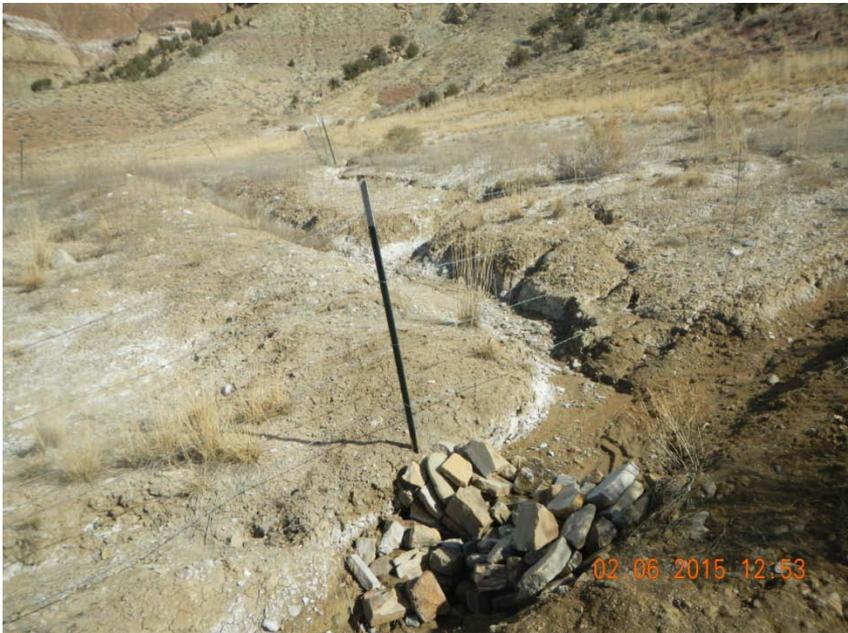
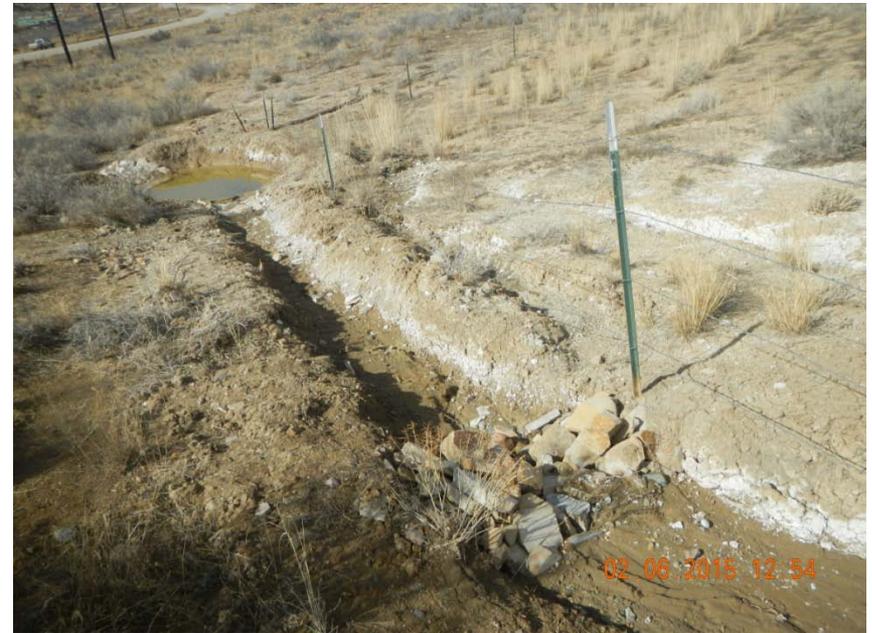
Dam filling with sediment and over flowing water washing outside of ditch
