Site Photos: API# 05-011-06024

Date: February 5, 2015

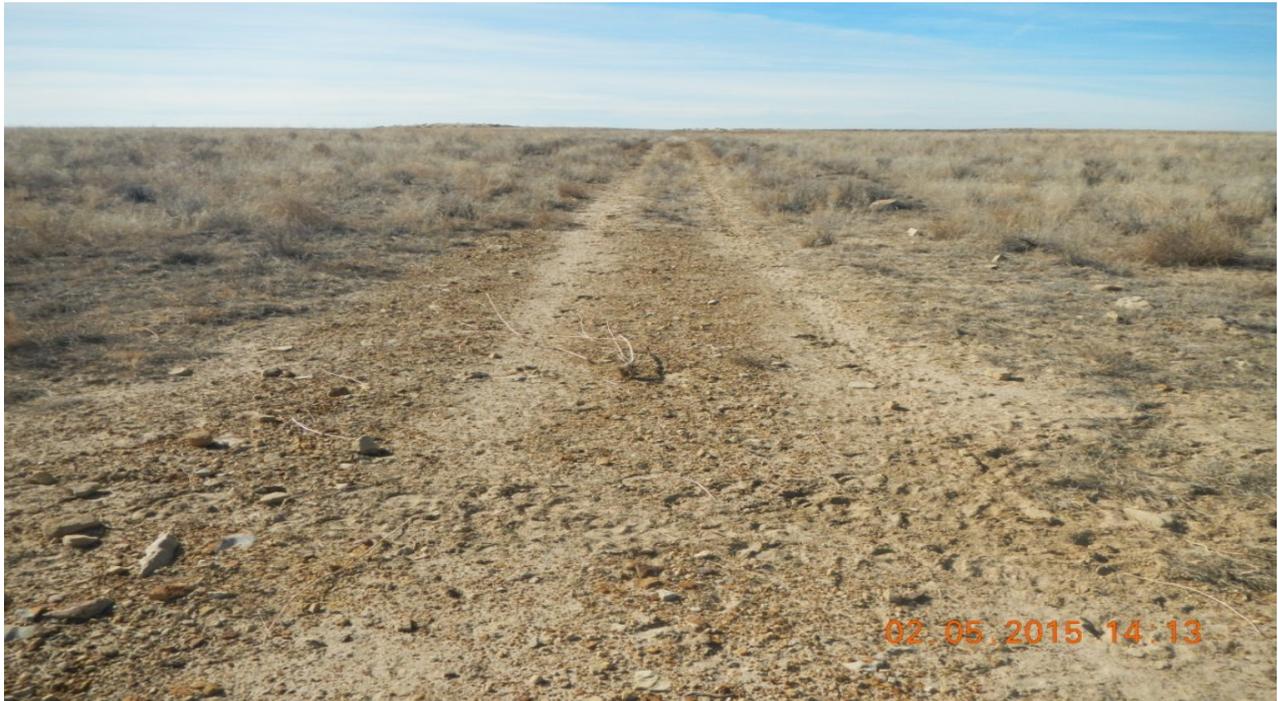
photo 1: Facing west along access road to the location. Road is visible and has inadequate vegetation.

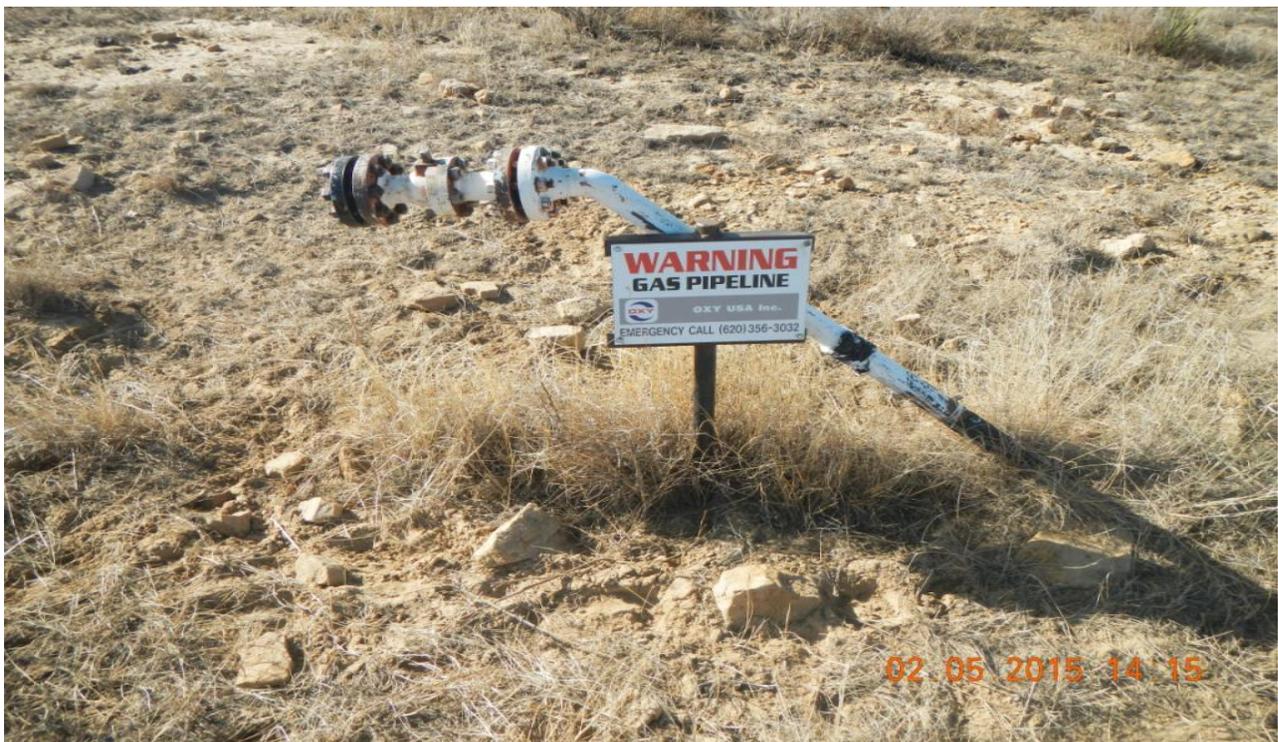
photo 2: Pipeline riser remains on the location. Lat/Long: 38.05236/-102.81947

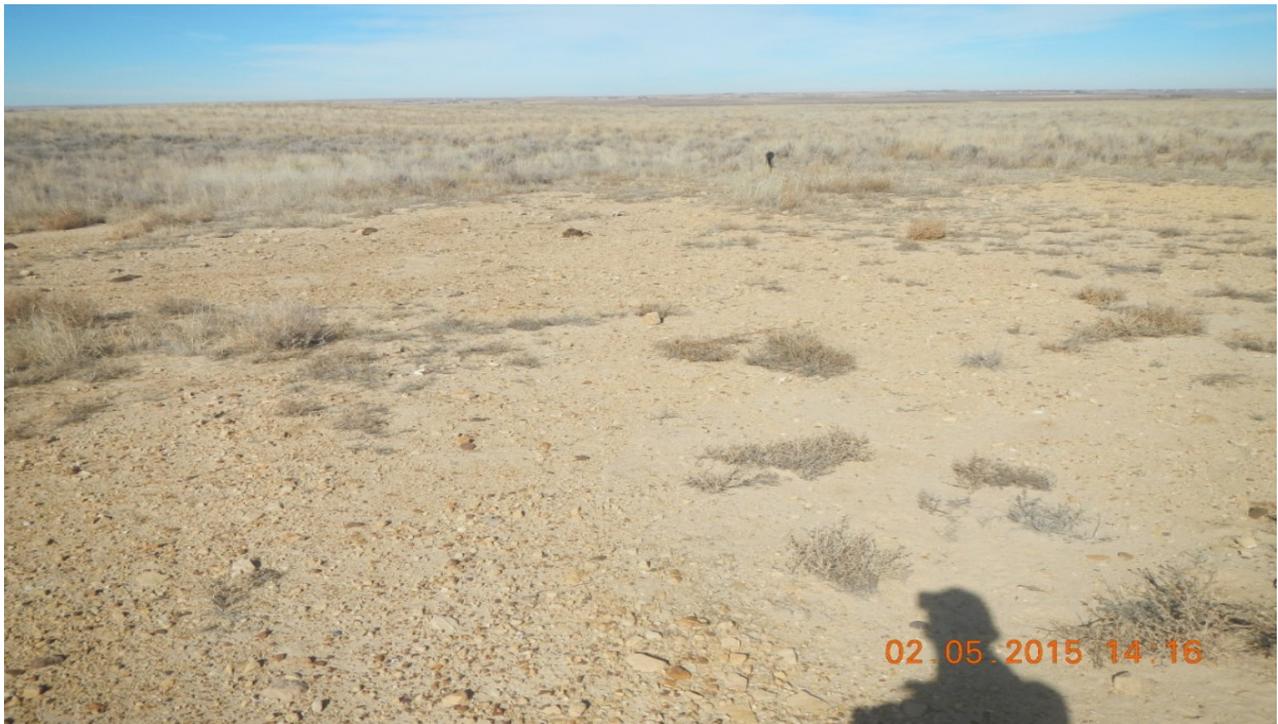
**photo 3:** Center of the location facing north.

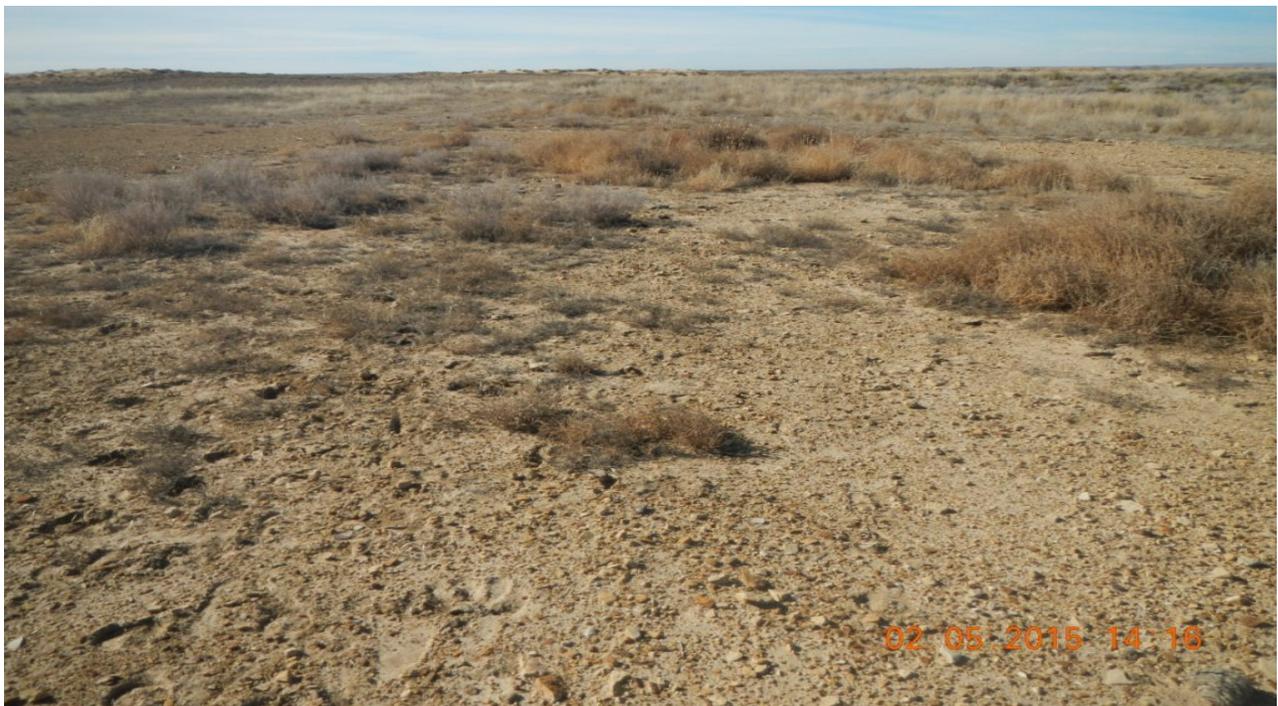
**photo 4:** Center of the location facing west.

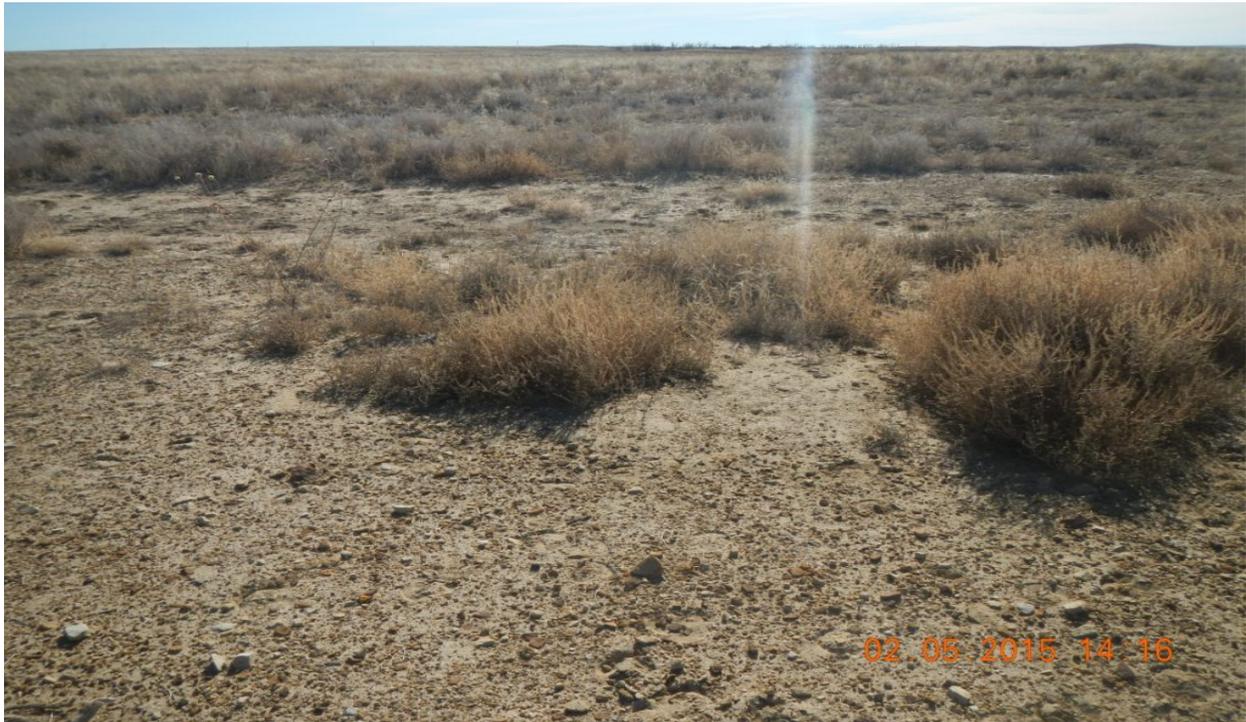
photo 5: Center of the location facing south.

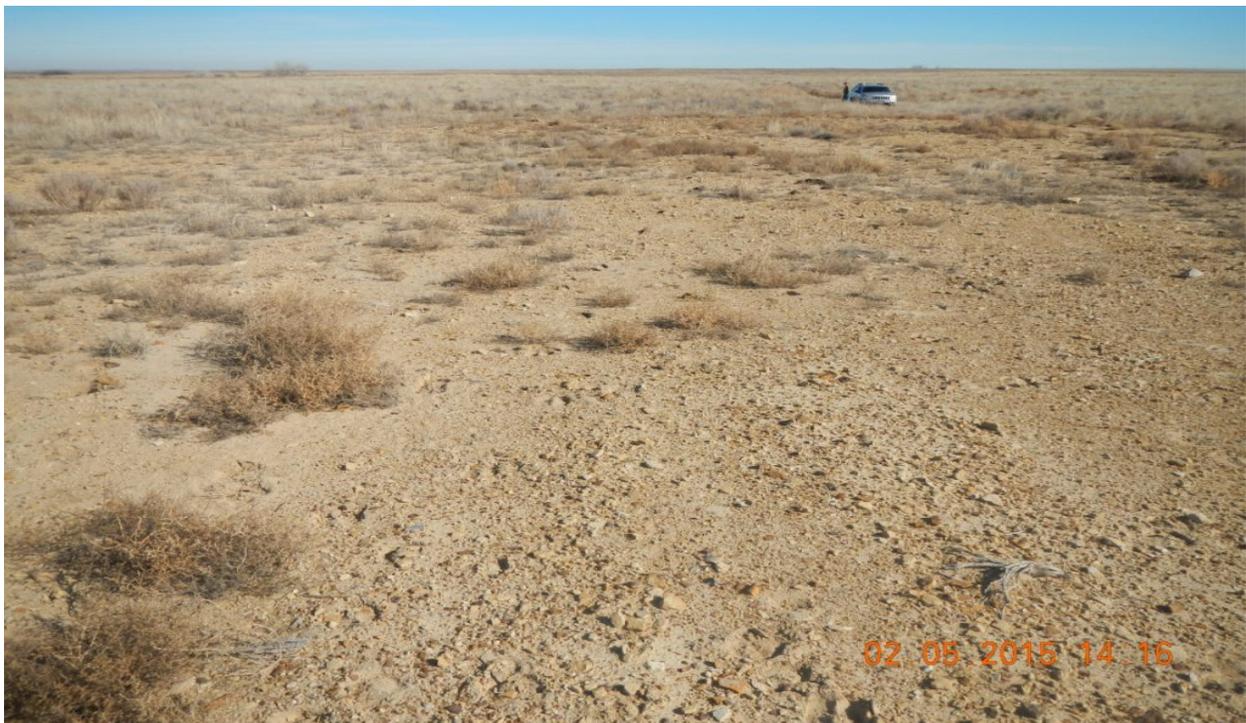
photo 6: Center of the location facing east.

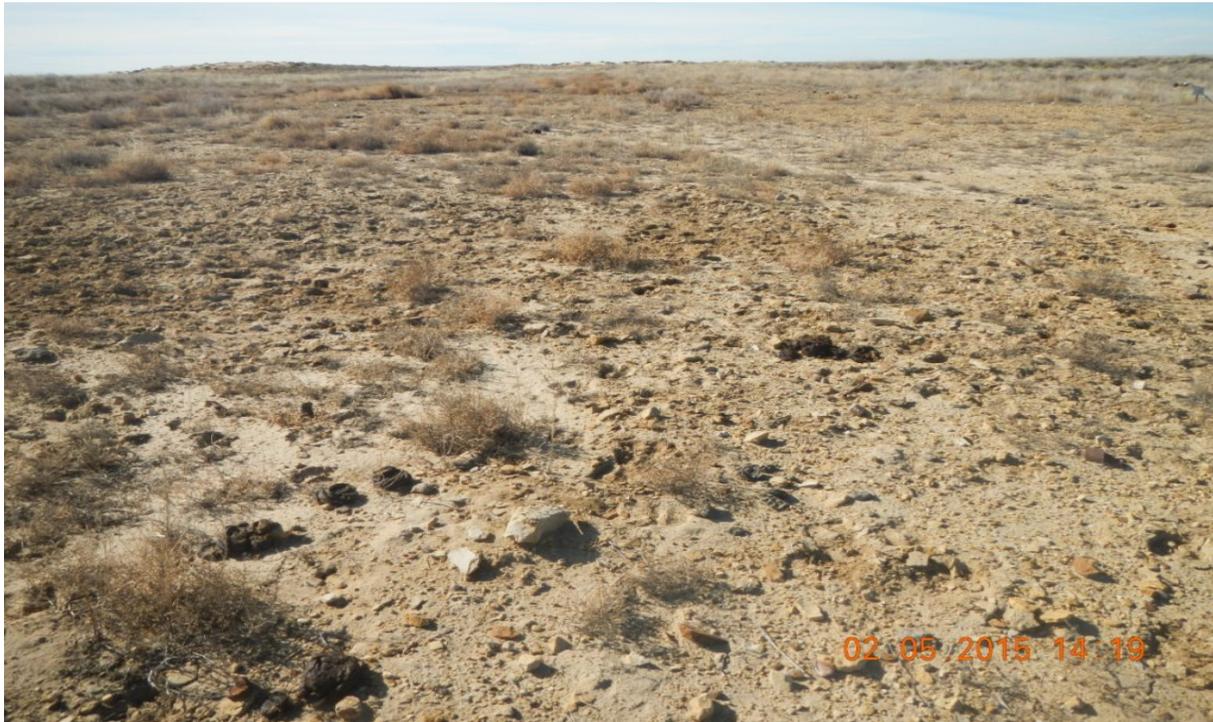
**photo 7:** East side of the location facing west towards disturbance area.

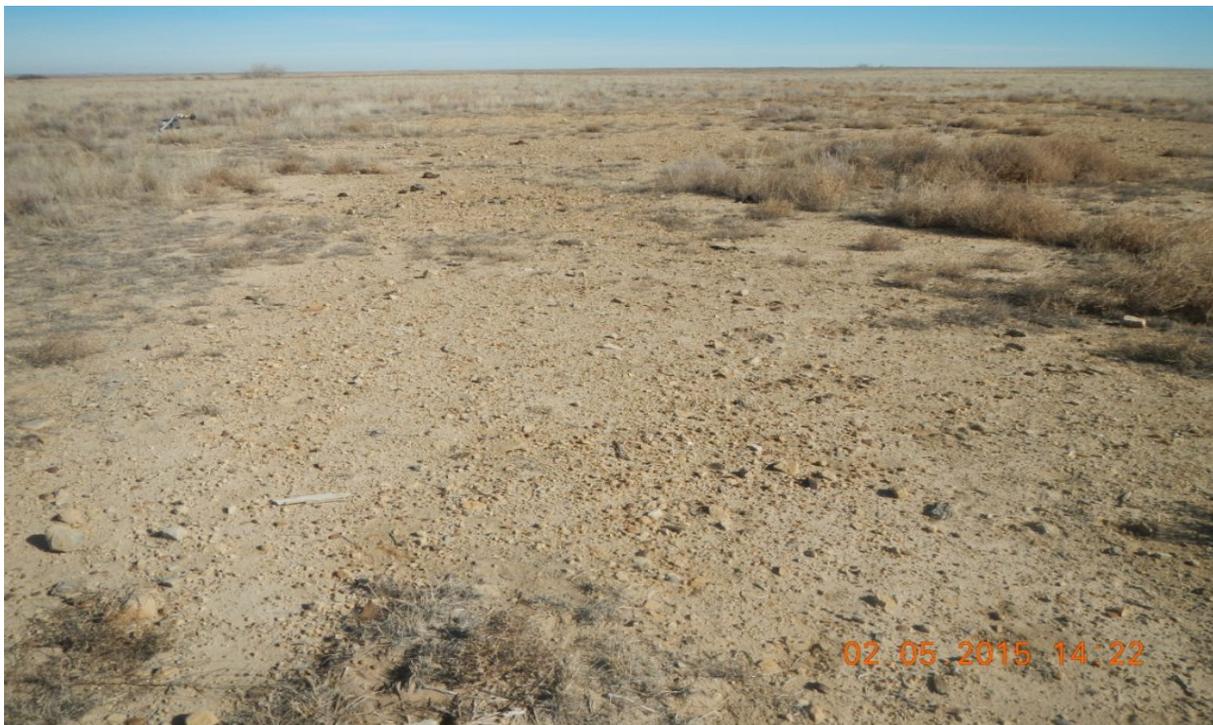
**photo 8:** West side of the location facing east towards disturbance area.

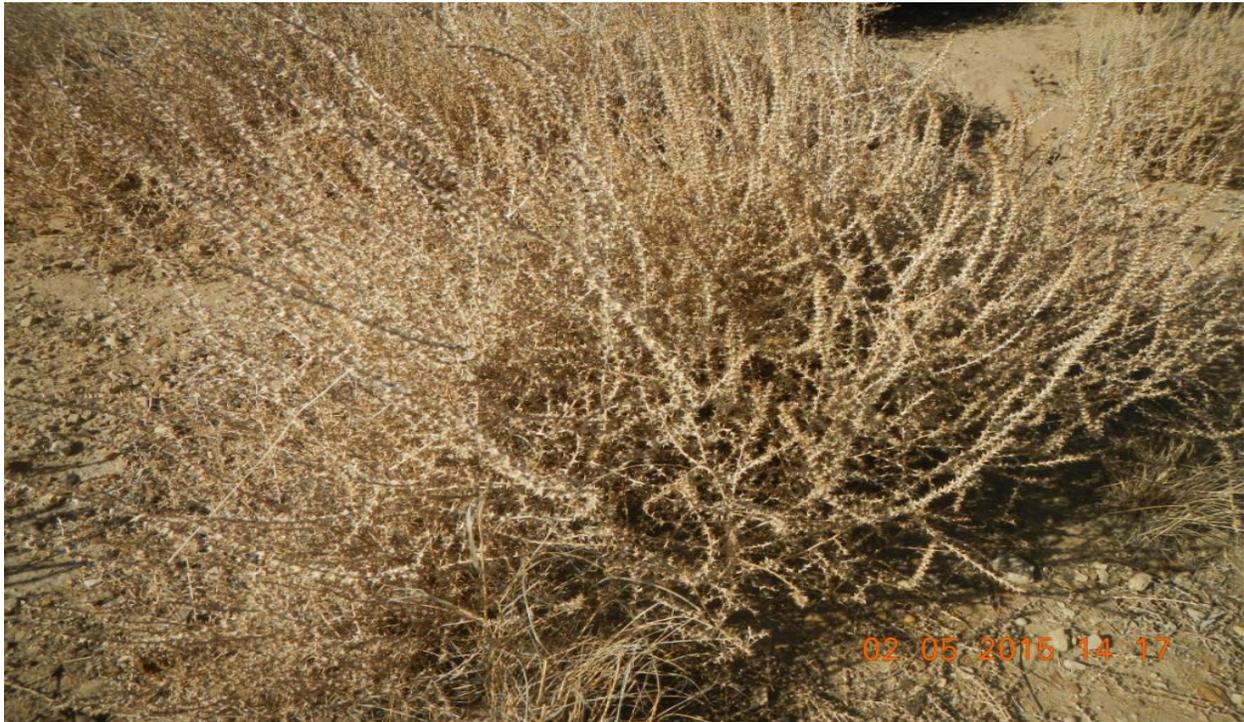
photo 9: Weed growth (Russian thistle) throughout the location.

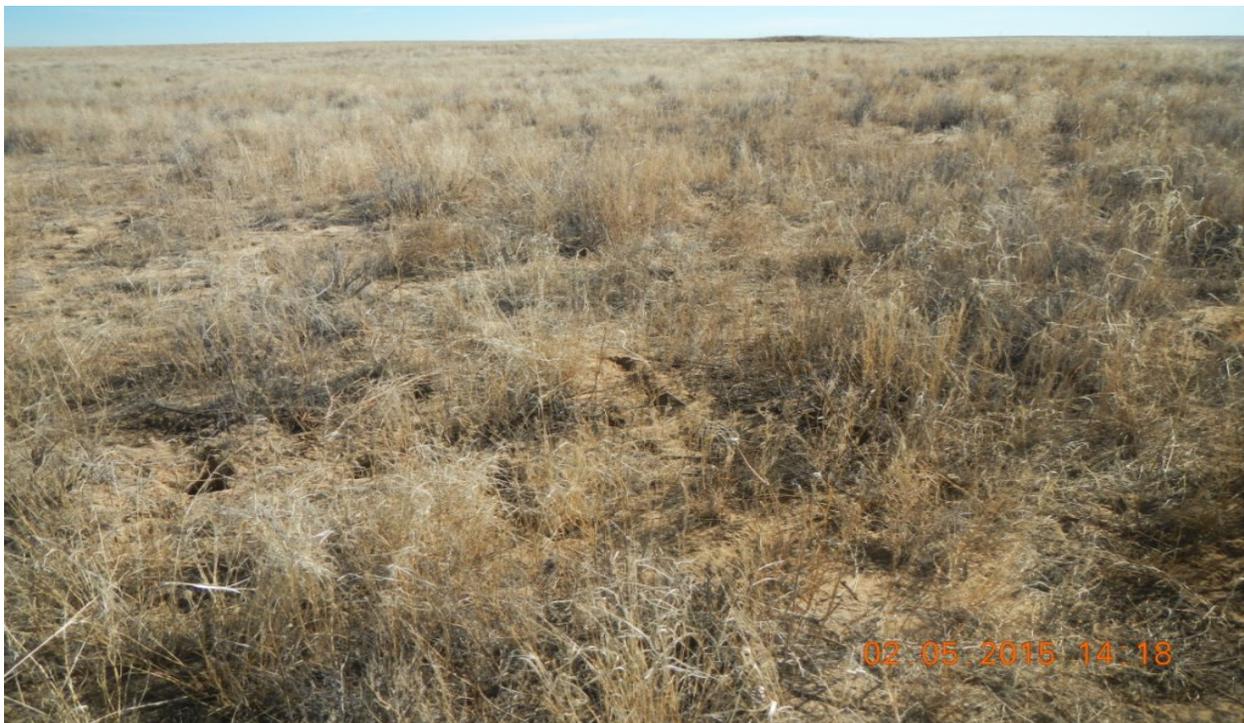
photo 10: Facing southeast, surrounding vegetation around the location.
