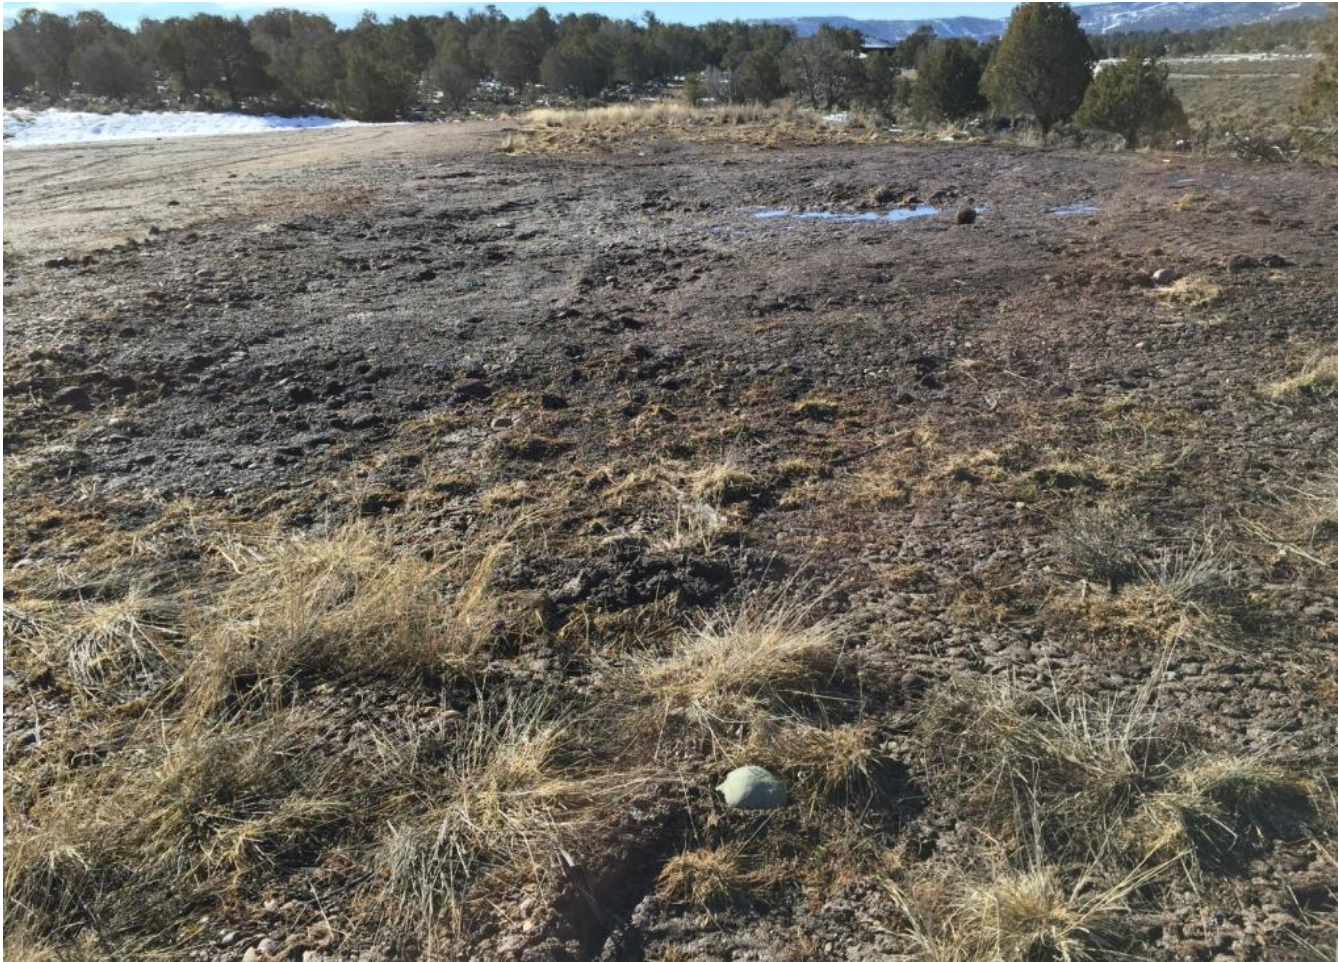
Photo 1. View of area where pit, old equipment, and debris were formerly located in western portion of the project area. From northern portion facing southward.

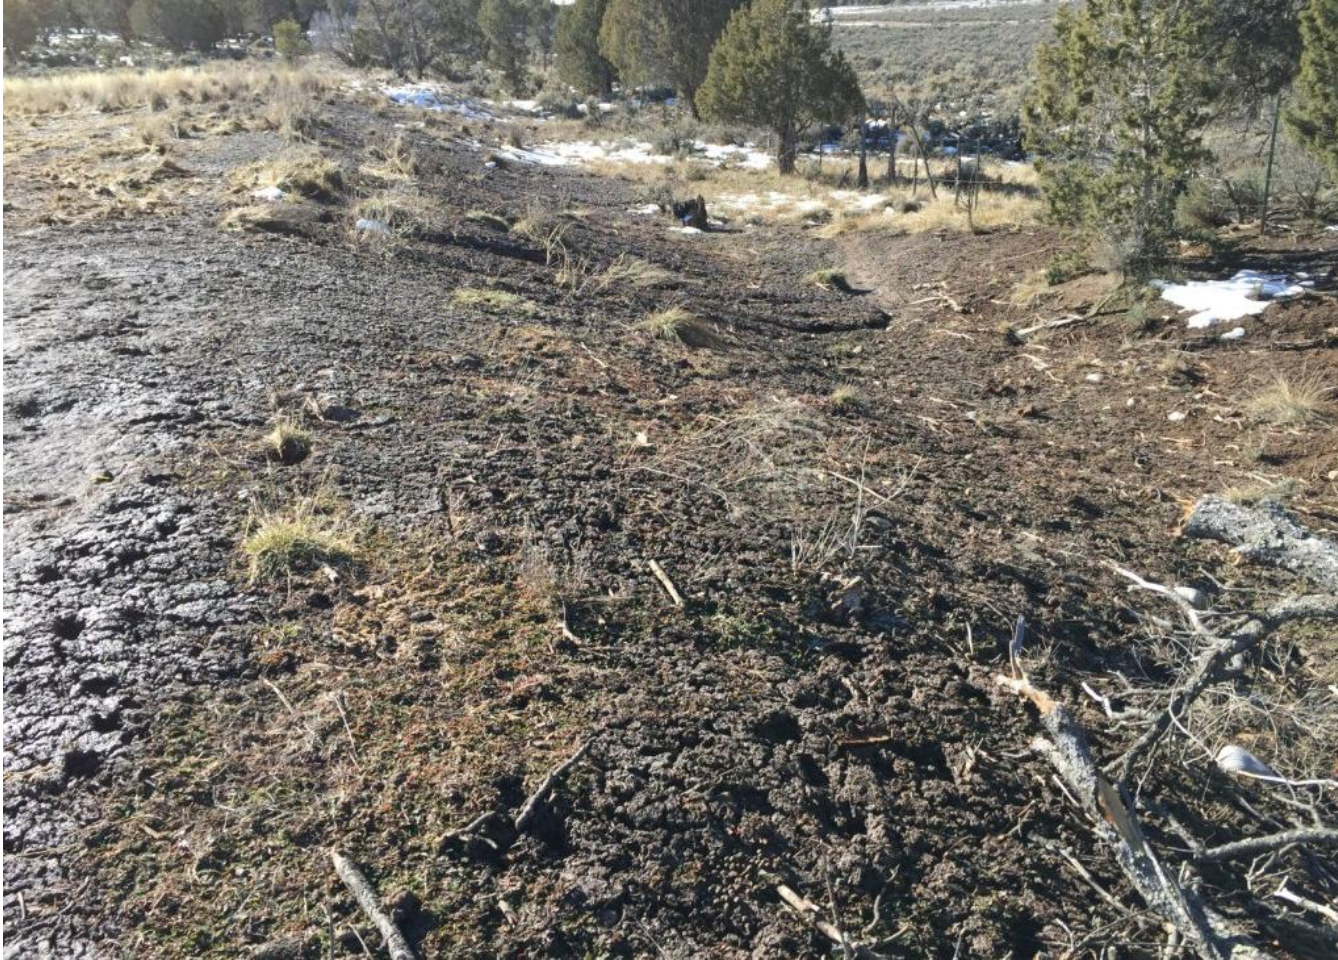
Photo 2. View of stormwater erosion channels and unprotected soils in western portion of the project area facing southward.

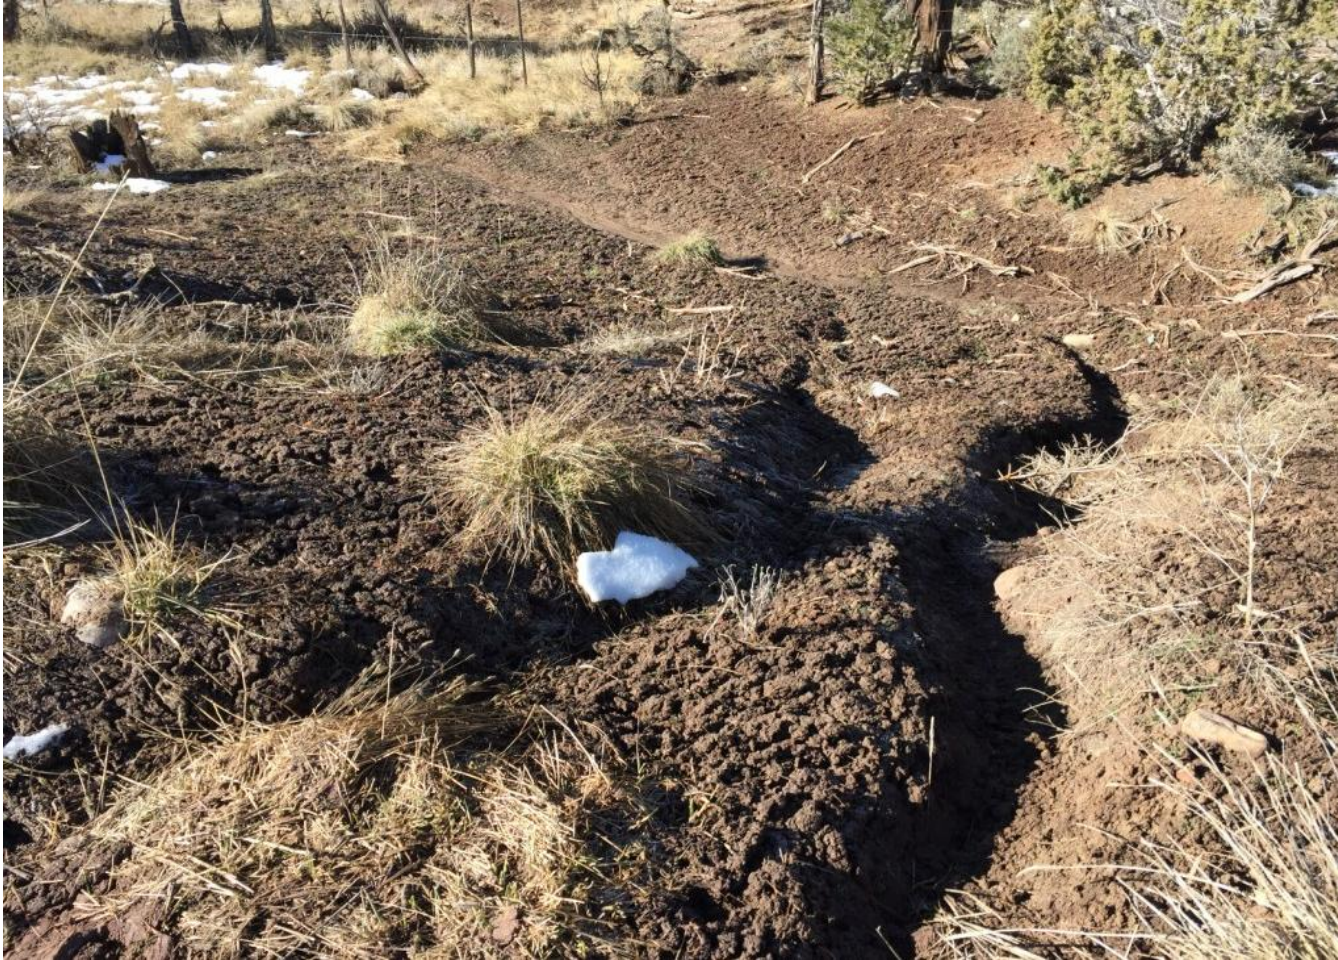
Photo 3. View of a stormwater erosion channel that directs stormwater discharge outside of the project area (fence in background).
