GV52-3 Pad

Inspection# 675201163

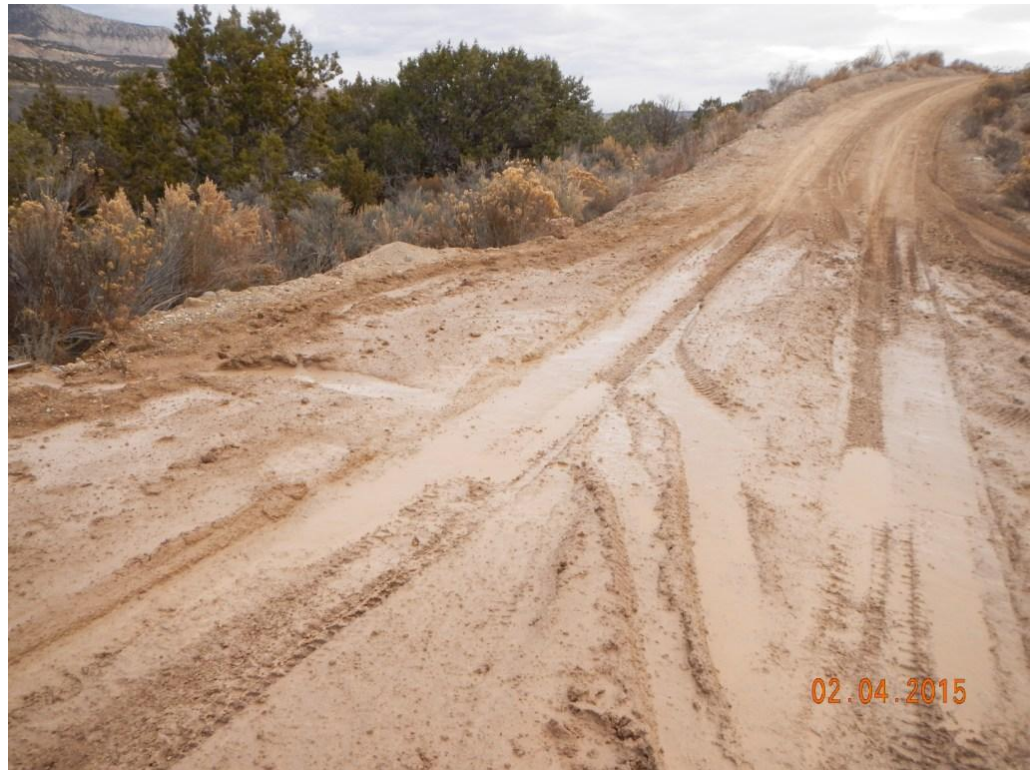
Access road not stabilized
with erosion on road side.

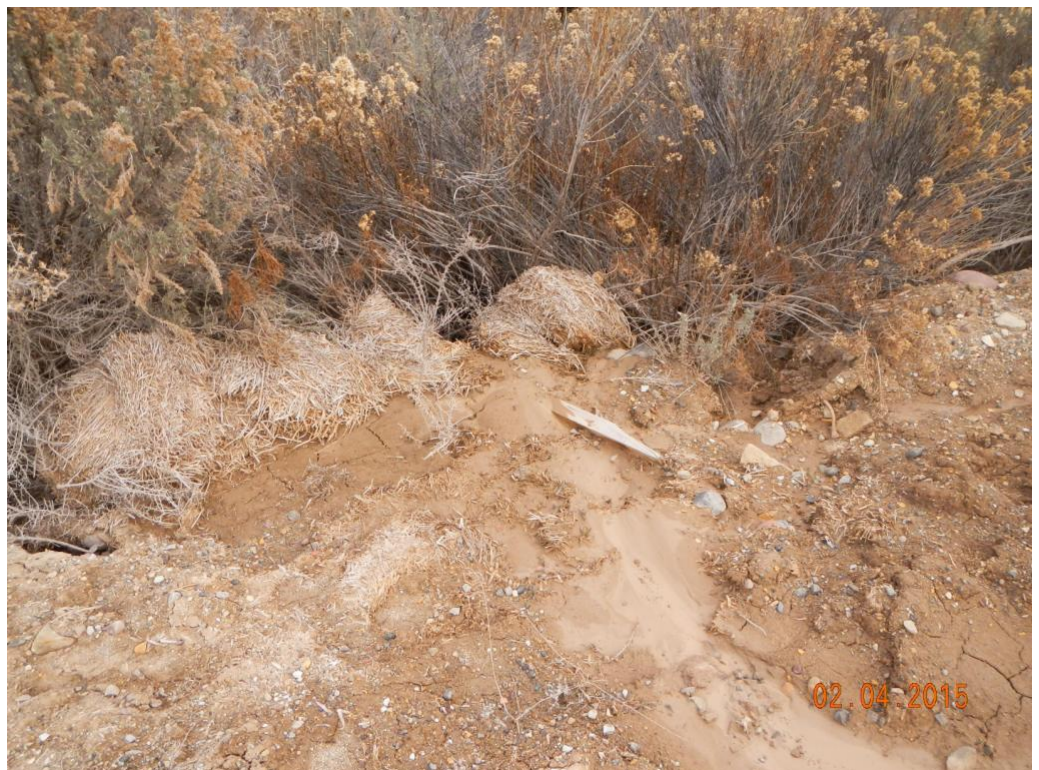
Failed BMP due to road side
erosion.

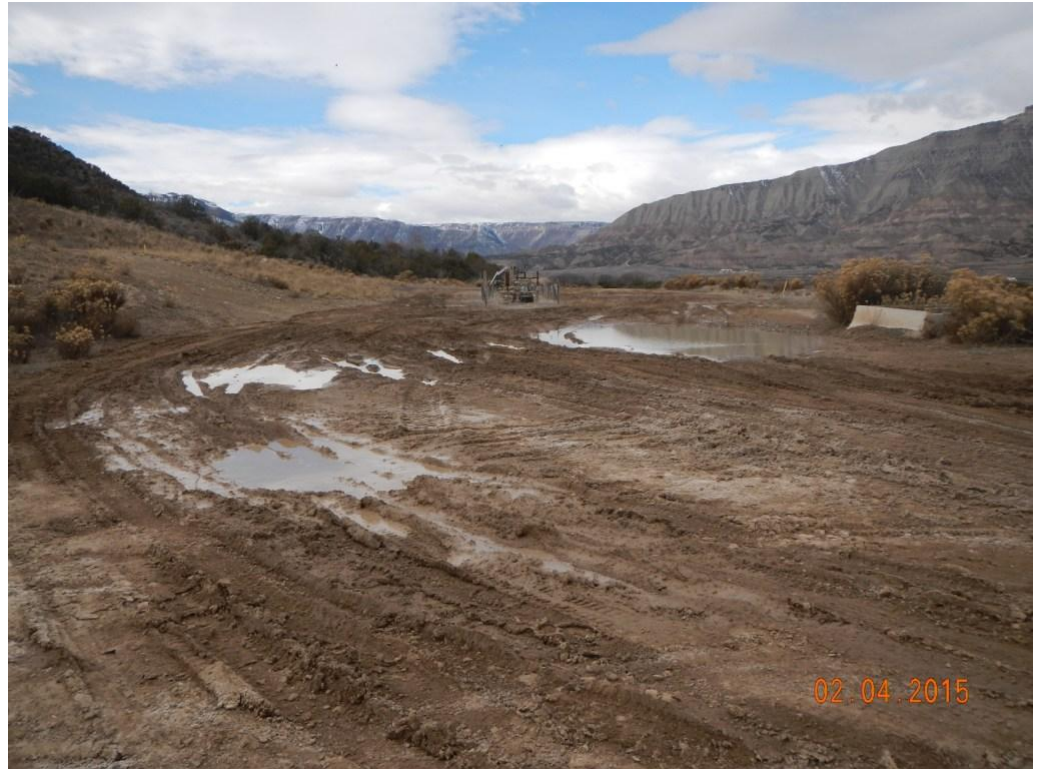
Location is not stabilized.
