WPX Energy

GM 226-35 Pad

Location # 324121

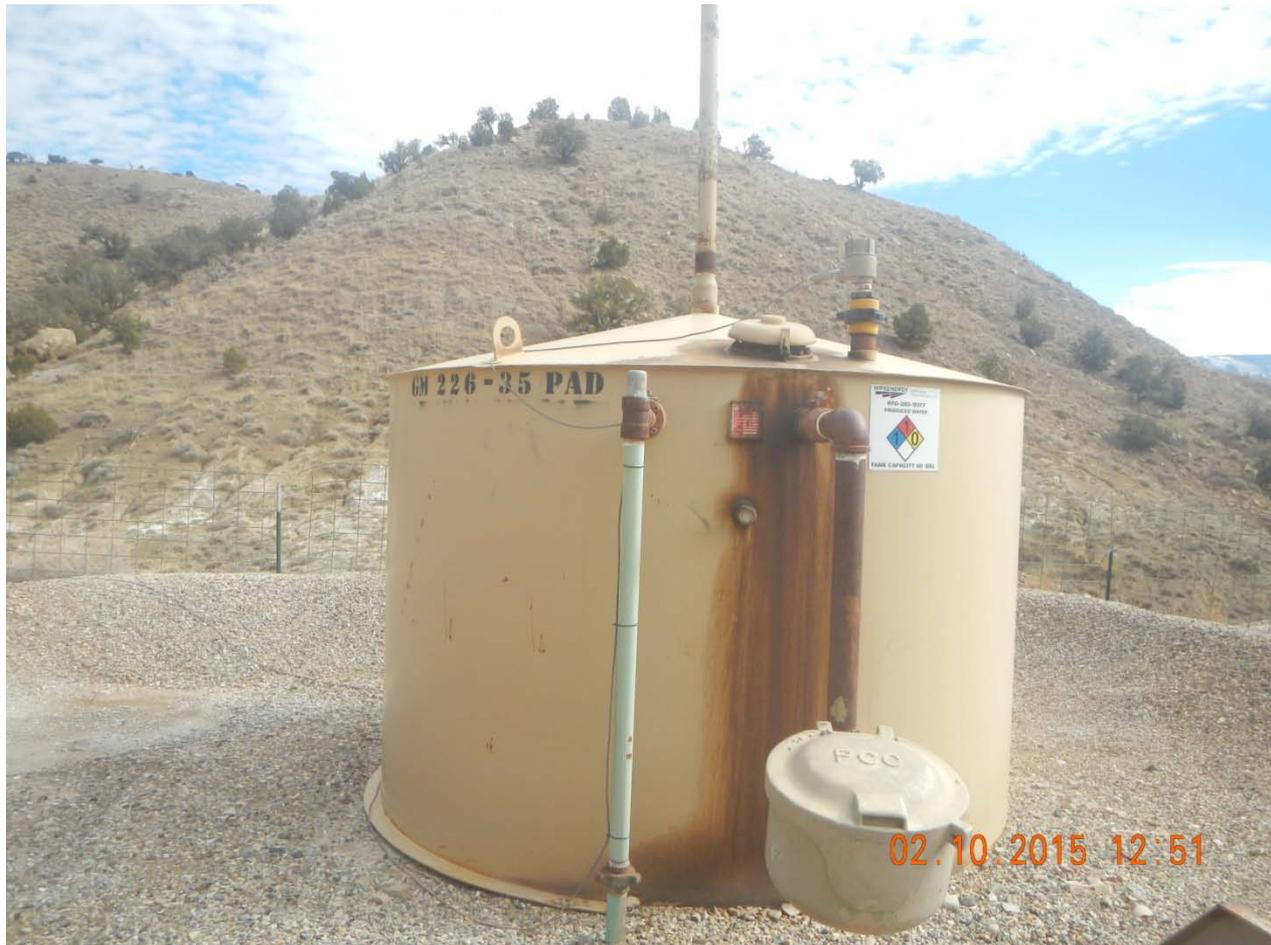
Stain down front of tank

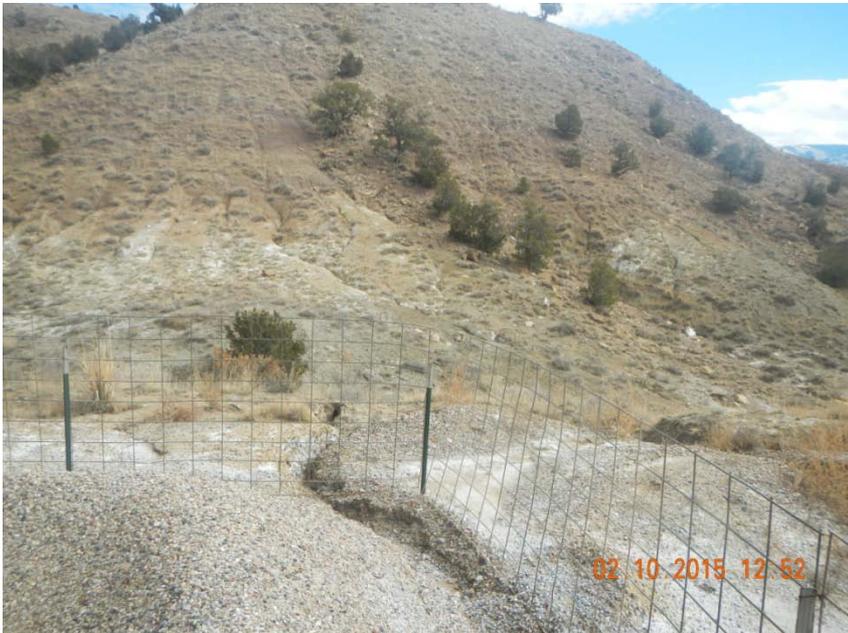
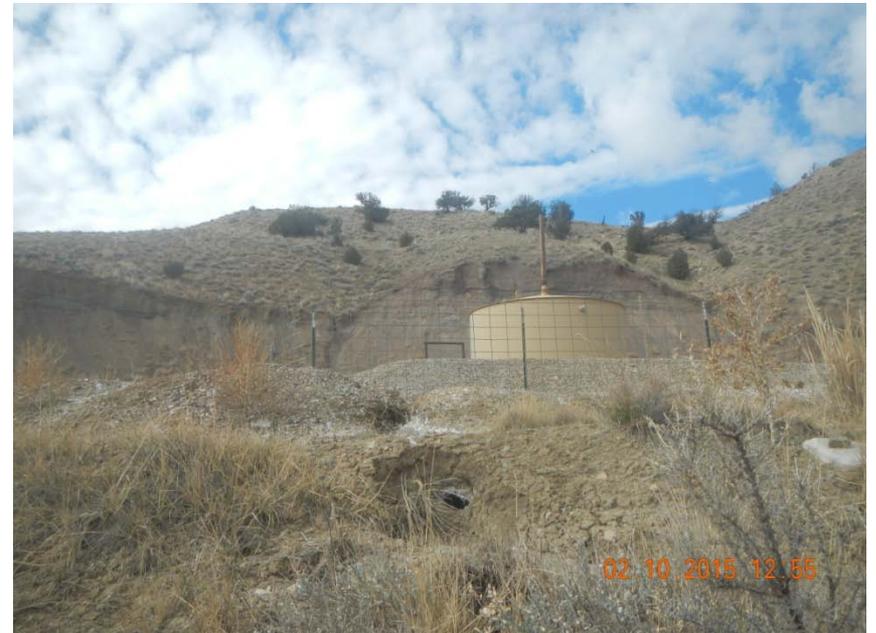
Erosion rill running of location at tank battery

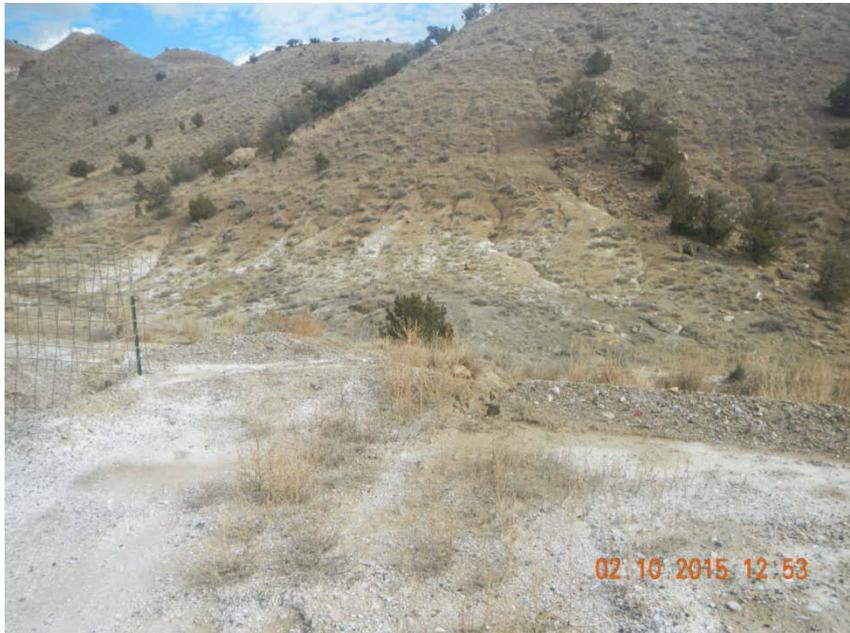
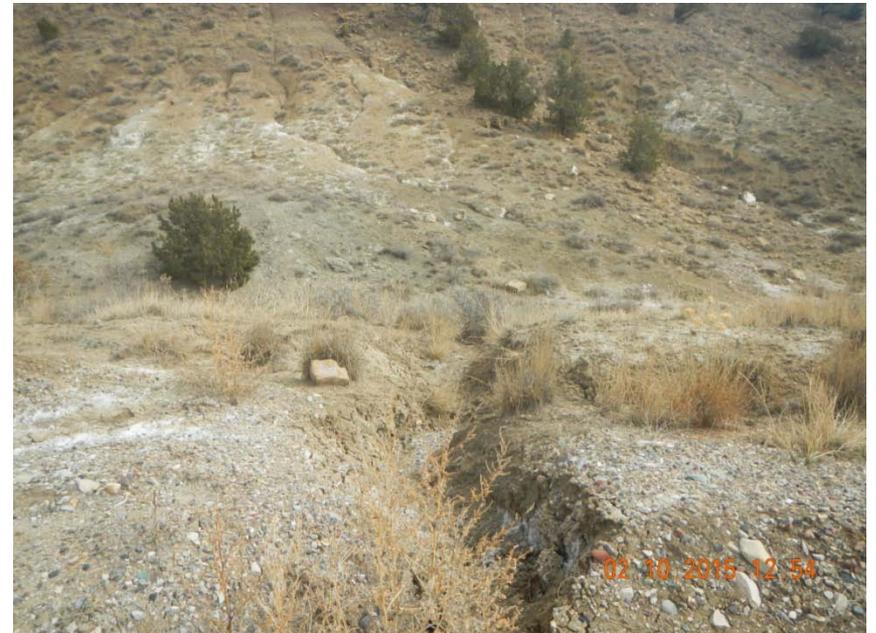
Erosion rill running of location at tank battery

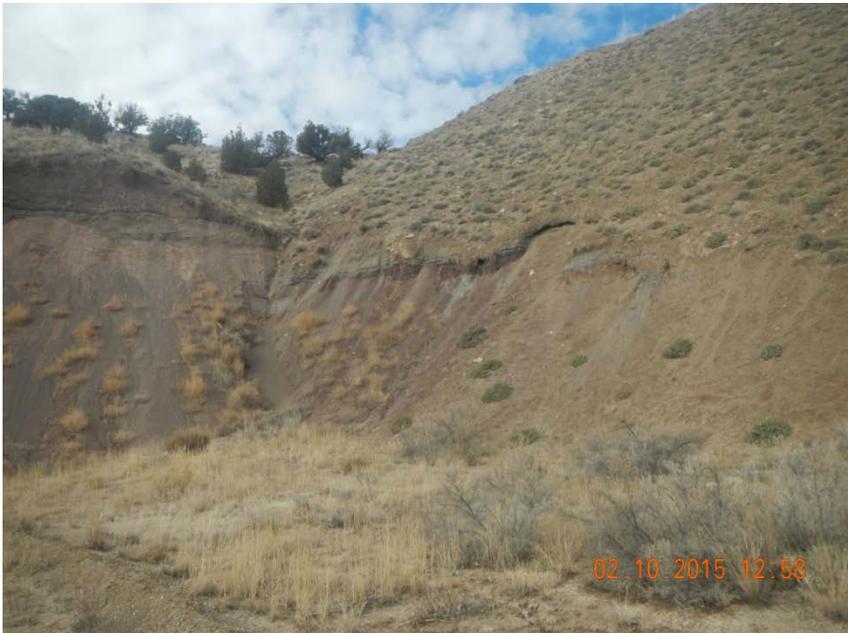
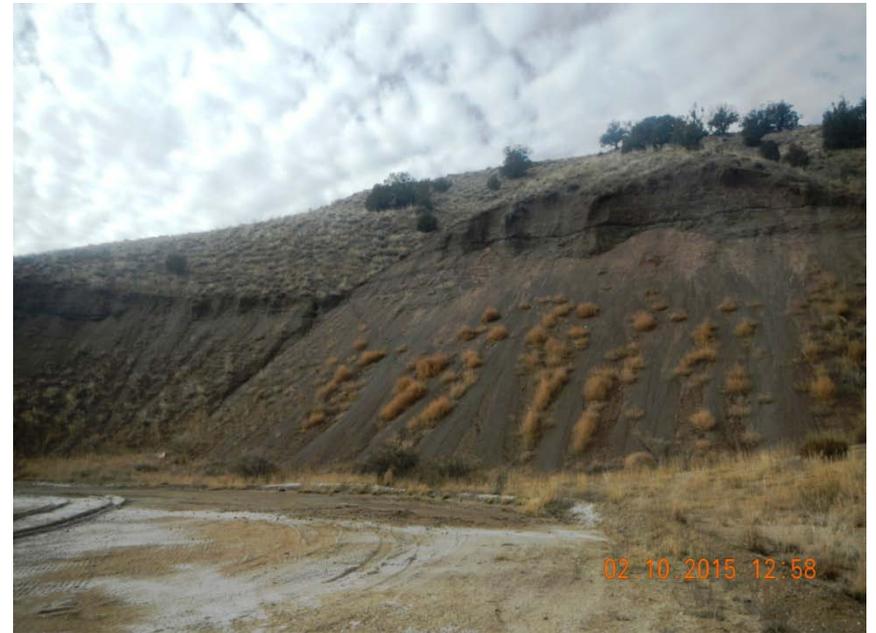
Unstable cut slope

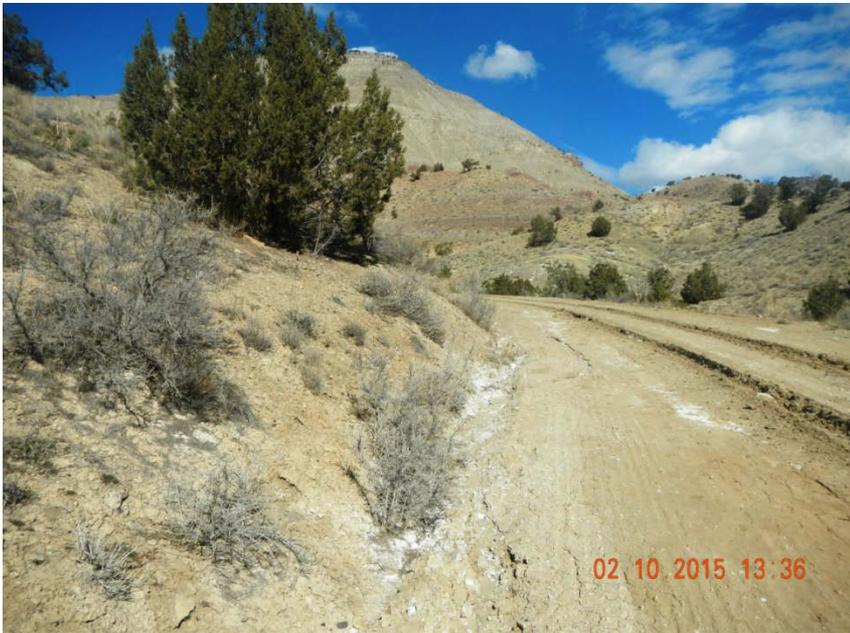
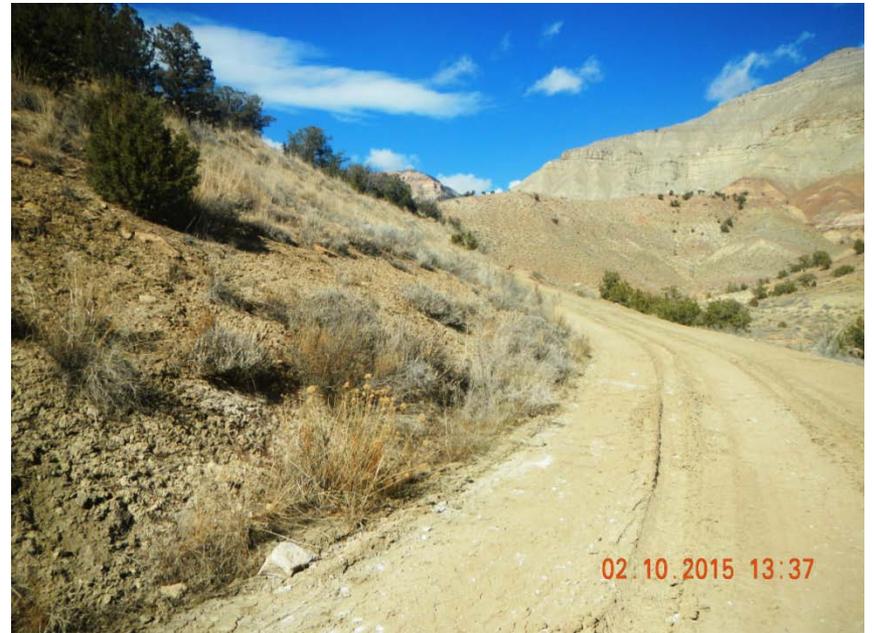
Road ditch needs cleaned out and erosion running through ruts
