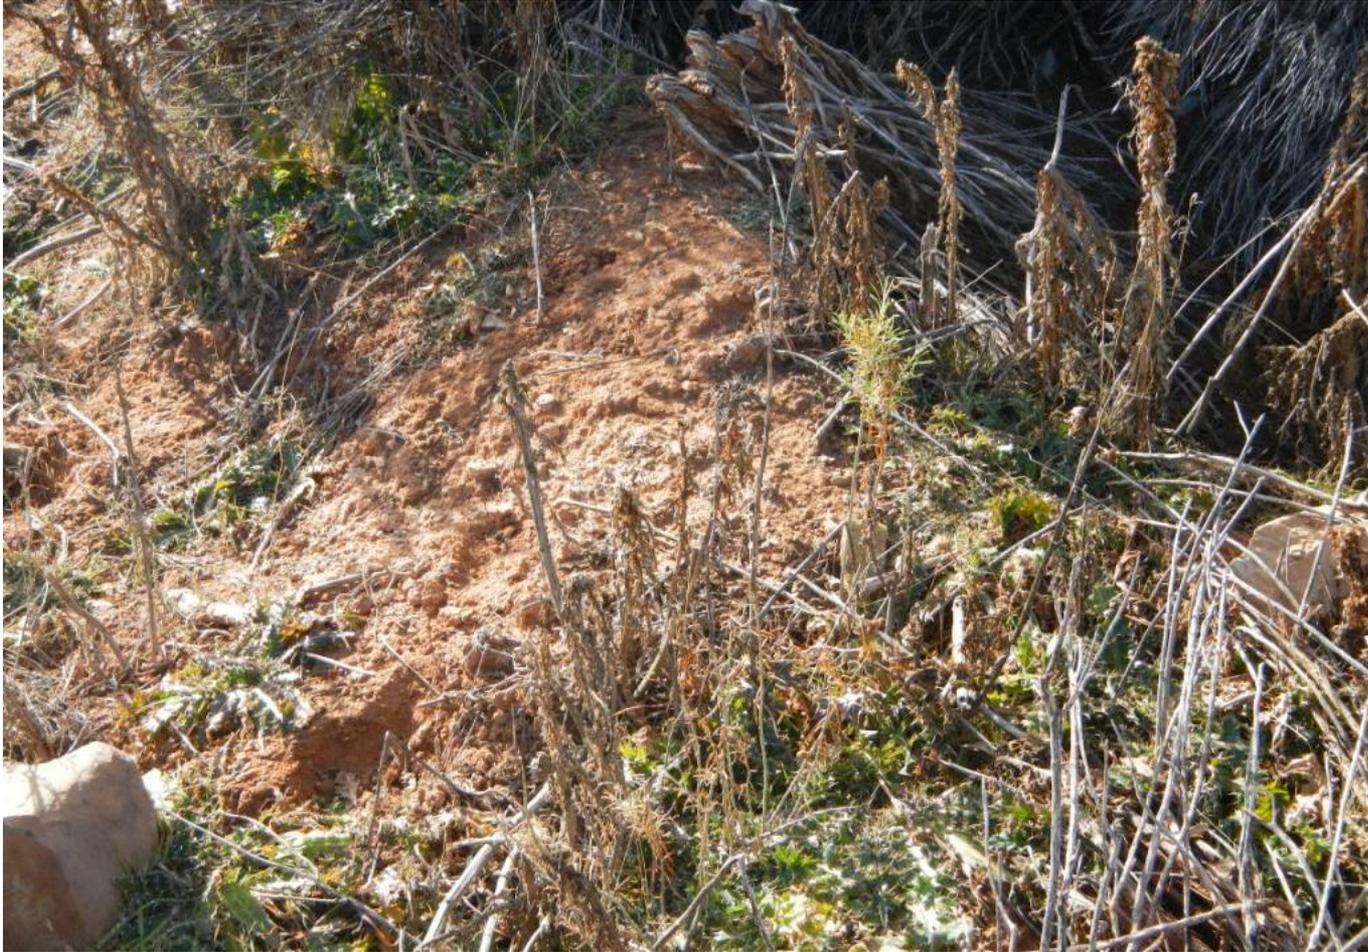
Photo 1. View of several musk thistle plants in the western portion of the project area.

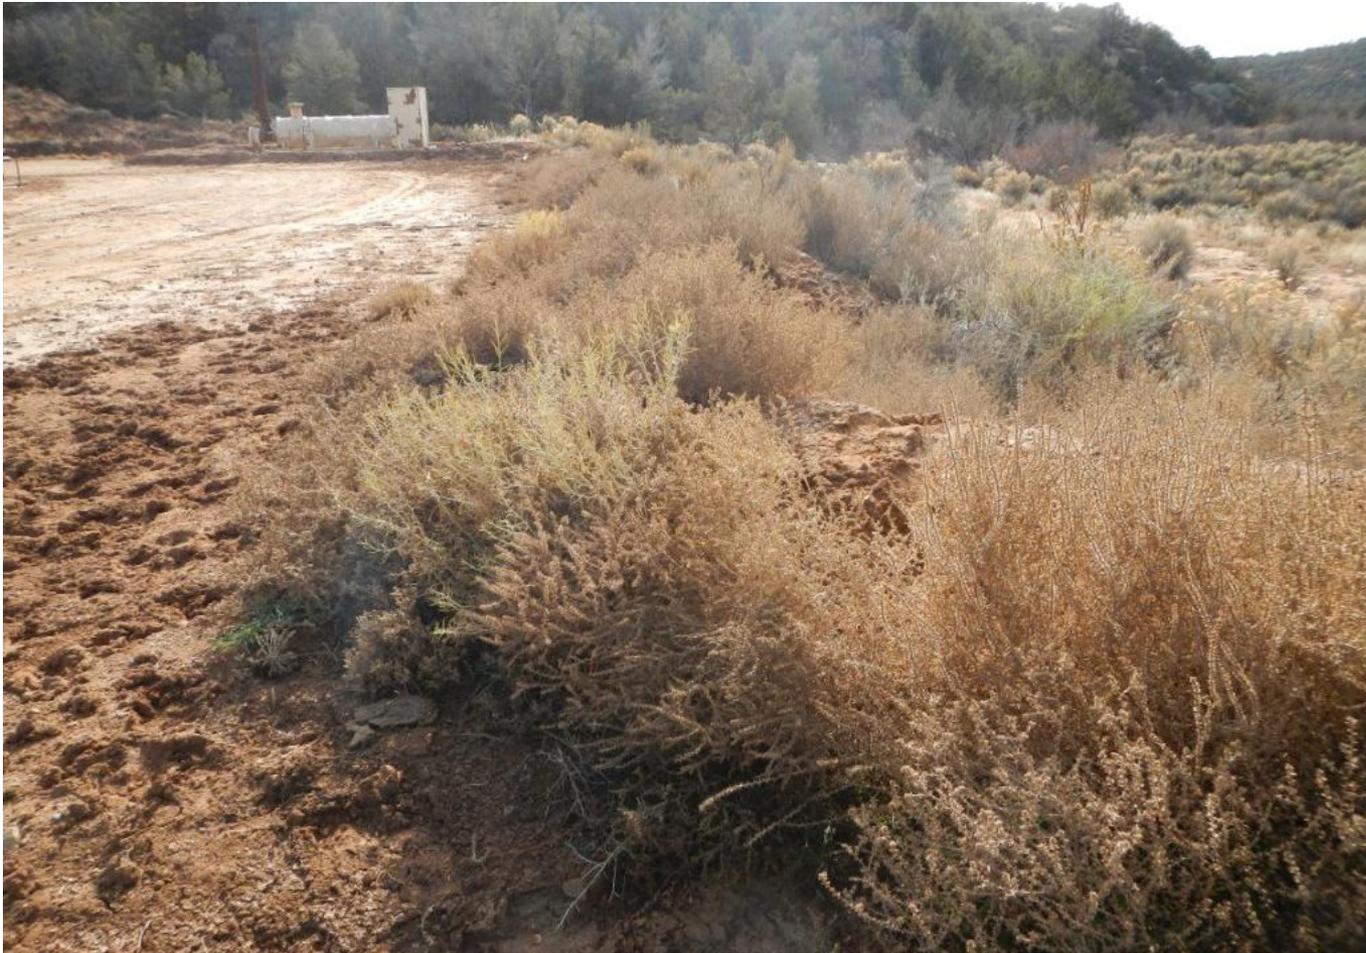
Photo 2. View of large (approximately 3 feet tall) Russian thistle plants bordering the western edge of the working area.

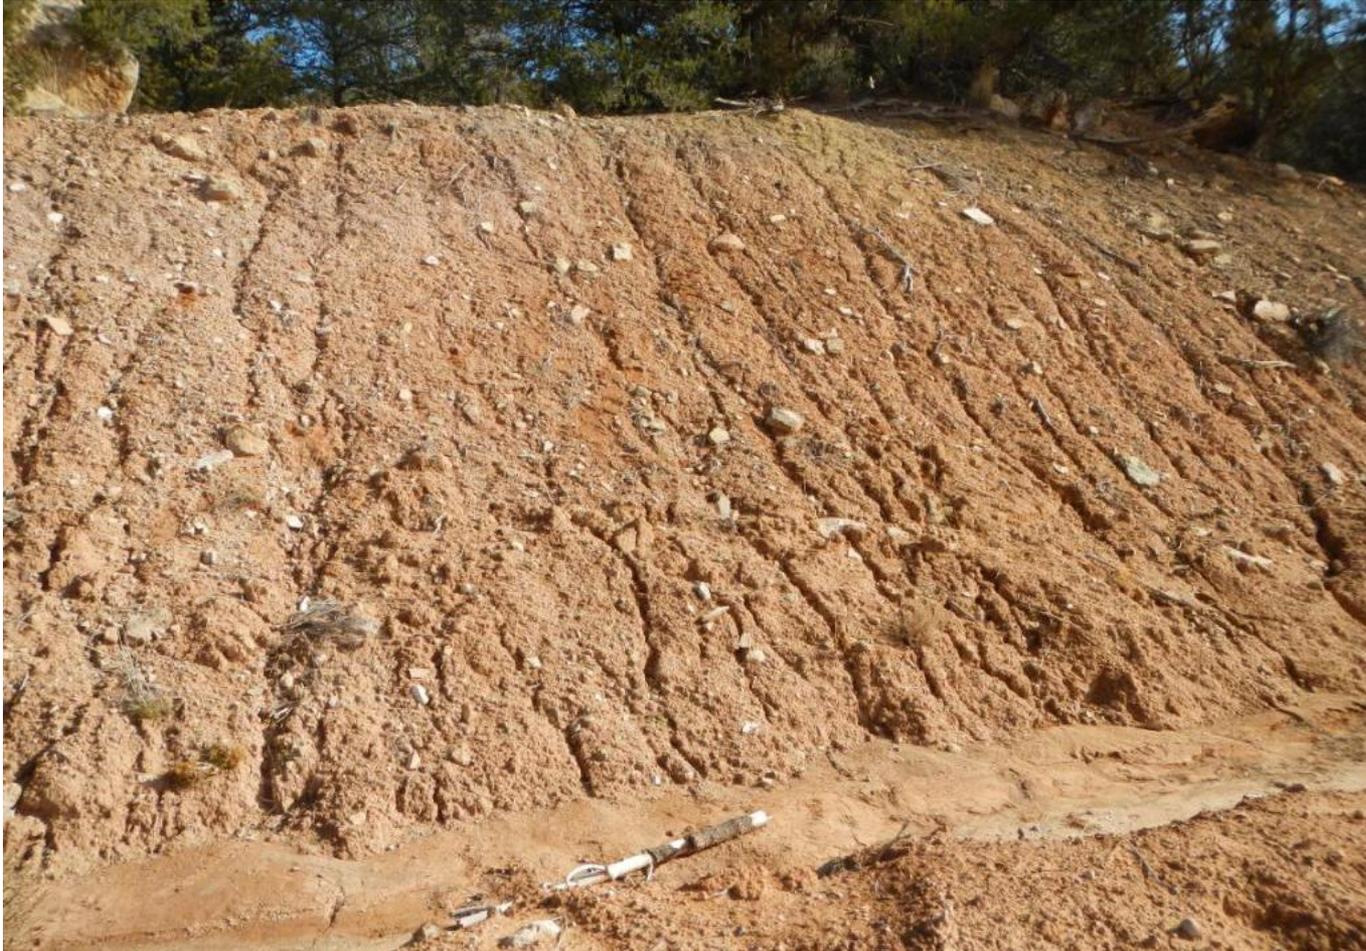
Photo 3. View of rill erosion and sediment deposition in and below a portion of the unprotected cut-slope in the eastern portion of the project area.

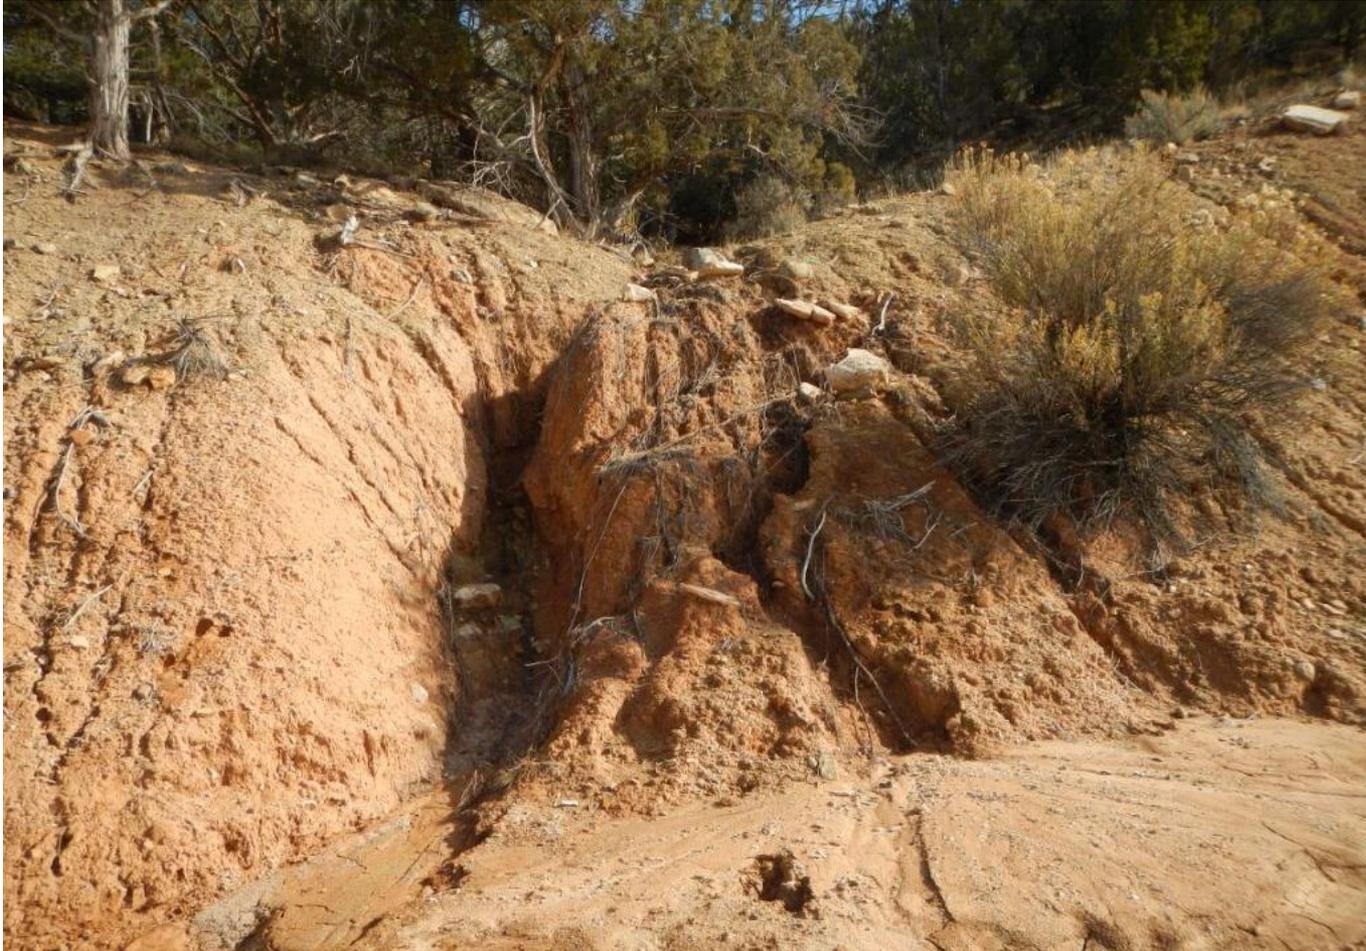
Photo 4. View of head-cut erosion and sediment deposition in eastern portion of project area.

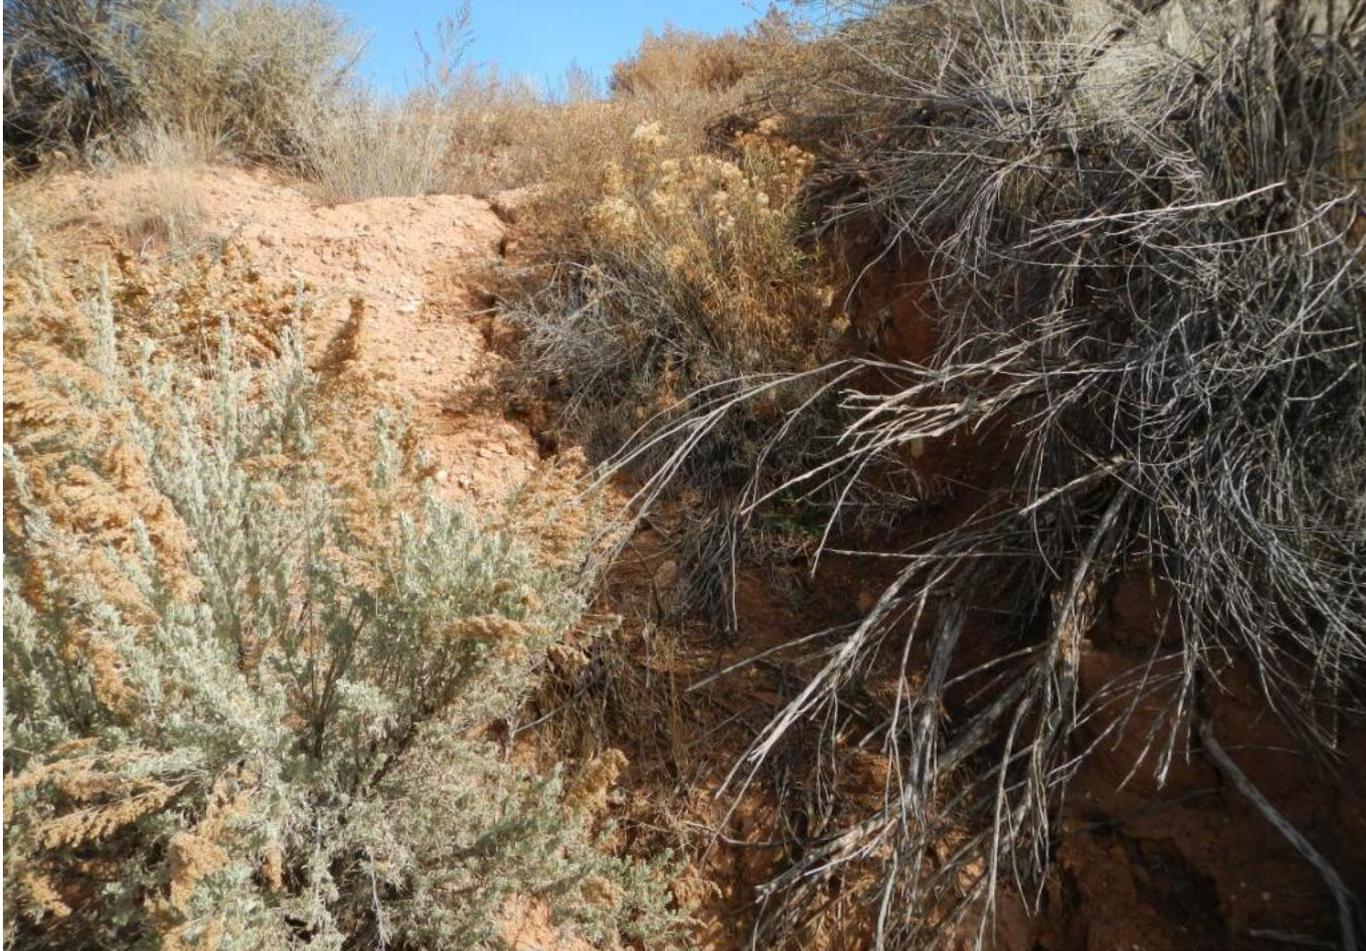
Photo 5. View of erosional channel in northwestern portion of project area.

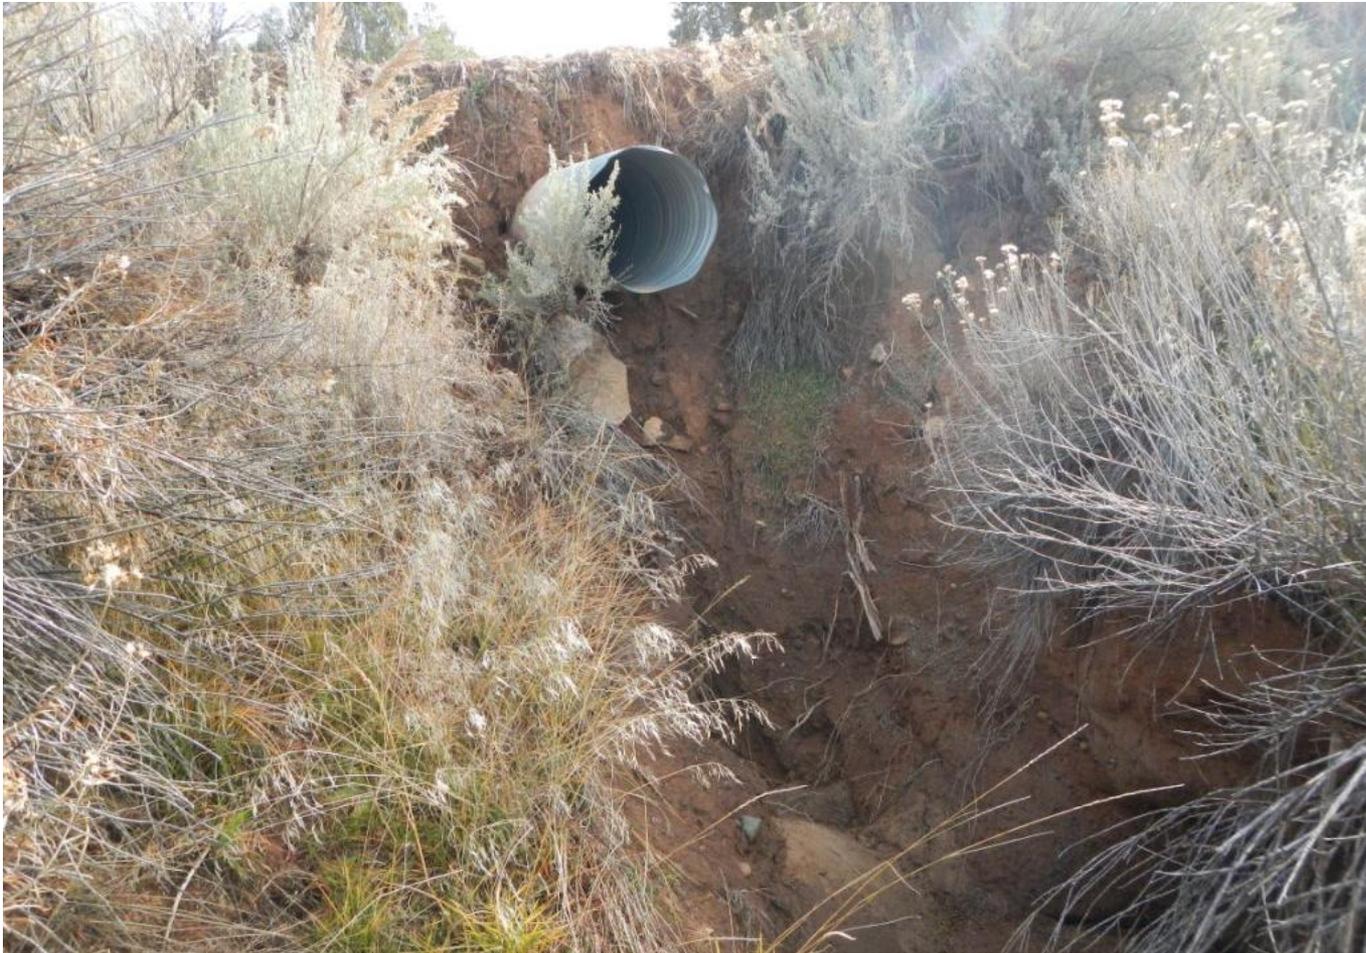
Photo 6. View of erosion at culvert outlet on the access road near the entrance to the well pad. Erosion from stormwater flows exiting the culvert appear to have eroded approximately 10 feet of soil.
