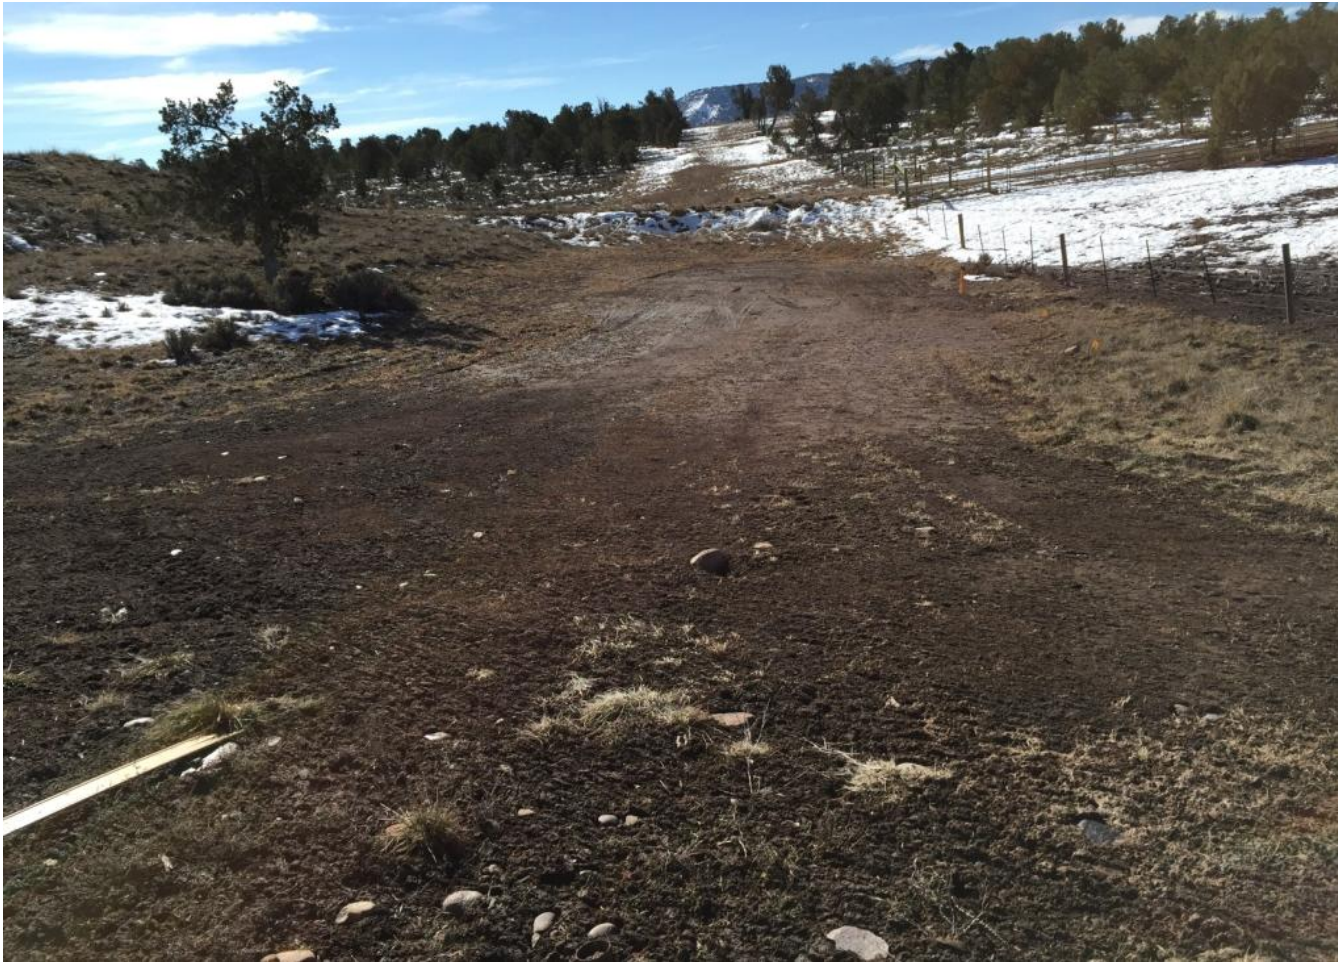
Photo 1. View of area where pipeline subsidence was recently repaired. This area needs to be revegetated.

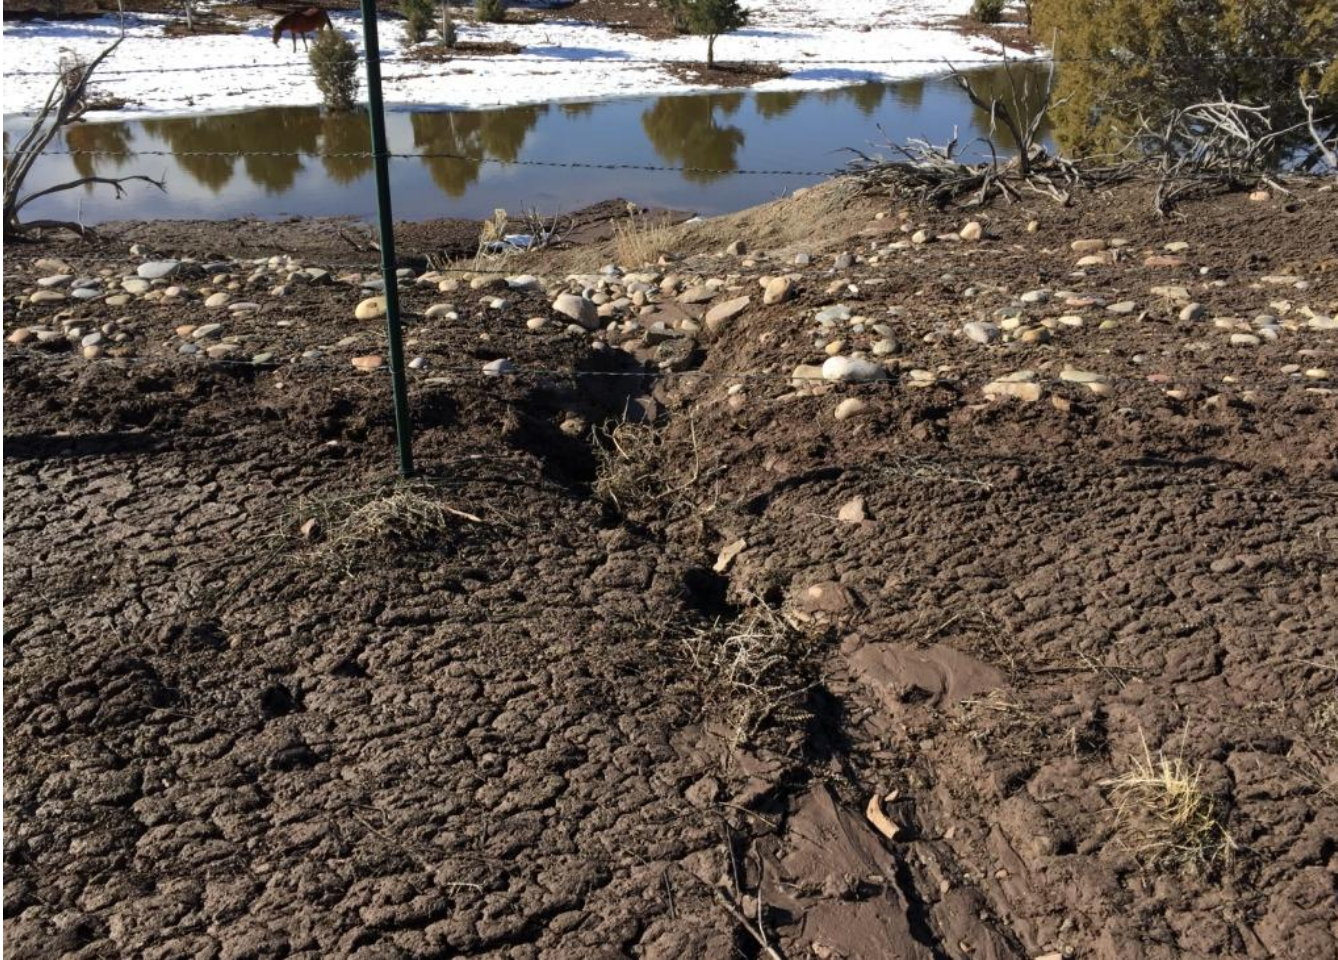
Photo 2. View of erosional channel flowing from well pad directly into a pond adjacent to the western edge of the project area.

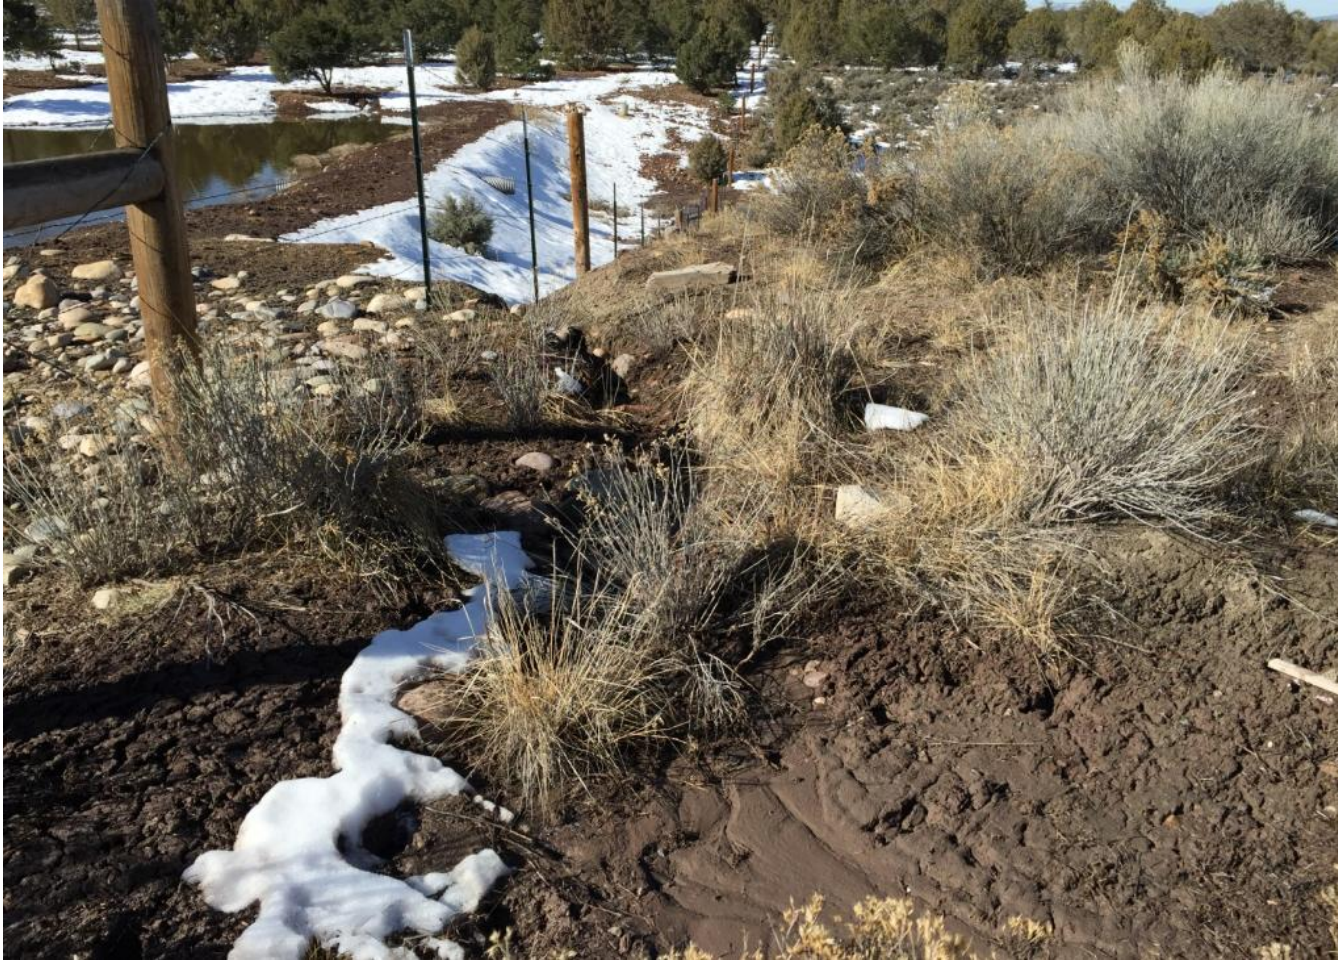
Photo 3. View of another erosional channel flowing off of the western edge of the well pad.

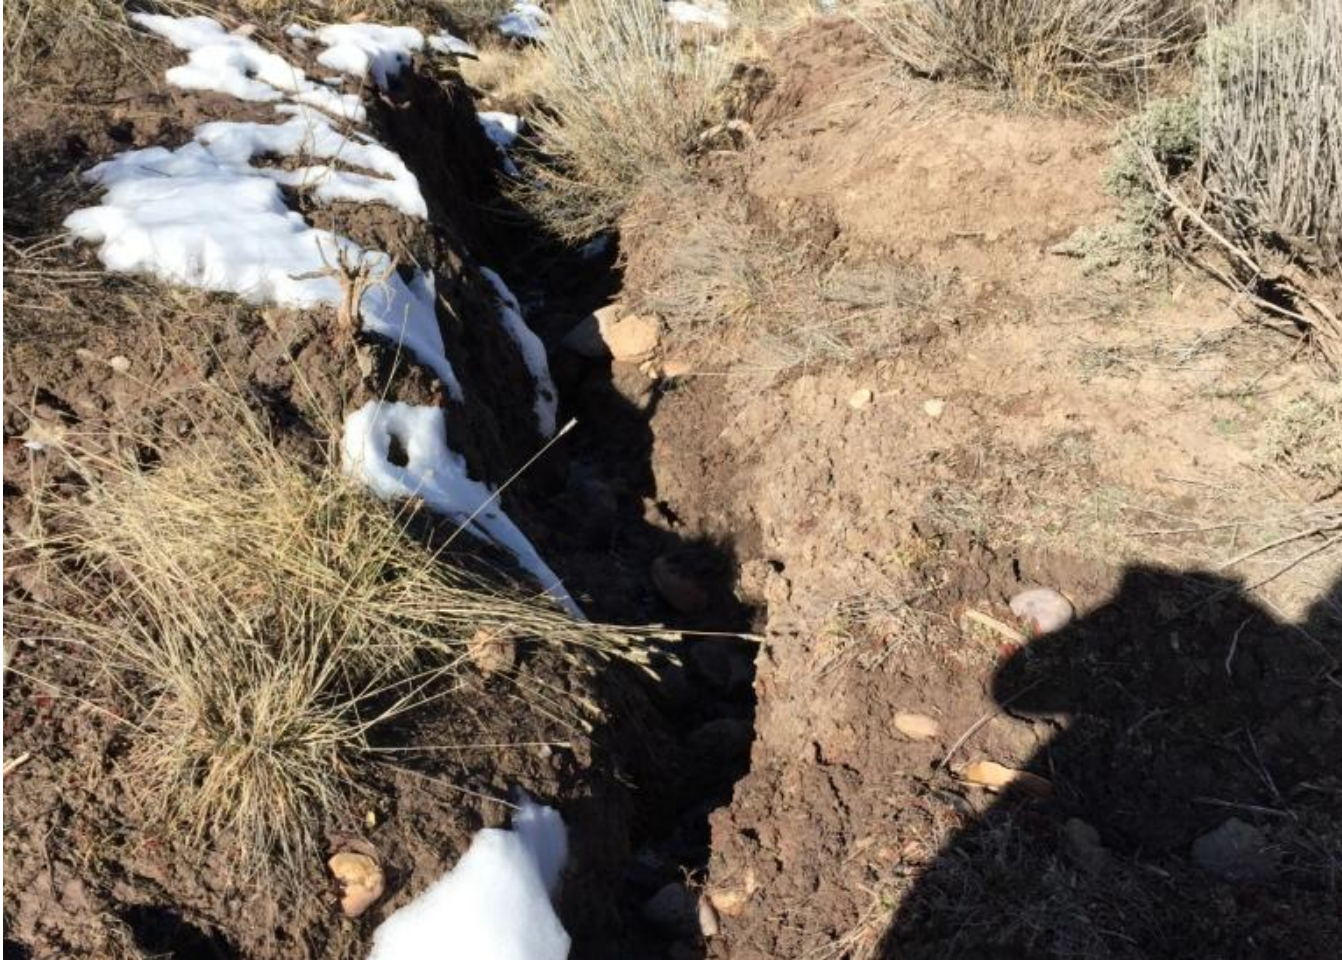
Photo 4. View of an erosional channel in northwestern corner of well pad that appears to be caused from stormwater overflow from silt trap in northern portion of project area (see Photo 5).

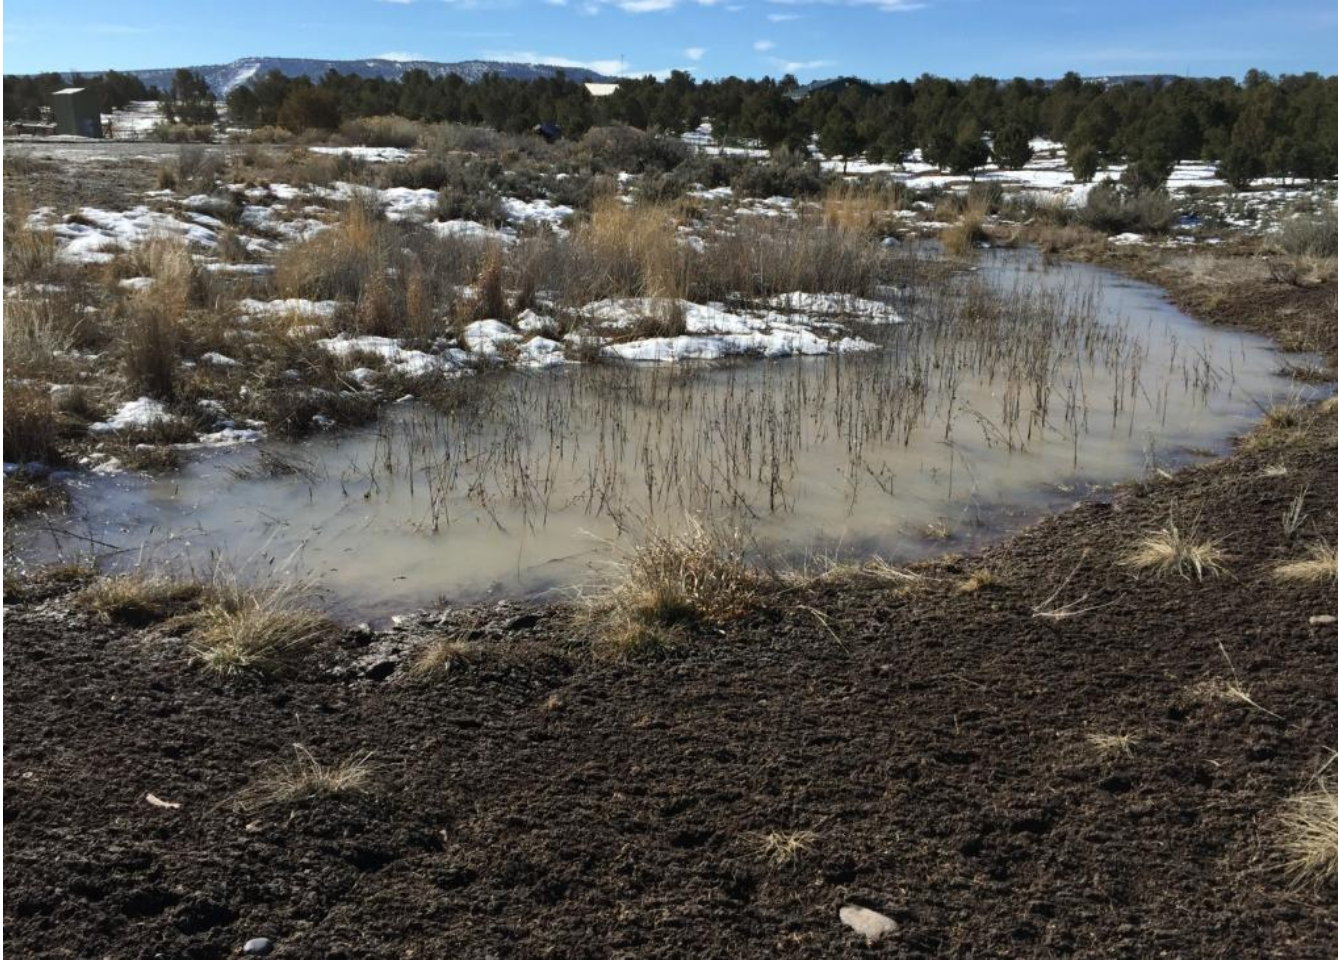
Photo 5. View of silt trap in northern portion of project area that appears to overflow and erode to the northwest (shown in background).

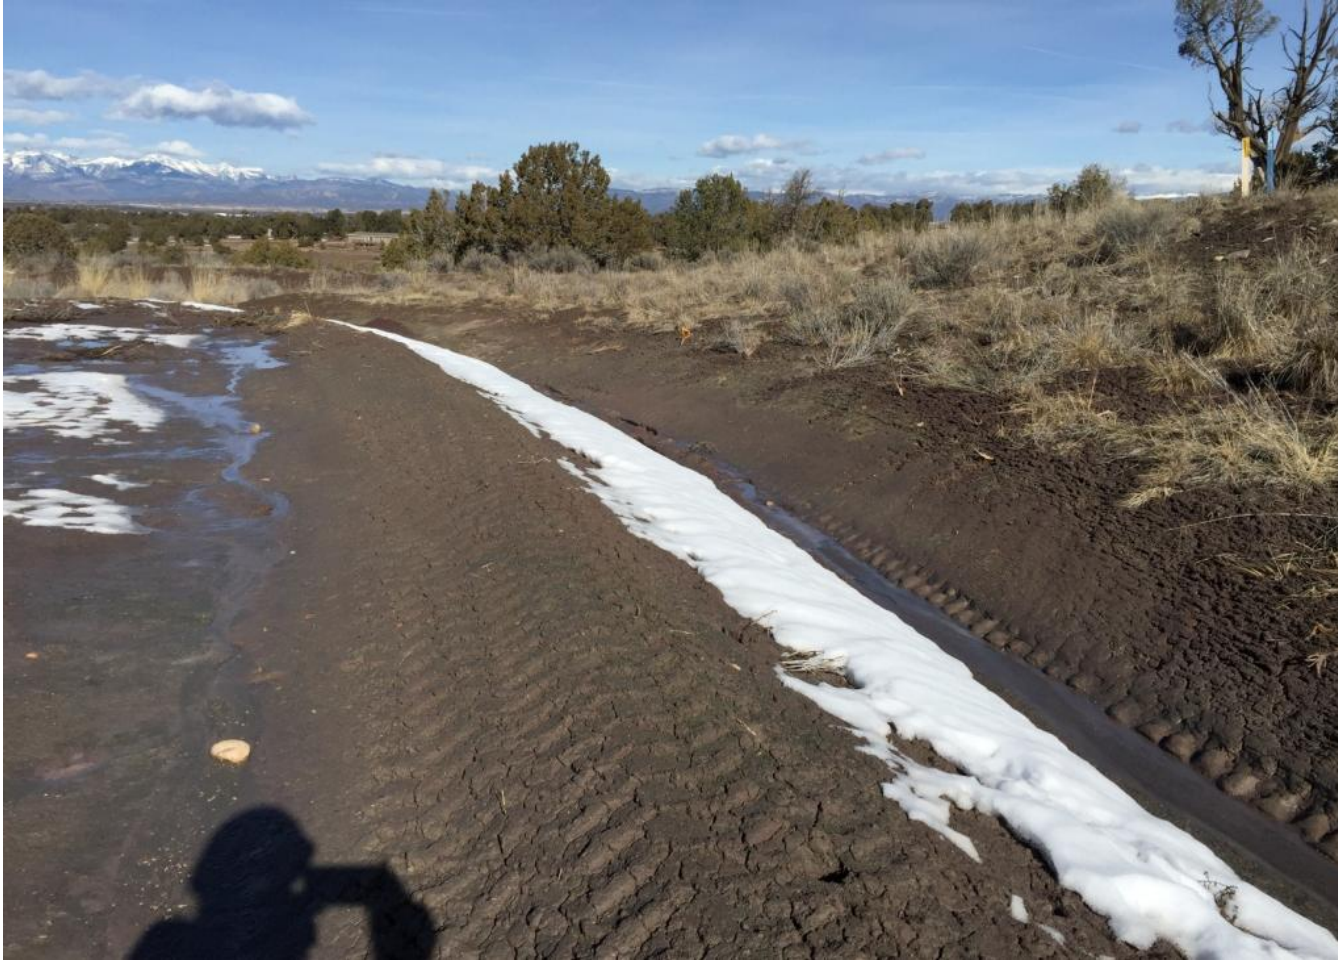
Photo 6. View of new berm and stormwater diversion along eastern edge of project area facing northward.

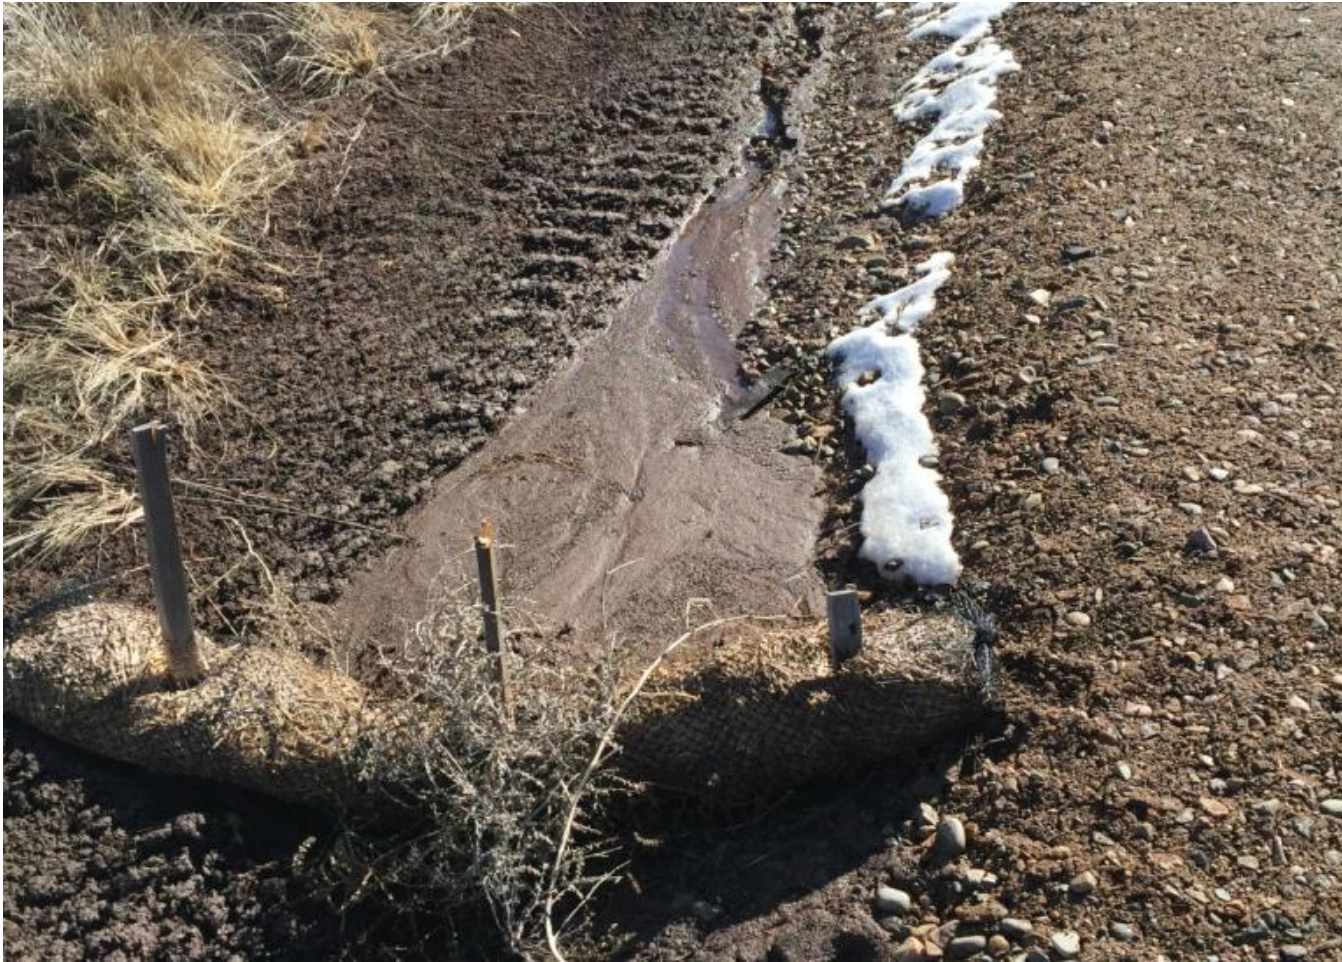
Photo 7. View of straw wattle along northern edge of access road that may not be sufficient to contain stormwater flows as it is almost full of sediment.
