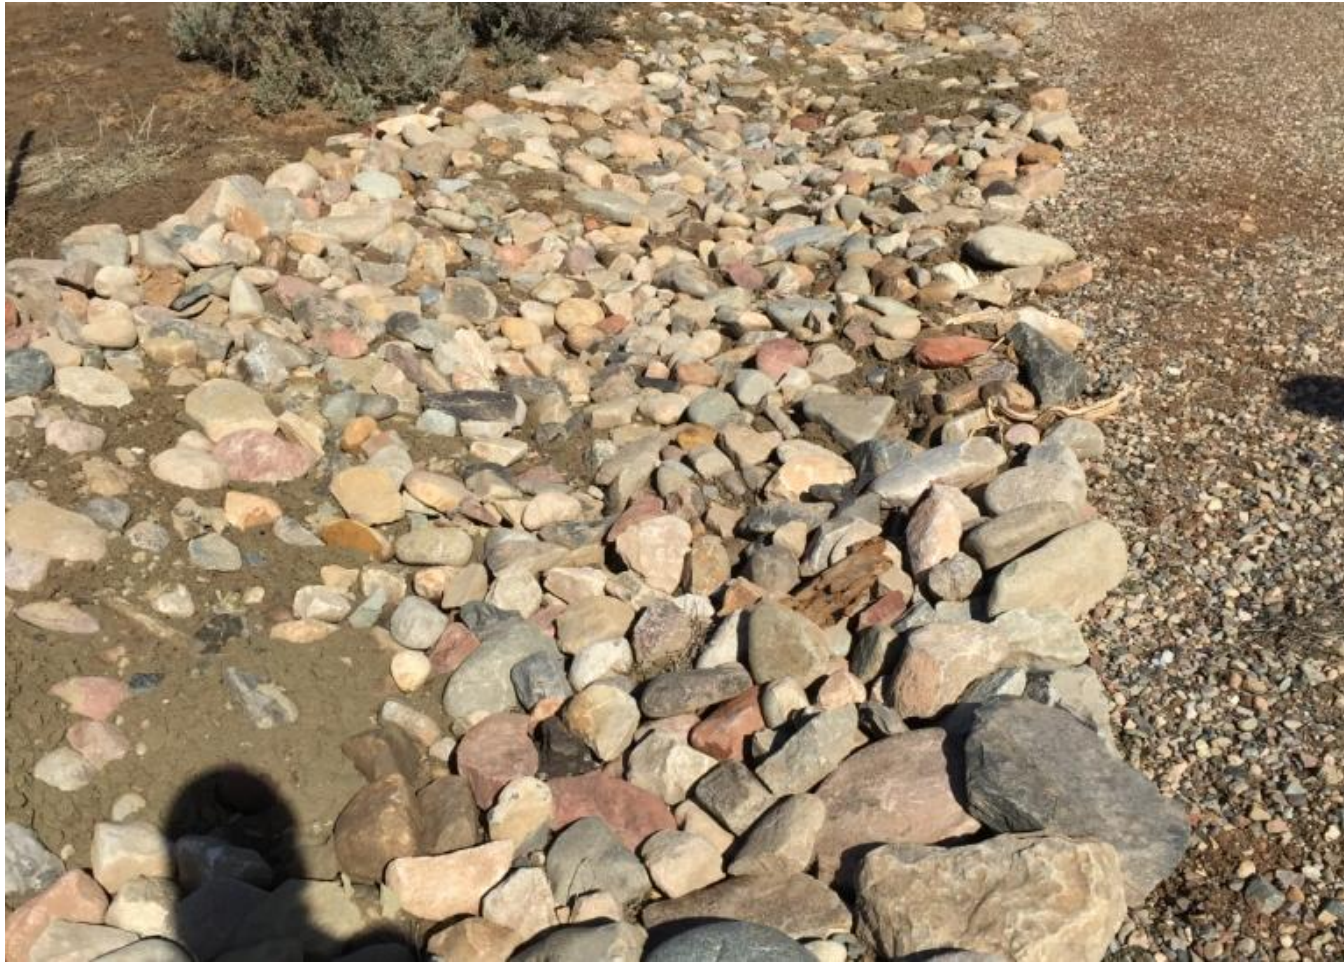
Photo 1. View of drainage diversion on the southwestern corner of project area.

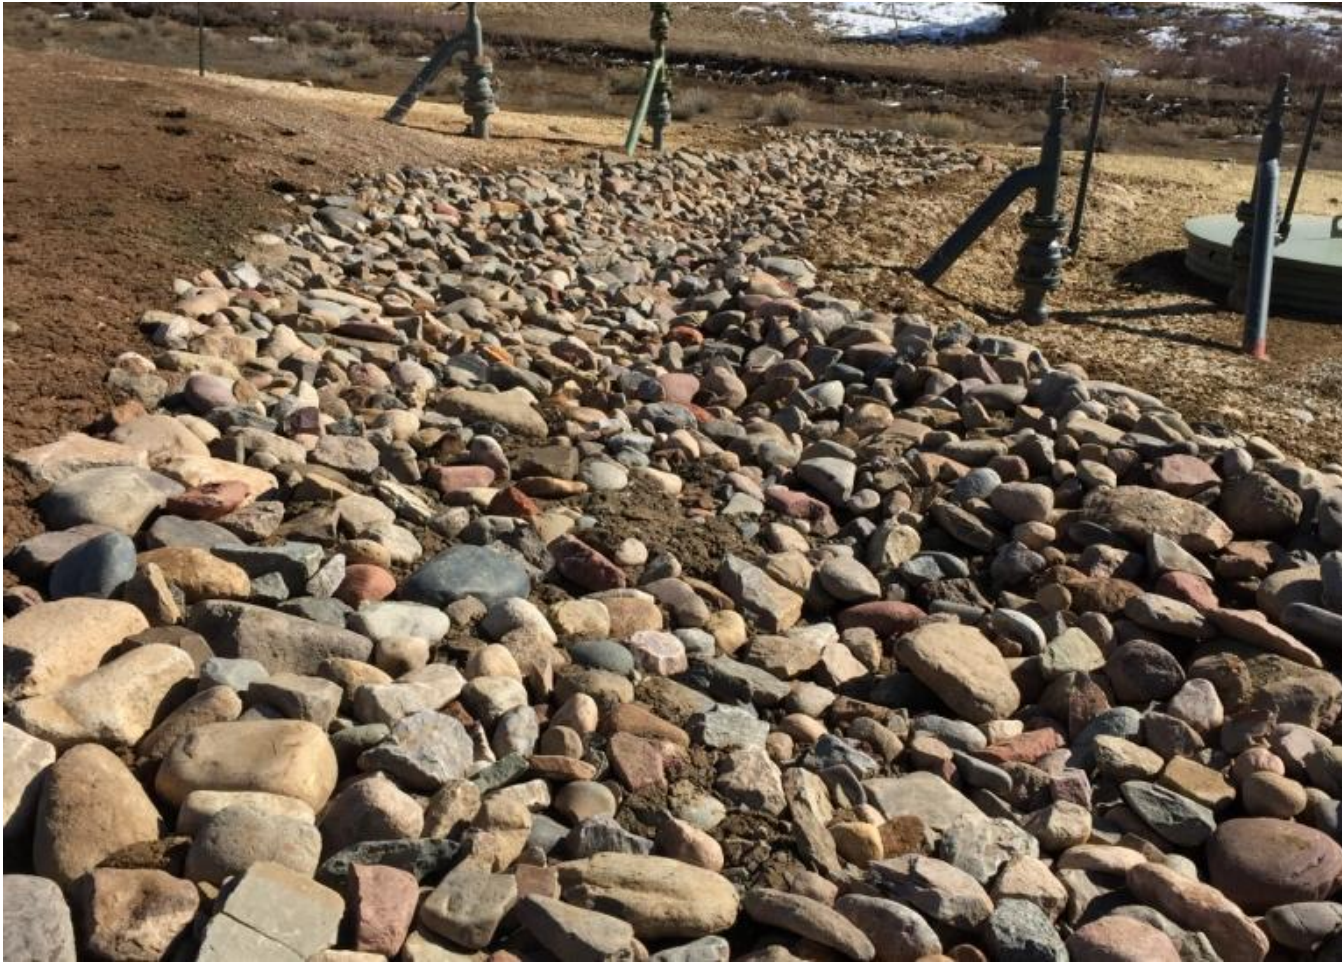
Photo 2. View of the top of a newly installed diversion channel in southeastern corner of project area.

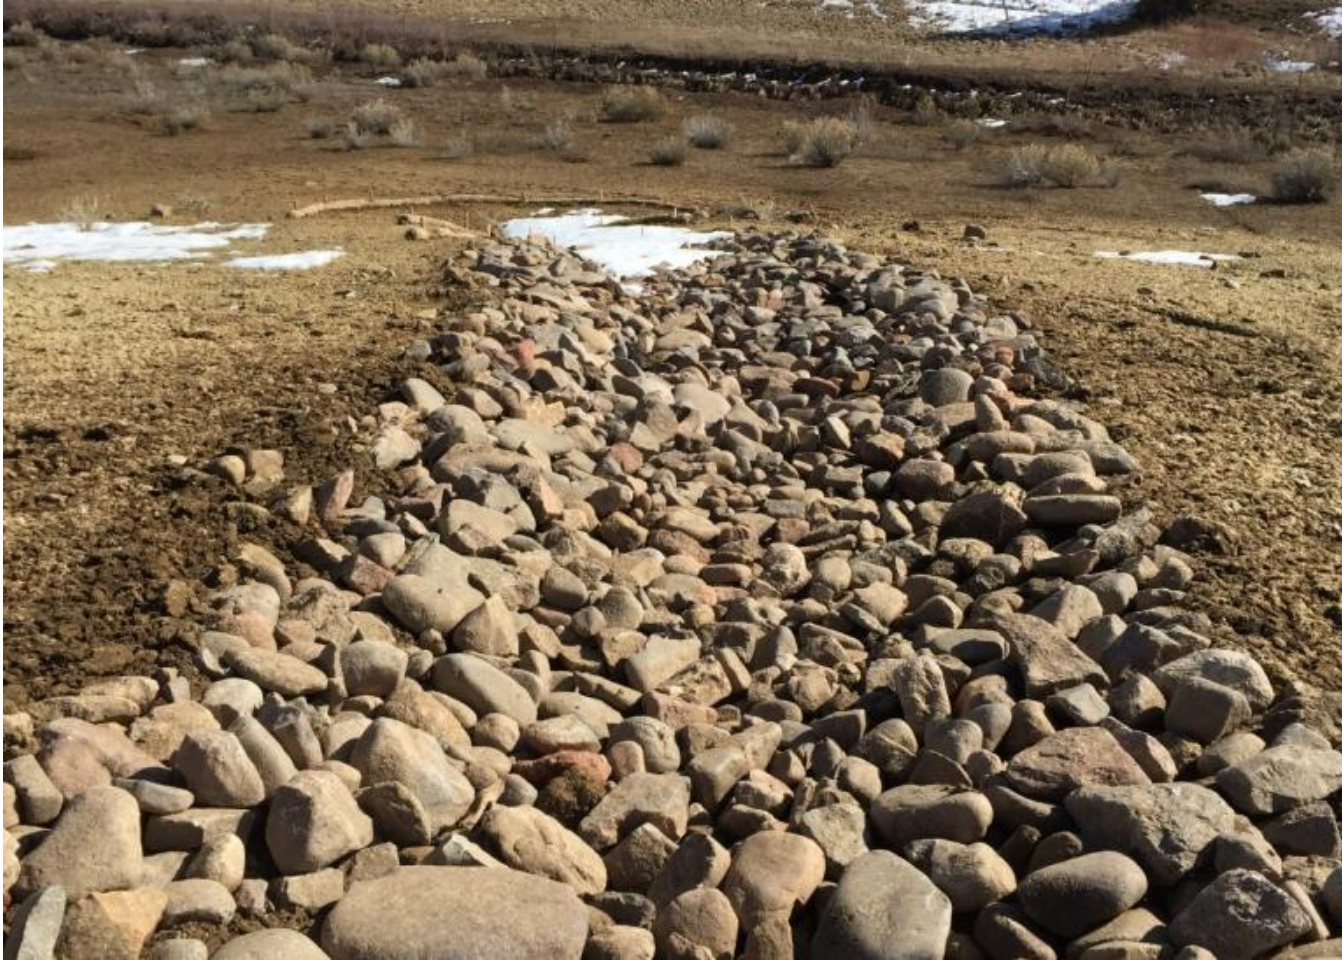
Photo 3. View of the bottom of a newly installed diversion channel, hydromulch, and straw wattles. Channel appears to be sufficient to de-energize and filter flows toward the irrigation canal shown in background.

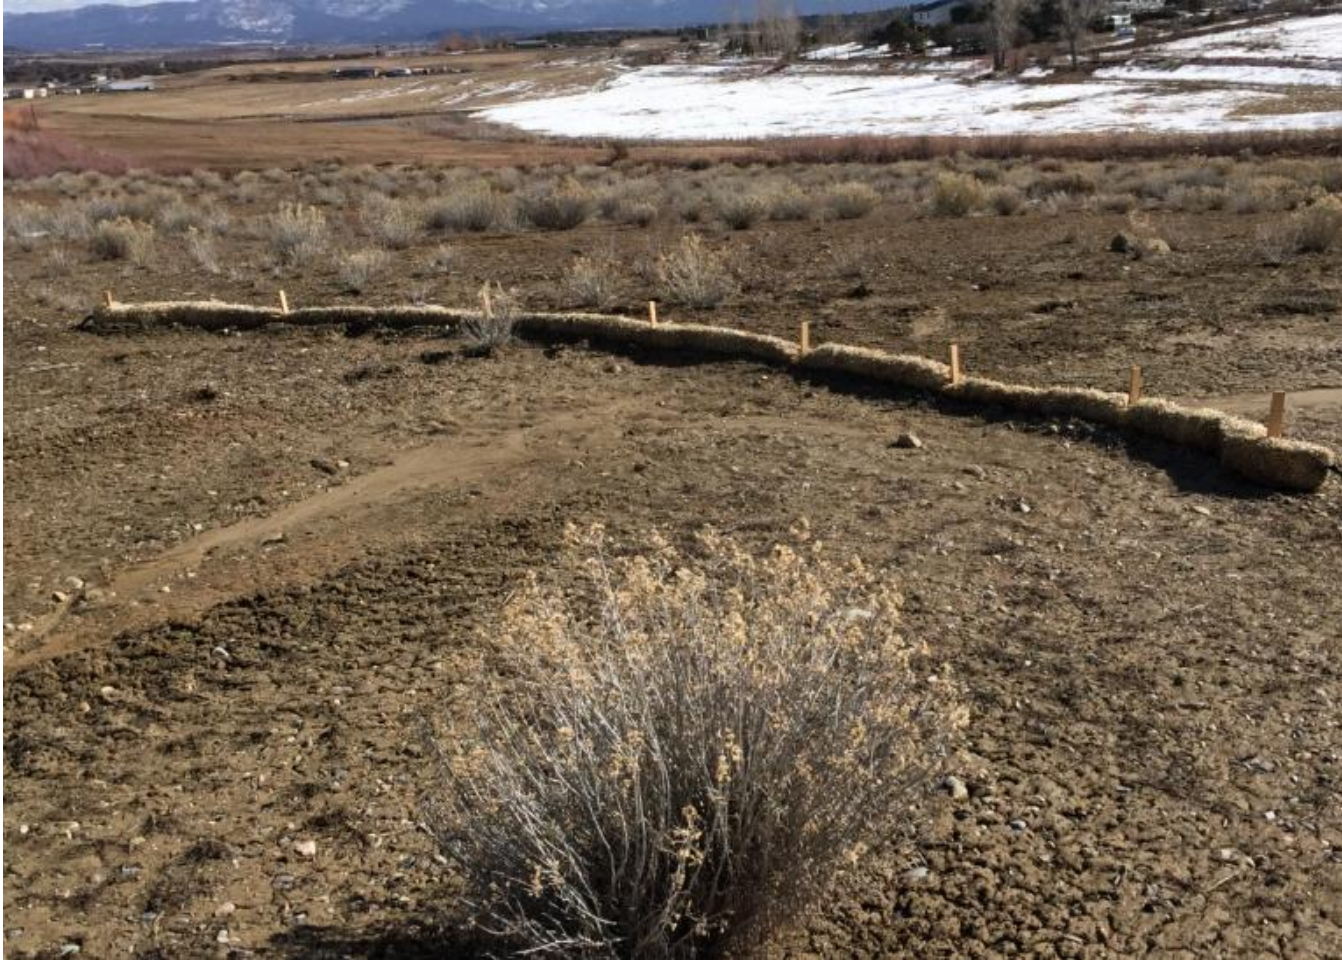
Photo 4. View of area in northeastern corner of project area where diverted stormwater flows from the northern edge of the well pad.

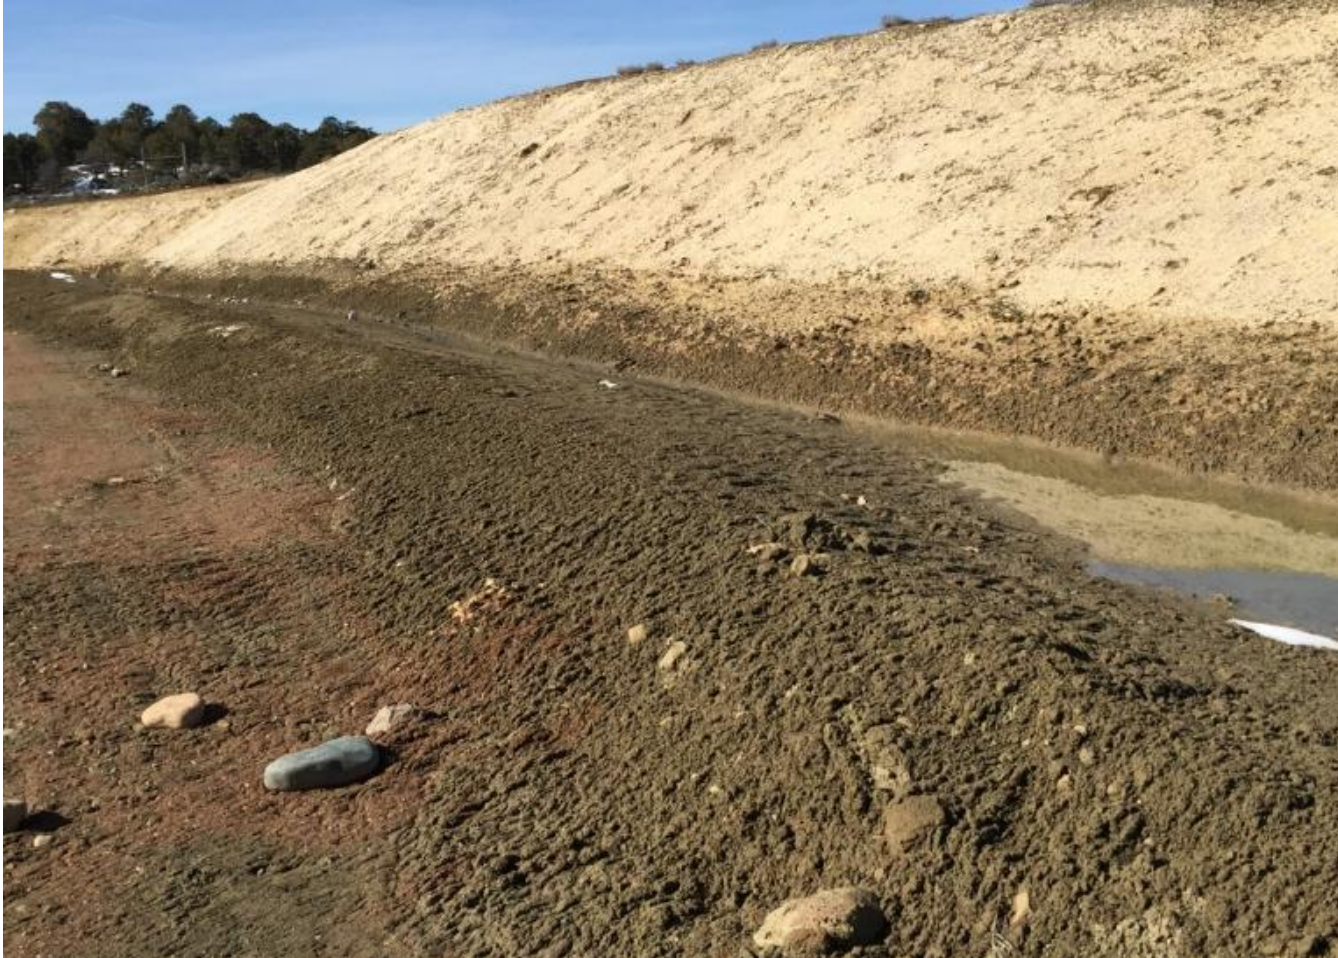
Photo 5. View of newly installed berm and hydromulch in northern and northwestern portions of the project area from northern edge facing westward.
