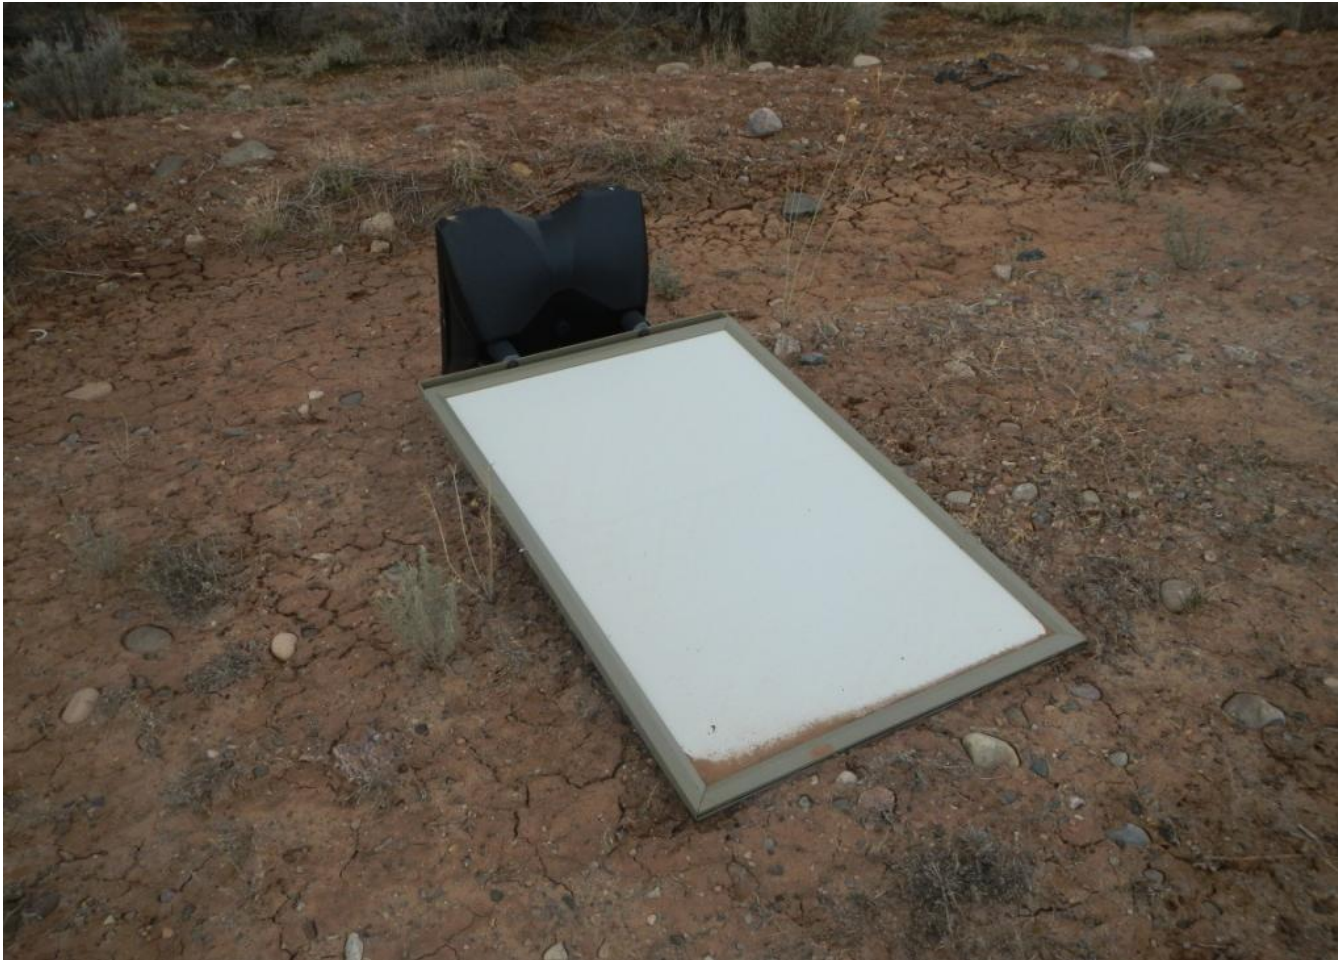
Photo 1. View of well sign that appears to have blown over.

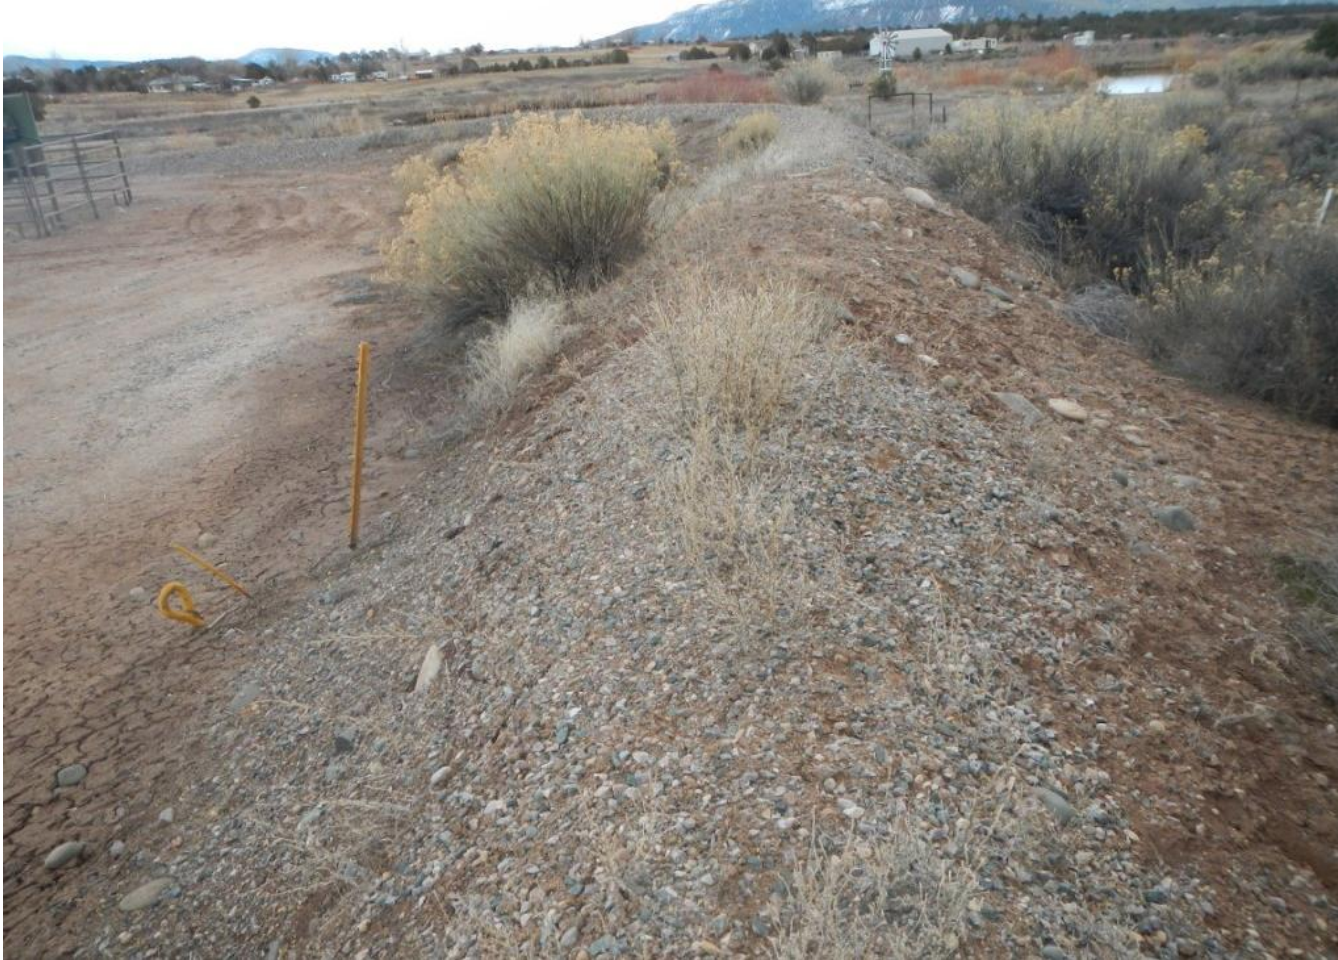
Photo 2. View of vegetation on berms which is largely comprised of weeds such as kochia (*Kochia scoparia*) and cheatgrass (*Bromus tectorum*), as well as the opportunistic native shrub, rabbitbrush (*Ericameria nauseosa*).

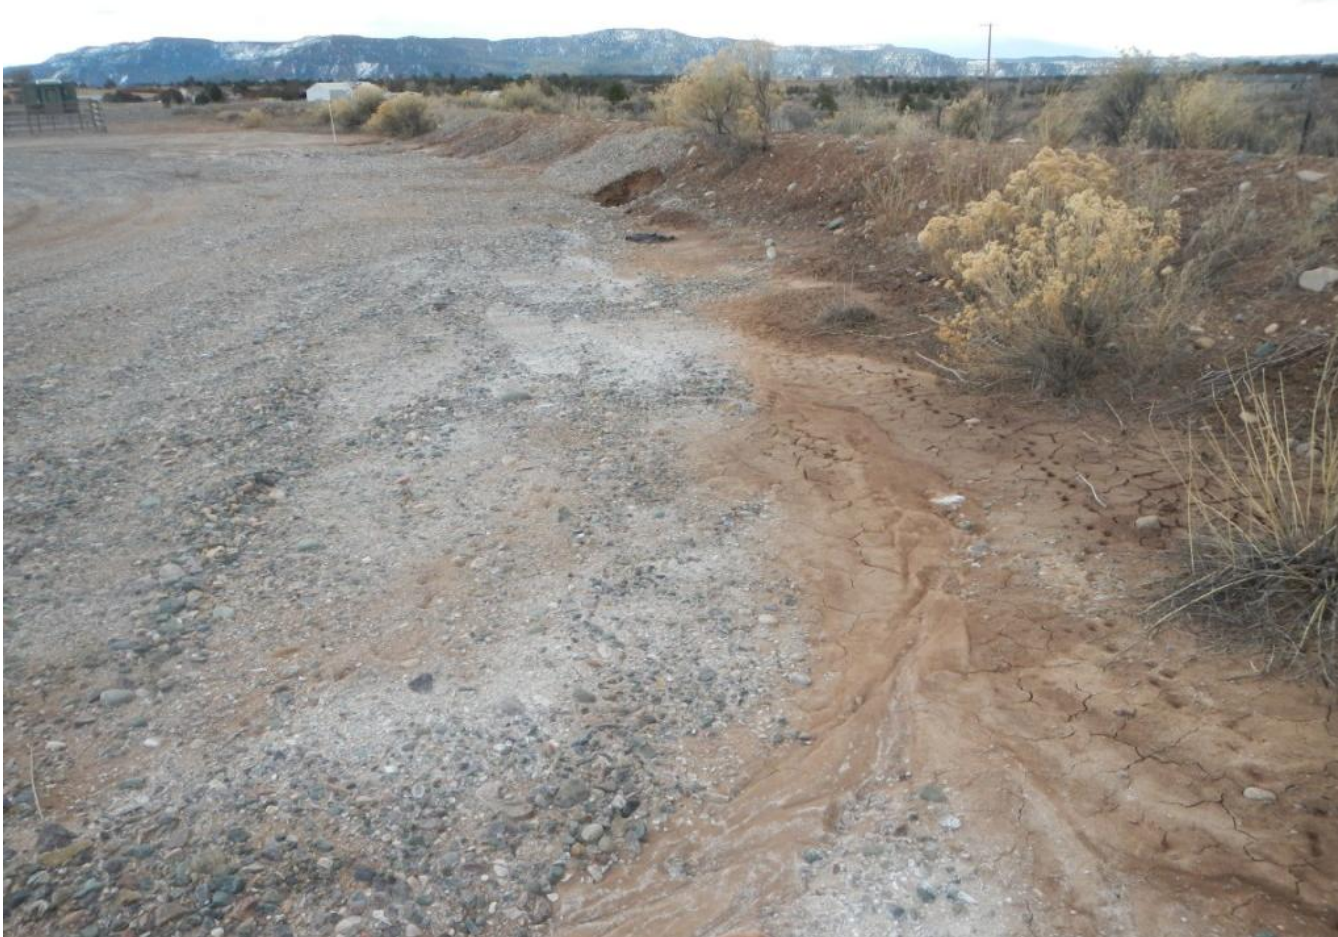
Photo 3. View of southern edge of working area from southwestern corner facing eastward. It appears that stormwater flows along southern edge and erodes through weaknesses in southern berm.

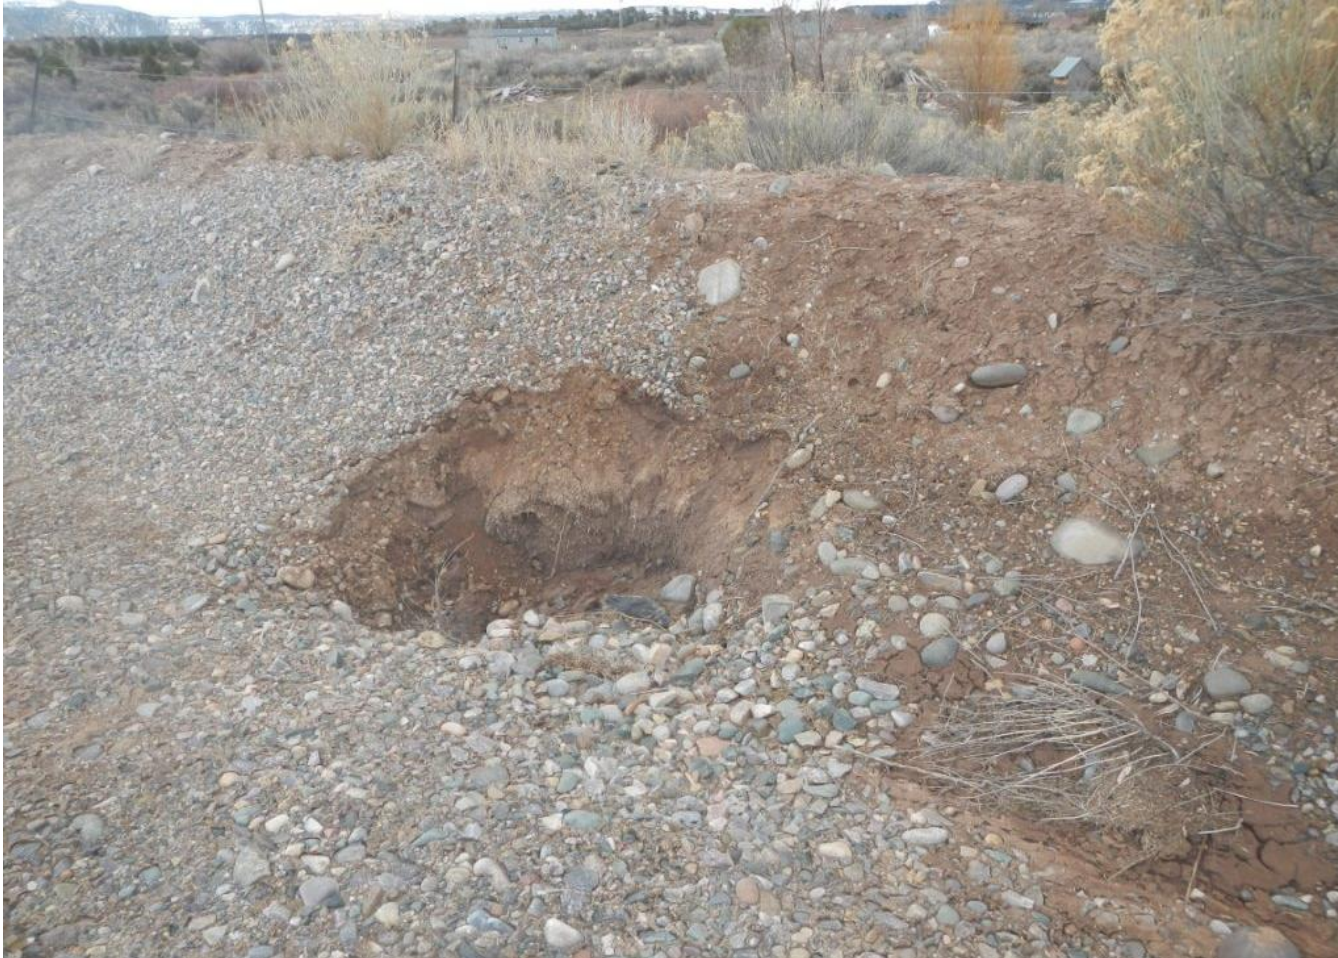
Photo 4. View of area in southern berm where it appears that stormwater flows have eroded a hole that flows through the well pad.

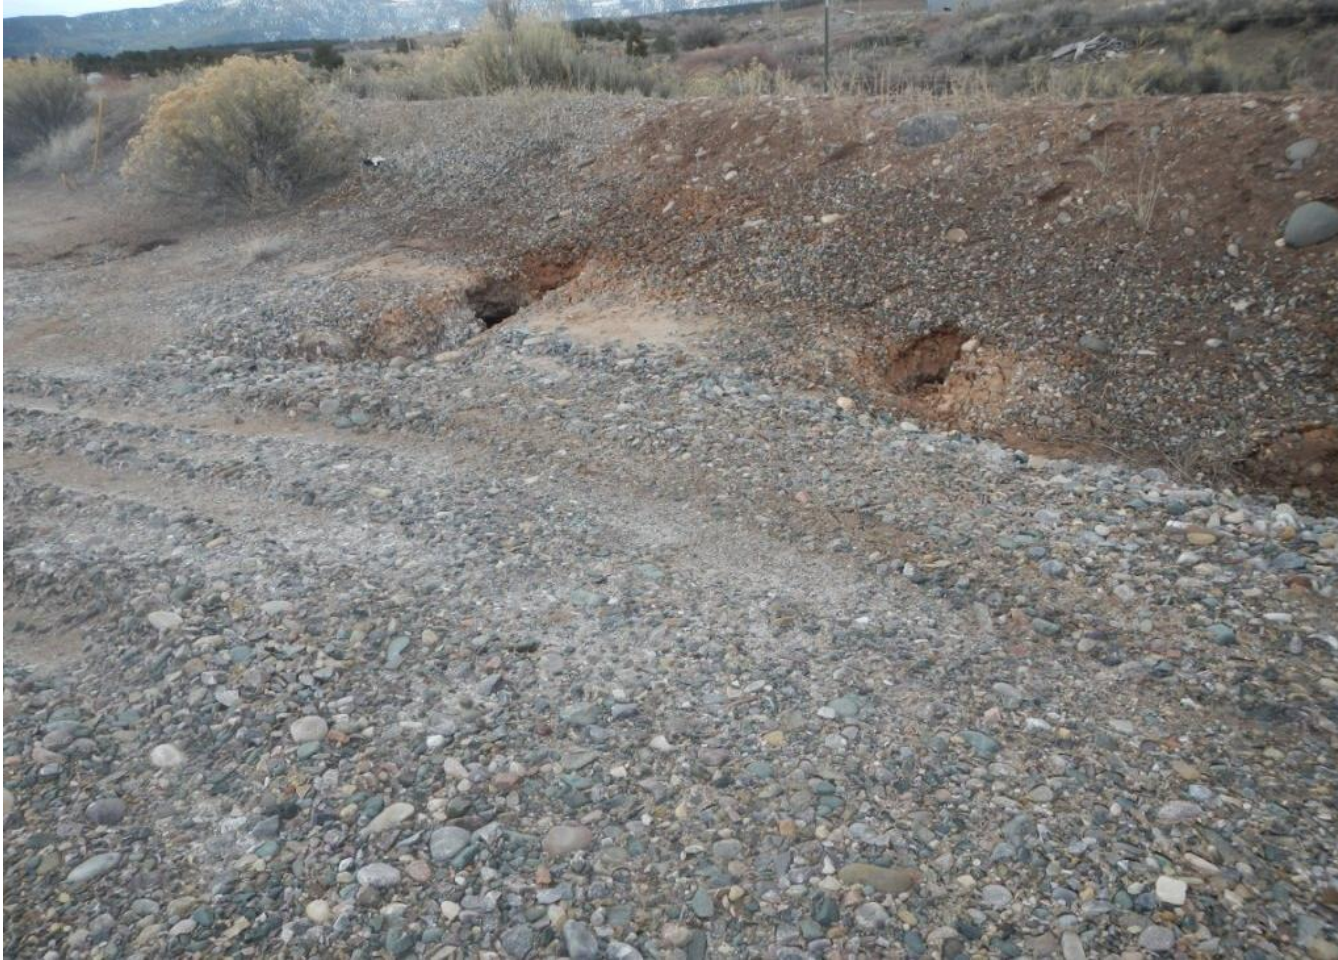
Photo 5. View of additional areas in southern berm where it appears stormwater flows have eroded through the well pad.

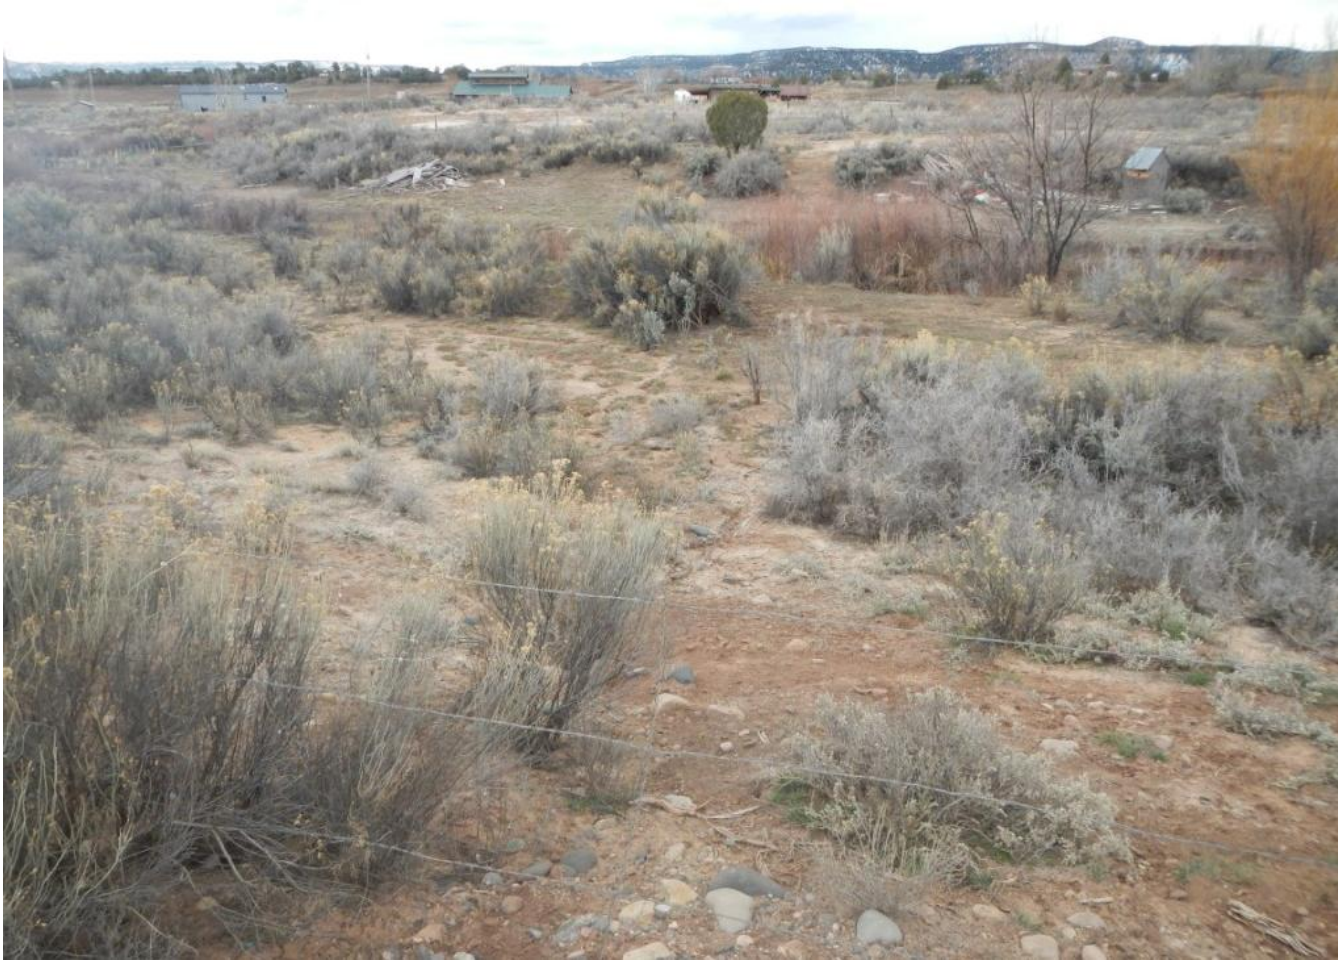
Photo 6. View of area south of well pad where flow patterns can be seen exiting the well pad below holes in berm and flowing toward nearby perennial stream (in background).

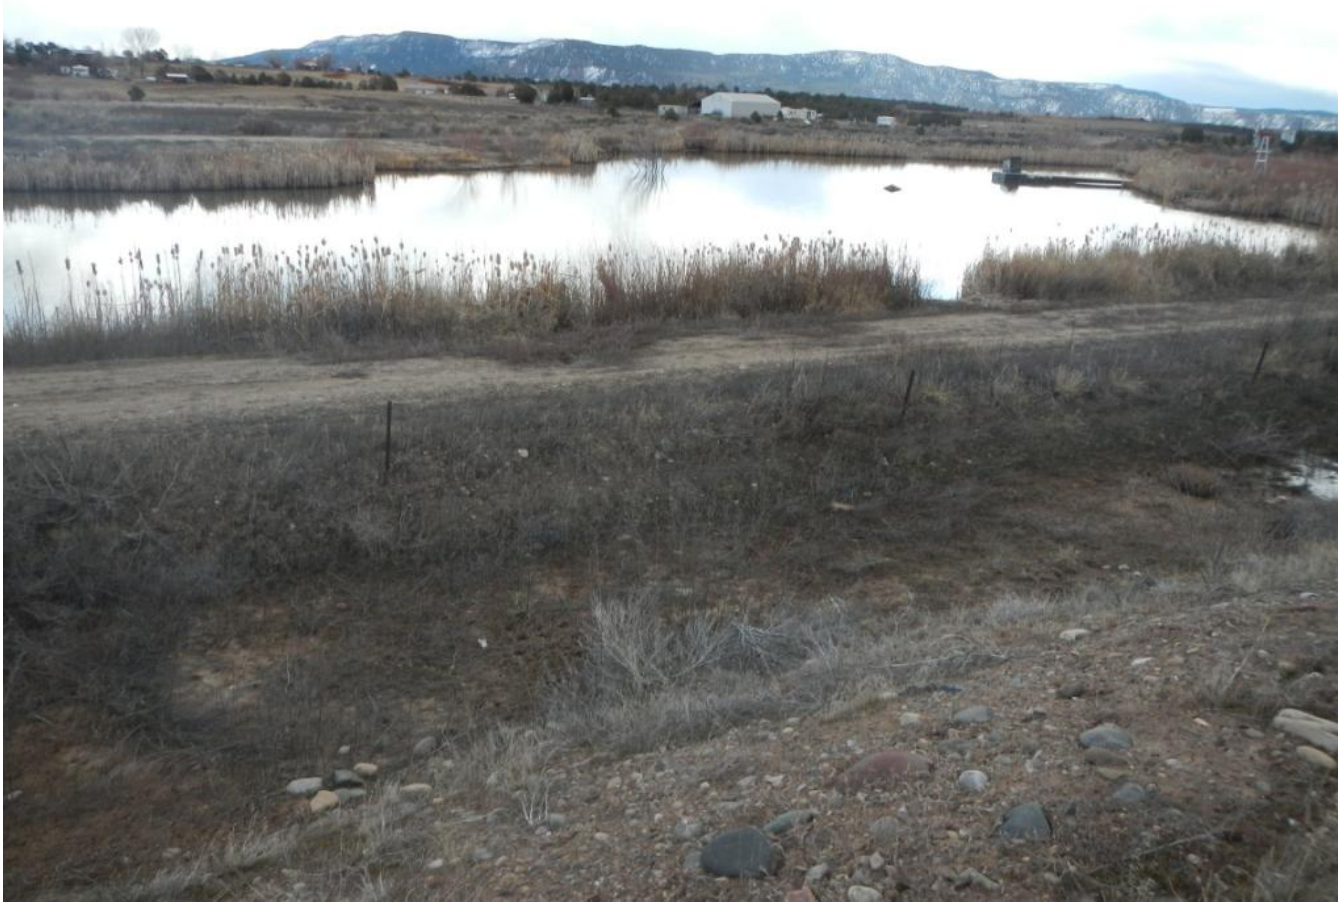
Photo 7. View of pond adjacent to eastern edge of well pad. Vegetation on well pad is largely kochia in this area.
