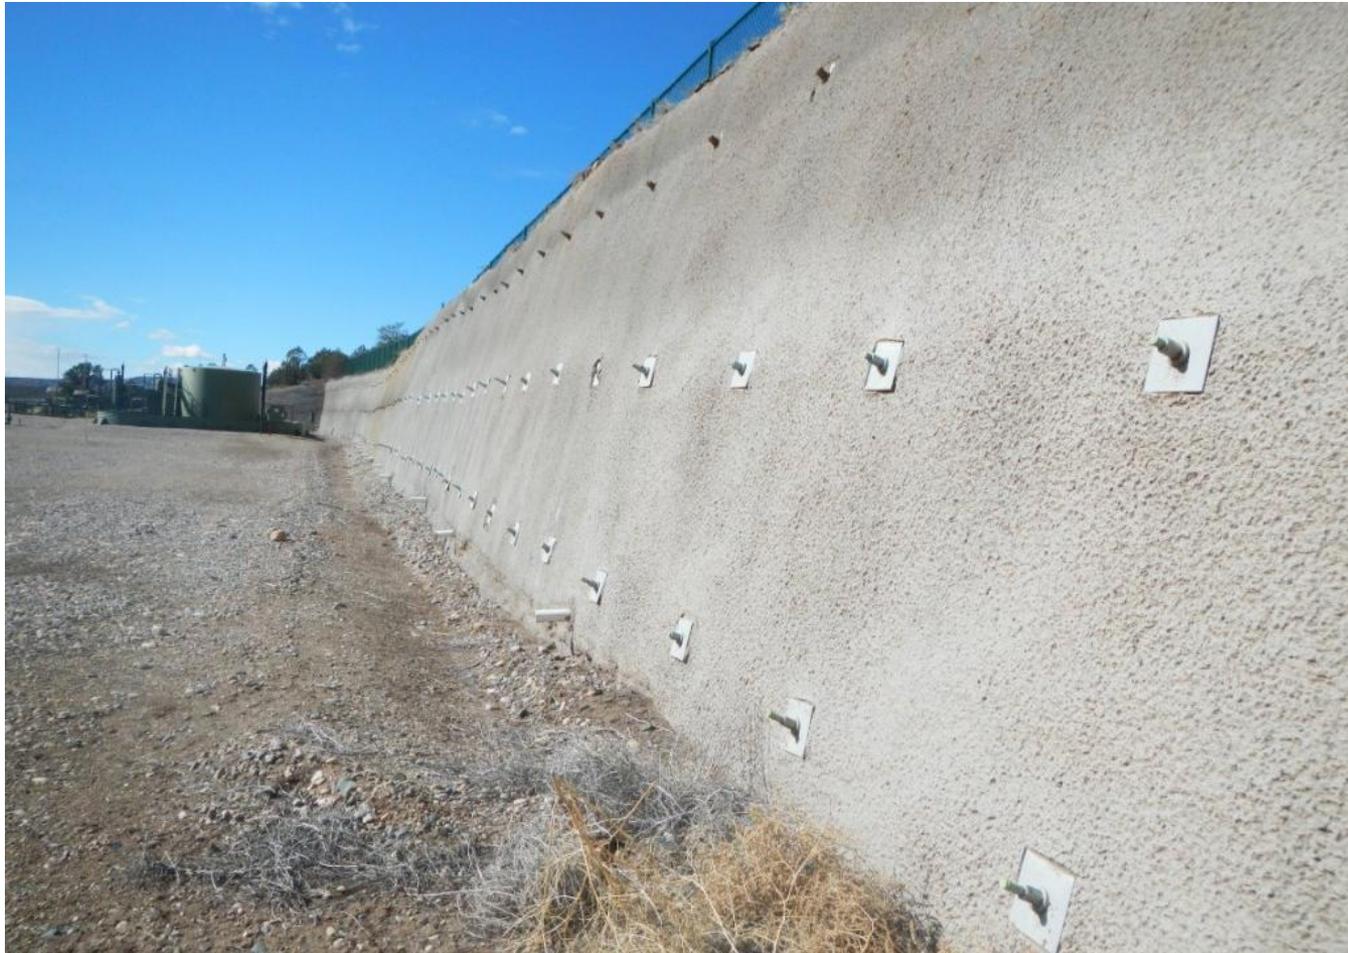
Photo 1. View of concrete stabilization of northern cut-slope.

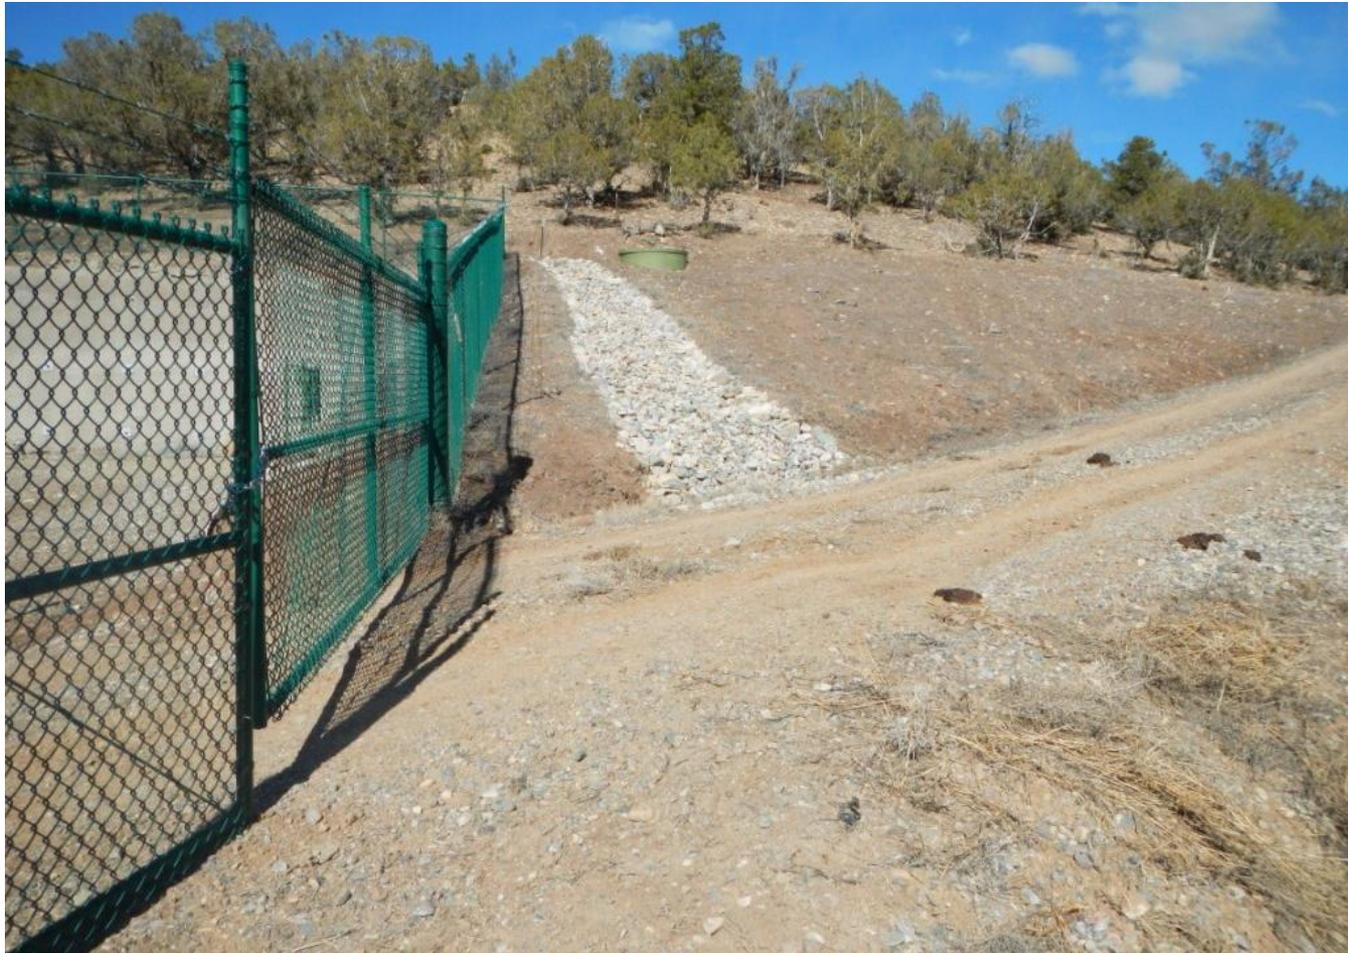
Photo 2. View of northeastern edge of project area from mid-eastern side facing northward.

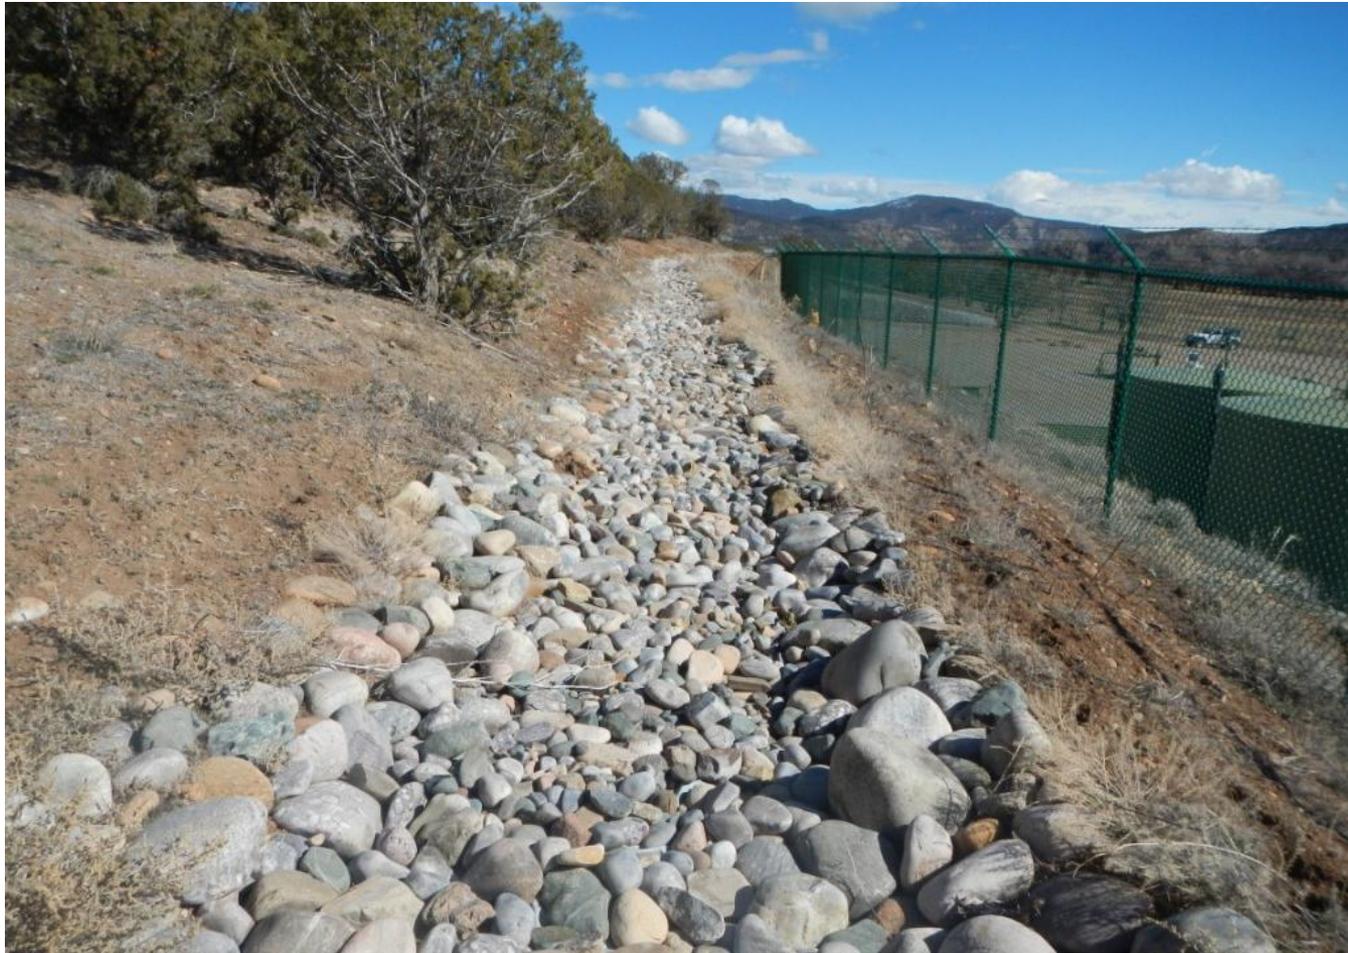
Photo 3. View of armored stormwater diversion from northwestern corner facing eastward.

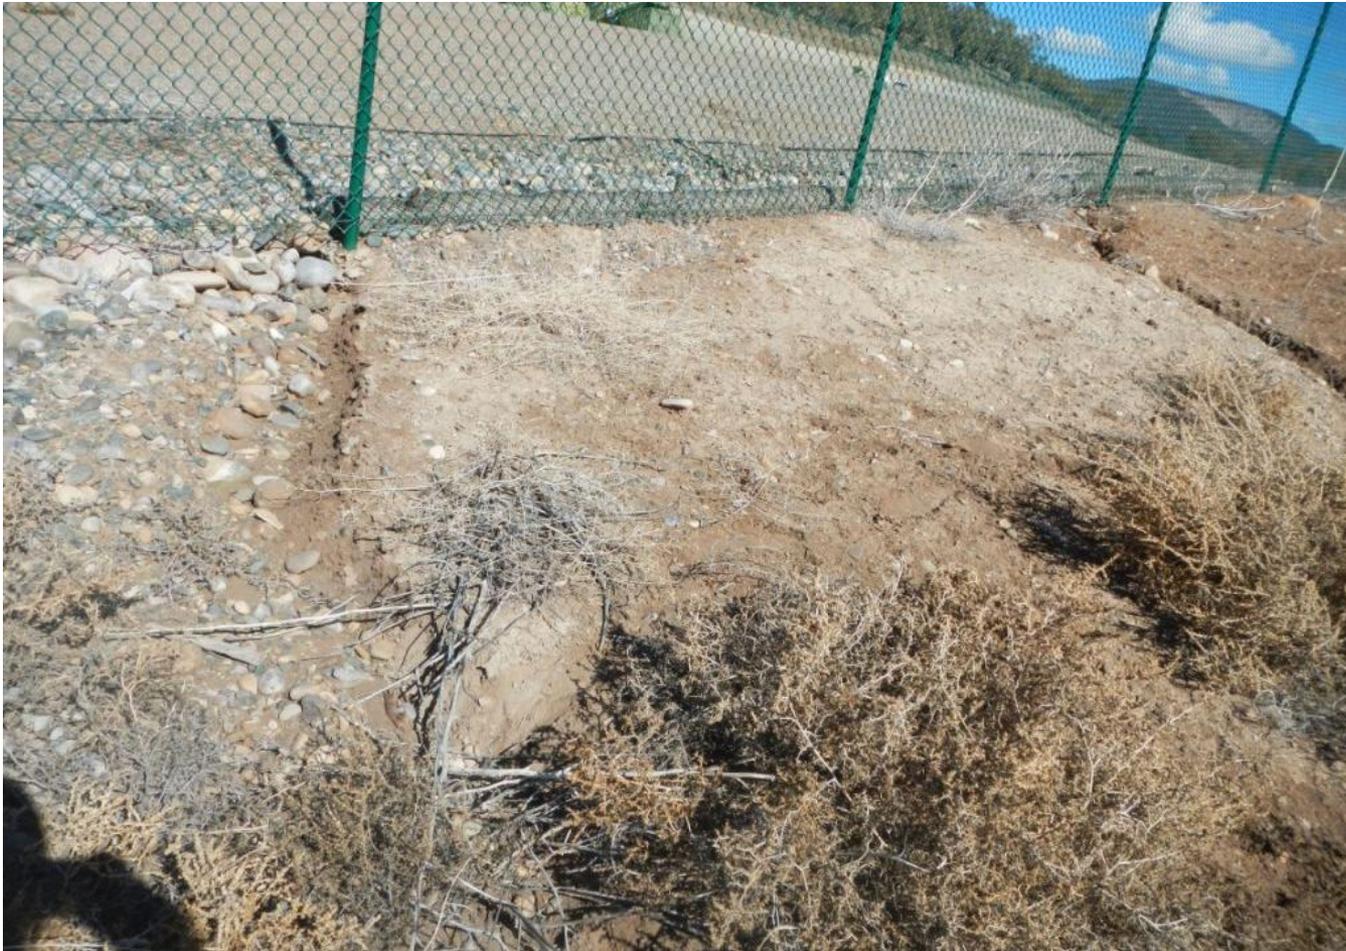
Photo 4. View of rill erosion forming in southern portion of project area. Successful revegetation of this area would provide better stabilization of these slopes.

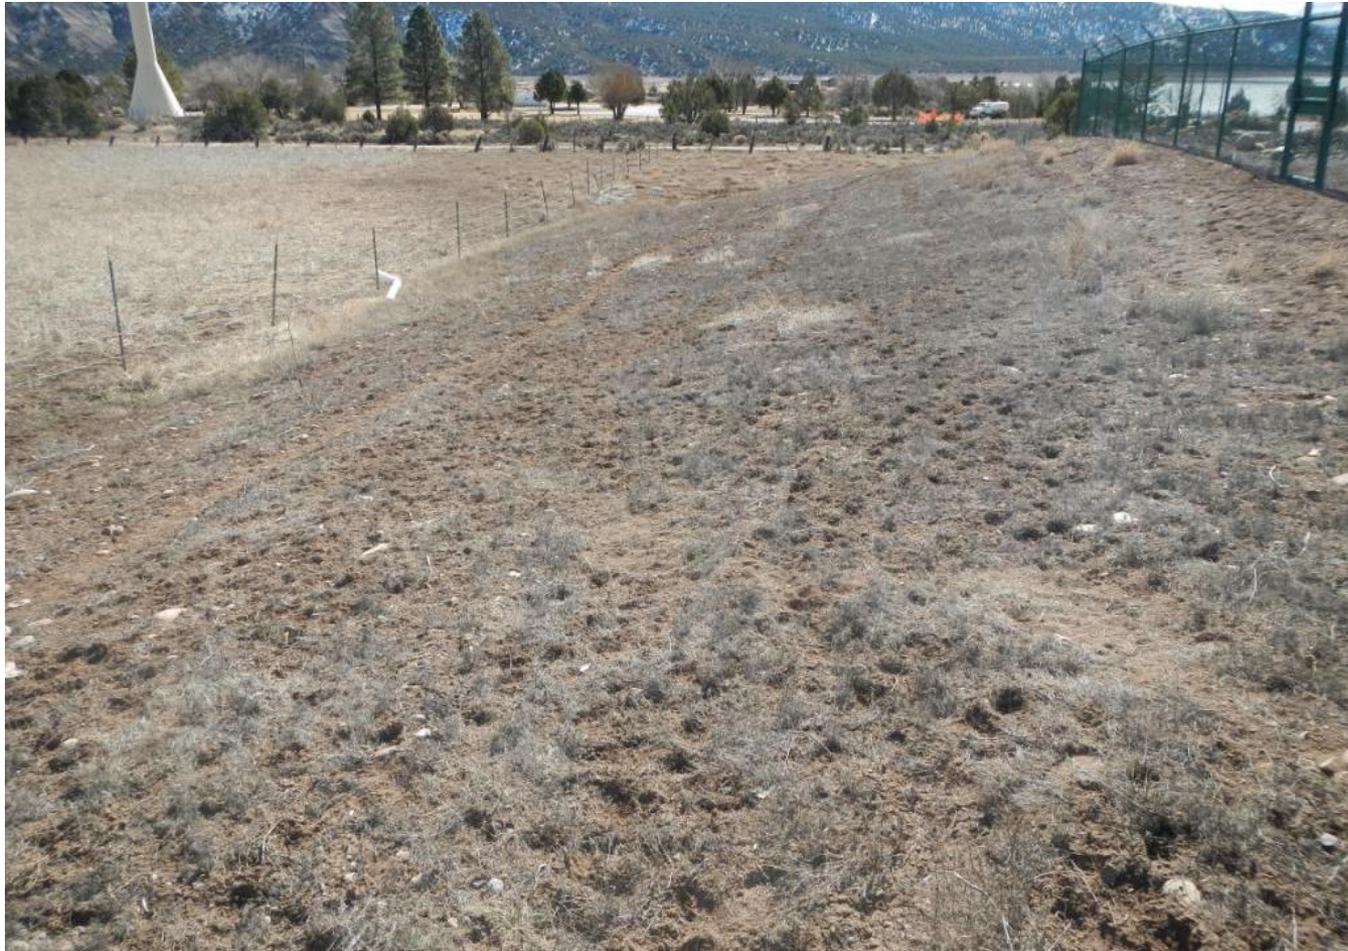
Photo 5. View of southeastern portion of project area from mid-eastern edge facing southward. Dried vegetation is predominantly Russian thistle (*Salsola tragus*).

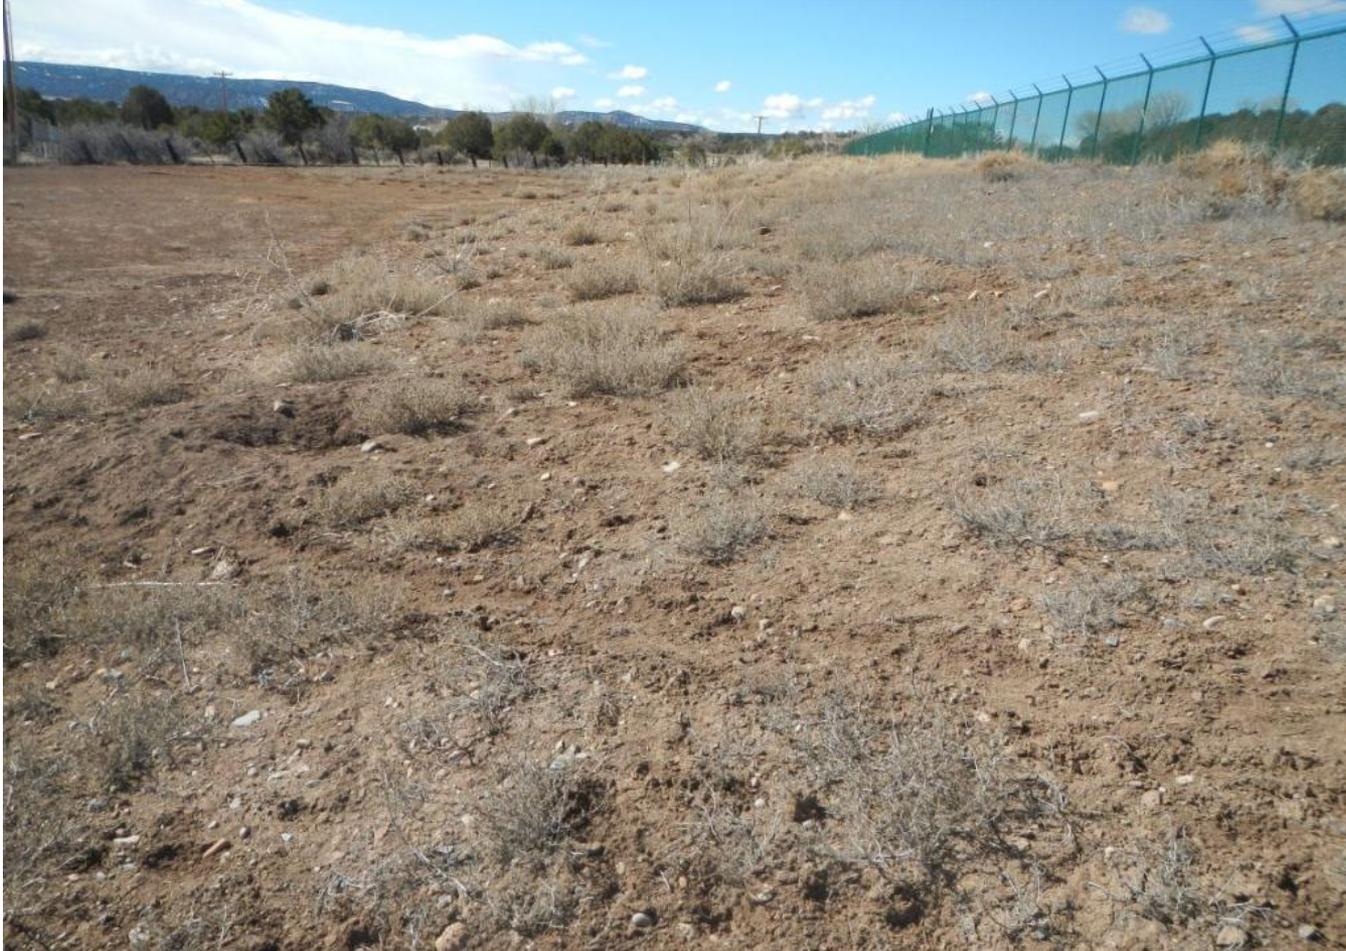
Photo 6. View of southern portion of project area from southeastern corner facing eastward. Vegetation is largely Russian thistle.
