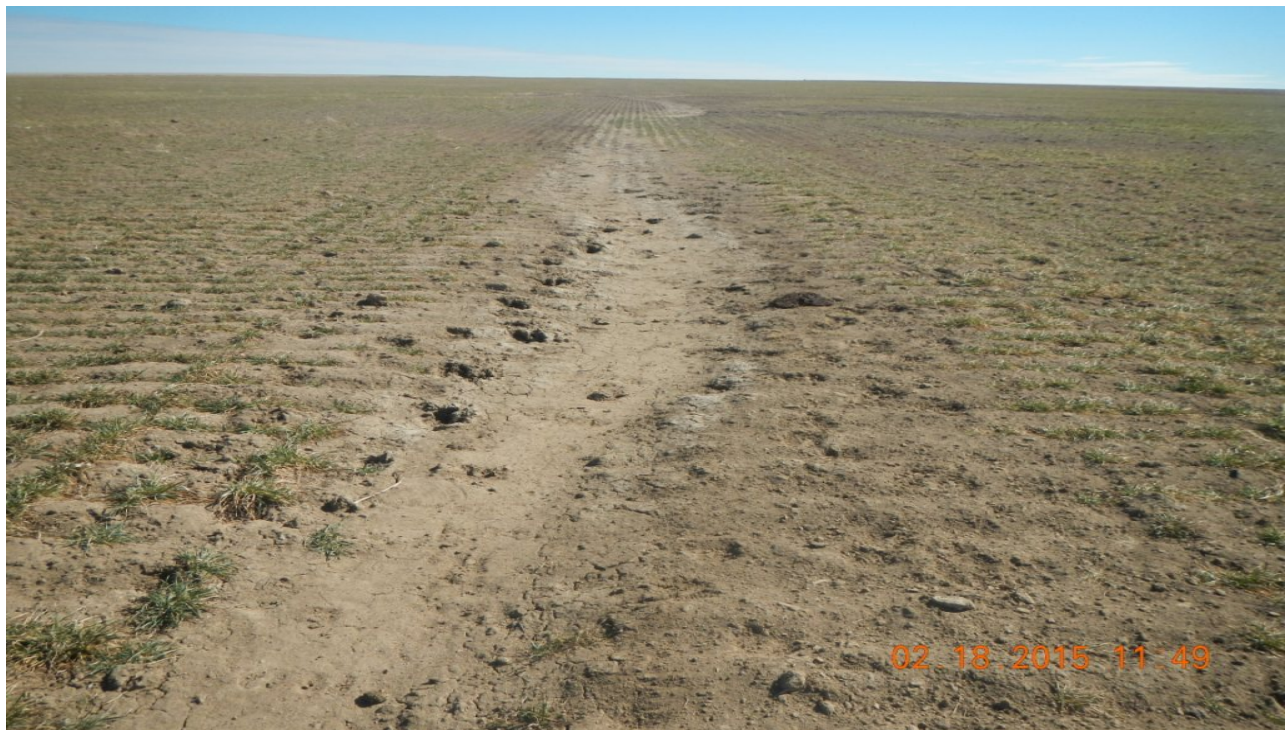
photo 1: Facing east towards the location. Evidence of access road does not have crop growth.

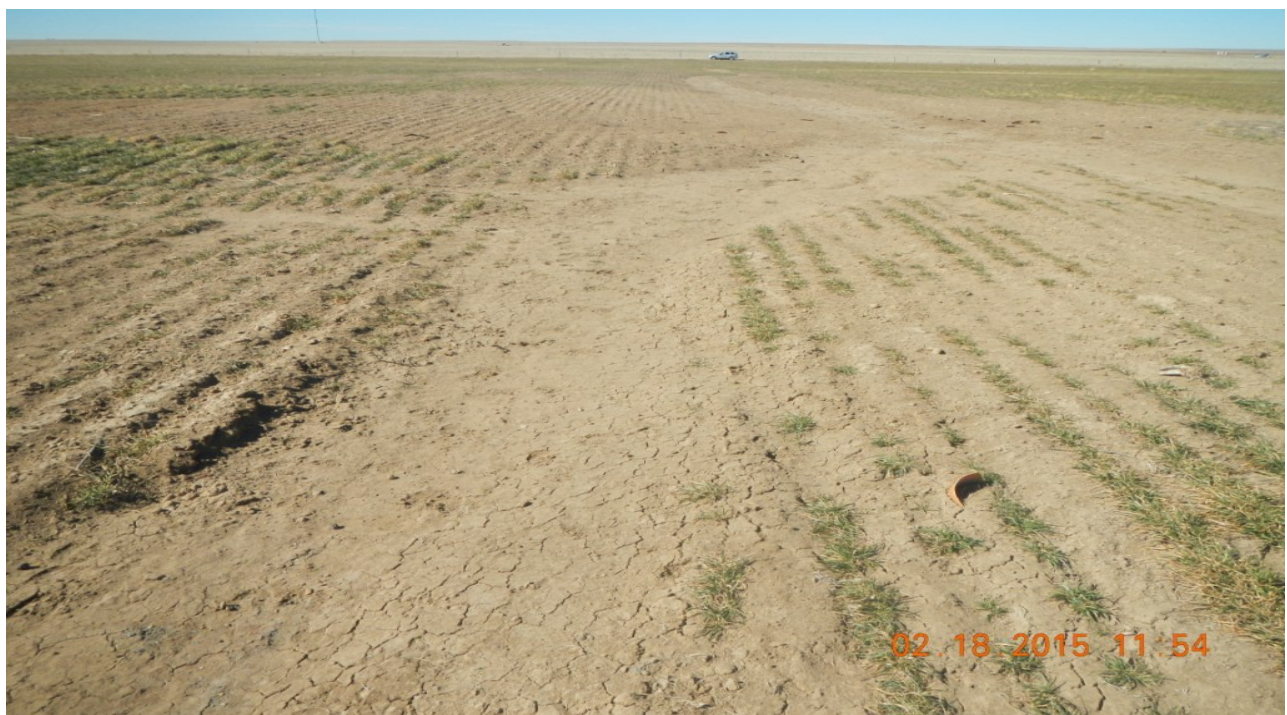
photo 2: Facing west from the location. Evidence of possible erosion through center of the location.

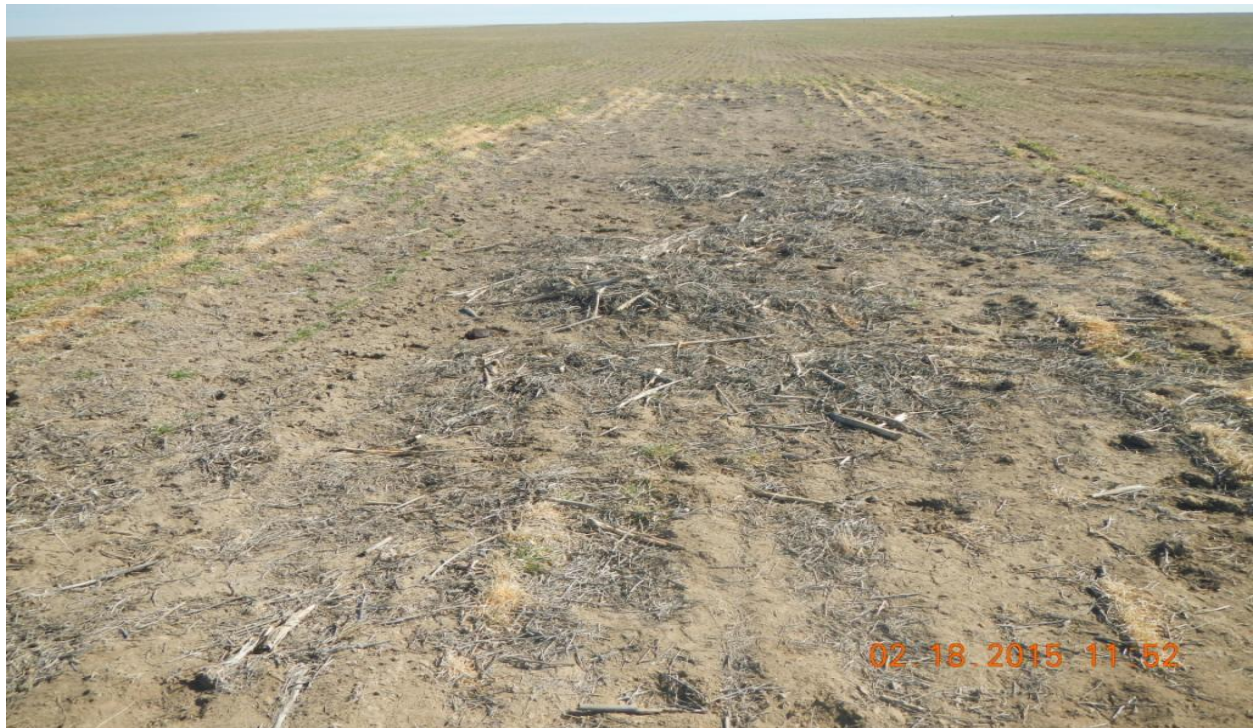
photo 3: North side of the location. Area of subsidence with no crop growth approximately 60'x20'.

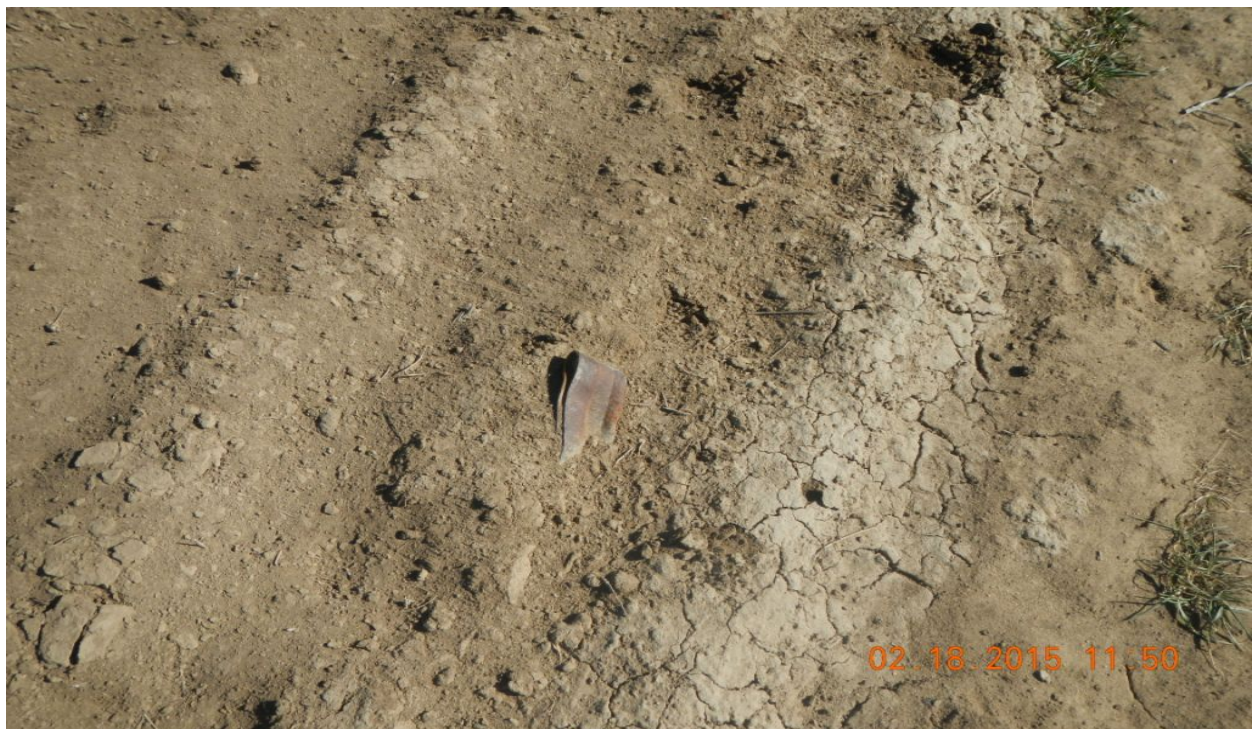
photo 4: Piece of metal debris found on the location.

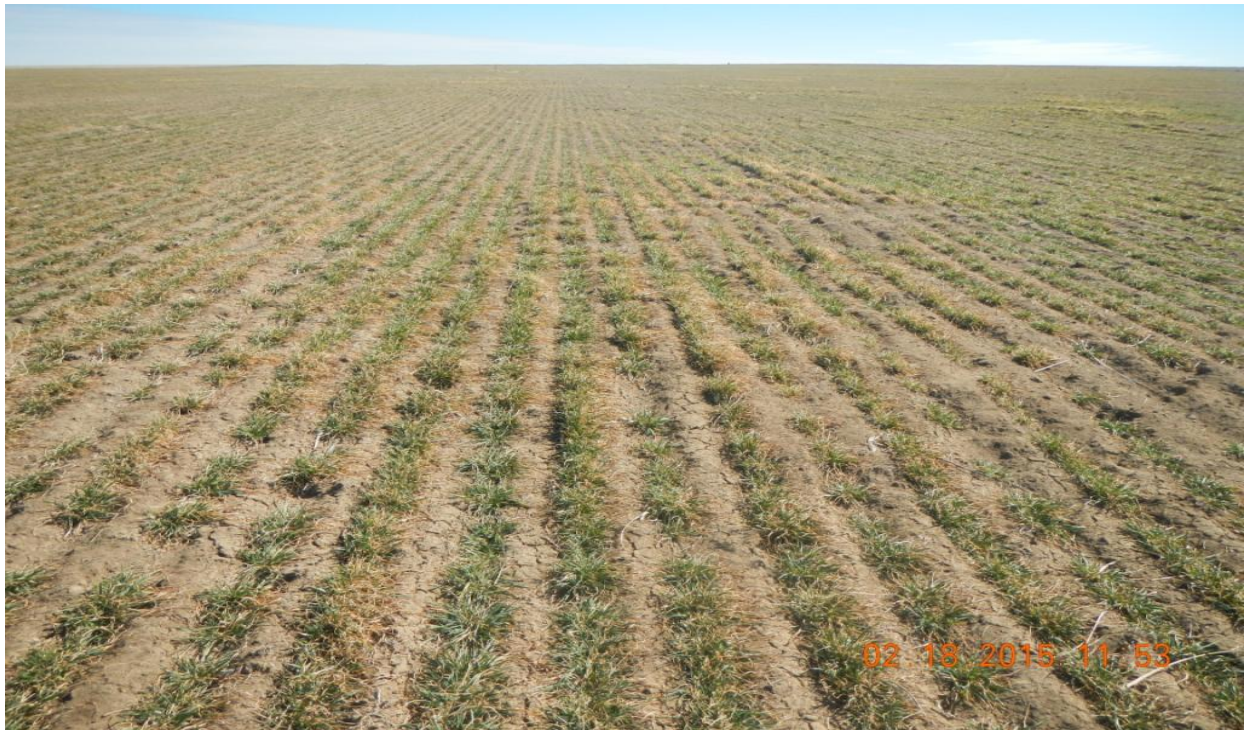
photo 9: Facing east, surrounding crop growth.

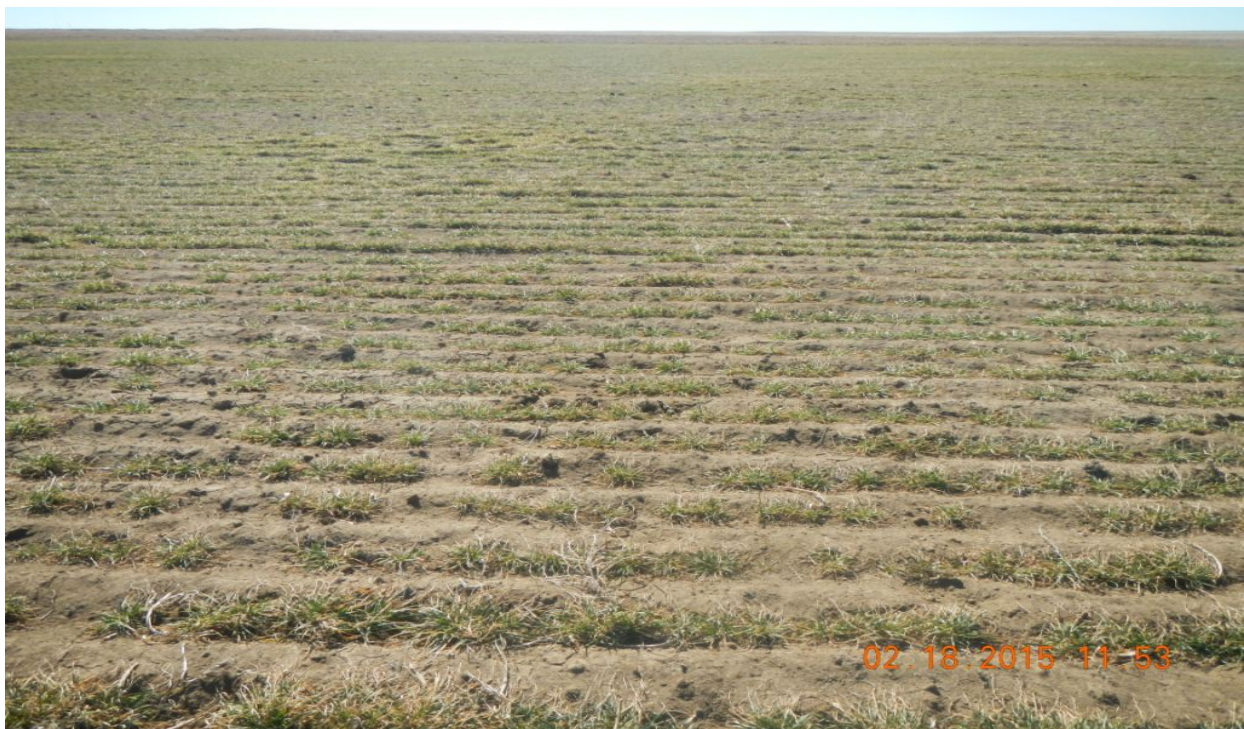
photo 10: Facing south, surrounding crop growth.
