Complaint #: 200426201

Well Number: 05-123-40177 Location #: 438862

Inspection Document #:67400 **2063**

Nature of complaint: Lights, Traffic, Noise

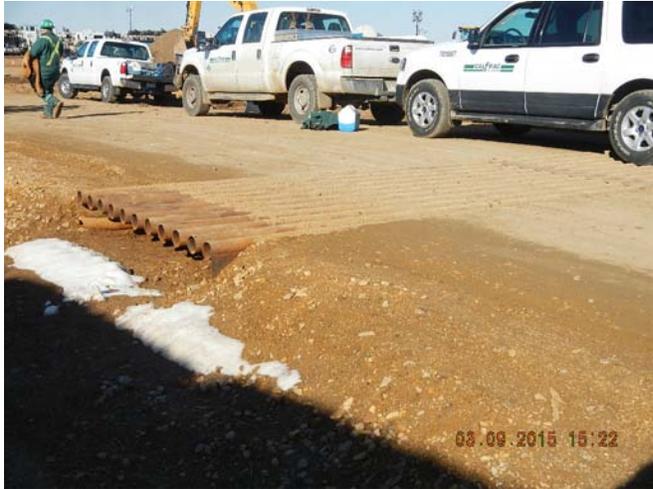
cattle guard type track pad

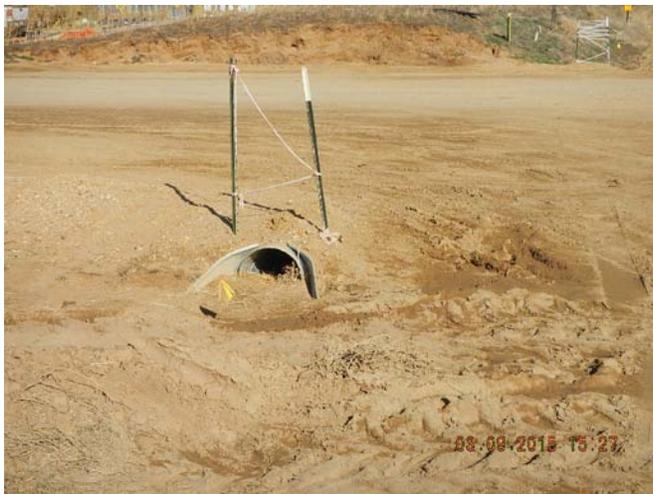
culvert at location entrance

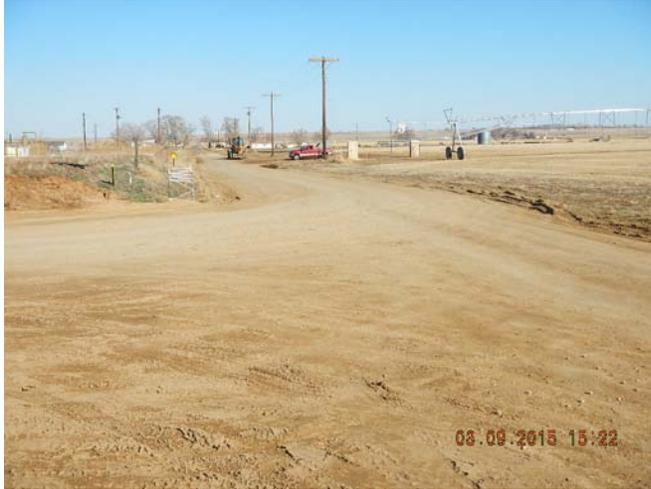
entrance/Exit road condition

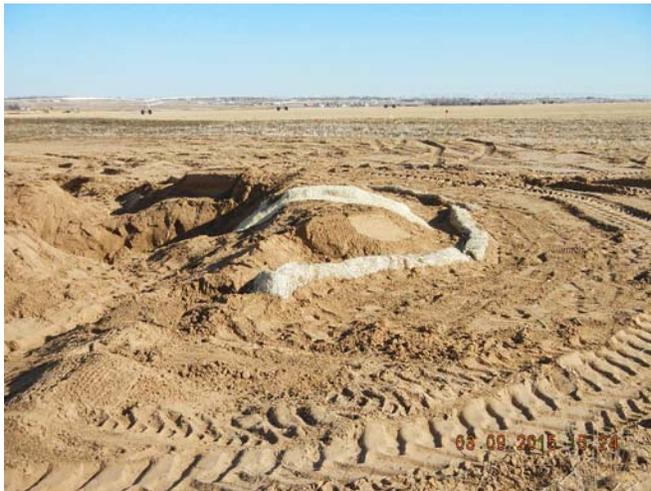
sediment trap

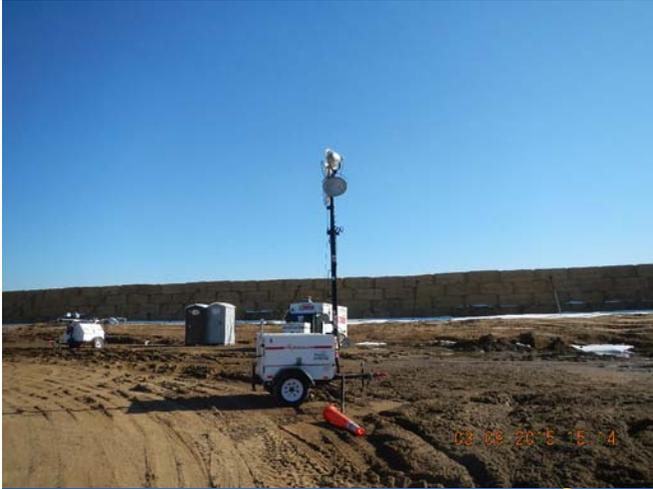
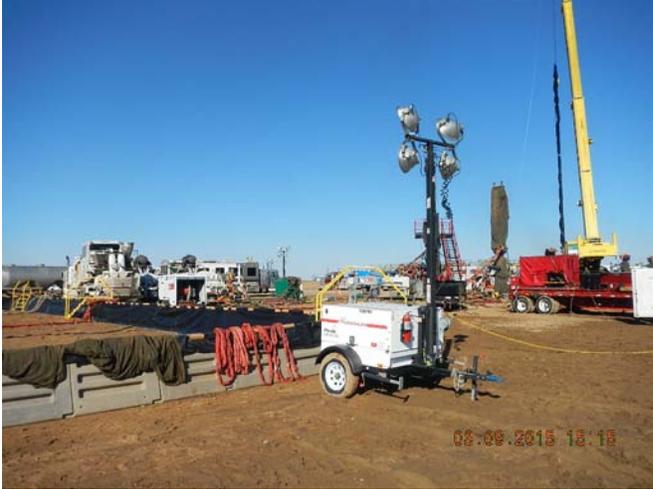
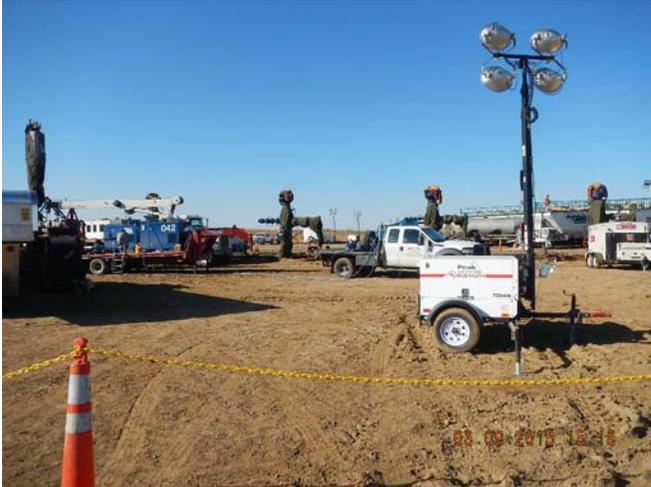
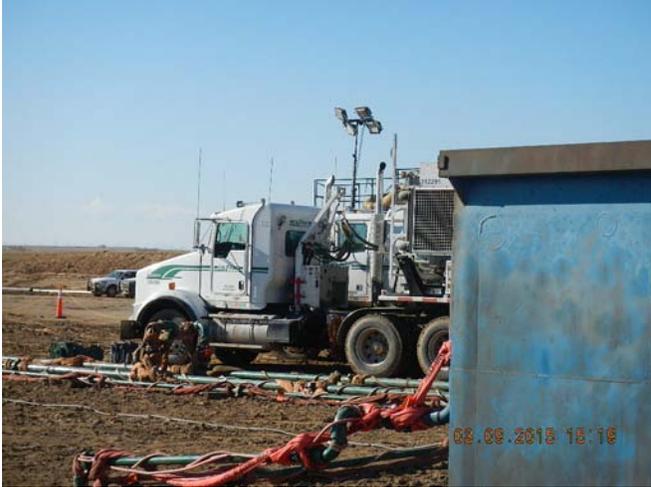
Multiple portable diesel powered lighting units were on the location. During the day light inspection, it was observed that the lights were kept to a minimum height and were directed downward. The Anadarko representative on sight offered that they would survey and attempt to identify any areas of potential improvement during the night shift. Representative photos of the lighting units follow.
