## Titanium 26-10-7HI & 2

Inspection# 673401880

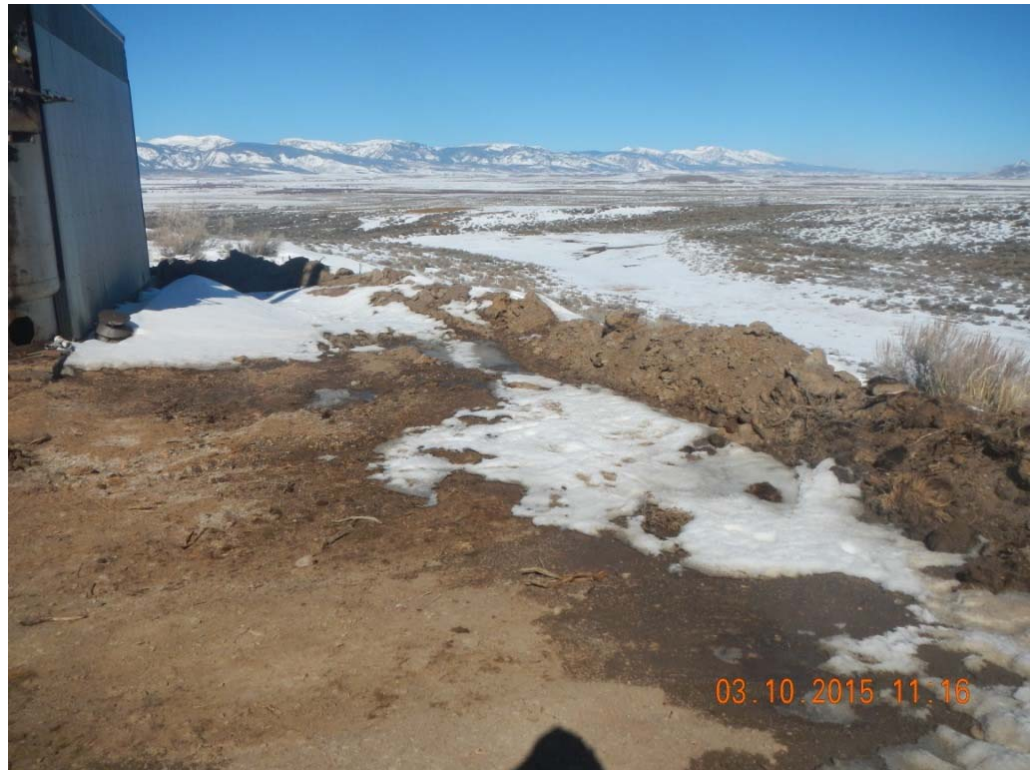
Stained soil in perimeter  
berm.

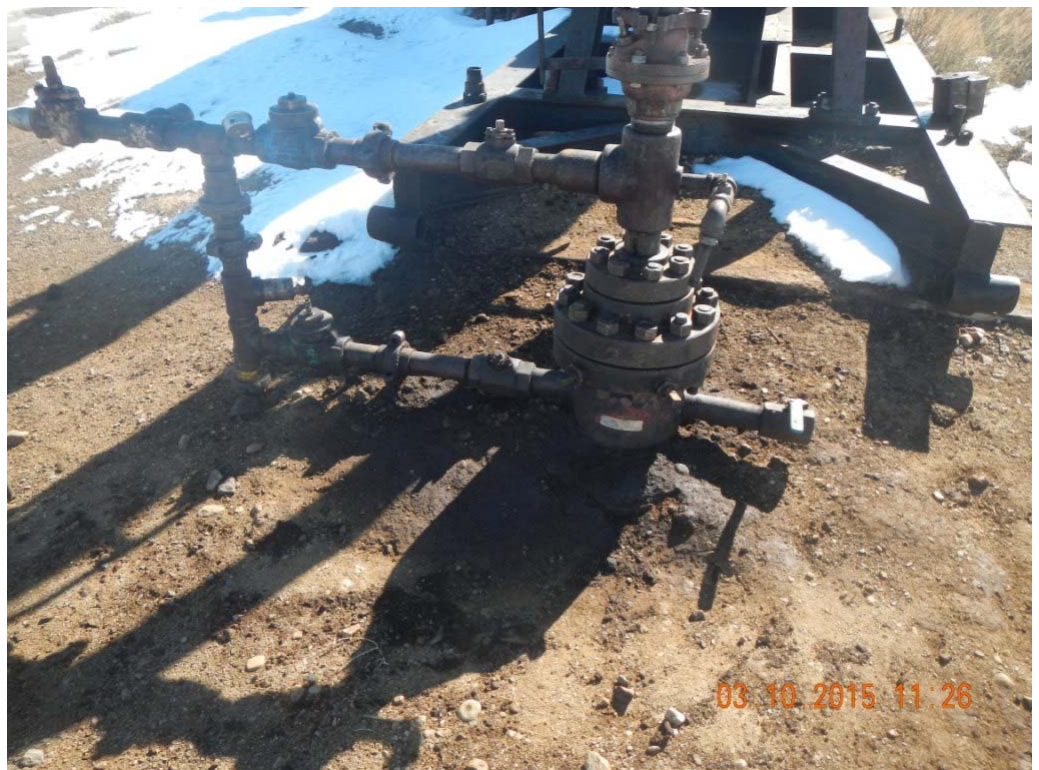
Stained soil at wellhead, no  
wellhead sign

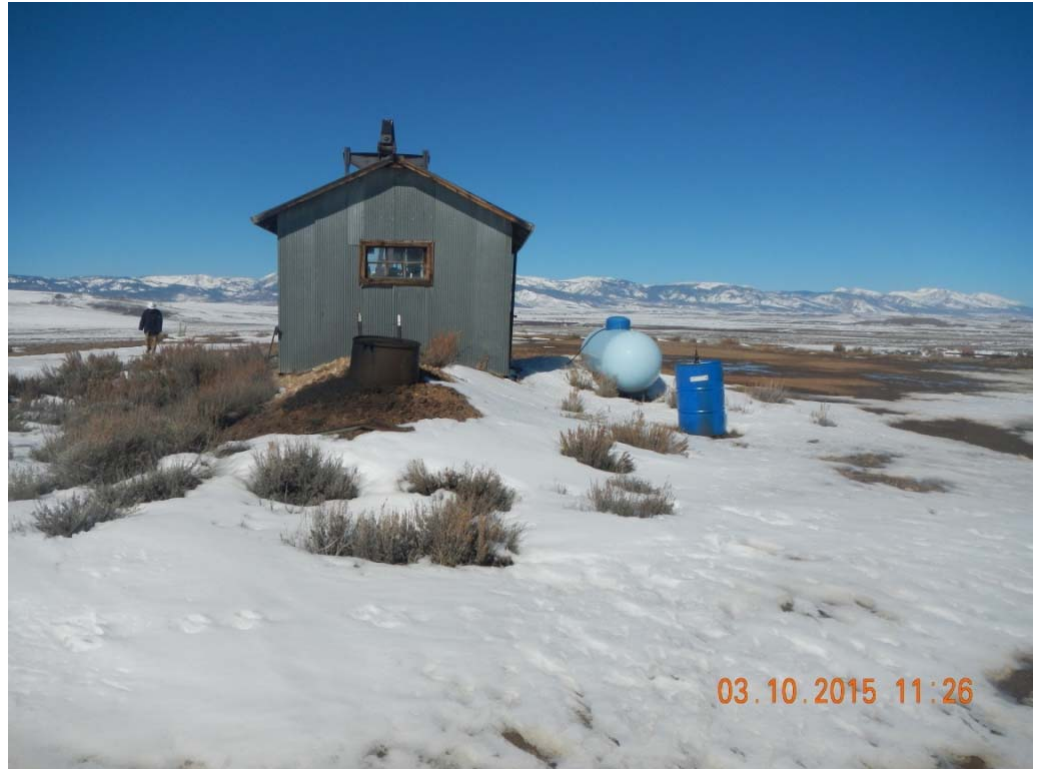
Stained soil from exhaust,  
lube oil barrel without  
secondary containment.

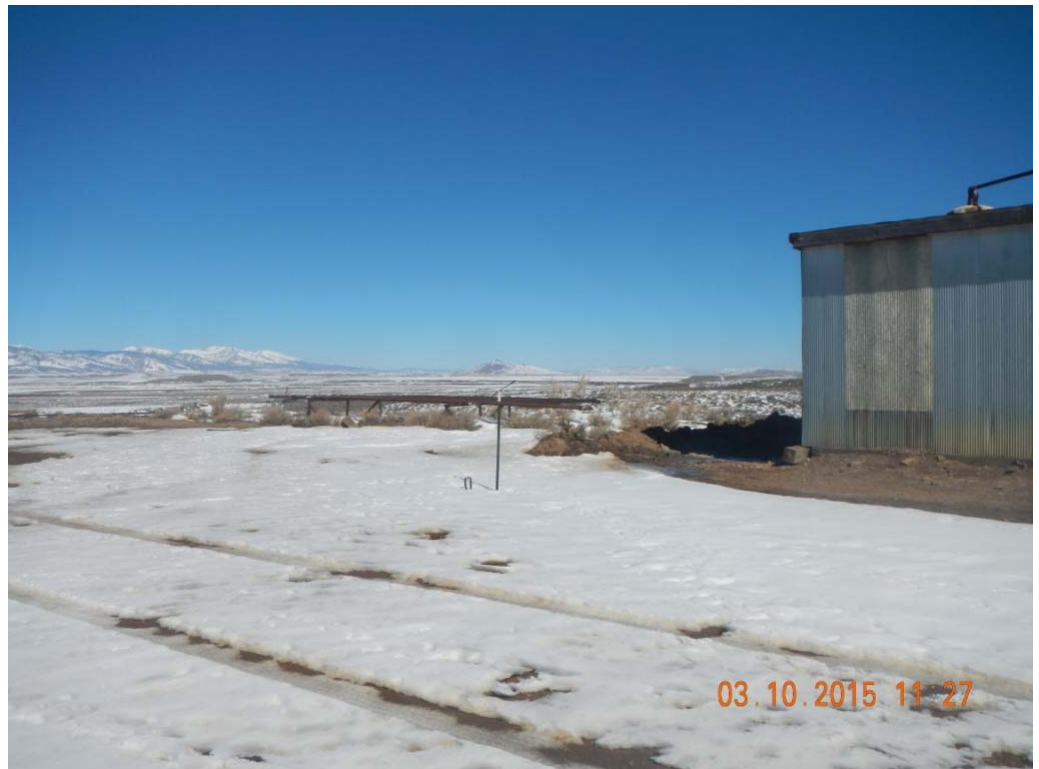
Tubing stored on location.
