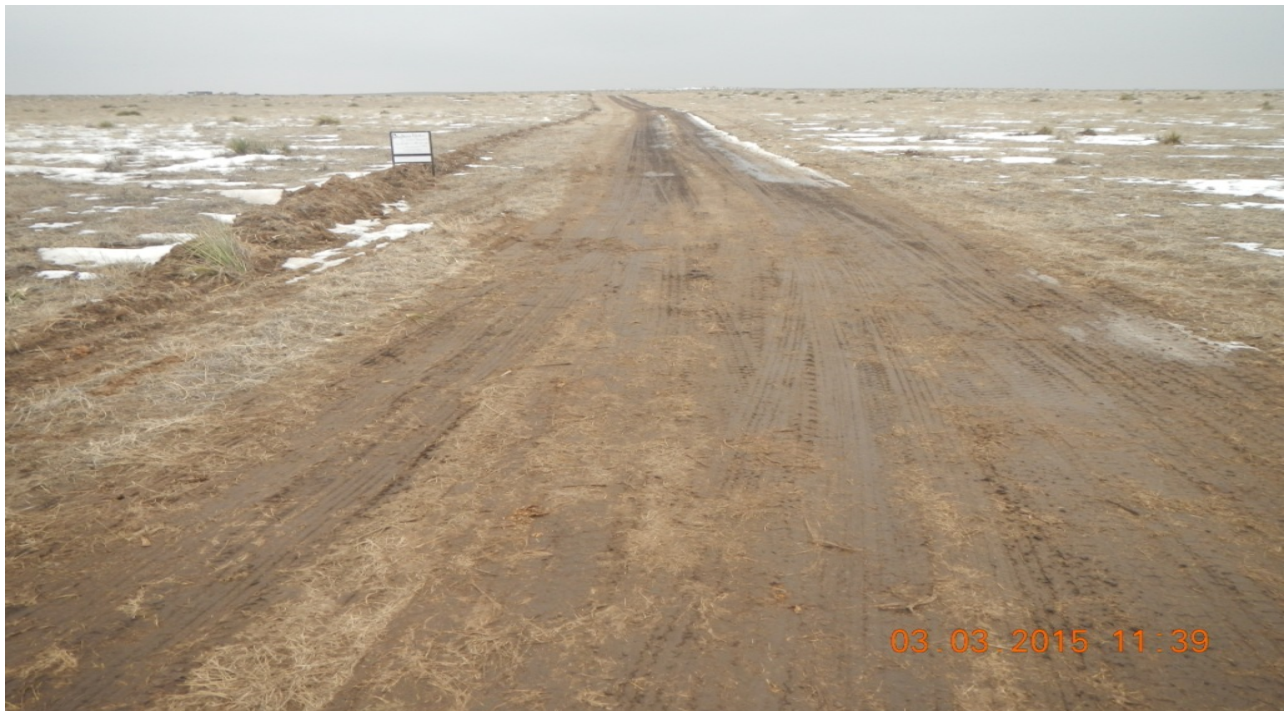
photo 2: Facing north along the access road. Topsoil was not salvaged and is being heavily compacted.

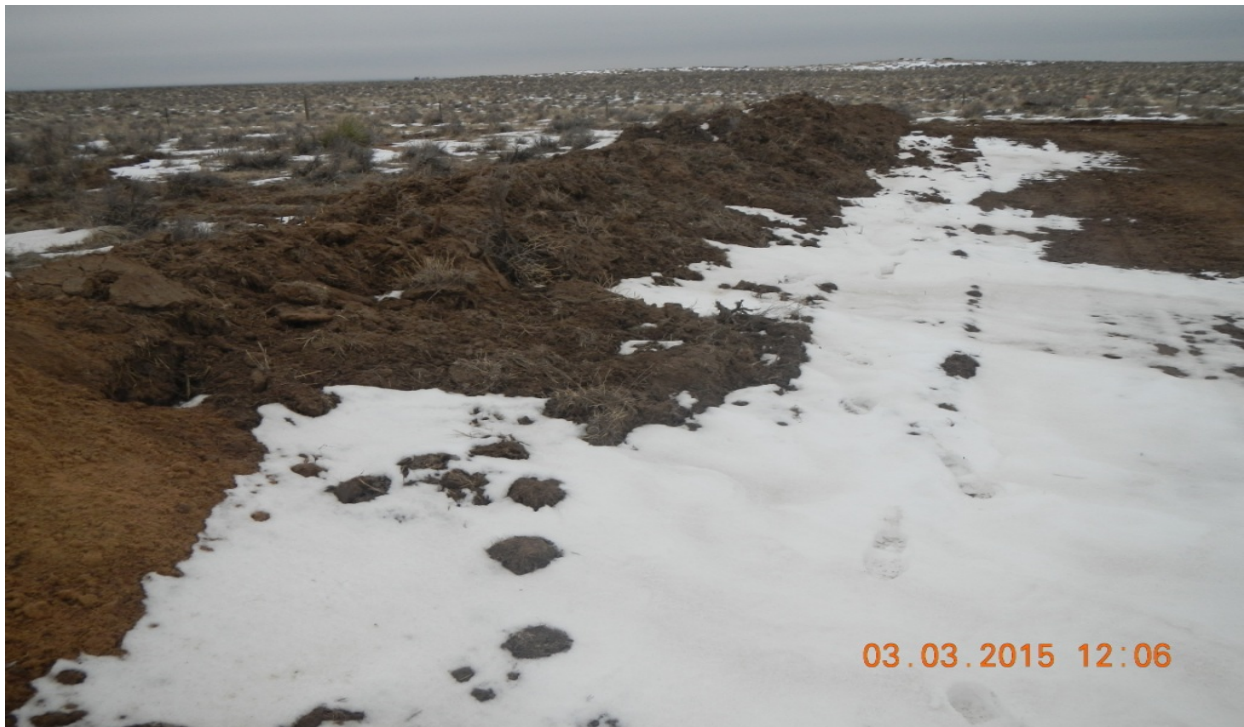
photo 10: Topsoil pile at the northeast corner of the location. Approximate size 60'x10'x5'.

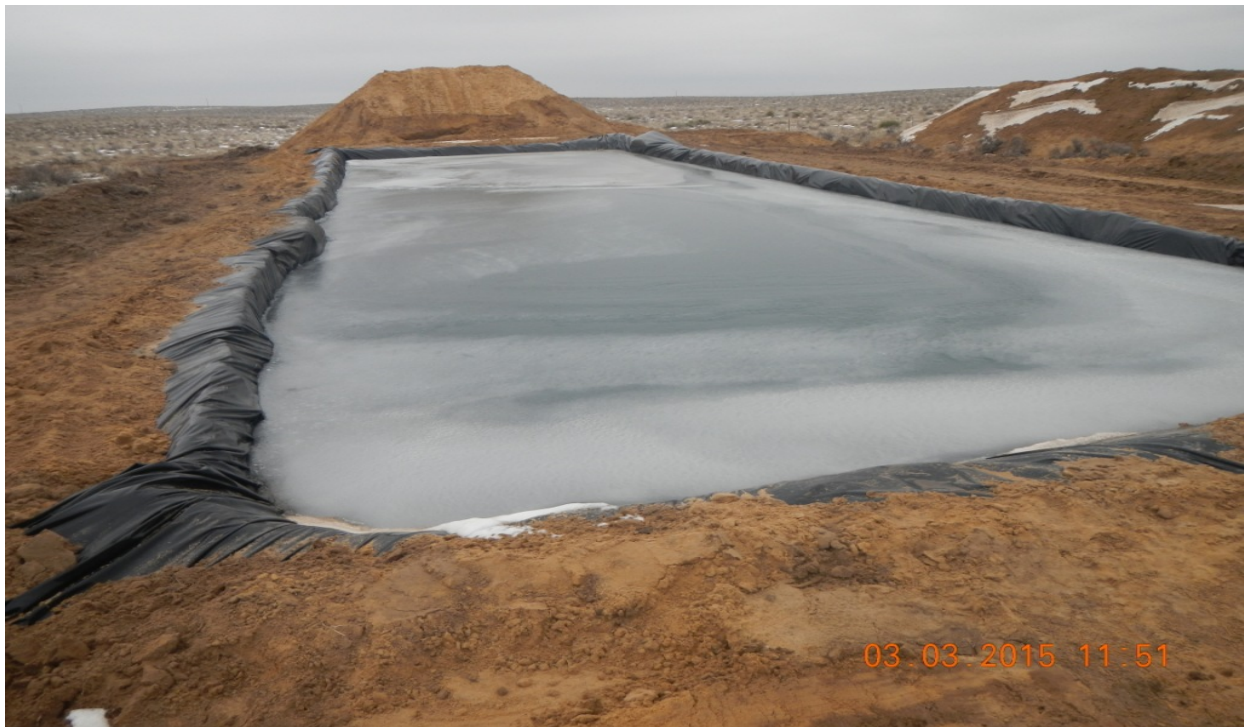
photo 14: Lined pit at the northwest corner of location does not appear to have 2ft. of freeboard.

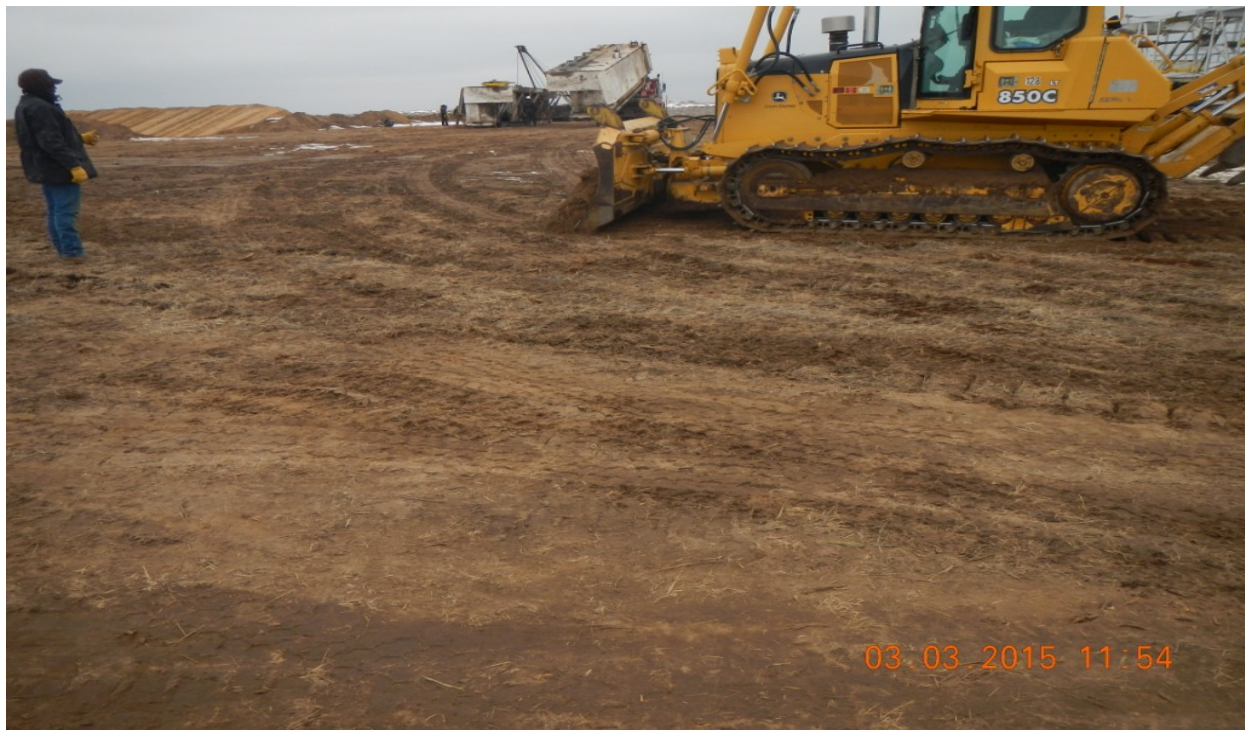
photo 15: Dozer pushing topsoil, leveling the pad. Top soil compacted and being mixed.

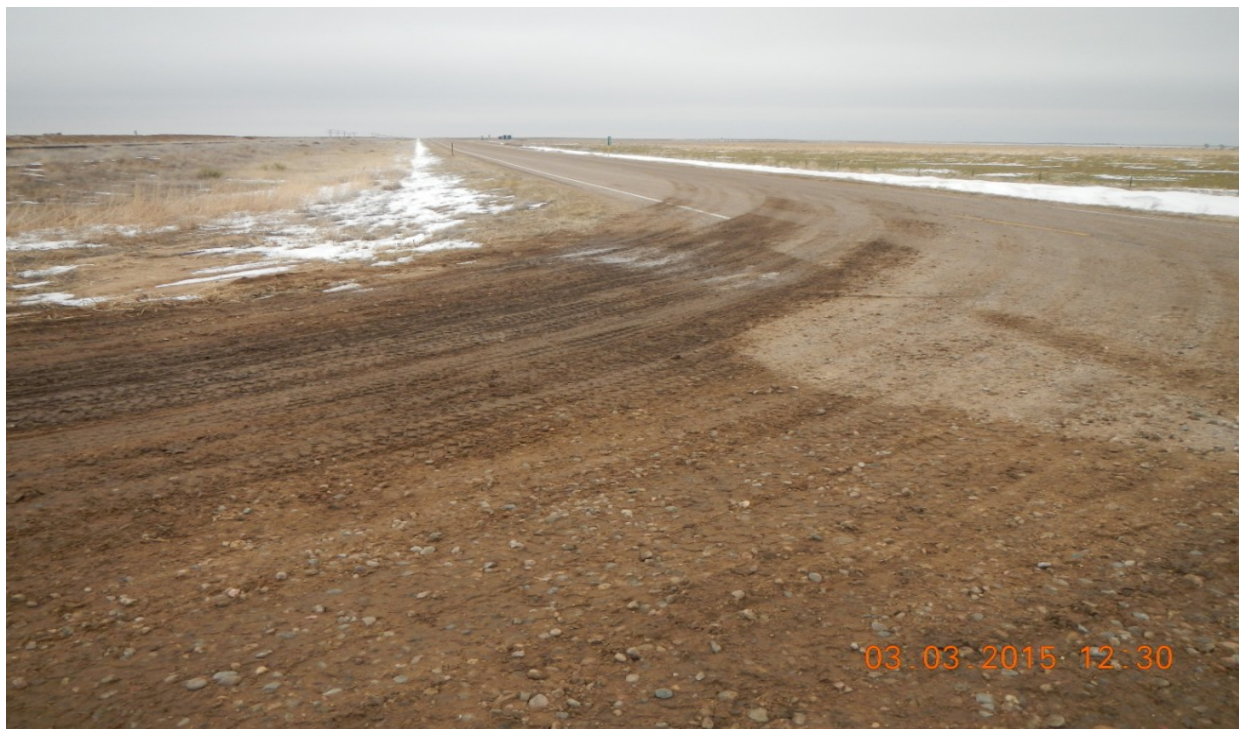
photo 18: Vehicle tracking mud onto Hwy 96 from the access road.
