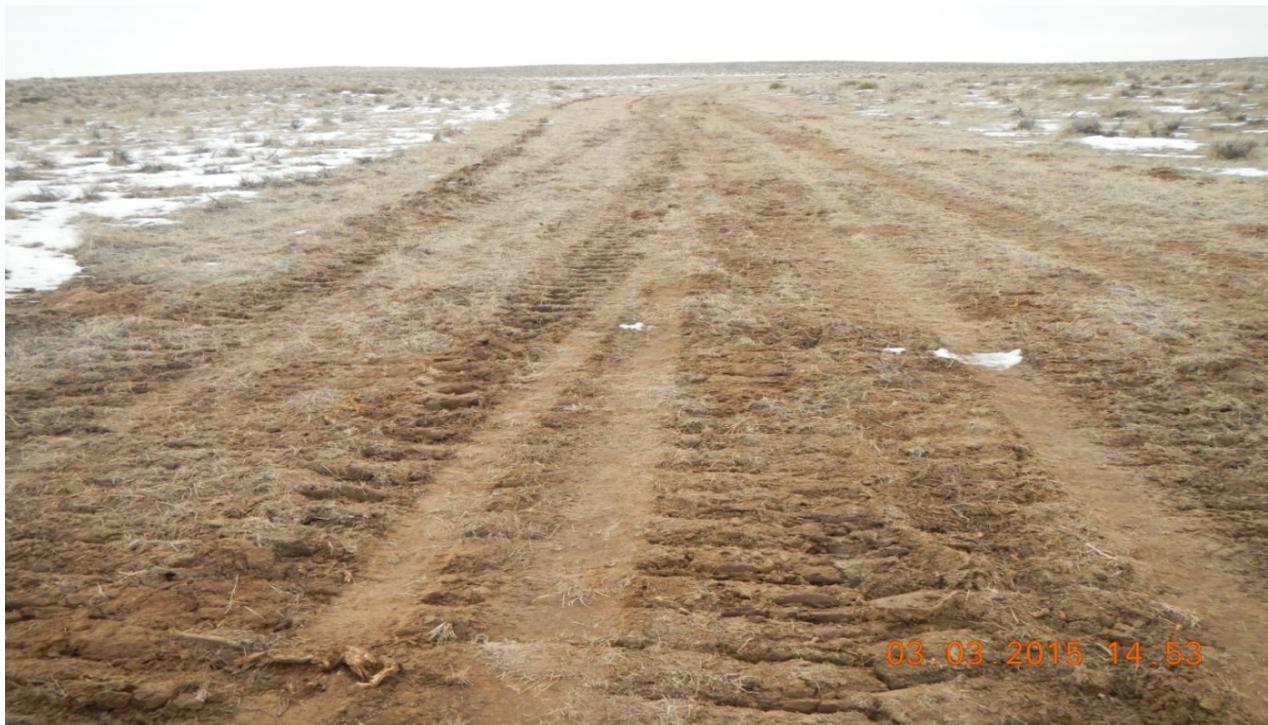
photo 1: North along access road traveling to the location.

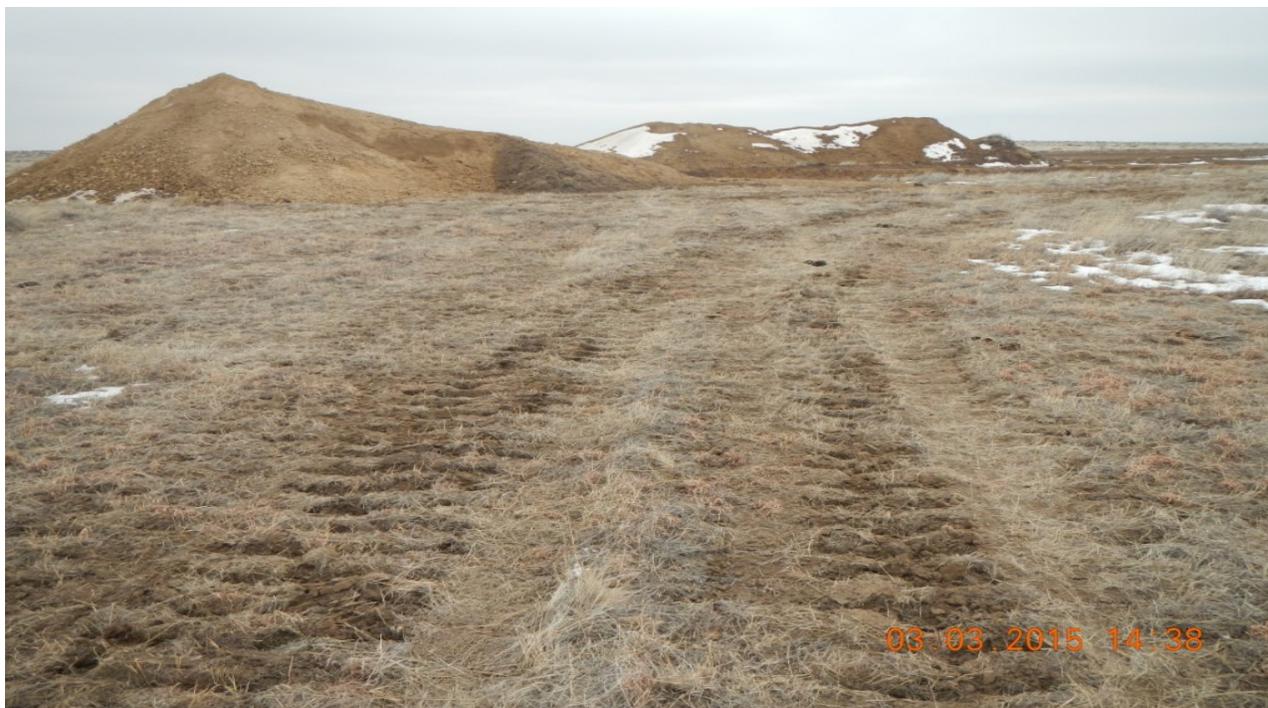
photo 2: Facing east along access road towards the location.

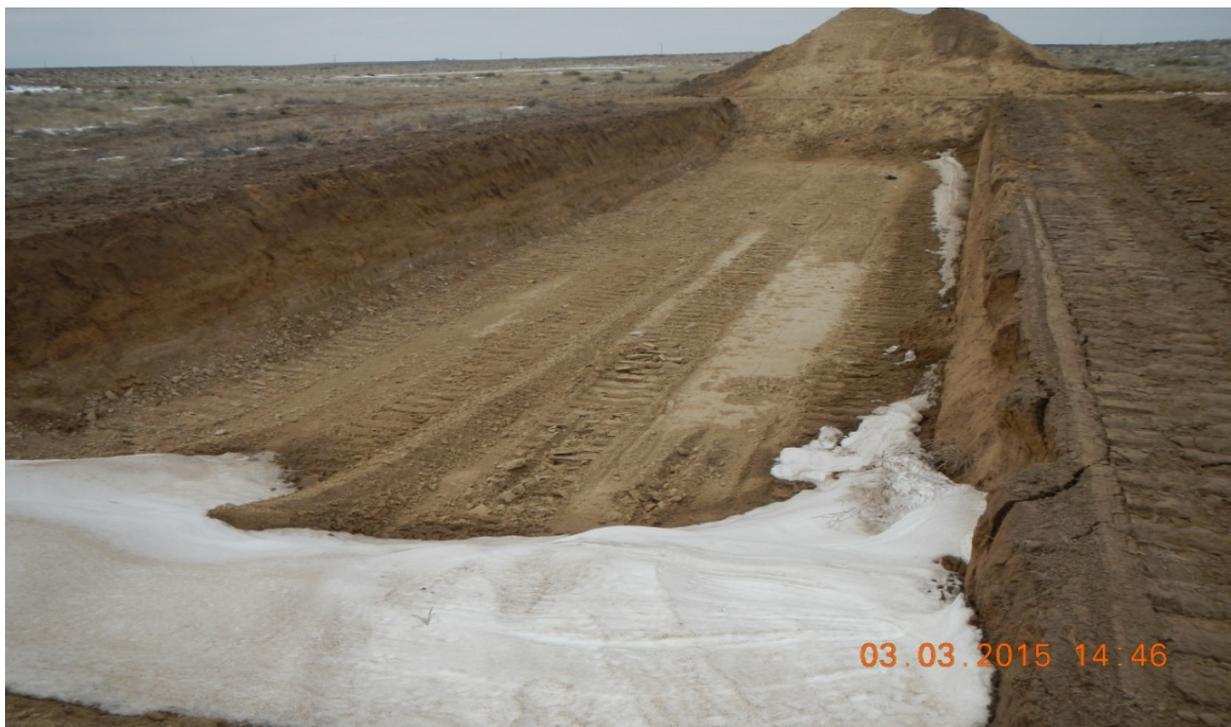
photo 3: Southeast corner of pit. Lat/Long: 38.47938/-102.67259

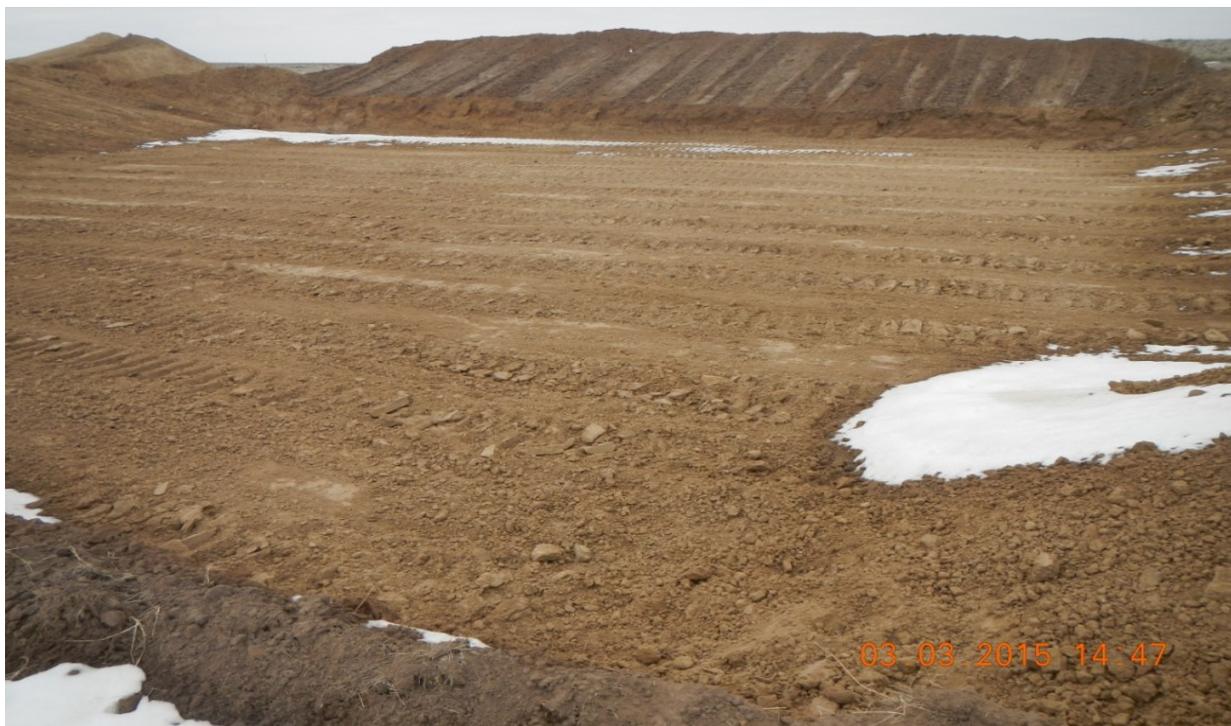
photo 4: Southeast corner of pit. Lat/Long: 38.47936/-102.67194

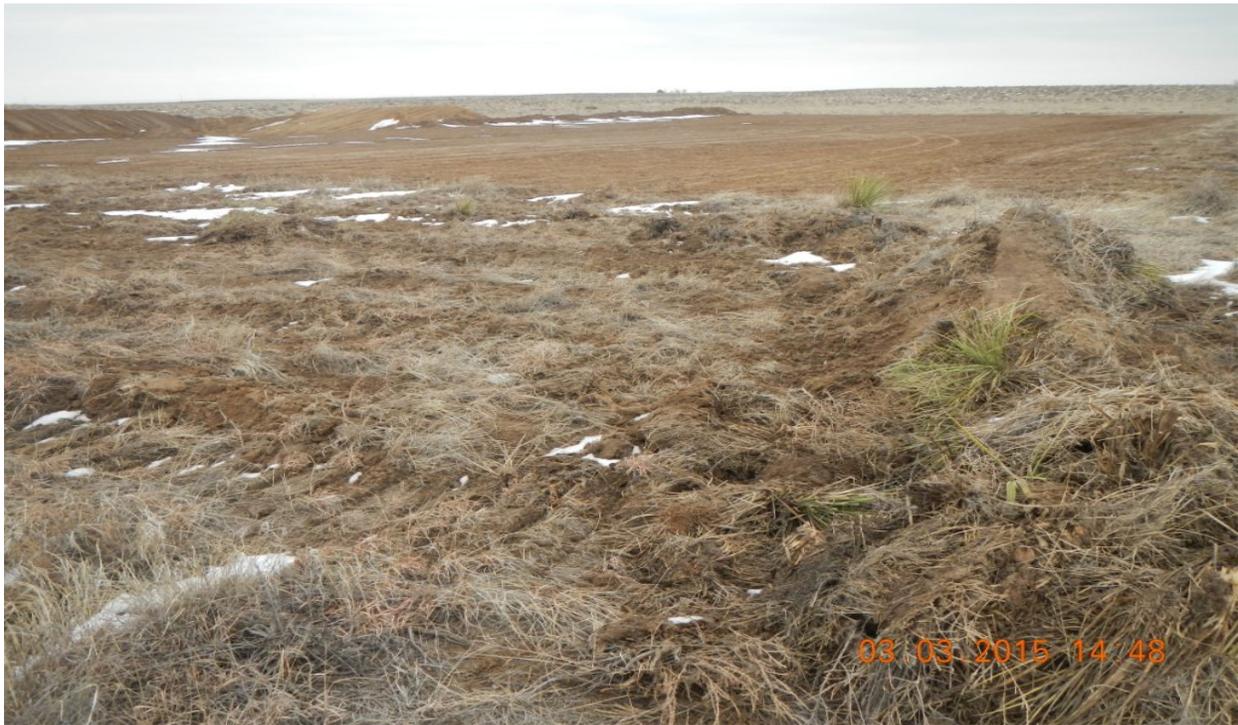
photo 5: Southwest corner of the location facing northeast.

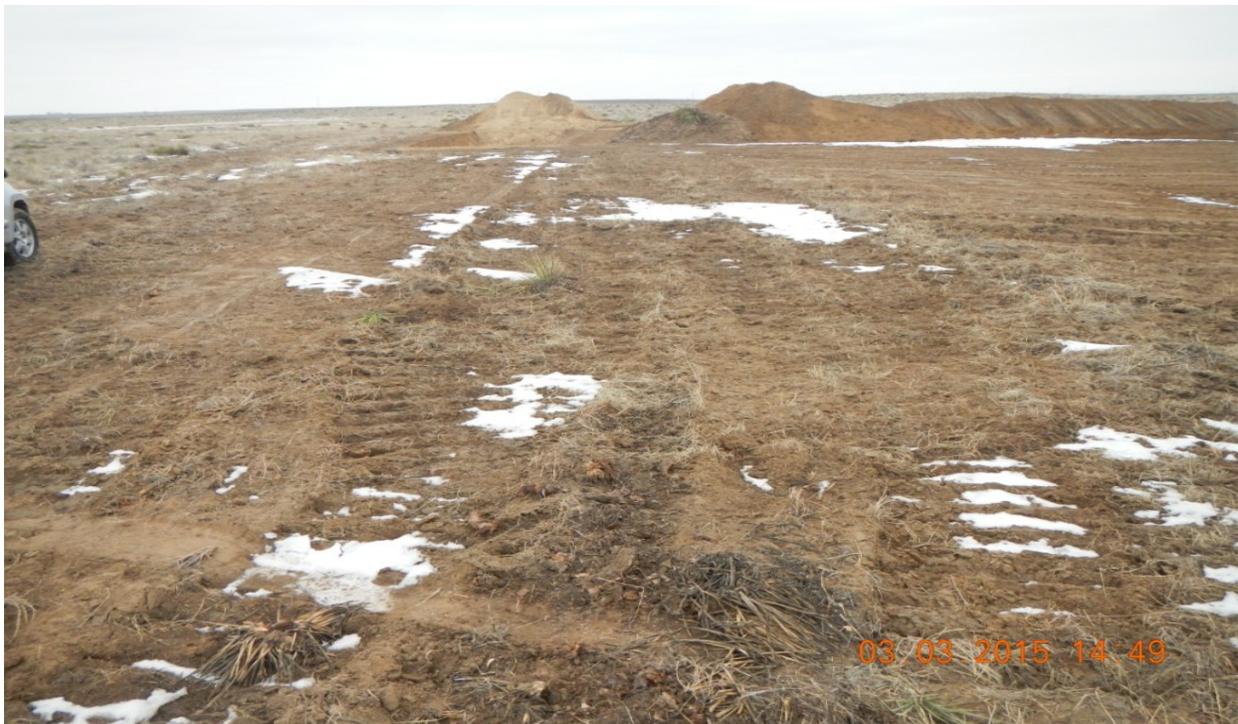
photo 6: Southwest corner of the location facing north.

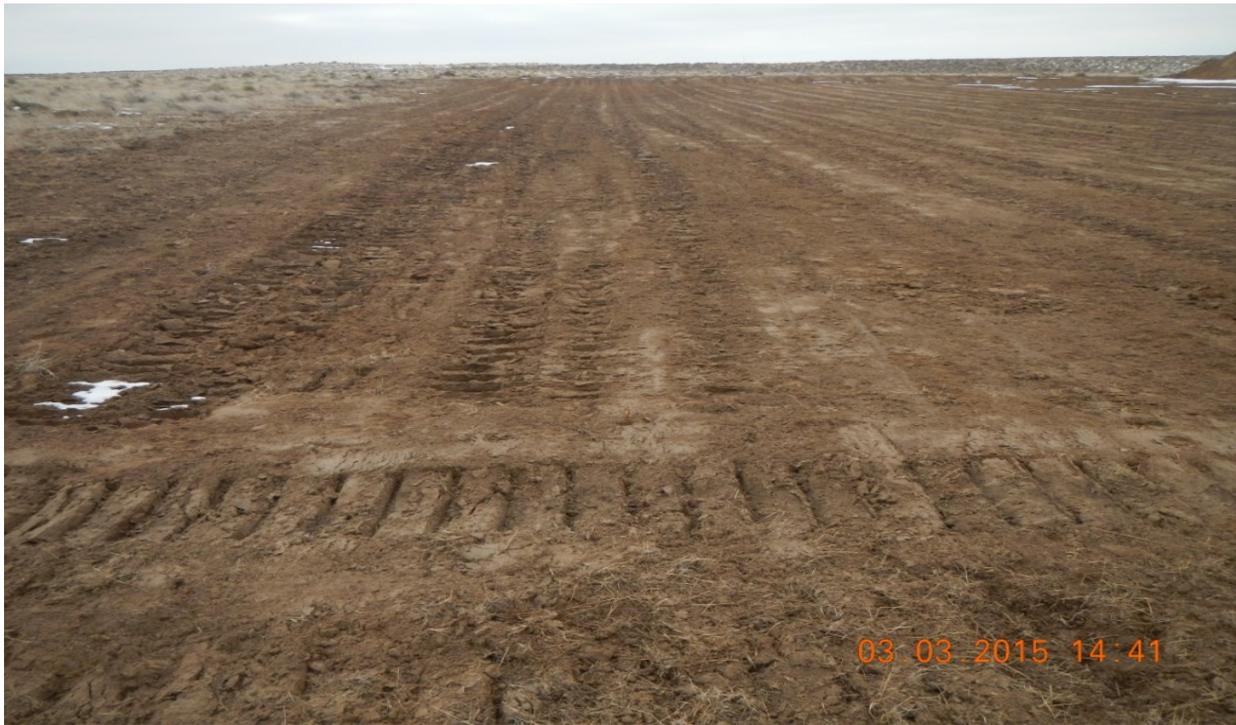
photo 7: Southeast corner of the location facing west.

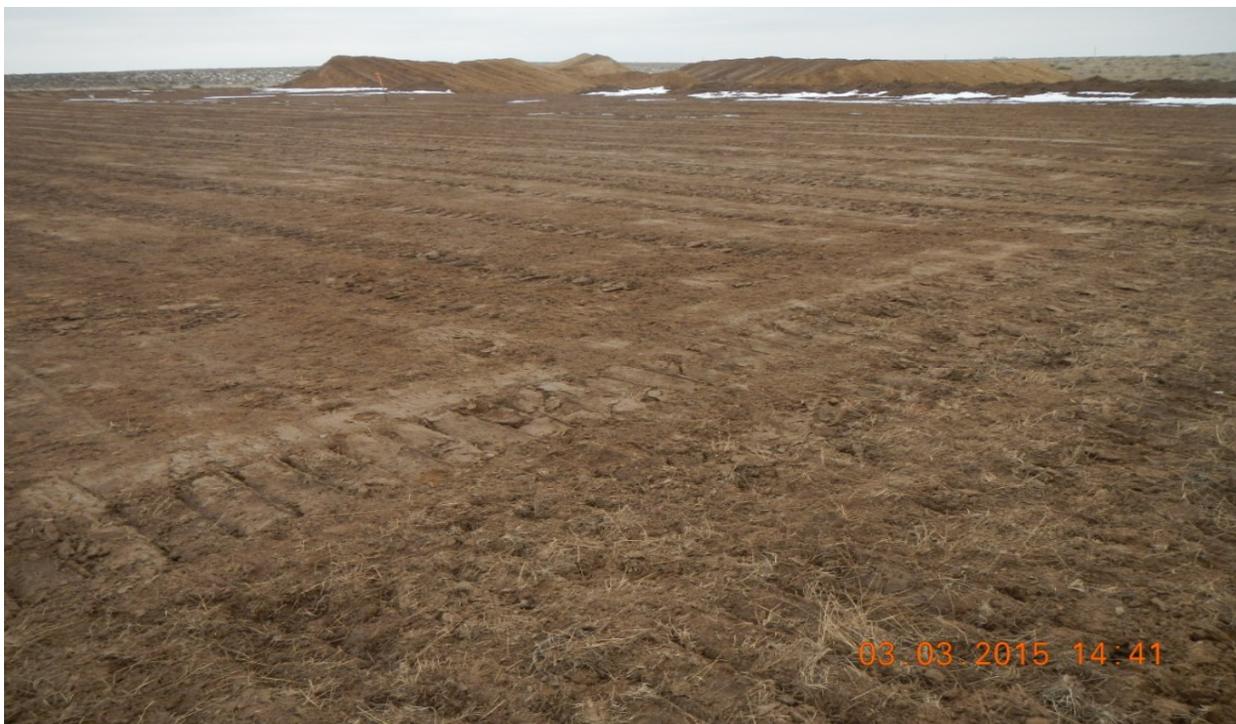
photo 8: Southeast corner of the location facing northwest.

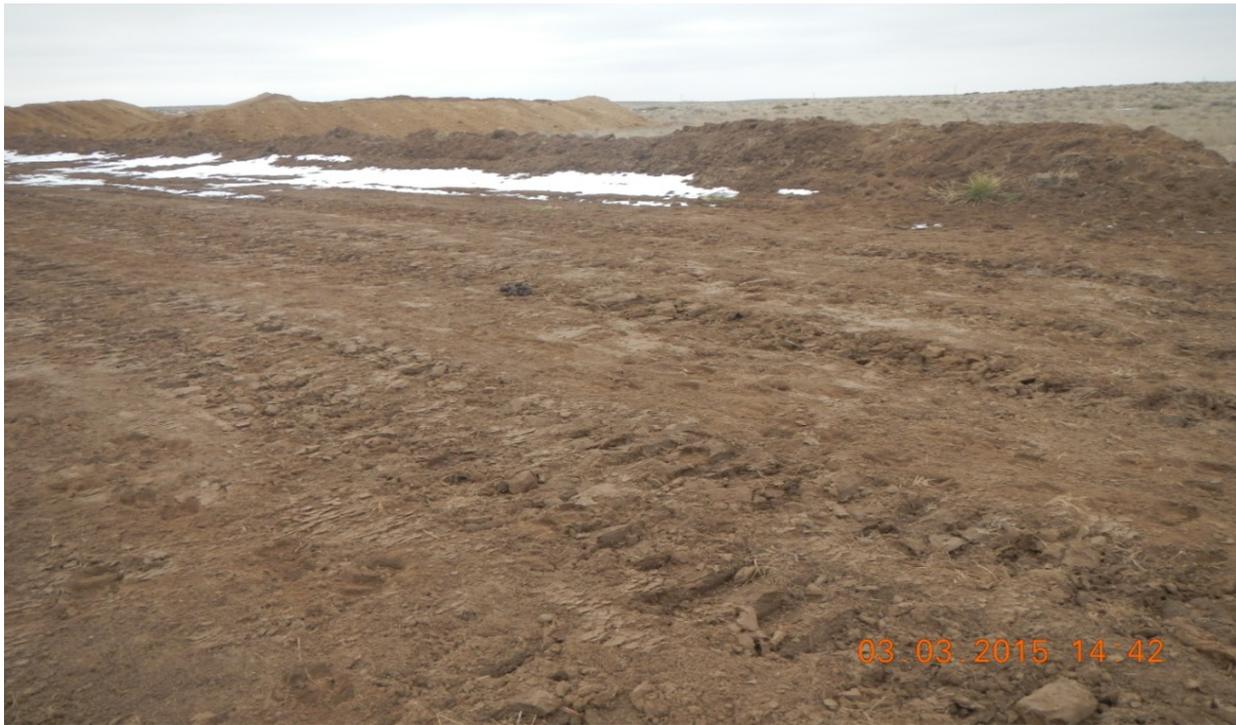
photo 9: Southeast corner of the location facing northwest towards the topsoil pile.

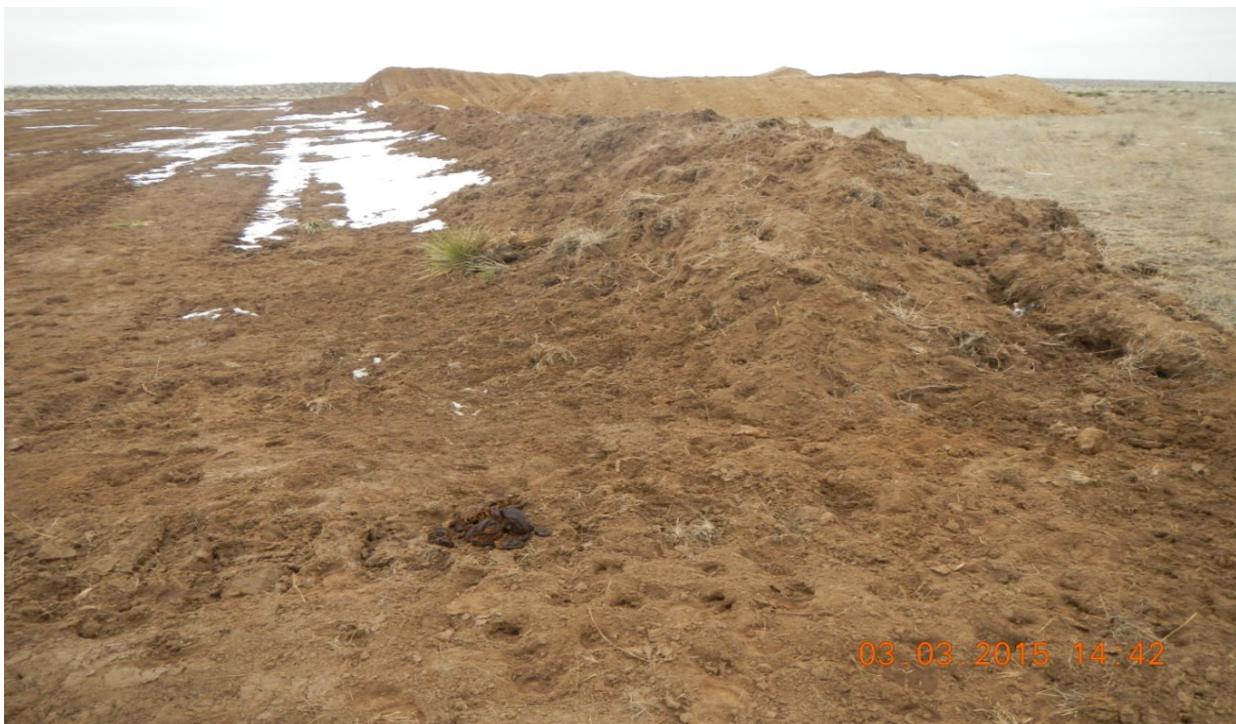
photo 10: Southeast corner of the location facing west towards the topsoil pile.

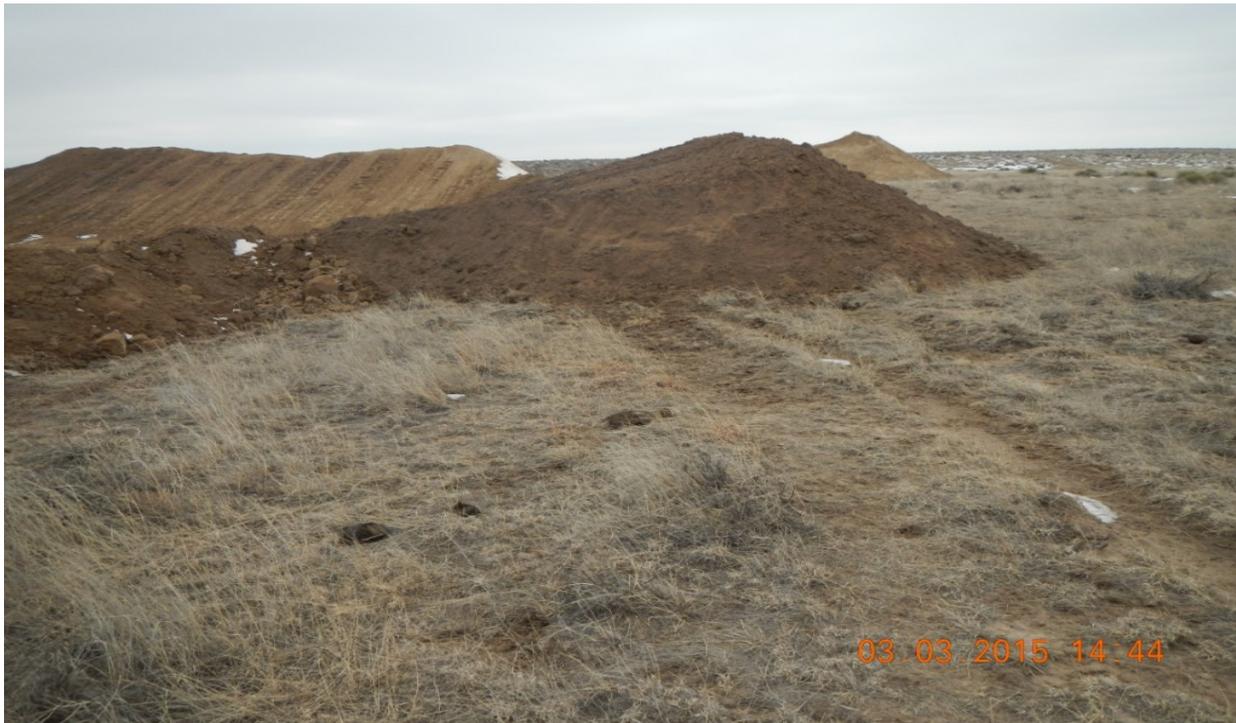
photo 11: North side of the location facing west. Dark topsoil pile separated from the drilling pit area.

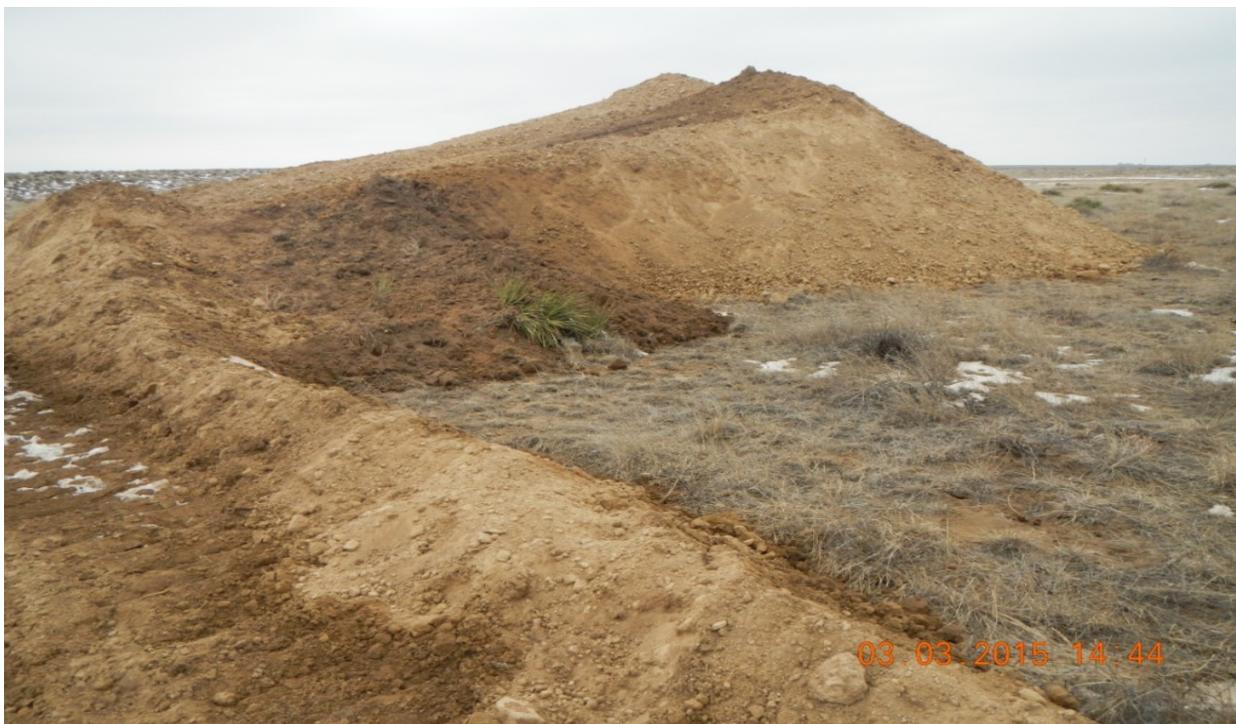
photo 12: North side of the location facing west. Soil pile pushed out from the pit area.

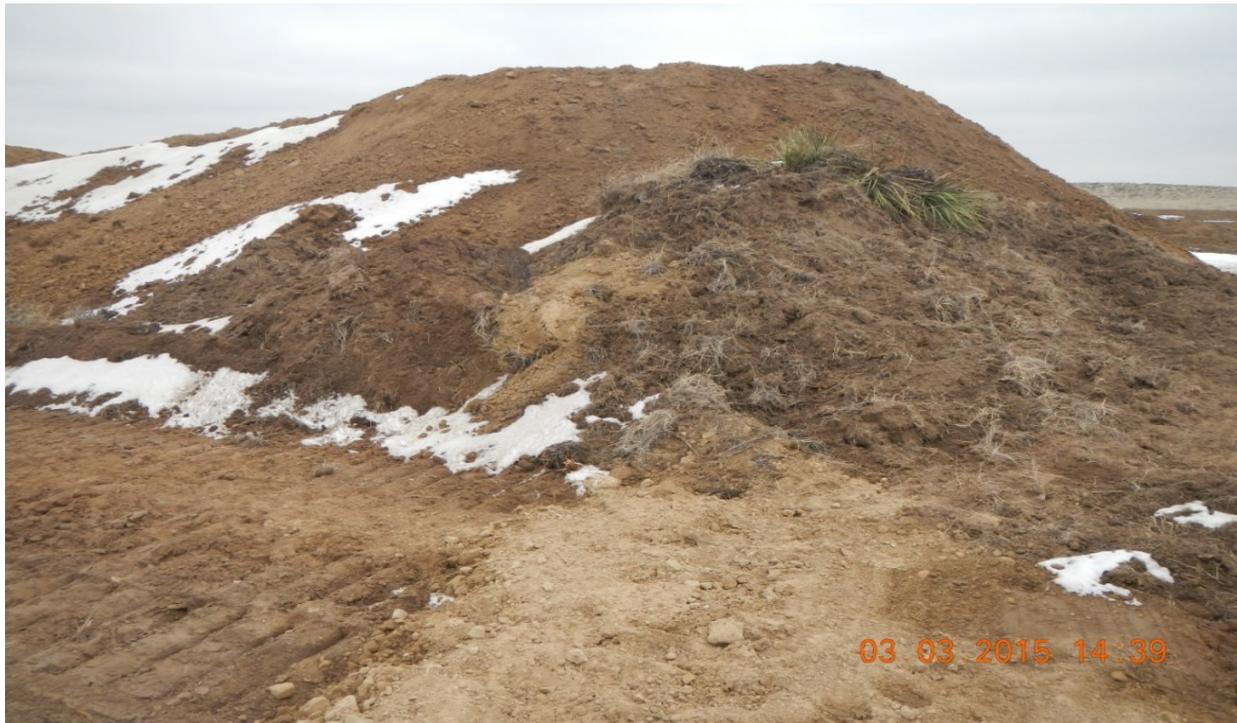
photo 13: It appears topsoil had not been properly segregated.

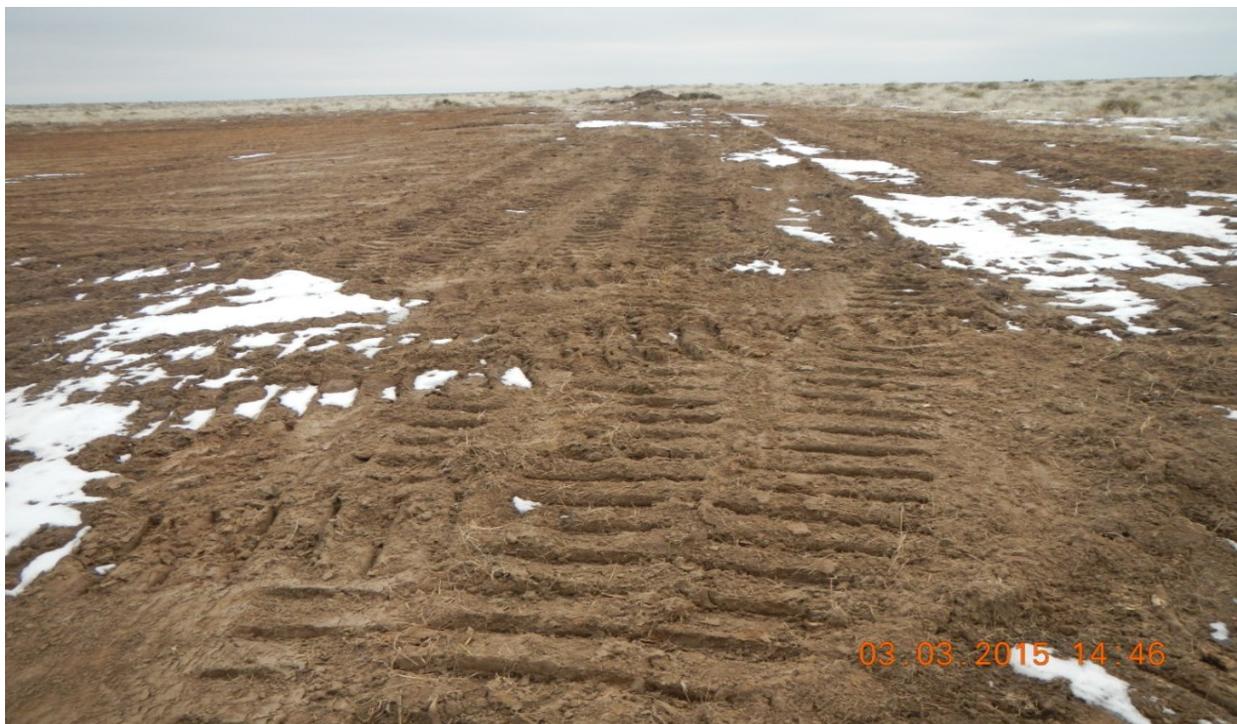
photo 14: Northwest corner of the location facing south.
