photo 1: Well sign, Anderson 42-18R

photo 2: Well sign, Anderson 42-18V

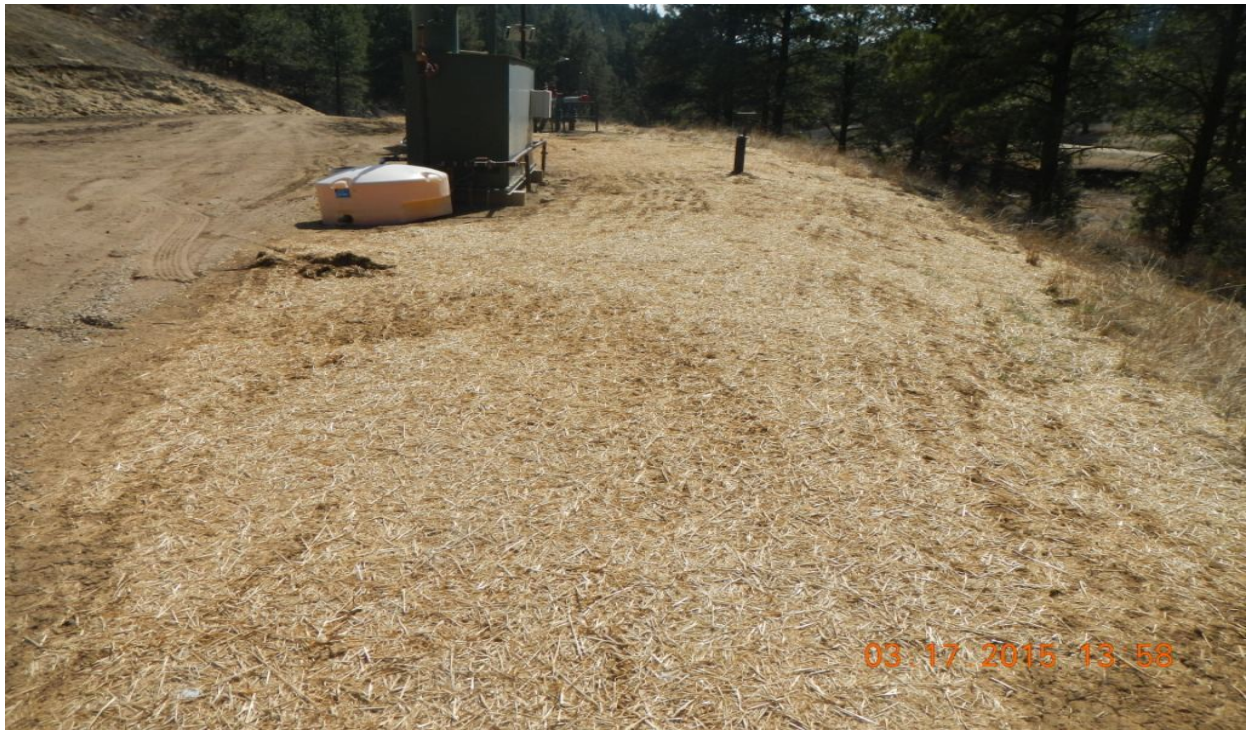
photo 3: West side of the location facing south. Area has recently been mulched.

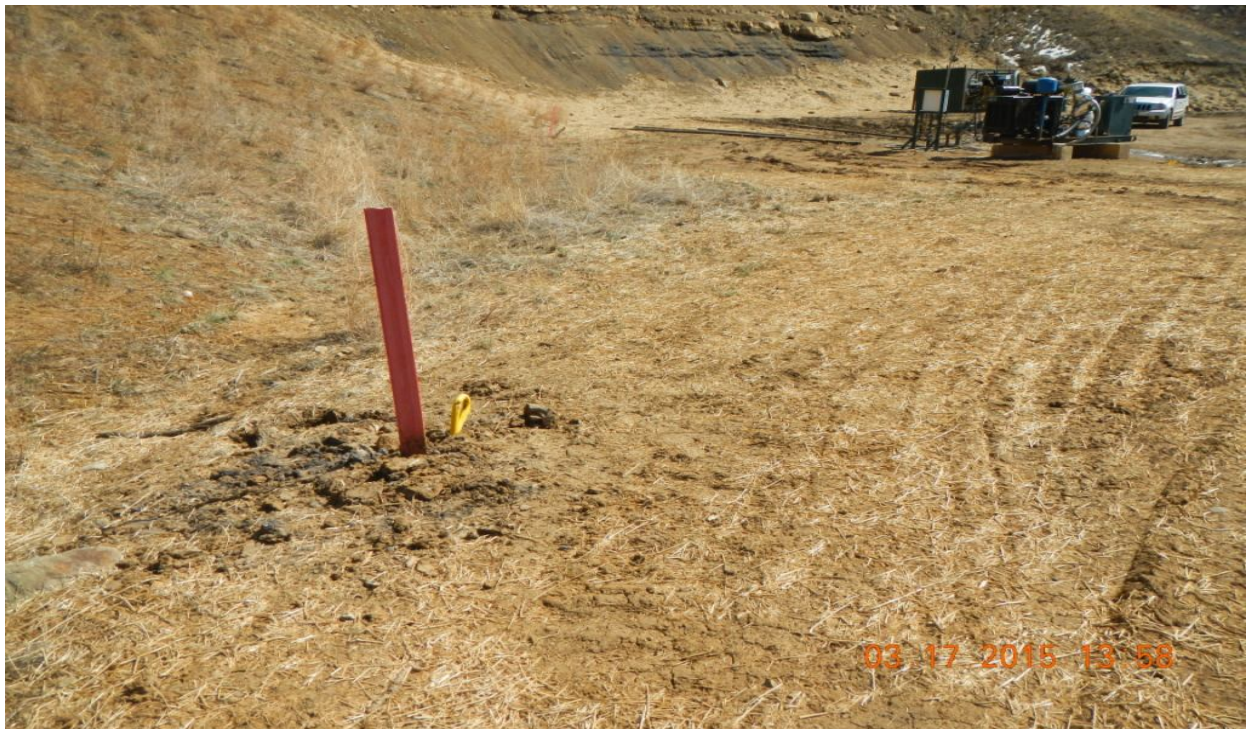
photo 4: North side of the location facing southeast.

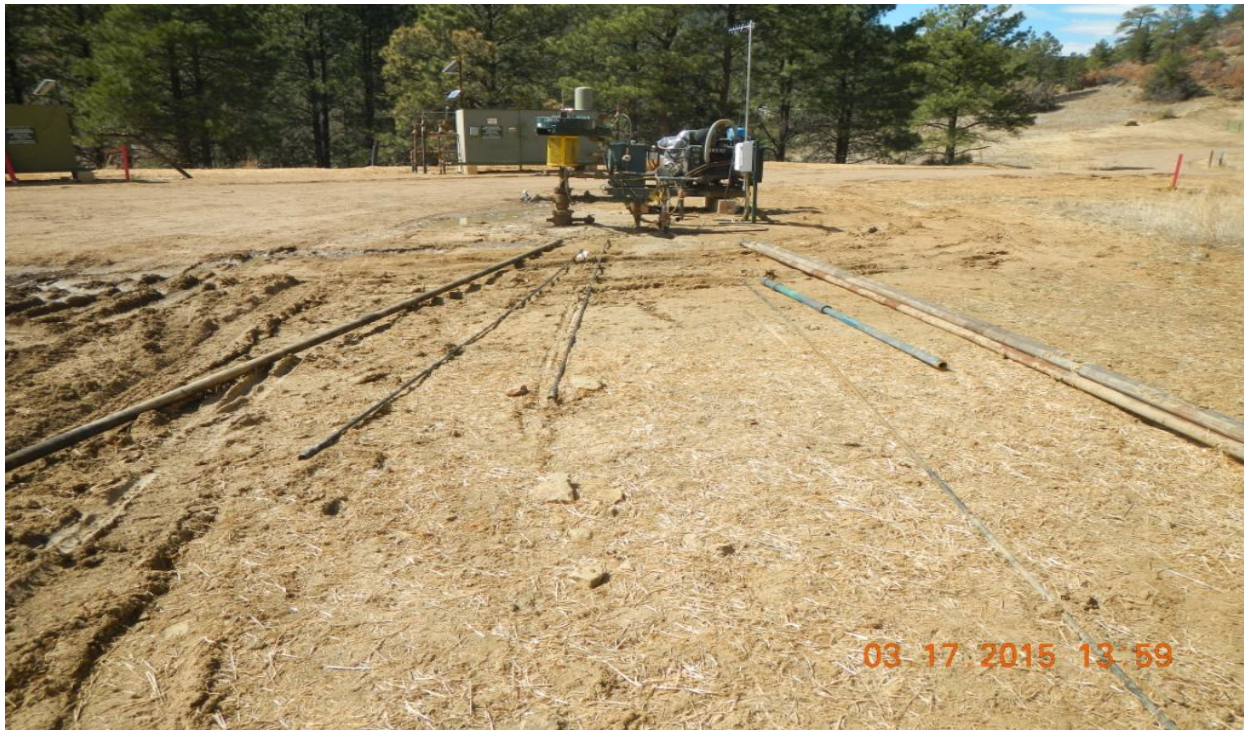
photo 5: Unused pipe was left at the location.

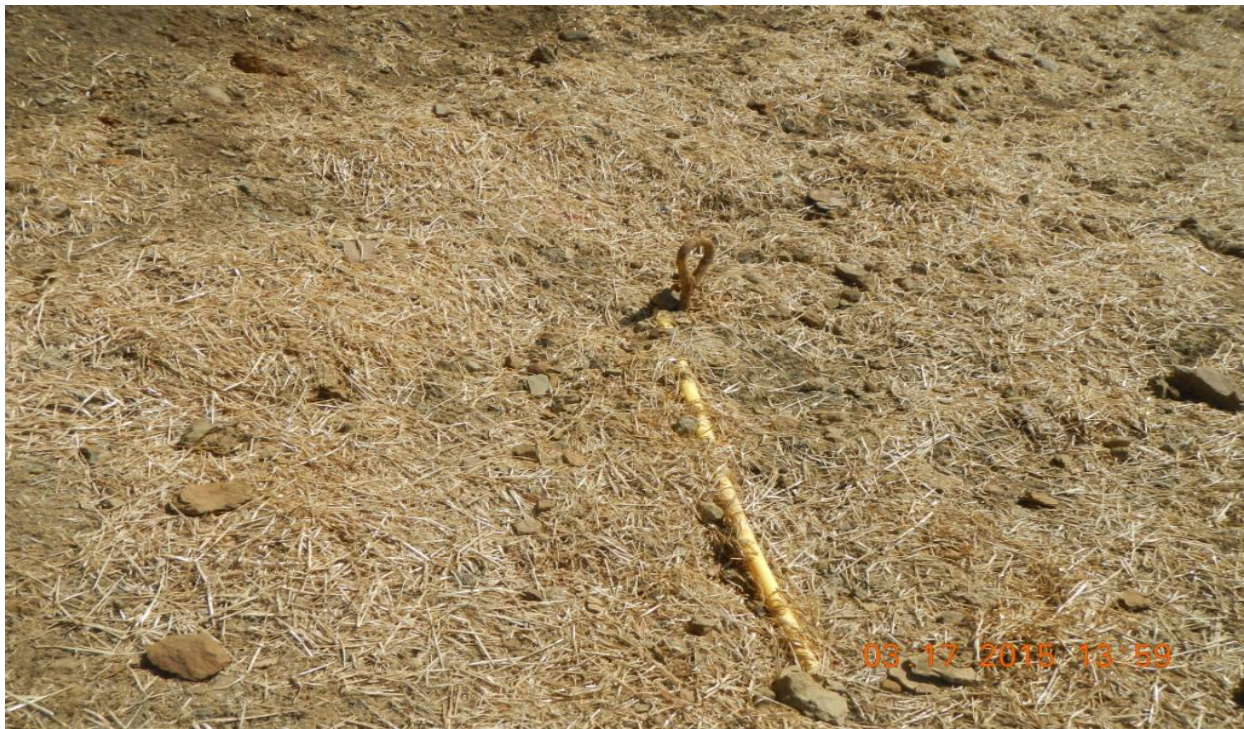
photo 6: Guy line anchor has fallen over at northeast corner of the location.

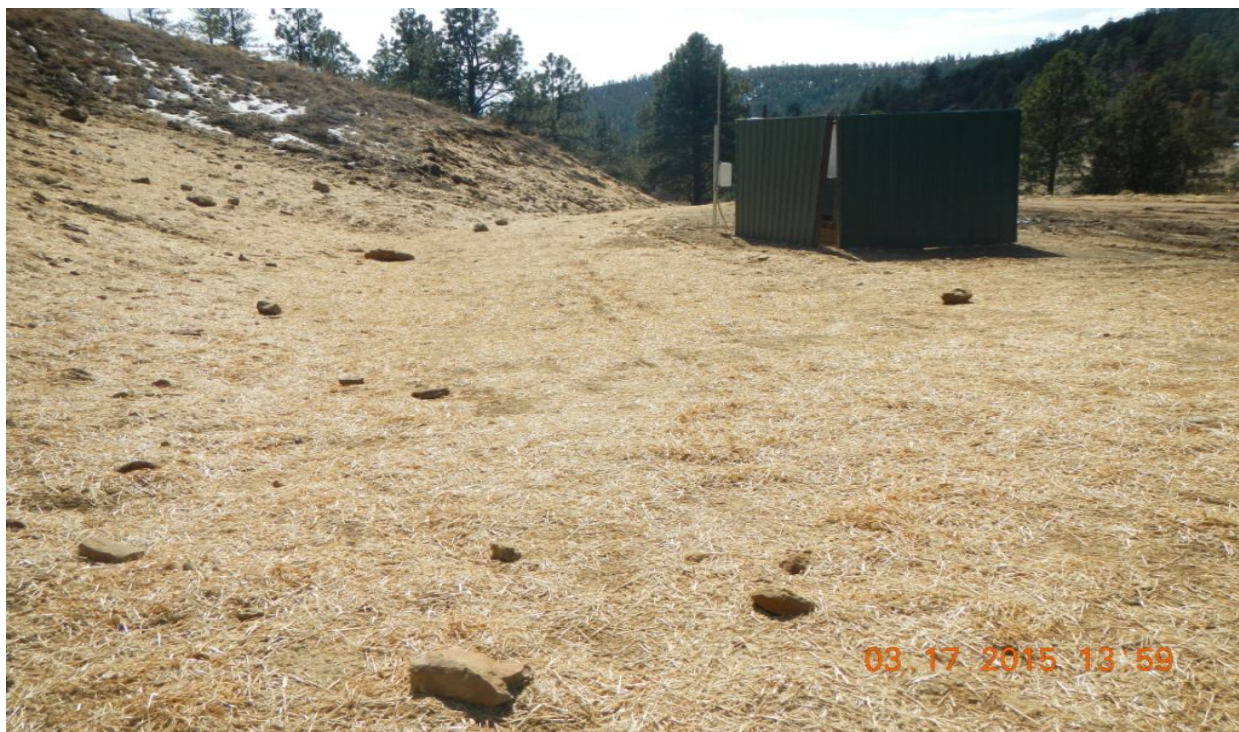
photo 7: The location has recently been straw mulched.
